NASA Technical Memorandum 81974

THUNDERSTORM HAZARDS FLIGHT RESEARCH -
STORM HAZARDS '80 OVERVIEW

JUNE 1981

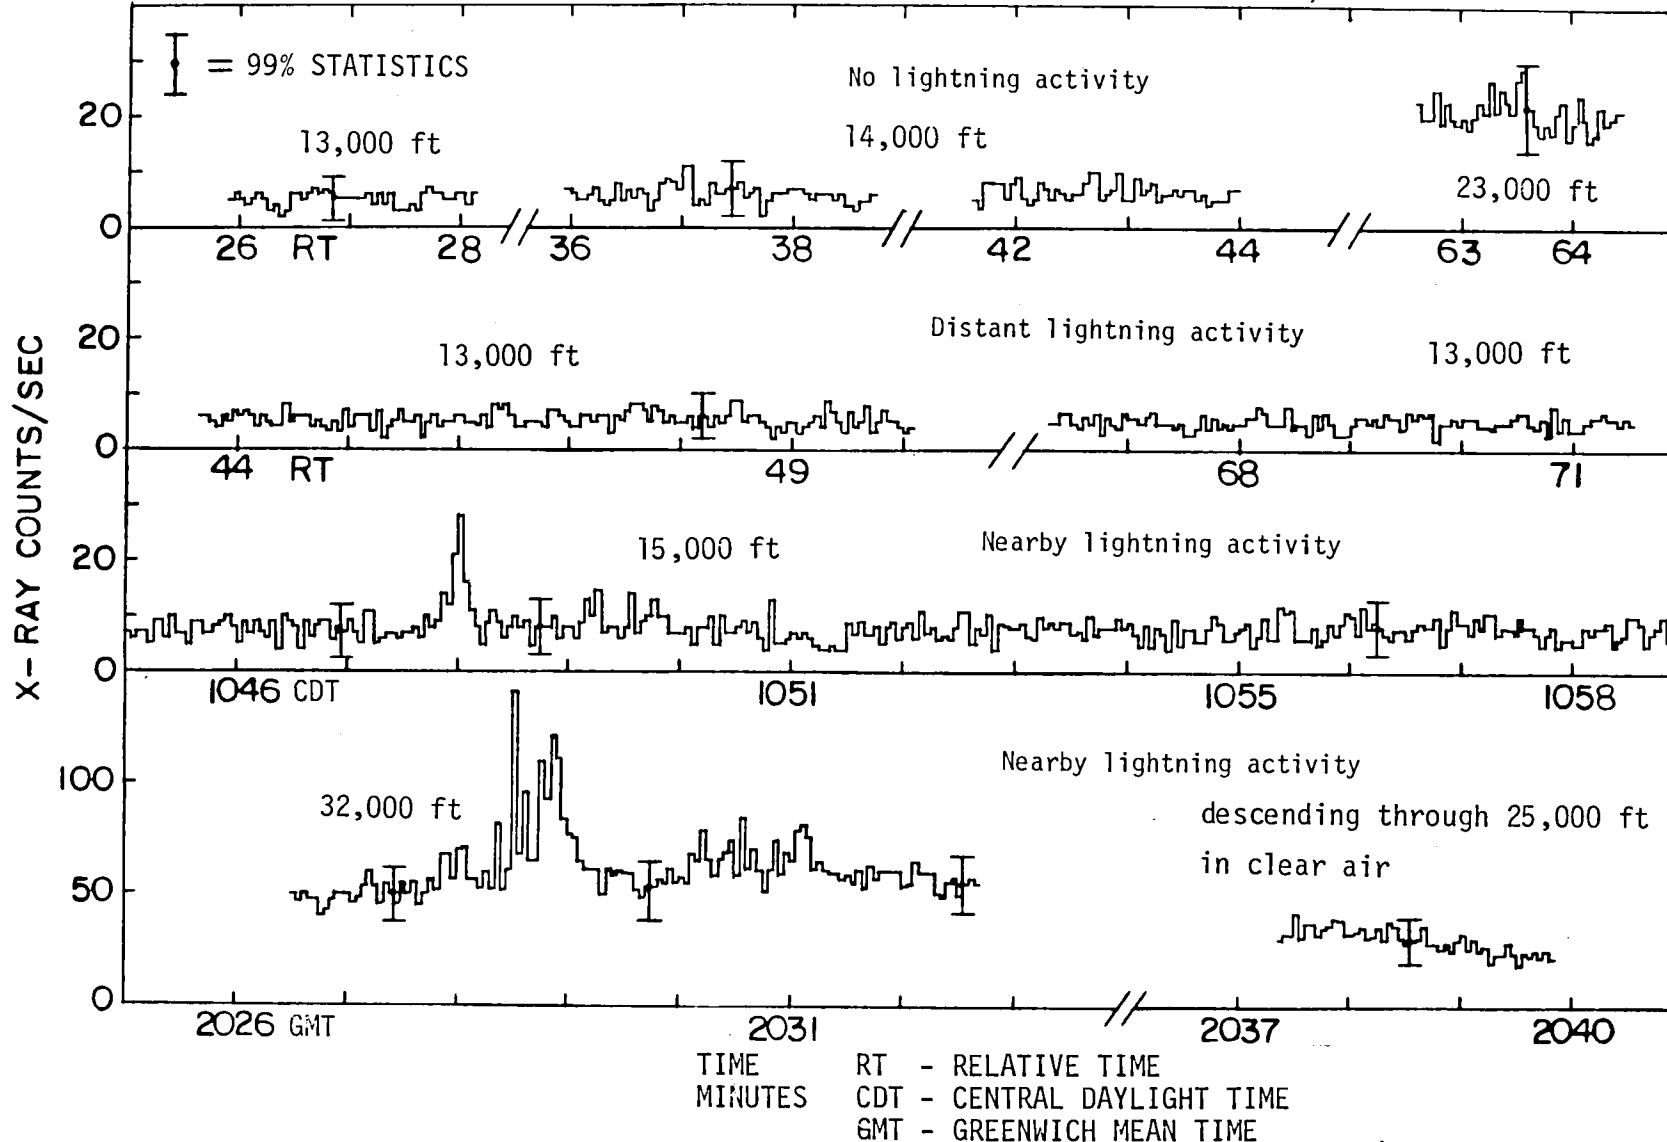
LIGHTNING X-RAYS -- > 12 KEV -- 3 SEC. AV. -- FLIGHTS 14, 13, 17, 38 ; 1980

Figure 11.- X-ray activity with and without lightning.

Detection of X-rays experiment.- This experiment confirmed the theory that lightning discharges X-ray fluxes. Although the results are preliminary, one strike generated 7 - 8 times the normal level of energetic electron activity associated with X-rays. In Figure 11, the top two data clips illustrate the activity of one X-ray energy level (12 thousand electron volts, keV) recorded in clear air with no nearby lightning. The error bars shown indicate the range wherein 99 percent of the clear air data fall. Also, it is noted that the error bar range varies with altitude. The remaining two data clips illustrate how this X-ray energy level was increased by nearby lightning activity. Additional analysis of the X-ray data is in progress (Ref. 6).

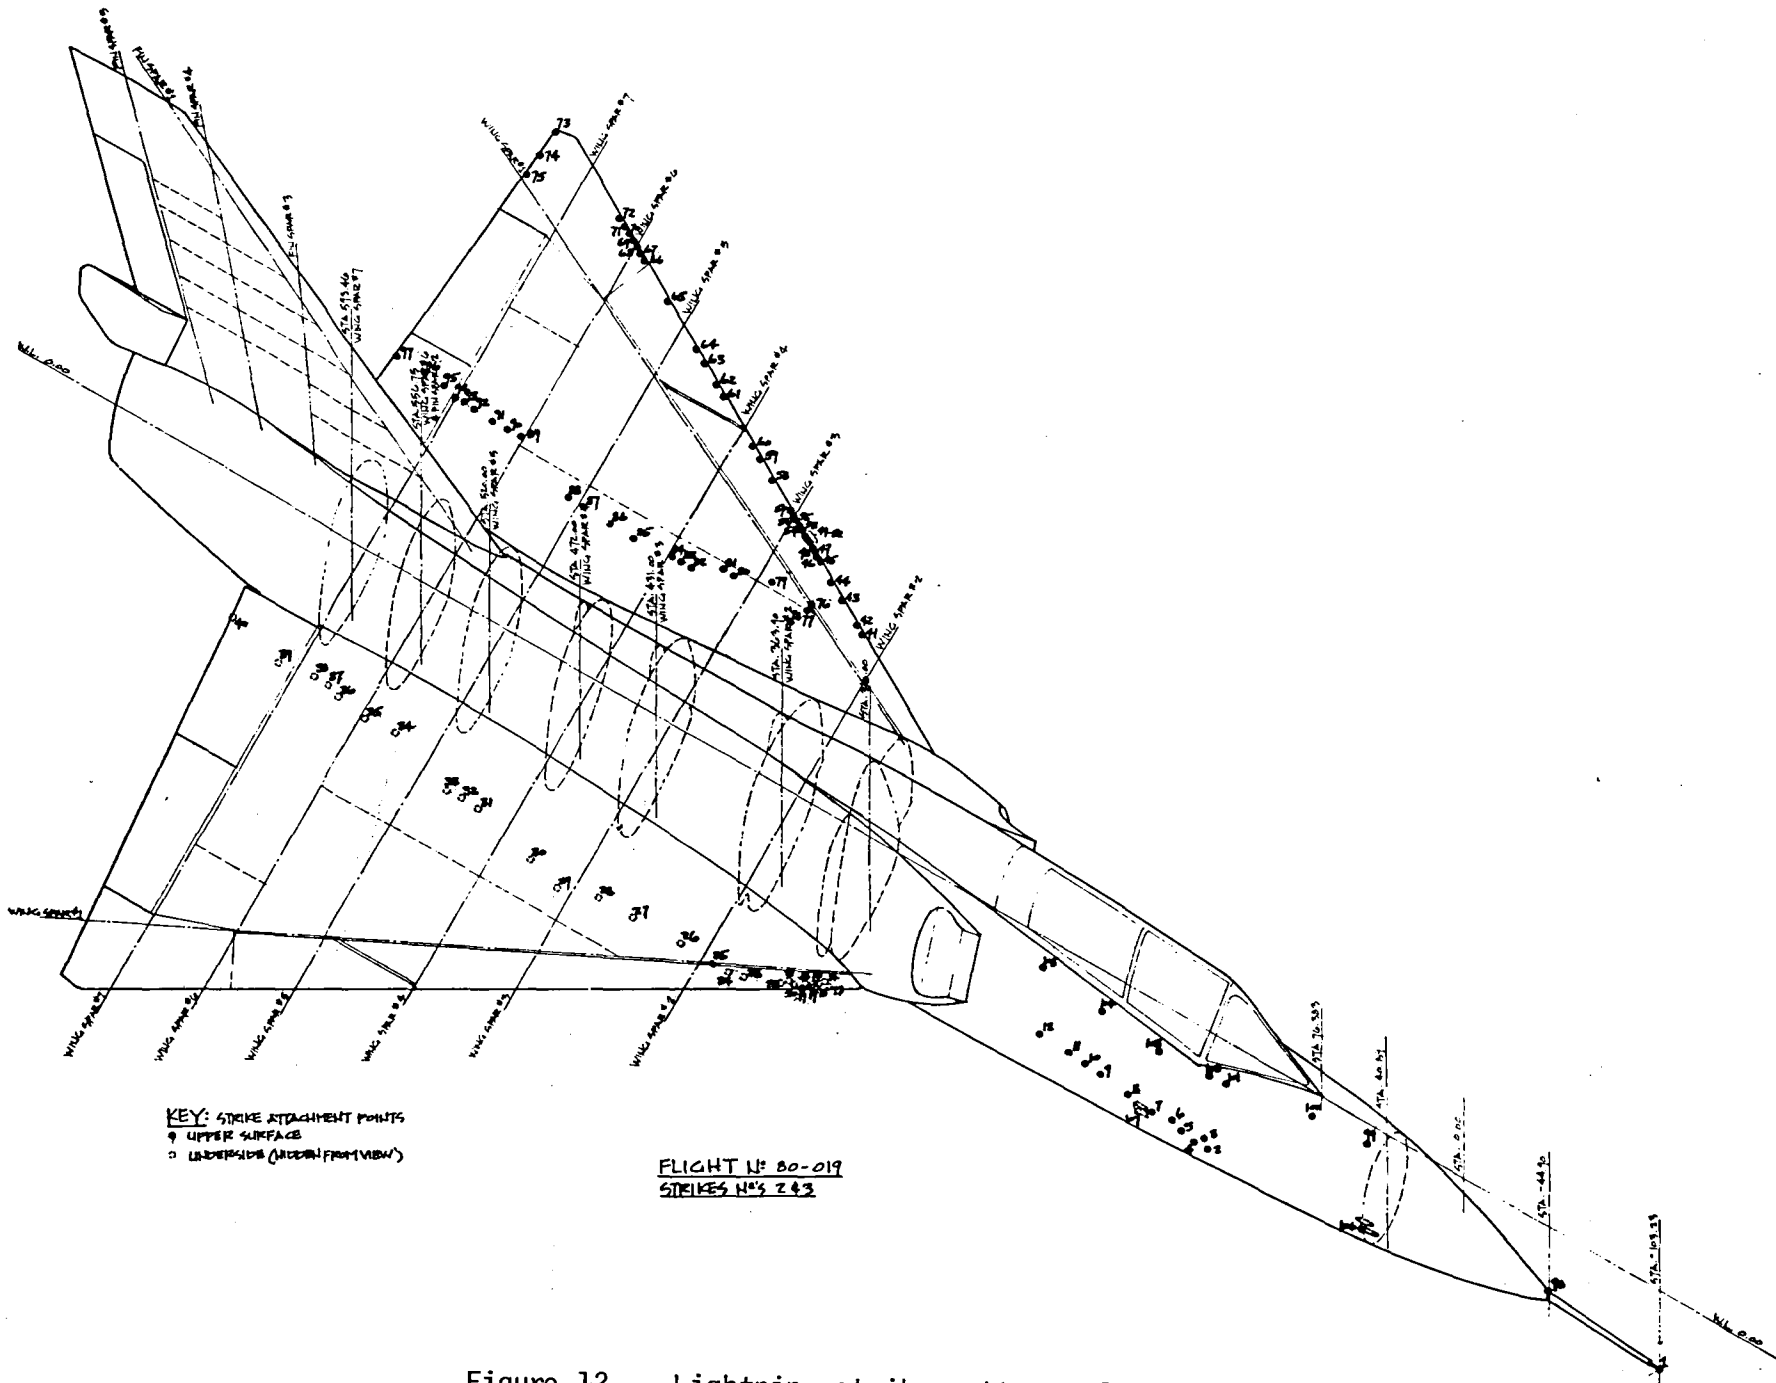
Figure 12.- Lightning strike patterns from two strikes.

Figure 12 shows an example of the strike pattern results from two lightning strikes that occurred on one flight. The flash swept aft across the top of the center of the left wing during one strike and beneath the center of the right wing during the other strike. In the past, most designers have considered mid-wing areas to be a region of very low probability of direct or swept lightning strikes, yet strike patterns like this occurred in three out of 10 strikes-a rather high percentage. These results thus indicate that greater attention should be given to design of protection for the surfaces of integral wing fuel tanks, at least in swept-wing aircraft. Additional information of this nature will become available as more strikes are recorded in the future.
