JT9D Performance Deterioration Results from a Simulated Aerodynamic Load Test

Prepared for the
Seventeenth Joint Propulsion Conference
cosponsored by the AIAA, SAE, and ASME
Colorado Springs, Colorado, July 27-29, 1981

JT9D PERFORMANCE DETERIORATION RESULTS FROM
A SIMULATED AERODYNAMIC LOAD TEST

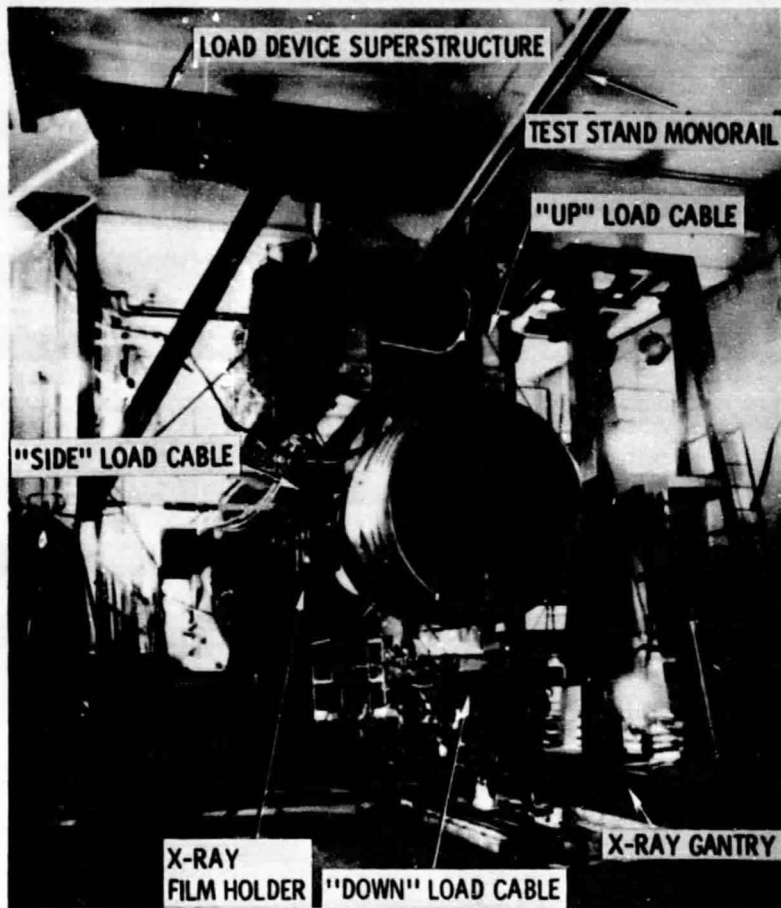
Figure 3. - JT9D-7AH test engine prepared for approach load.

The test was conducted in the P&W production radiographic test stand (Fig. 3). This stand was designed for sea level testing of large high bypass gas turbine engines with airflow rates up to 3000 lb/sec. The stand is equipped with a fully Automatic Production Test Data Acquisition and Control (APTDAC) system, which programs the engine test including the performance of such operations as start-

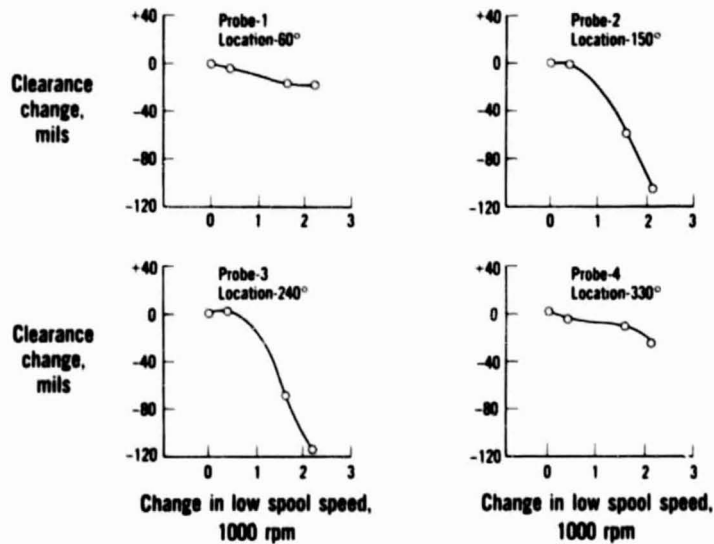
Figure 10. - Fan clearance changes (from ground idle) due to thermal loads - proximity probe data.

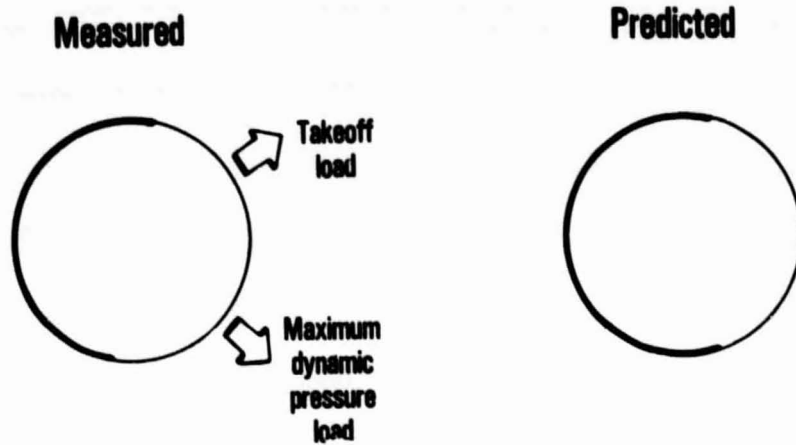
Fan outer airseal (looking forward)

Figure 14. - Predicted versus measured outer seal wear patterns produced by flight loads.

Seal land wear patterns observed during the teardown of the test engine are shown in Fig. 14 for the fan. The locations of wear were as expected. Wear in the upper left quadrant was produced by the maximum dynamic pressure air load which pulled the fan case down and to the right. The take-off air load pulled the fan case up to the right and produced wear in the lower left quadrant of the fan outer air seal.

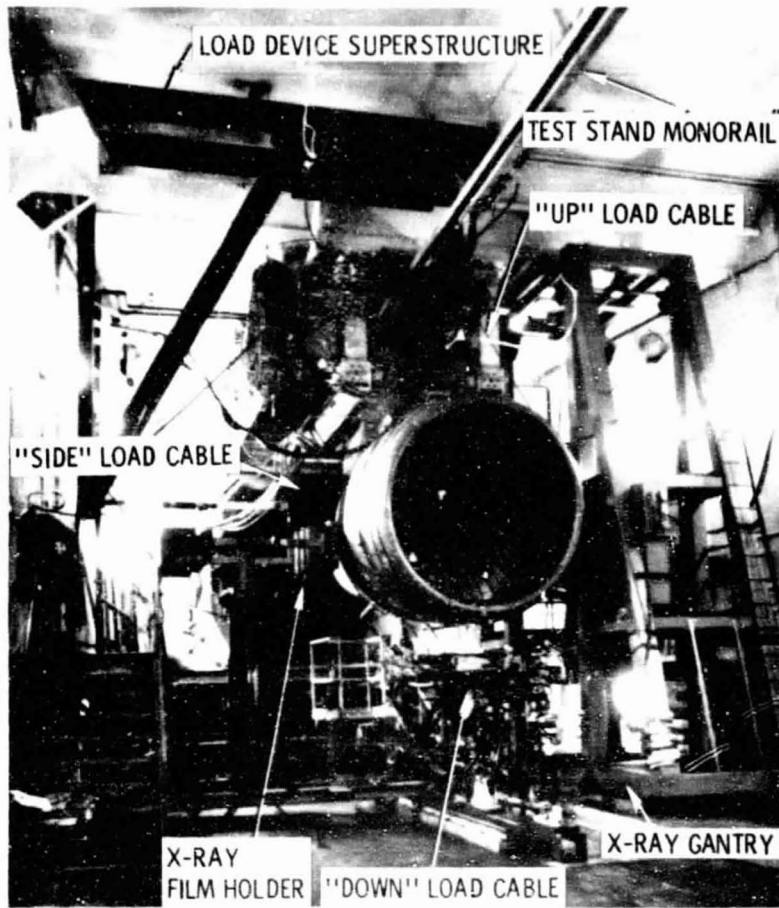
Figure 3. - JT9D-7AH test engine prepared for approach load.
