NASA Technical Memorandum 81960

Evaluation of Emergency-Locator-  
Transmitter Performance in Real  
and Simulated Crash Tests

Huey D. Carden  
*Langley Research Center  
Hampton, Virginia*

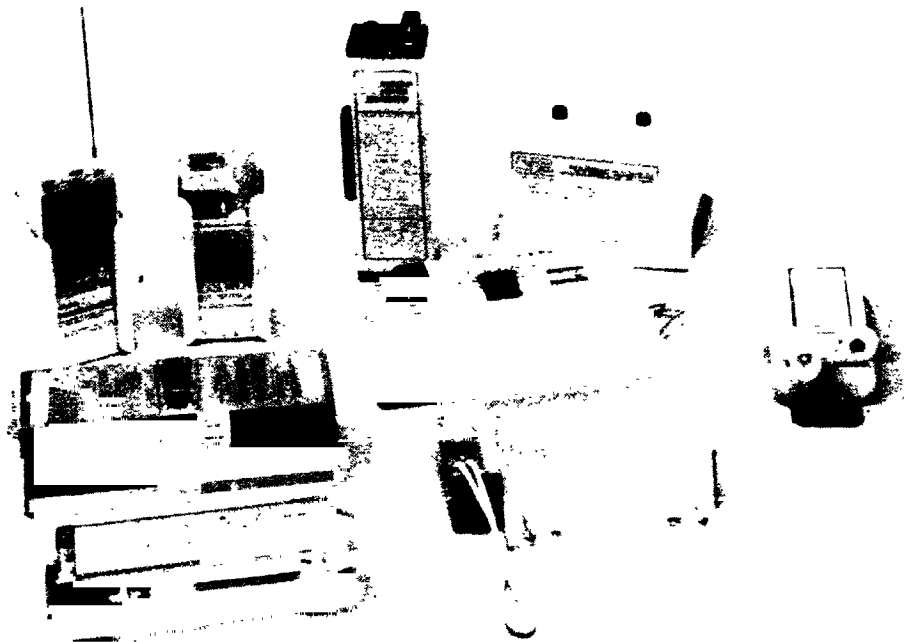
Figure 1.- Typical ELT's.

Description of ELT units.- Figure 1 is a photograph of nine emergency locator transmitters (ELT's) typical of the units from various manufacturers. The units are among those used for evaluating the performance of sampling of in-service and off-the-shelf units under realistic crash impacts to determine the basic causes of ELT false activations and/or nonactivation.

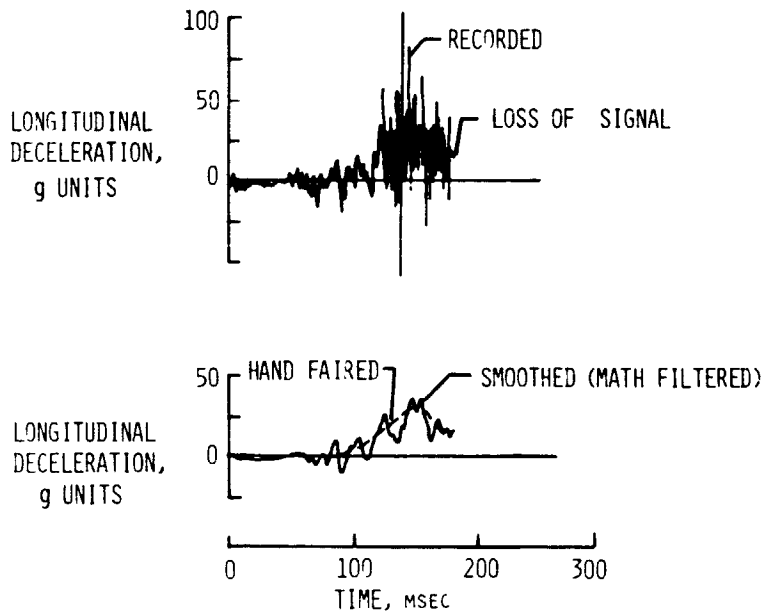
(a) Concrete surface.

Figure 3.- Typical measured longitudinal deceleration pulses for three different airplanes.

Crash pulses.- Typical measured longitudinal decelerations are presented in figure 3 for crashes of three different airplanes on concrete and dirt surfaces. The data are from accelerometers located on relatively rigid structure in the cabin area of the airplanes. These data show the nature of an actual environment the ELT can be subjected to in a crash situation. Figure 3(a) is for the crash test onto concrete. The top trace is the measured data with substantial high-frequency structural vibrations superimposed on the much lower frequency crash pulse. The bottom trace is smoothed data which show the underlying low-frequency, triangular-shaped crash pulse. The smoothing was accomplished using a least-squares fit reduction technique discussed in reference 7.

Two crash test decelerations for impacts on dirt are shown in figure 3(b). Basically no difference is noted between the crash pulses on dirt and on a concrete surface. (Compare fig. 3(a) and fig. 3(b).) The data of figure 3(b) also show the same high-frequency, local structural vibrations of the airplane overlaid on the low-frequency pulse evident in the smoothed data.

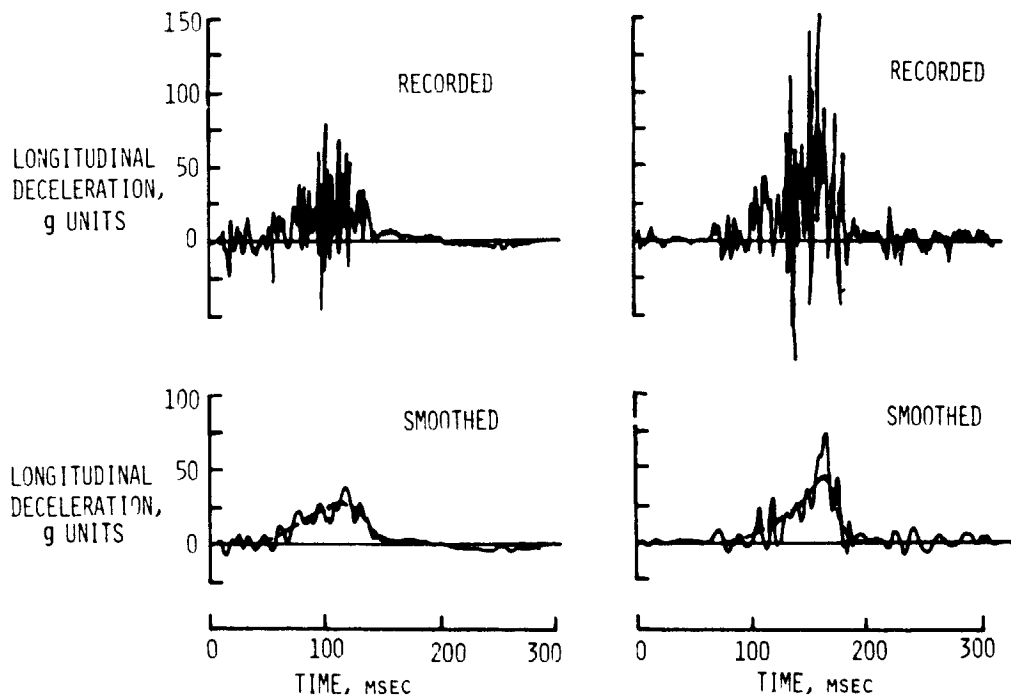
(b) Dirt surfaces.

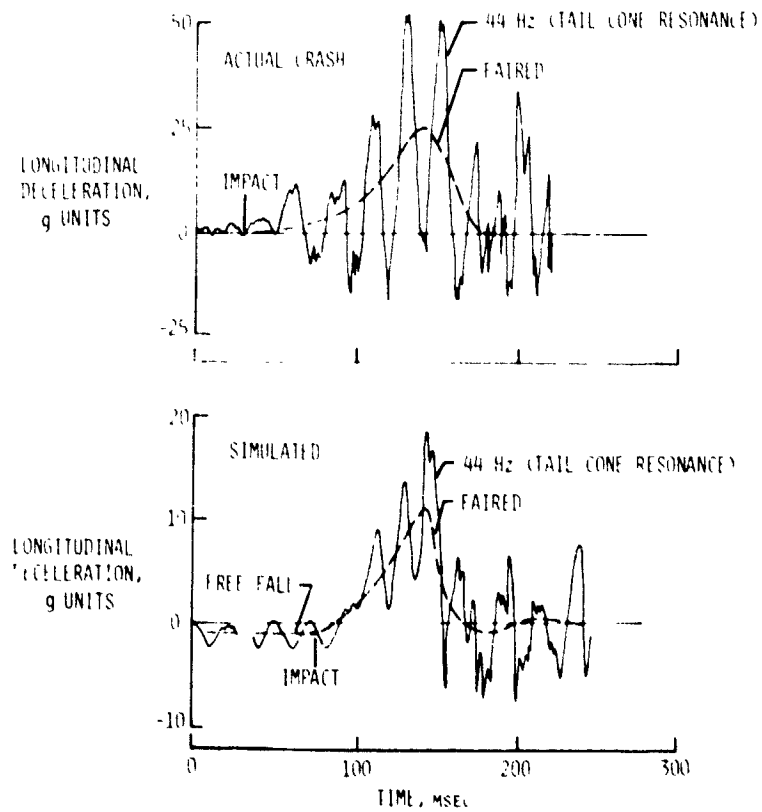
Figure 5.- Comparison of actual and simulated longitudinal deceleration crash pulse on ELT.

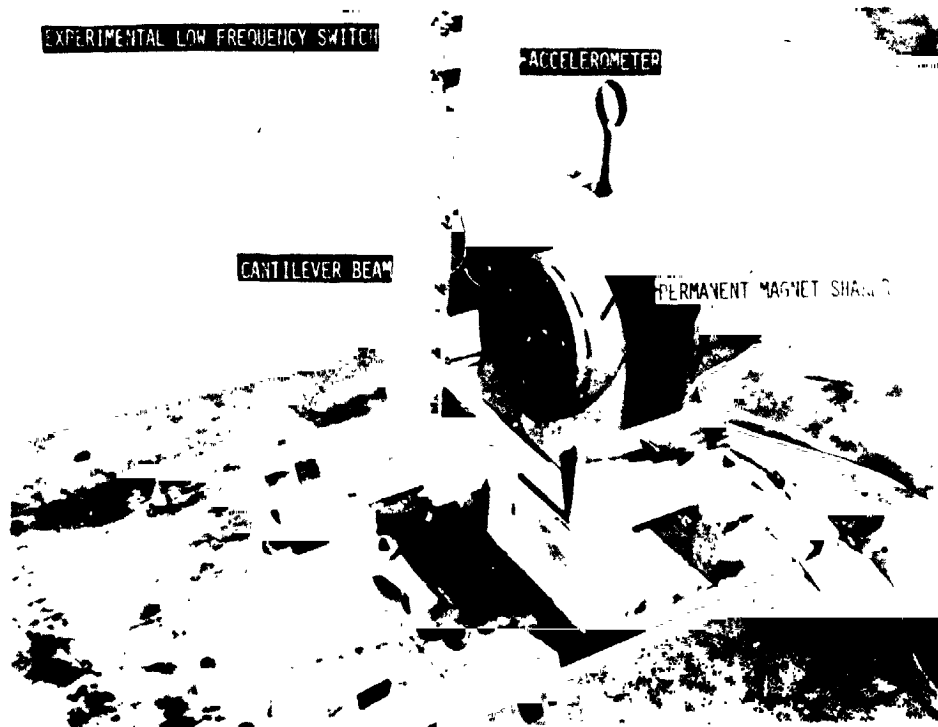
Figure 8.- Switch vibration apparatus.

Description of switch vibration apparatus.- In addition to the instrumentation used with the impact apparatus, figure 8 shows the additional apparatus used for conducting the ELT switch vibration study. A permanent magnet shaker with required electronics was used for vibrating the base of a beam clamped in a vise. The inertia switches were mounted to the tip of the beam. The cantilever beam approach permitted the necessary displacements at the low-frequency vibrations with the limited  $\pm 0.635$ -cm ( $\pm 0.25$ -in.) displacement capability of the shaker.

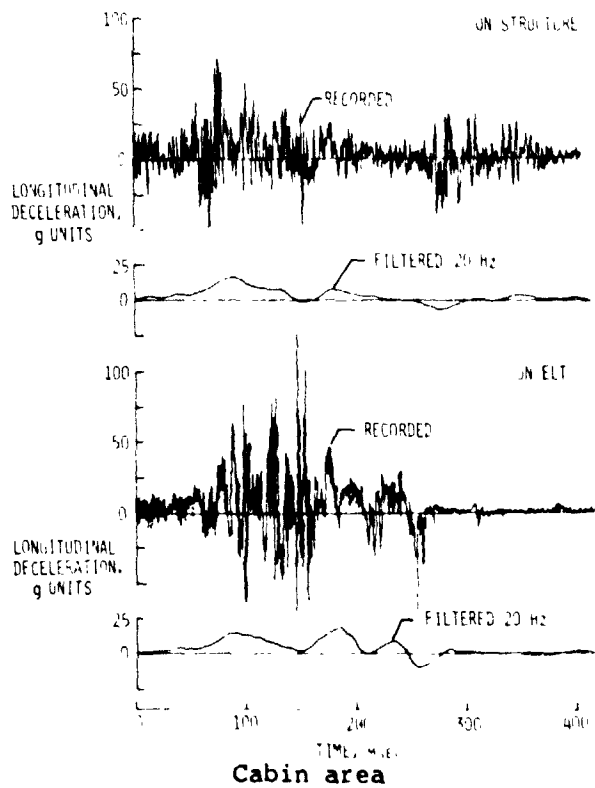
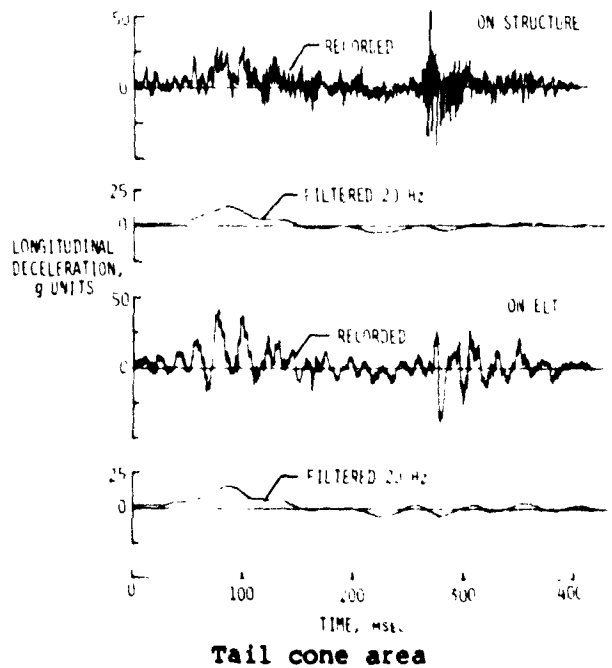
(a) Flight path,  $-30^\circ$ ; pitch angle,  $-30^\circ$ .

Figure 10.- Longitudinal decelerations in crash test airplane. Velocity, 27 m/sec (60 mph).

$-30^\circ$  flight path.- Decelerations at the  $-30^\circ$  flight path are presented in figure 10(a). The top of figure 10(a) shows the recorded and filtered (20-Hz low pass filter) decelerations in the cabin area. The two histories at the top are on the cabin structure whereas the next two are on the ELT unit. The bottom of figure 10(a) presents similar data for the tail area. The data indicate the presence of similar high-frequency local vibrations prevalent in the crash tests discussed in the section "Crash Environment Determinations." The filtered data show that the low-frequency underlying crash pulse was approximately 15g which is well above the 5g to 7g threshold for ELT activation. A comparison of the ELT data in the tail cone area with those in the cabin indicates that the superimposed high-frequency vibrations were of somewhat lower magnitude in the tail than in the cabin, however; the basic crash pulse loading in this region of the airplane was also approximately 15g. The ELT in the cabin activated during the crash. In the tail, one of the two ELT's failed to activate; yet when the ELT was removed from the airplane immediately after the crash test and swung by hand, it did activate.

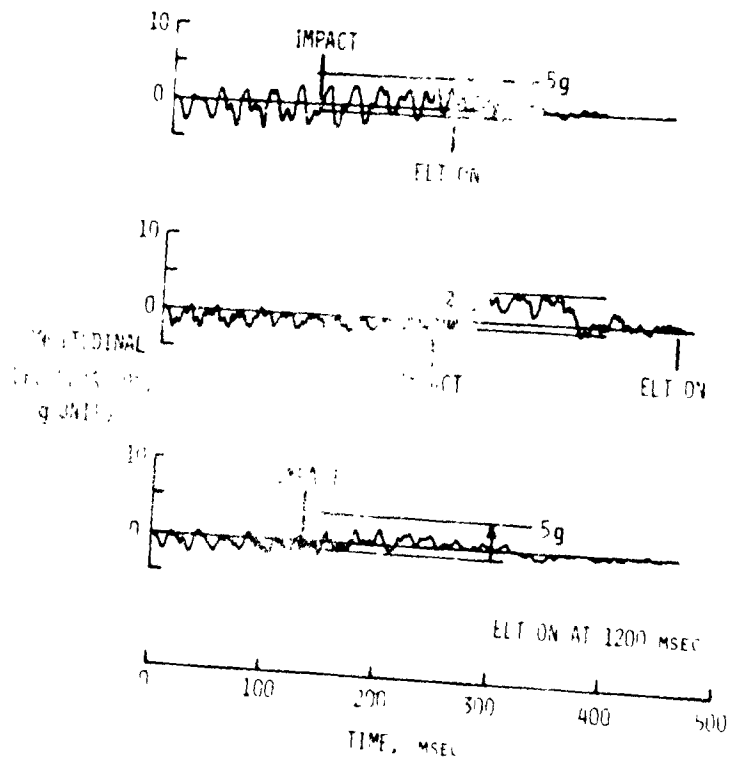
(a) Out of specifications - below threshold.

Figure 11.- Typical laboratory impact test results on ELT activation.

Out of specifications - below threshold.- Typical longitudinal decelerations on three of five ELT units that activated during the impact study well below the proper specified threshold activation level of 5g are shown in figure 11(a). The structural resonance of the airplane tail cone may be noted on all the deceleration traces. Typically for these ELT units, the impact apparatus had to be lowered until the impact wedges (fig. 4) were just touching or actually penetrating the glass beads before activation of the units would not occur upon impact of the test apparatus.

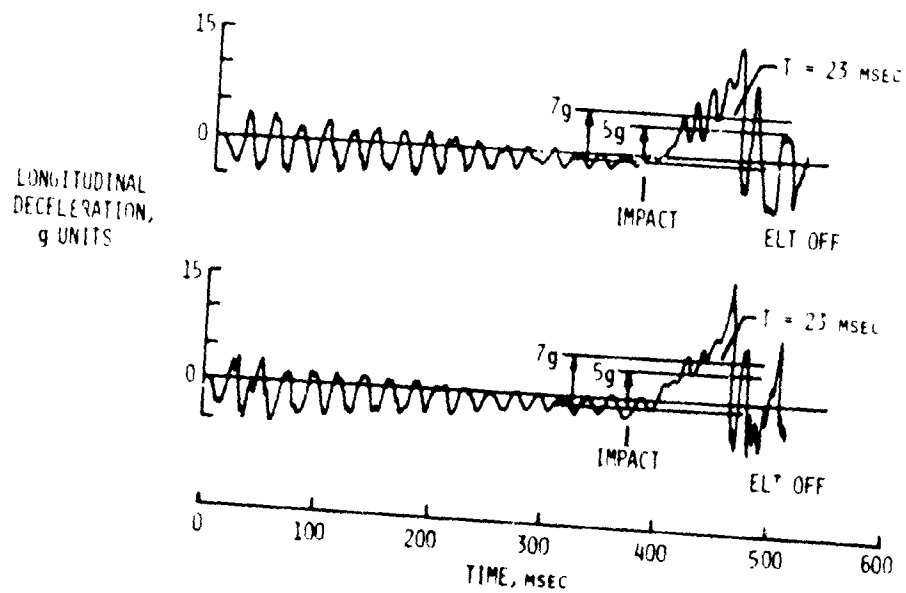
(b) Out of specifications - above threshold.

Out of specification - above threshold.- Figure 11(b) presents longitudinal decelerations on two of three ELT units that did not operate at the proper specified deceleration level although, as noted in the figure, the ELT units experienced sufficient deceleration magnitude and time (T) durations to have activated even at the upper allowed 7g level. These particular ELT units also failed to properly activate even from the upper limit of impact velocity of the apparatus of approximately 4.57 m/sec (15 ft/sec).

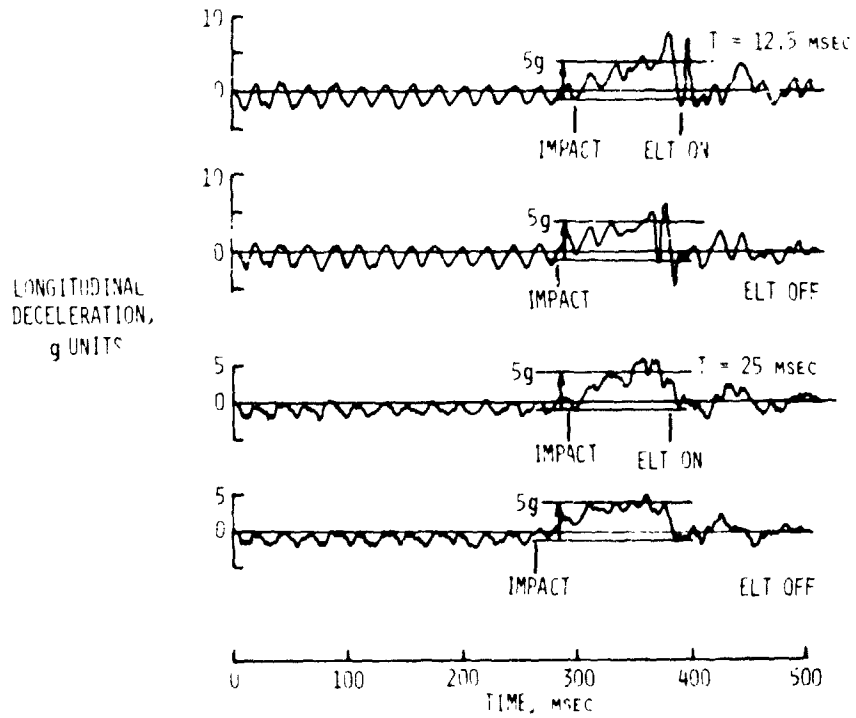
(c) Within specifications.

Within specifications.- Decelerations for two of three units that activated within the ELT activation specification levels are shown in figure 11(c). The top traces are for one unit; the two bottom traces are for a second ELT. The upper traces for each ELT (labeled "ELT ON") show that when the ELT's experienced a deceleration pulse greater than 5g for at least 12.5 msec, activation of the unit occurred (activation verified by radio receiver). Similarly, the deceleration on the same unit at a slightly lower impact velocity shows that the magnitude of the deceleration was not above 5g for sufficient time and the ELT properly did not activate (traces labeled "ELT OFF"). A comparison of the measured time to reception of signal from ELT's indicates a wide spread in delay time for transmission to occur. Whether some part of the delay was a result of some of the units being out of specifications could not be assessed from these tests.

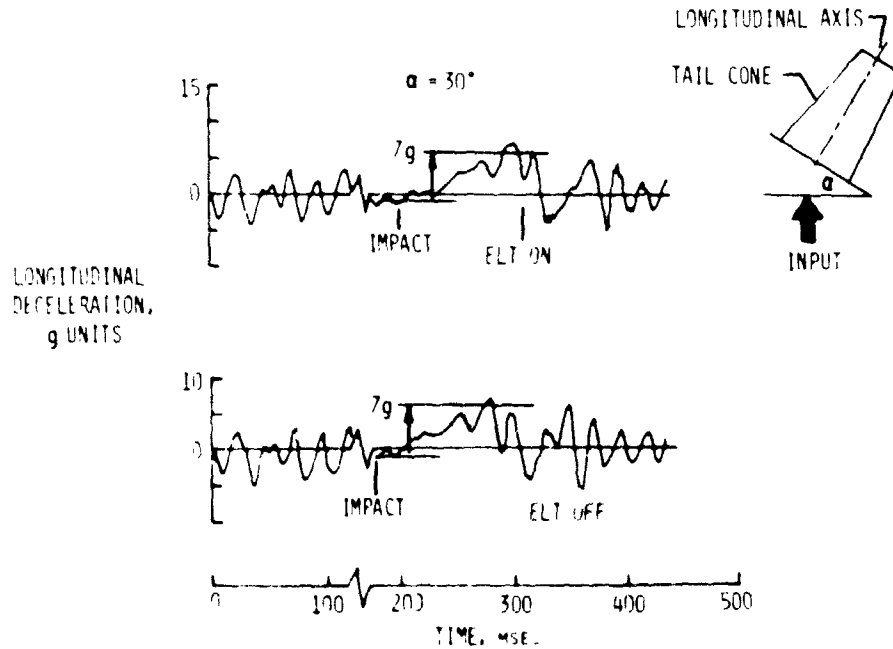
Figure 12.- Off-axis impact results.

The previous data are for impacts along the longitudinal axis of the tail cone in the ELT impact test apparatus. Tests were also conducted to evaluate off-axis impacts on the activation of ELT's. The cylindrical section with the airplane tail cone mounted on the platform (fig. 4) can be rotated relative to the impact wedges of the ELT impact test apparatus. Any angle between 0° and 90° can be obtained in this fashion so that the impact wedges can be set at any desired angle to the sensitivity axis of the ELT mounted in the tail cone. Figure 12 illustrates typical results of the off-axis deceleration input study. Angles,  $\alpha$ , of 0°, 15°, 30°, 45°, and 90° were used in the investigation. An ELT which was within the activation specification levels was used in the tests. The data illustrated in figure 12 are for an angle

of 30°. In the top part of the figure, the component of the impact deceleration acting along the longitudinal sensitivity axis of the ELT was of sufficient magnitude to exceed the activation threshold and the ELT activated. On the other hand, the bottom figure shows that at a slightly lower deceleration level, the magnitude of the component along the sensitivity axis of the ELT was not sufficient to activate the ELT. Analysis of all the off-axis data indicated that, as expected, if the component of deceleration along the ELT sensitivity axis is greater than the 5g threshold, the ELT activates and forces perpendicular to the sensitive axis of the ELT did not cause activation problems.

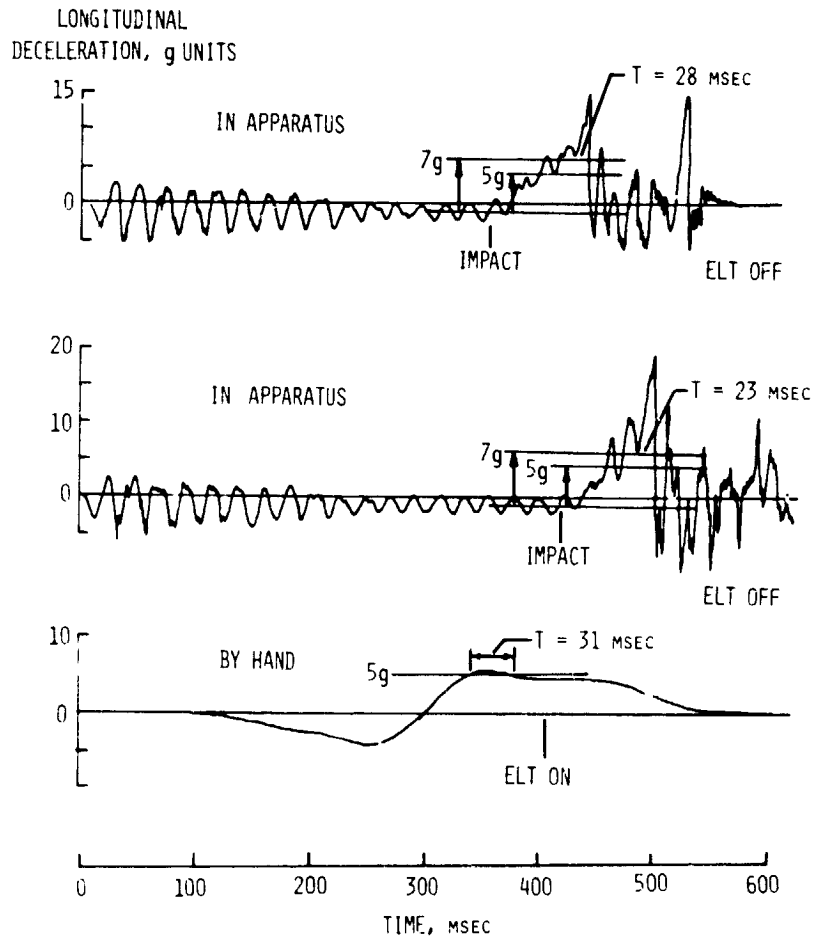
Figure 13.- Anomalous ELT activation behavior.

Figure 13 illustrates anomalous behavior exhibited by an ELT unit used in the impact tests. The deceleration trace at the top of the figure is for an impact with the ELT mounted in the tail cone of the ELT impact test apparatus. As may be noted in the first two traces in the figure, the ELT experienced deceleration magnitude and duration well exceeding the 5g and 7g threshold levels but the ELT did not properly activate. However, when the ELT was removed from the tail cone and whirled by hand to produce the deceleration (bottom trace) that just exceeded the 5g threshold, the ELT activated. Based upon these results, it was concluded that the cantilever beam inertia switch was being affected by the higher frequency vibrations. Additional results on the evaluation of the sensitivity of the impact sensors to local vibrations are discussed in subsequent sections.

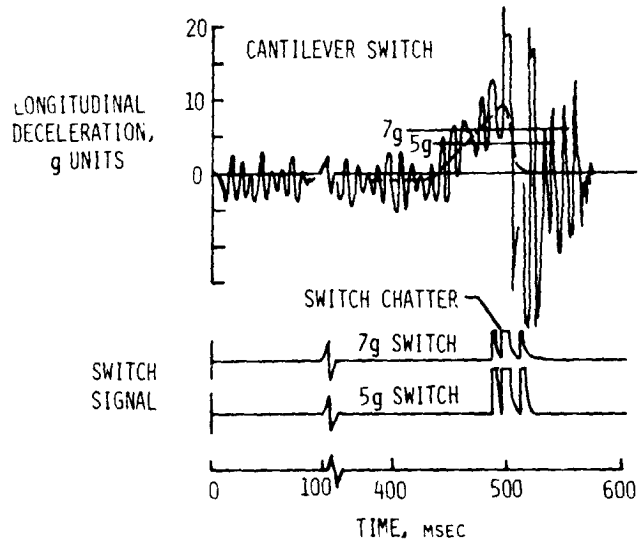
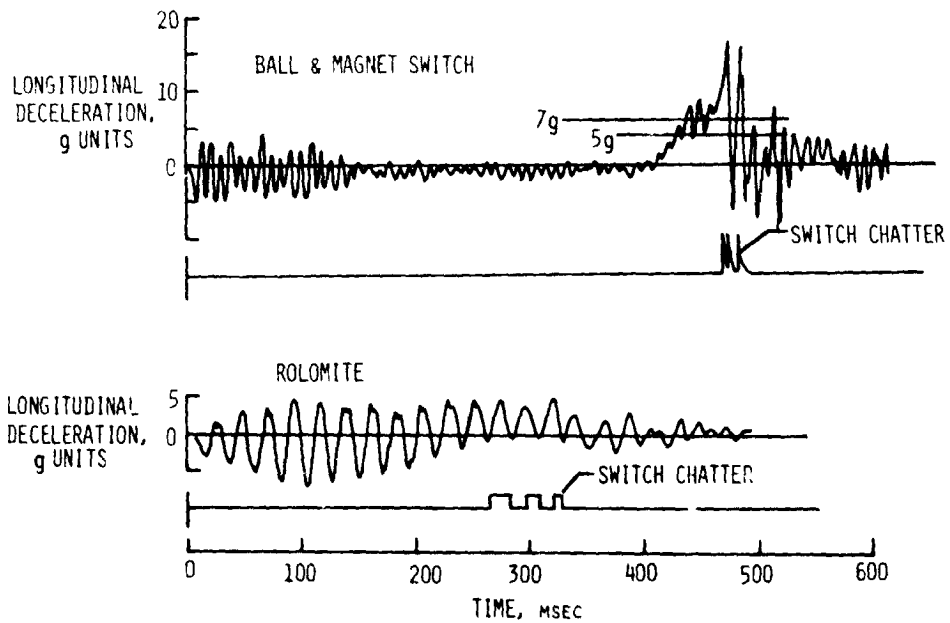
(a) Cantilever beam switch.

(b) Ball and magnet and rolomite switches.

Figure 14.- Inertia switch chatter during impact tests.

Inertia switch chatter.- Figures 14(a) and 14(b) indicate that ELT sensors respond to the structural vibrations superimposed on the lower frequency input deceleration pulse obtained with the impact test apparatus. Figure 14(a) shows results for two cantilever beam switches. The top trace in the figure is the impact deceleration, whereas the lower two traces are switch contacts for both a 5g and a 7g threshold switch. The contact of the switches is being affected by the higher frequency vibrations on the input deceleration pulse. Responses of a ball and magnet and a rolomite switch to pulse inputs with higher frequency vibrations are shown in figure 14(b). The top traces are the input to the ball and magnet switch and the switch contact behavior. The two bottom traces are for the rolomite switch. Both sensors show chatter from the superimposed higher frequency structural vibrations.

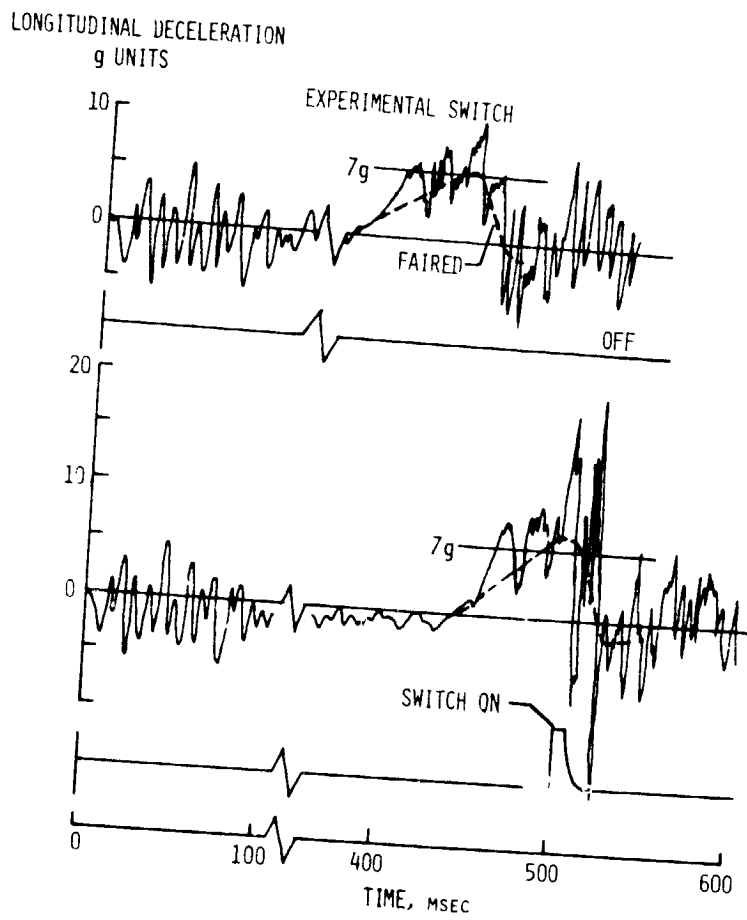
(c) Experimental low-frequency switch.

The impact behavior of the experimental low-frequency switch is shown in figure 14(c). The top trace in the figure shows the deceleration pulse with the higher frequency vibrations, which was imposed on the experimental switch. Neither the underlying deceleration pulse nor the vibrations caused the switch to make contact in this case. In the bottom trace, a deceleration pulse

exceeded the activation threshold of the low-frequency switch, and switch contact occurred. Data for these tests indicate that the switch made contact as it should have but was not affected by or was sensing the higher frequency structural vibrations present on the basic input pulse. This behavior is highly desirable to minimize possible false activations from structural vibrations during noncrash situations or nonactivations during crashes because of the vibration-induced on-off-on-off contact of the switch which may prevent ELT electronic latching times from being achieved.

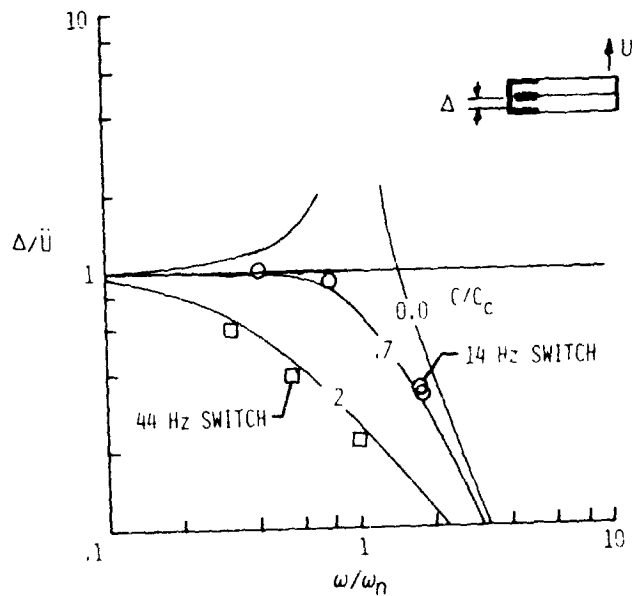
Figure 15.- Sinusoidal vibration test results for ELT switches.

Switch vibration sensitivity.— In figure 15, a classical plot used to describe the behavior of a simple oscillator is presented to allow a comparison between the response of the experimental low-frequency switch (14-Hz cantilever) and a commercial switch (44-Hz cantilever). In nondimensional terms, the ratio of the switch gap displacement  $\Delta$  (for switch contact to occur) to the switch base acceleration  $\ddot{U}$  at contact is given as a function of the ratio of sinusoidal forcing frequency  $\omega$  to the undamped switch natural frequency  $\omega_n$ . Three curves for damping ratios  $C/C_c$  of 0.0, 0.7, and 2 are presented out of the family of curves possible depending on the damping values ( $C$  is actual damping and  $C_c$  is critical damping). As indicated in the figure, the experimental 14-Hz switch had a damping ratio of 0.7. The switch will respond identically to the amplitude of input frequencies up to essentially its undamped frequency of 14 Hz ( $\omega/\omega_n = 1$ ) but becomes less responsive to those frequencies above 14 Hz. For example, at approximately 42 Hz, 3 times the natural frequency ( $\omega/\omega_n = 3$ ), the response ratio is only 0.1. On the other hand with its higher natural frequency, the commercial 44-Hz switch (with  $C/C_c = 2$ ) still has a ratio of 1/10 at approximately 88 Hz ( $\omega/\omega_n = 2$ ). The important point to note is that, even being more highly damped, the commercial switch is too sensitive to the frequencies in the range of 30 Hz and above which places it too much into the purely local structural vibration regime of airplanes. Data on switches presented in the form of this figure also allow one to readily determine the damping ratio in the sensor during experimentation with a switch design of a known undamped natural frequency. By testing the switch at  $\omega/\omega_n = 1$ , the switch damping can be found from a nondimensional plot such as shown here.

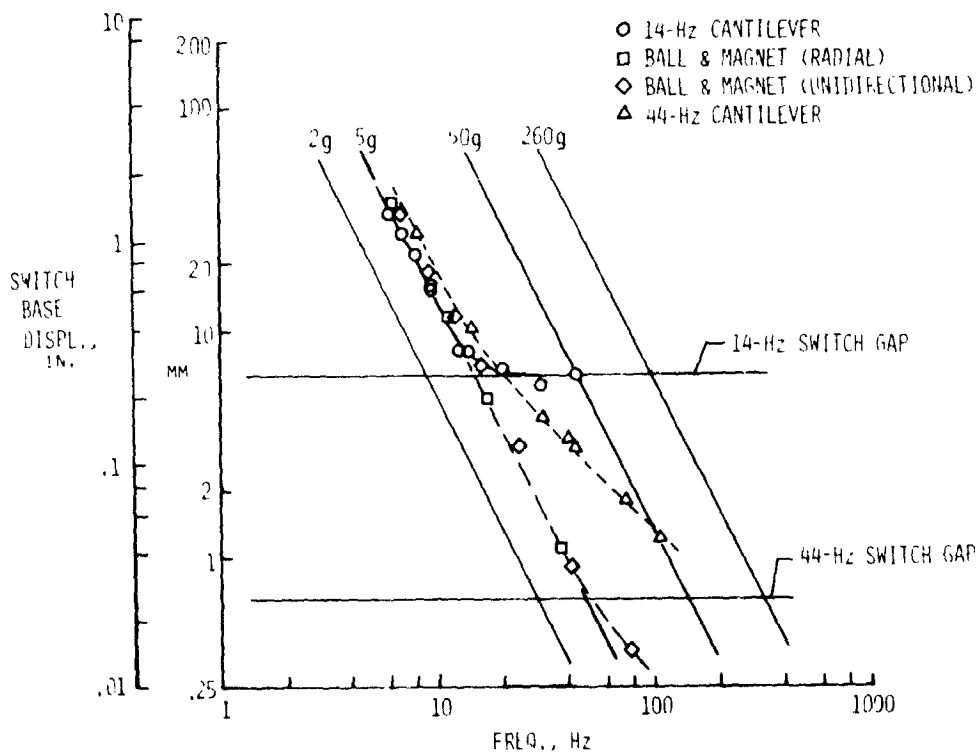
Figure 16.- ELT switch vibration displacement as a function of excitation frequency.

In figure 16, additional results from the switch sensitivity tests are presented for both the experimental 14-Hz cantilever switch and the 44-Hz commercial cantilever switch of the previous figure along with ball and magnet switches, one a unidirectional and one with a radial sensitivity. Switch base displacement for switch contact to occur is plotted as a function of the excitation frequency. Lines of constant  $g$  units are also shown in the figure for reference. The data indicate that below approximately 20 Hz the experimental cantilever switch, the commercial switch, and the two ball and magnet switches respond essentially the same. The only difference between the 44-Hz commercial cantilever and the other switches is that it is a 7g threshold switch instead of a 5g switch. Note, however, that, above approximately 20 Hz, the displacement of the switch base for switch contact to occur approaches the switch gap of 6.35 mm (0.25 in.) in the 14-Hz experimental switch whereas the 44-Hz switch displacement continues to decrease and approaches its switch gap of 0.635 mm (0.025 in.) at much higher frequencies. At the higher frequencies, the accelerations of the low-frequency 14-Hz switch must be very large before switch contact can occur. On the other hand, the 44-Hz commercial switch

makes contact at substantially lower displacements; for example, at 44 Hz the commercial switch will make contact at 24g, whereas 50g is required for the 14-Hz switch. Similarly, at 100 Hz, the commercial switch will contact at 54g, but the low-frequency switch requires 260g for contact to occur.

Data for the two different ball and magnet switches are quite revealing. At the low end below 20 Hz, the response is essentially the same as the other type of switches. However, with increasing frequency the g level for contact of the switch continues to be essentially 5g to 6g. At approximately 90 Hz, the level increased to only 9g. It is interesting to note that in reference 5, an ELT brand which had one of the worst false activation records was one that uses the ball and magnet switch. Based upon the data in this figure, that record can be better understood.
