NASA CR-165201
PWA-5604-31

TURBINE BLADE TEMPERATURE MEASUREMENTS
USING THIN FILM TEMPERATURE SENSORS

UNITED TECHNOLOGIES CORPORATION
Pratt & Whitney Aircraft Group
Commercial Products Division

Prepared for
NATIONAL AERONAUTICS AND SPACE ADMINISTRATION

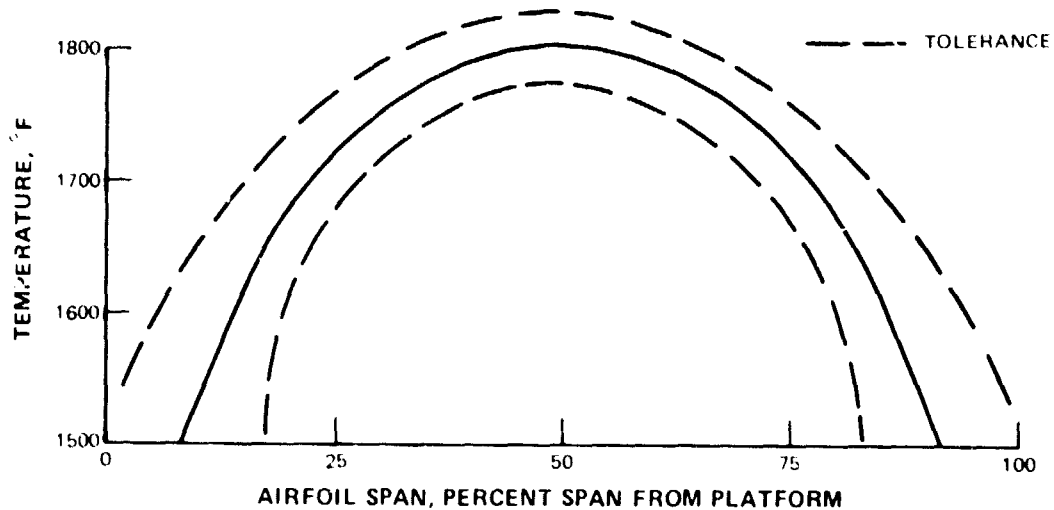
Figure 2 Contractually Specified Surface Temperature Profile - Blade surface temperatures during the test program were within the tolerance band.

1. Maximum operating temperature, 1250K (1800°F);
2. Test temperature profile as defined by Figure 2;
3. Fuel source for the exhaust gas flame, hydrocarbon fuel;
4. Twenty complete thermal cycles from room temperature to the 1140 to 1250K (1600 to 1800°F) temperature range;
5. Exhaust gas conditions of nominally 1 atmosphere pressure and a Mach number range of 0.5 to 0.7.
6. Peak vibrational accelerations of up to 8 g's in any or all axes over a frequency range of 100 to 400 Hertz.

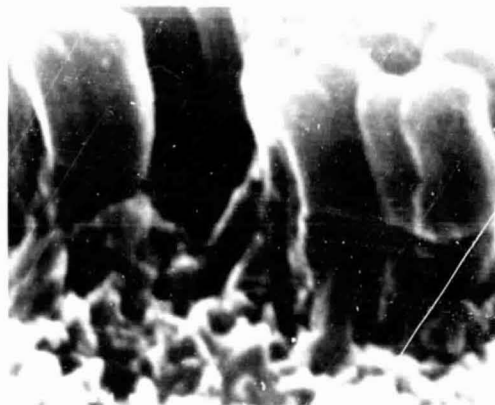
Figure 11 Scanning Electron Microscope Views of the Aluminum Oxide Structure on Blade C, Resulting in Poorly Adherent Platinum and Platinum-10% Rhodium Films - The "corn-cob" outer structure of the oxide is clearly visible at the higher magnifications. The fine-grained structure underlying the corn-cob (at a depth of 11,000 Angstroms) is also aluminum oxide. This is the same blade as that shown in Figure 10.

Further SEM examination of the Blade C oxide structure (Figure 11) reveals a corncob appearance with a demarcation plane within the corncob structure at the 6000-Angstrom depth. The corncob extends below this level to a depth of 11,000 Angstroms. Below this is a close-grained Al_2O_3 surface. It appears that the initial growth of Al_2O_3 was normal during heat treatment in hydrogen, and perhaps during part of the furnace oxidation in air. By the end of the oxidation process, the coarse nodular corncob structure had developed and was preserved during subsequent sputtering of Al_2O_3 and heat treatment in air. The literature reveals that various nodular, cellular, or columnar Al_2O_3 structures can be produced by growth on aluminum surfaces containing asperities or on aluminum surfaces pretreated with phosphoric or chromic acid in preparation for epoxy adhesive bonding of aluminum panels (Reference 9). The corncob structure is reminiscent of these structures but not exactly like any previously reported structure. Surface finish and oxidation were the same on all blades. In fact, Blade A and Blade C were oxidized in the same furnace at the same time. Therefore, it appears that the difference in structure may have stemmed from some difference in initial coating surface chemical composition.

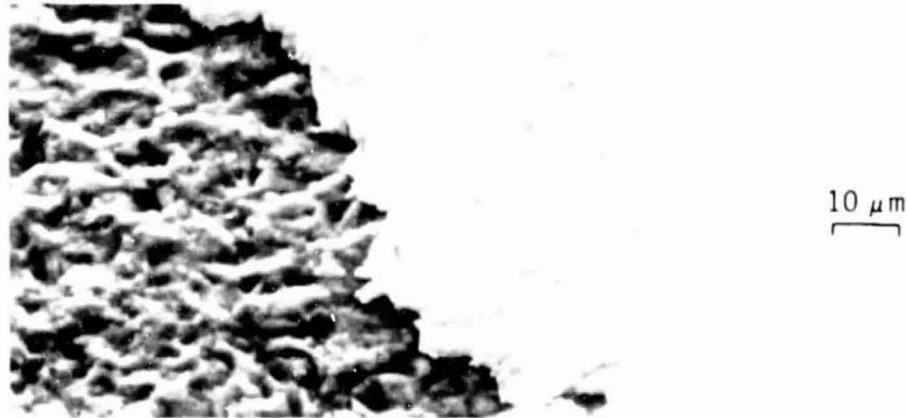
Figure 12 Scanning Electron Microscope View of Aluminum Oxide Surface (Darker Area at Left) and Platinum Film Surface on Blade No. 1 Before Combustor Tests - Adherence of platinum and platinum-10% rhodium films was generally good. The aluminum oxide structure is similar to that of Blade A, Figure 9, previously identified as a "good adherence" surface.

process was later confirmed by coating a second set of turbine blades for use in the combustor exhaust gas-stream tests. Figure 12 shows the surface structure of Blade No. 1 from this second batch, used successfully in combustor exhaust tests. The oxide structure is similar to the "good" structure in Figure 9. Further study of the coating process and alumina-forming process would be required to identify the cause of the difference in surface structure.

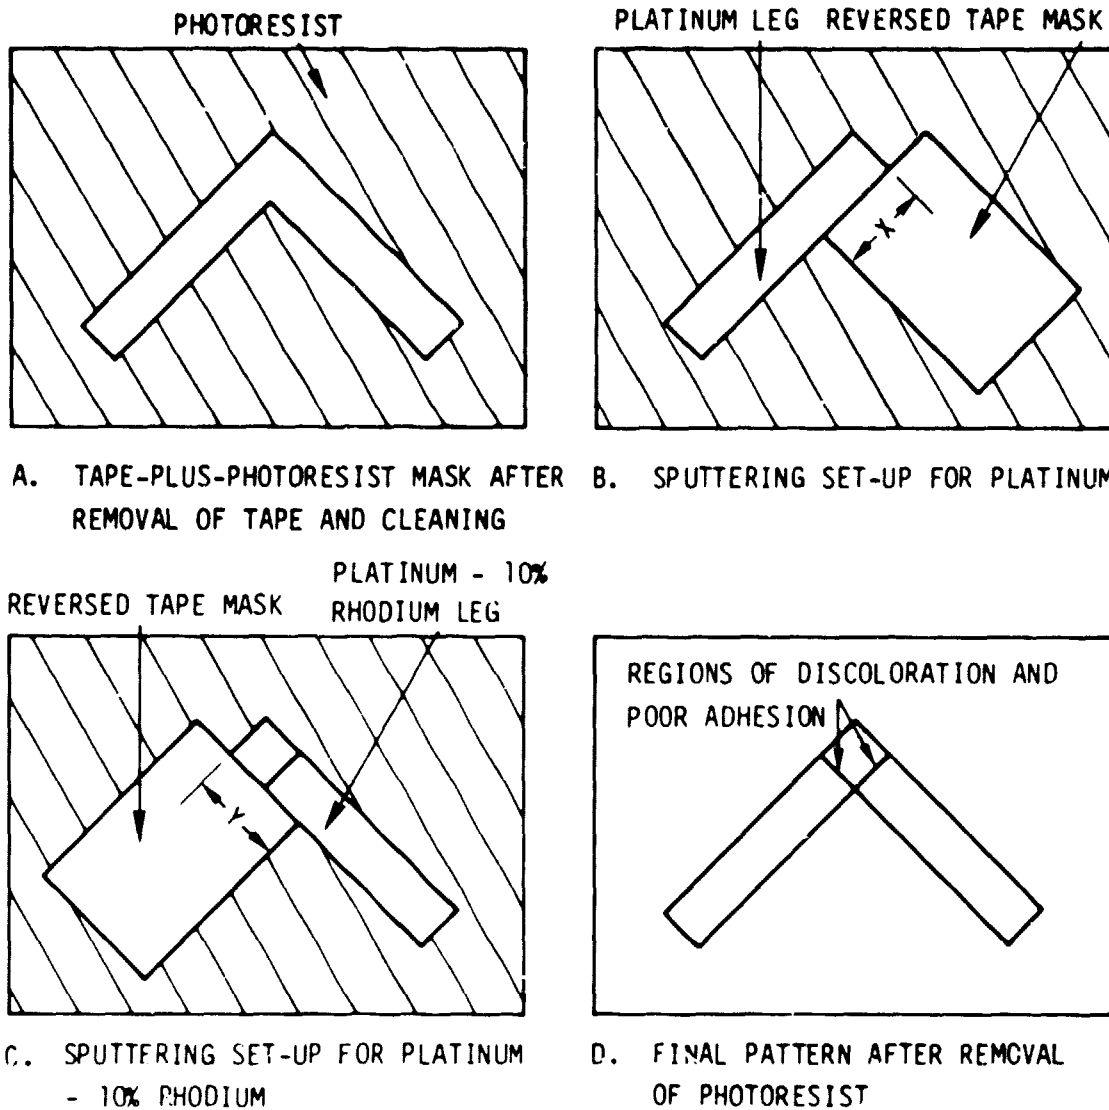
Figure 13 Crossed-Tape Masking Procedure, Showing Region of Poorly Adherent Films at Junction.

where the second film overlapped the first film to form a thermocouple junction. In these regions, the sputtered films were discolored and poorly adherent. A typical sequence of masking and sputtering steps, and the resulting region of poor adherence, is diagrammed in Figure 13.

It was concluded that two difficulties contributed to the poor result. First, where the tape shadow mask forms one edge of a sputtered region (that is, at X or Y in Figure 13) the nearby bare Al_2O_3 surface on which the sputtered film was being deposited could become contaminated by accidental sputter etching of the tape itself. Second, firm contact

of the tape shadow mask with the Al_2O_3 surface was difficult to achieve in region X or Y, and overheating and "burning" of the sputtered film could occur locally due to rf potential field concentrations in these areas. In the case of Blades A and B, where adherence of films was always better than on Blades C and D, some success was achieved with crossed tape masking, but results were always better with standard masking (Table III). In the case of Blades C and D, where adherence was poor with either procedure, the worst results were obtained with the crossed tape masking procedure.
