NASA CR-159794
MRC-SL-1007

FORMULATION AND EVALUATION OF C-ETHER FLUIDS AS LUBRICANTS USEFUL TO 260°C

MONSANTO RESEARCH CORPORATION

16. Abstract Three base stocks were evaluated in bench and bearing tests to determine their suitability for use at bulk oil temperatures (BOT) from -40 to +260°C. A polyol ester gave good bearing tests at a bulk temperature of 218°C, but only a partially successful run at 274°C. These results bracket the fluid's maximum operating temperature between these values. An extensive screening program selected lubrication additives for a C-ether (modified polyphenyl ether) base stock. One formulation lubricated a bearing for 111 hours at 274°C (BOT), but this fluid gave many deposit related problems. Other C-ether blends produced cage wear or fatigue failures. Studies of a third fluid, a C-ether/disiloxane blend, consisted of bench oxidation and lubrication tests. These showed that some additives react differently in the blend than in pure C-ethers.

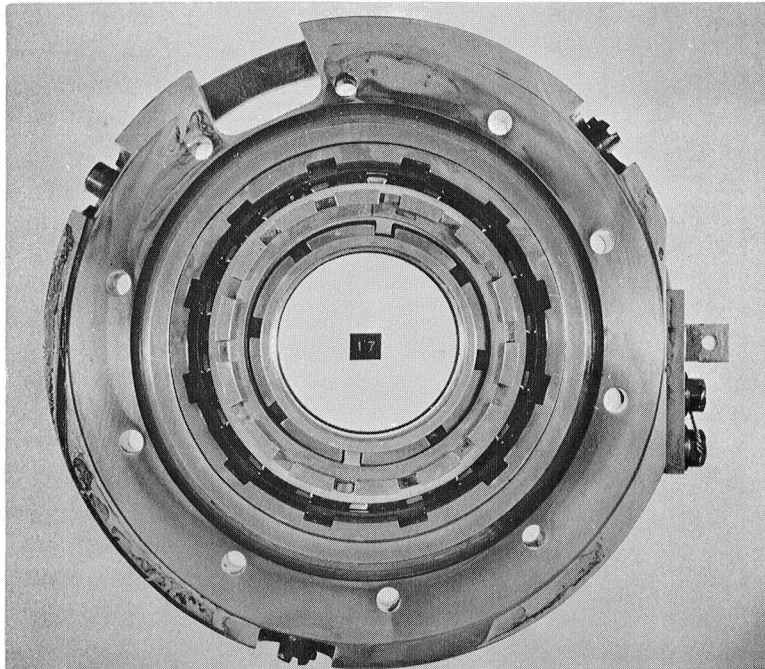
Figure 6. Bearing Test 17. Overall View of Bearing and Housing Viewed from the Direction of Test Oil Supply

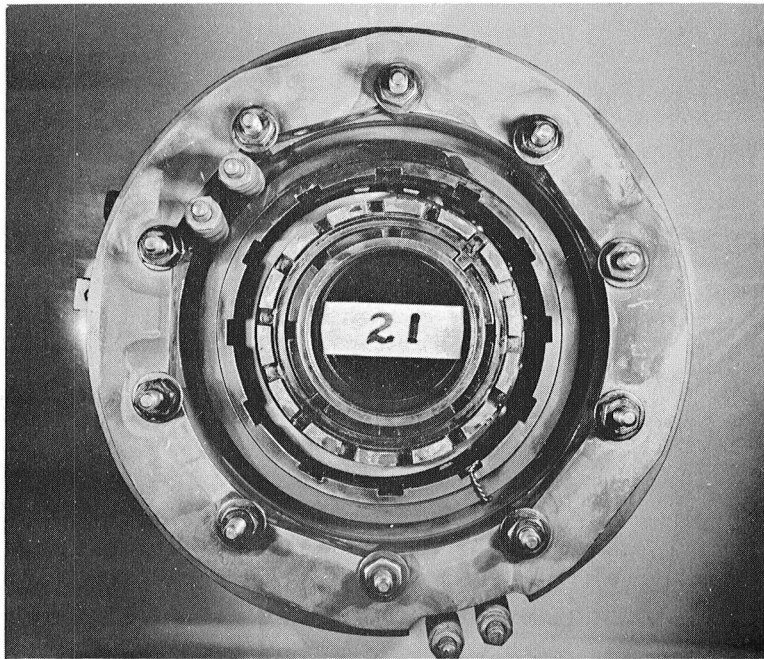
Figure 18. Bearing Test 21. Overall View of Bearing and Housing Viewed from the Direction of Test Oil Supply

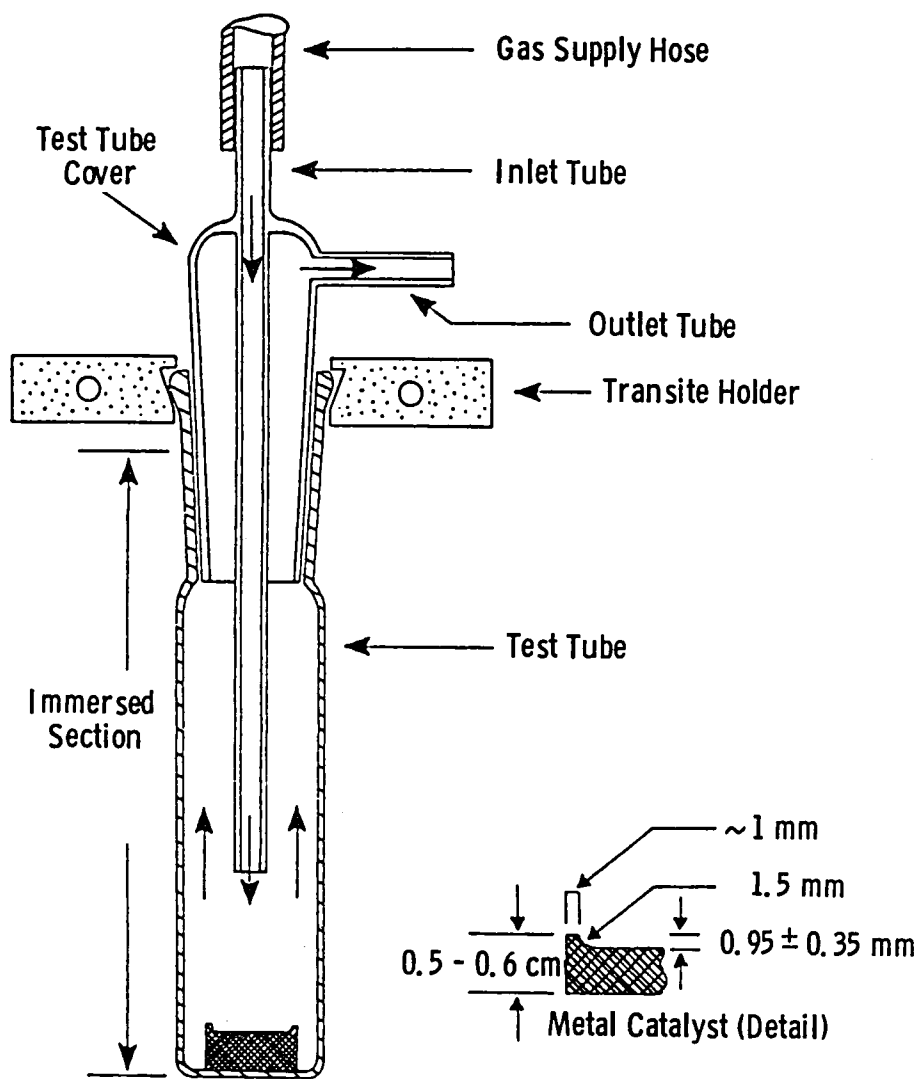
Figure A1. The Microtest Oxidation Apparatus

Twenty-five minutes is required for the metal surface to reach constant temperature. The temperature was monitored by measuring the temperature at the metal surface with a copper-constantan thermocouple at the beginning of each day and by continually checking the temperature of the Cerrobased metal. To

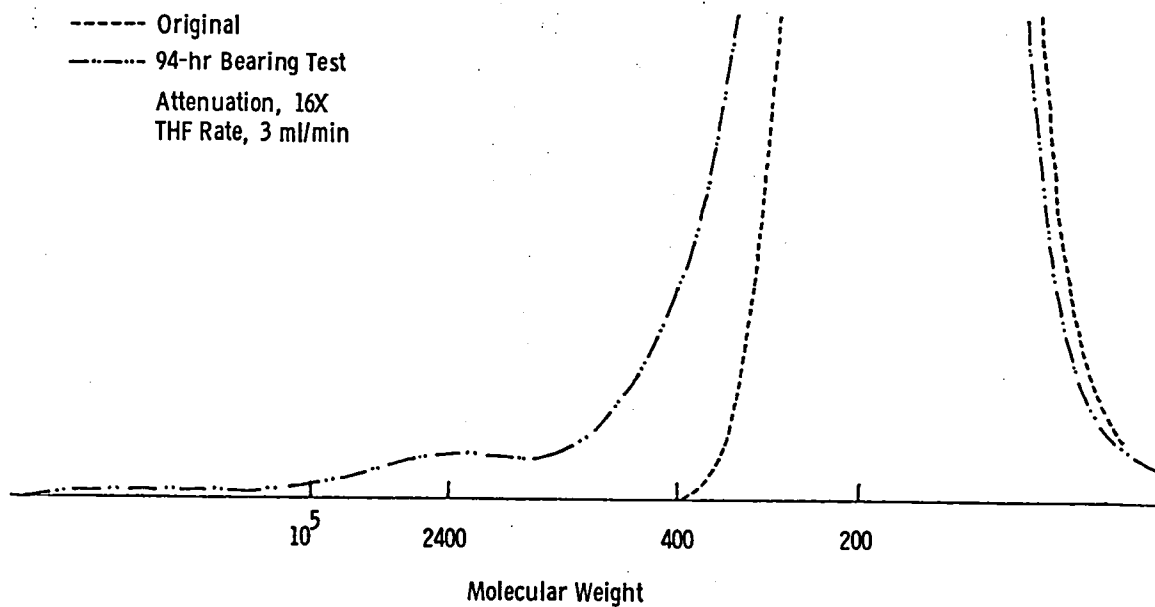
Figure A4. GPC Analysis of MCS 524 + PPA Before and After a 94-Hour Bearing Test

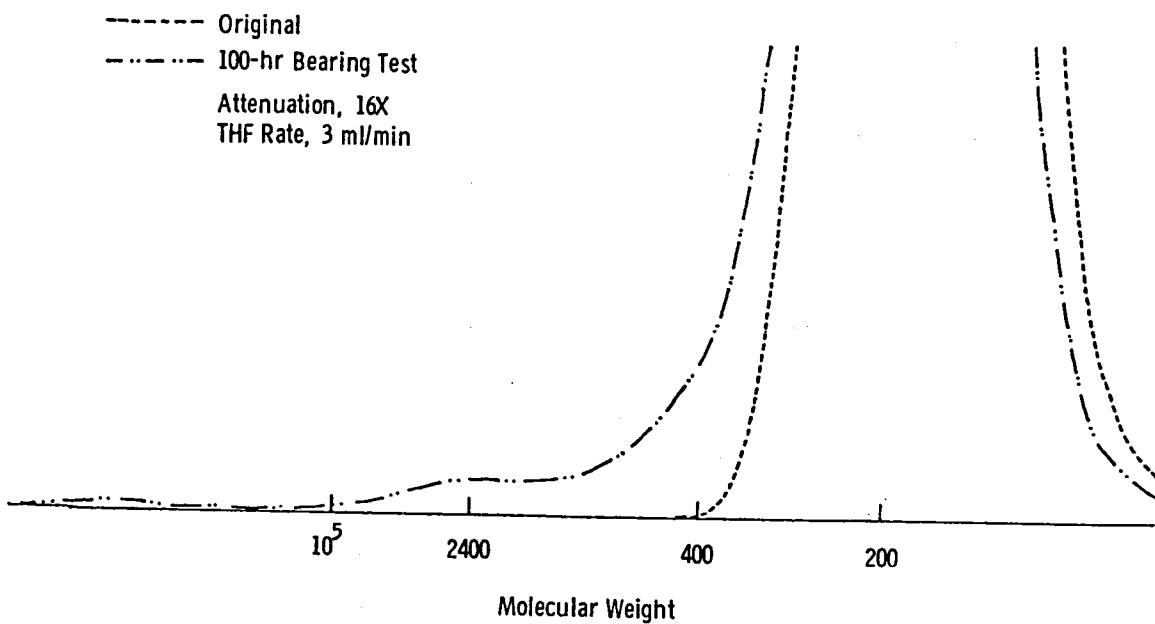
Figure A5. GPC Analysis of MCS 524 + PFGA Before and After a 100-Hour Bearing Test

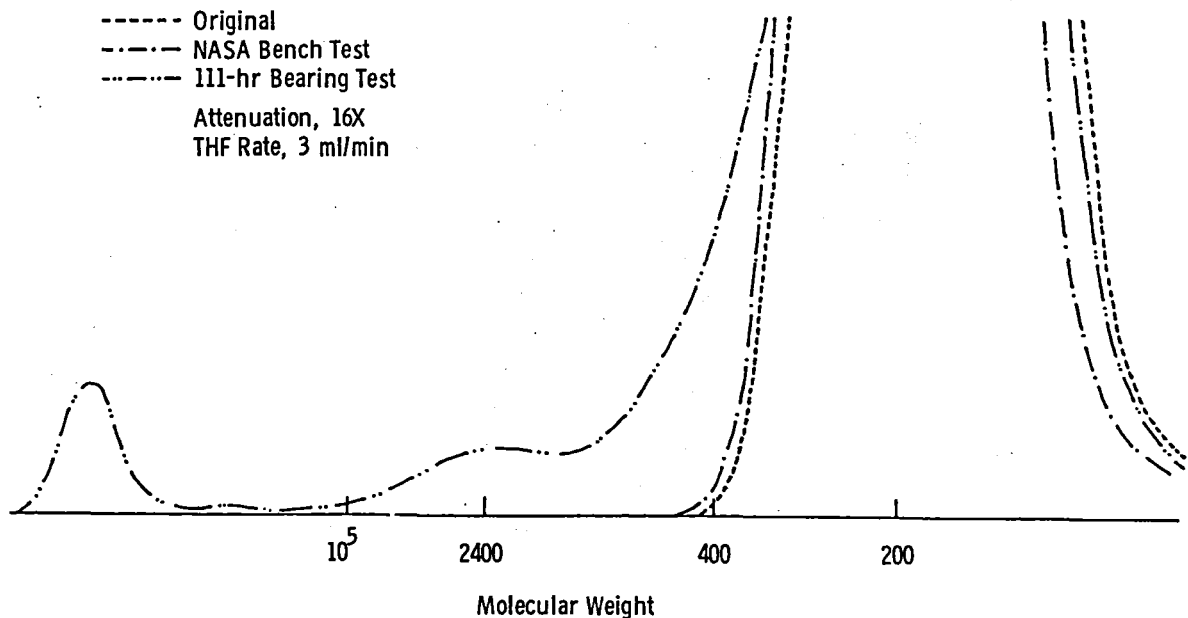
Figure A6. GPC Analysis of MCS 524 + FPPA Before and After Use in Bearing and Bench Pin on Disc Tests

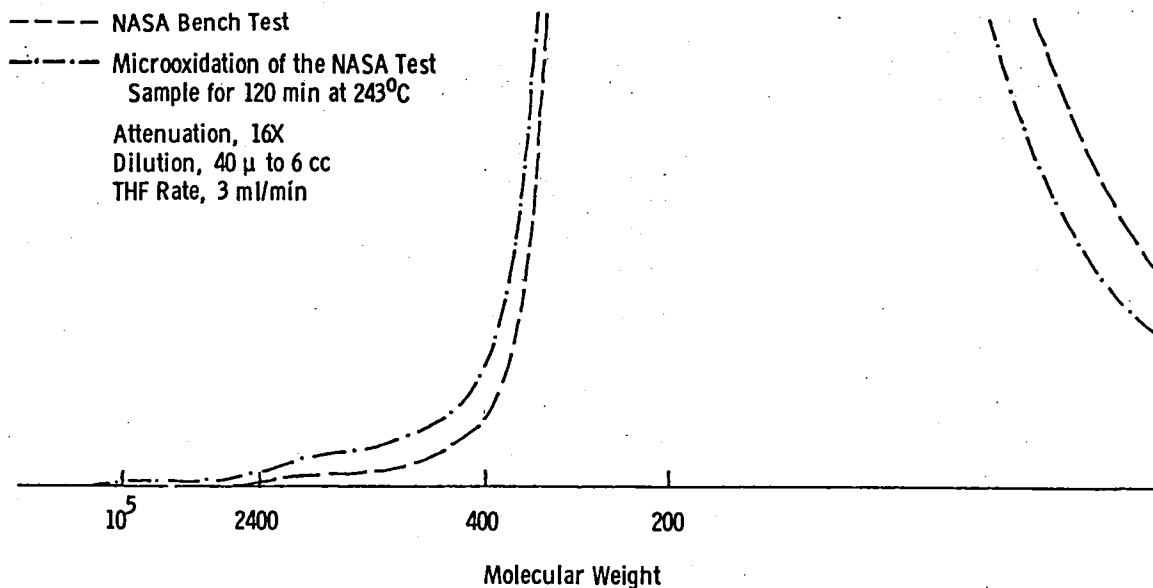
Figure A7. GPC Analysis of MCS 524 + FPPA From a NASA Bench Test Before and After a Microoxidation Test at 243°C

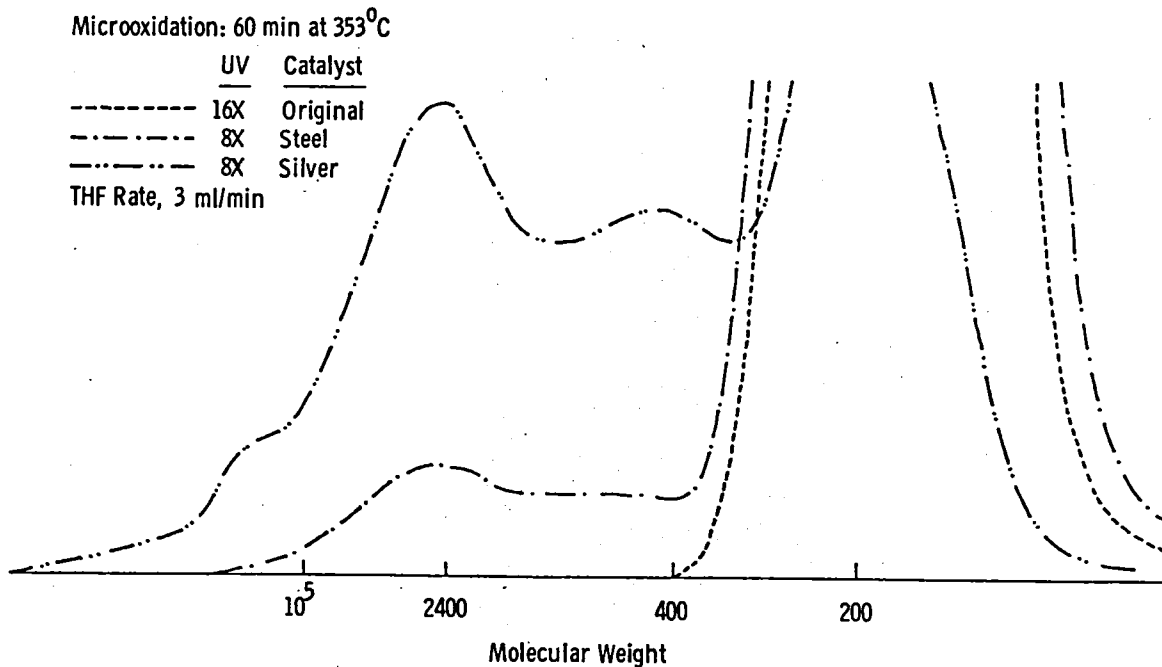
Figure A8. Microoxidation Tests With MCS 524 + PFGA at 353°C Using Steel and Silver Catalysts

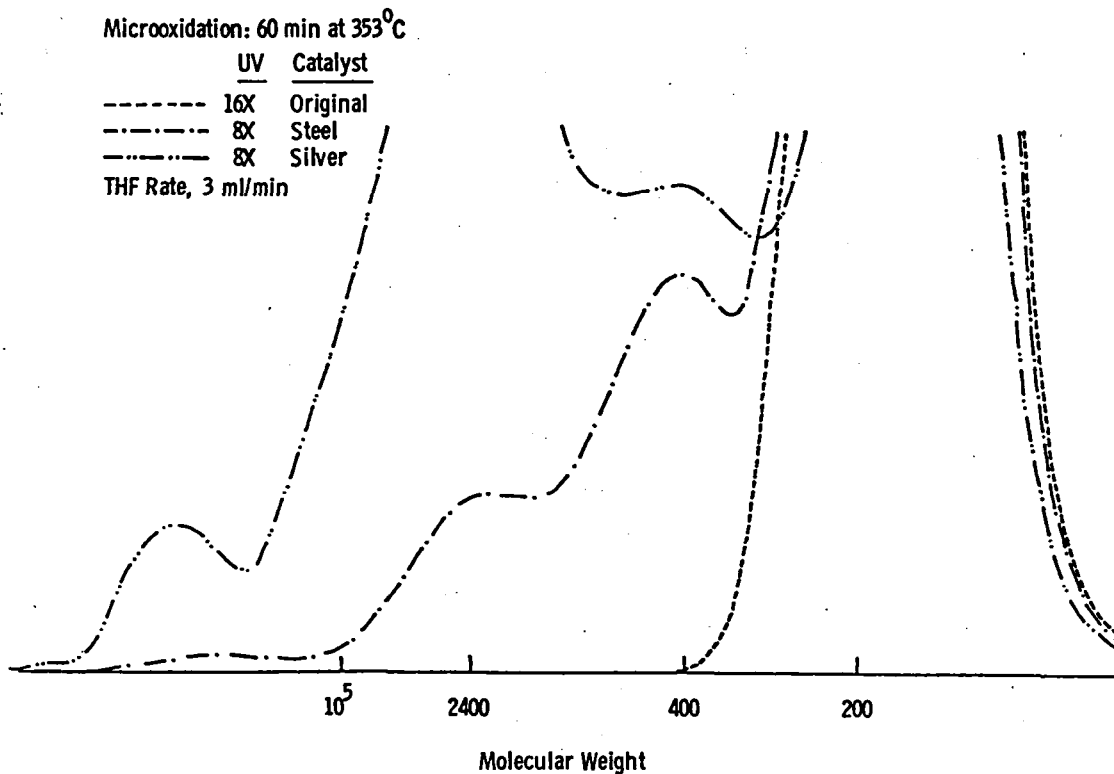
Figure A9. Microoxidation Tests with MCS 524 + PPA at 353°C Using Steel and Silver Catalysts

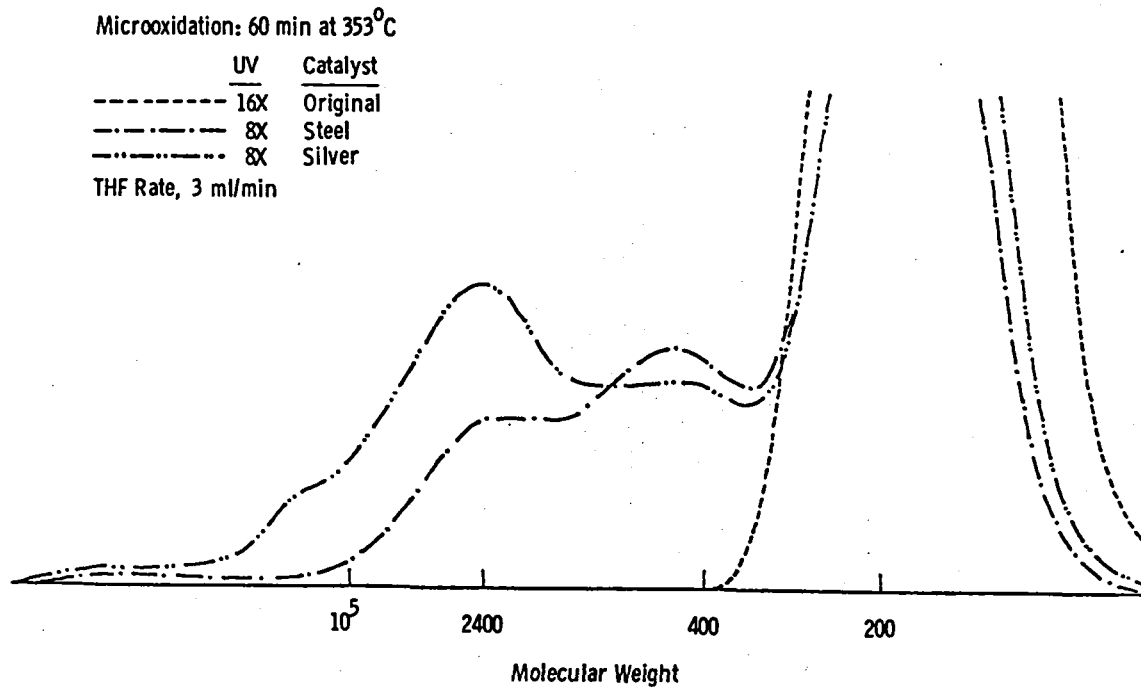
Figure A10. Microoxidation Tests with MCS 524 at 353°C Using Steel and Silver Catalysts

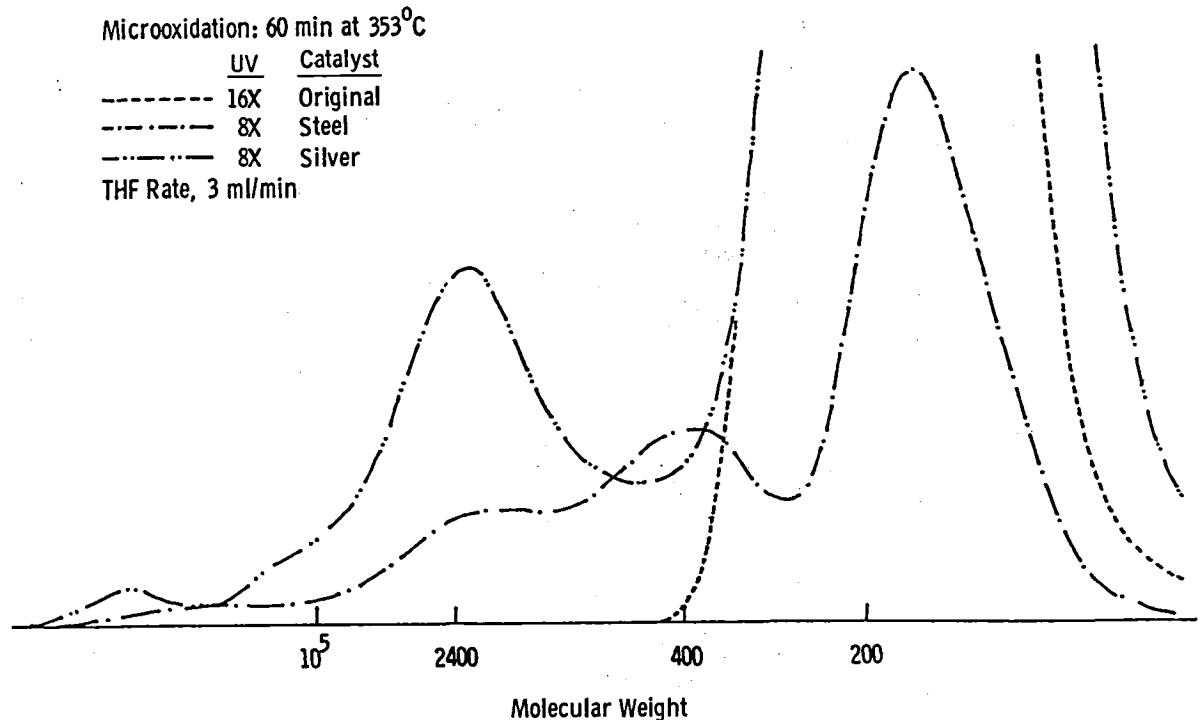
Figure A11. Microoxidation Tests With MCS 524 + FPPA at 353°C Using Steel and Silver Catalysts

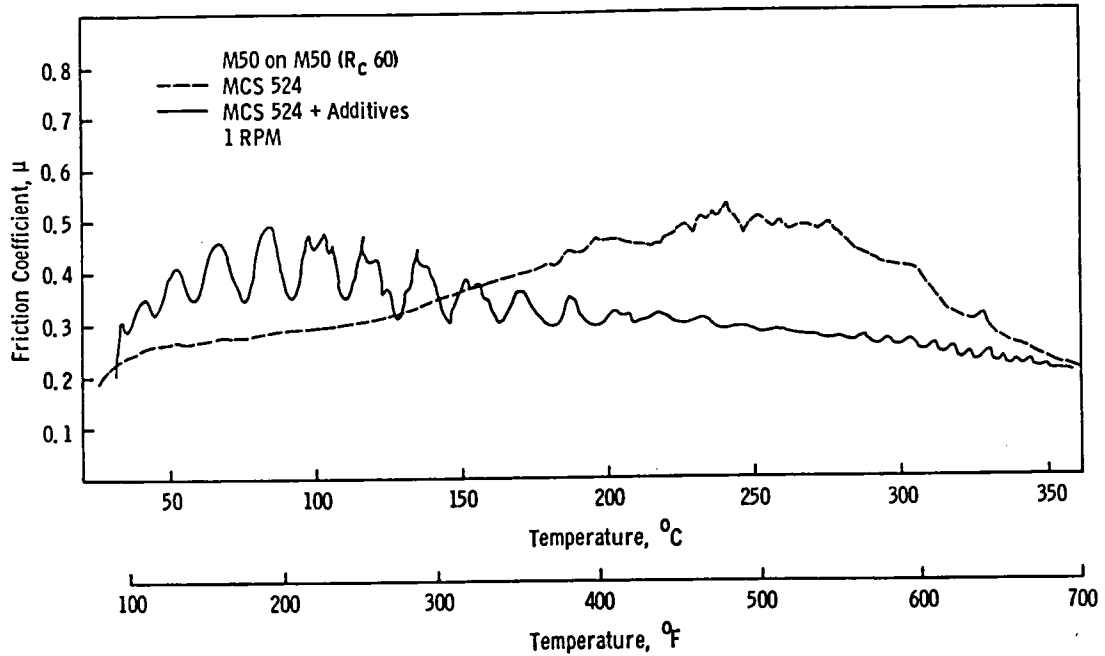
Figure A30. Friction Curves for MCS 524 and MCS 524 + ~0.07% PFGA + 0.3% SPFGA. Oscillations in the curve may be due to misalignment of a disc.

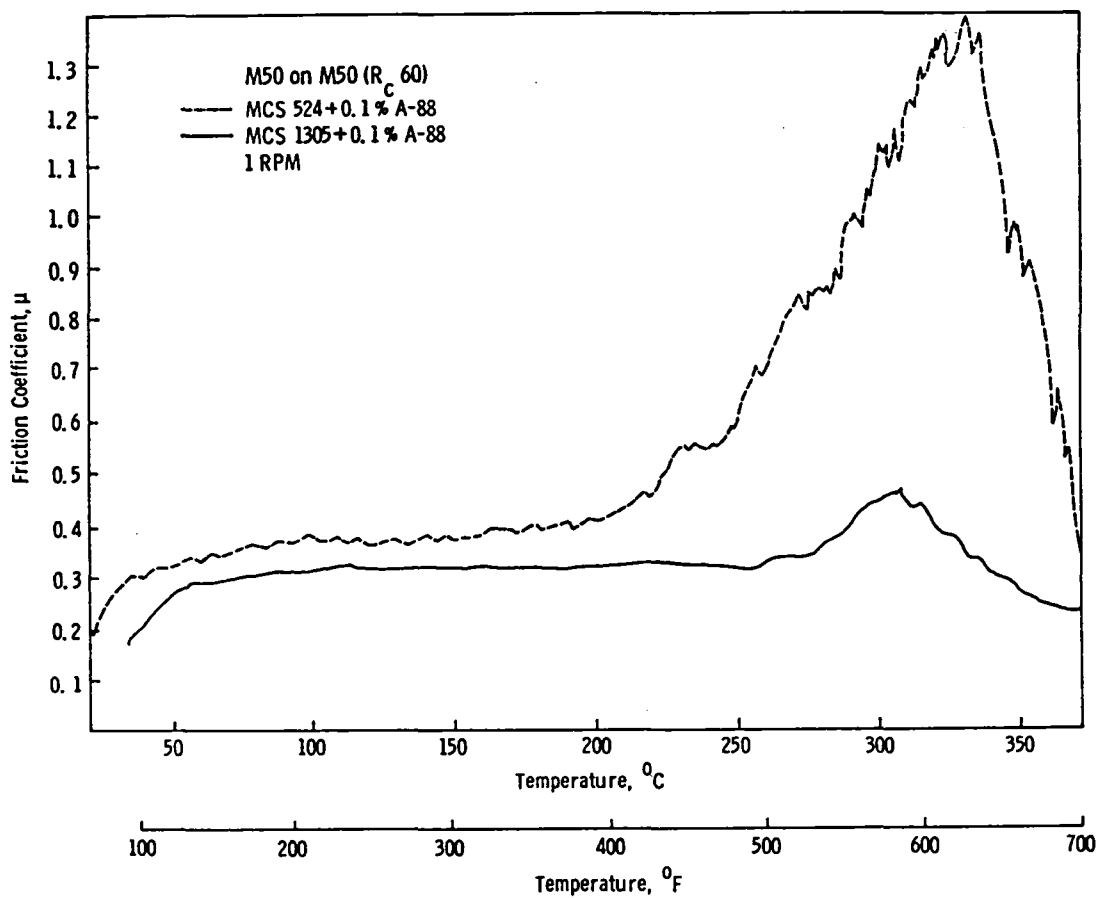
Figure B17. Friction Curves for MCS 524 + 0.1% A-88 and MCS 1305 + 0.1% A-88

Some of the additive surface reactions shown by the slow four-ball test (Figures B1 through B17) paralleled those in C-ethers. Occasionally, however, we see signal differences. The most noticeable, that for A-88, M50 on M50, results in elimination of the large μ rise observed in C-ethers (Figure B17).

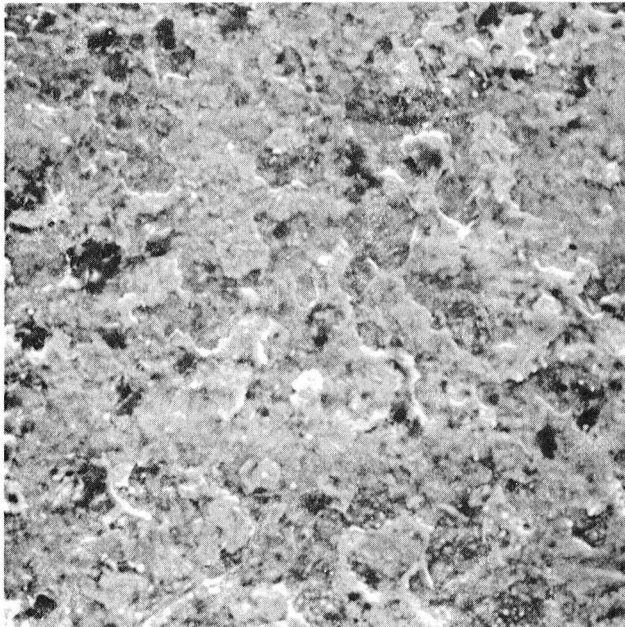
b. Higher magnification of view a (2500X)

Figure F2. SEM Photographs of S/N 22 Bearing Inner Ring Track After Test No. 20 Showing Metal Surface Microsmearing Damage

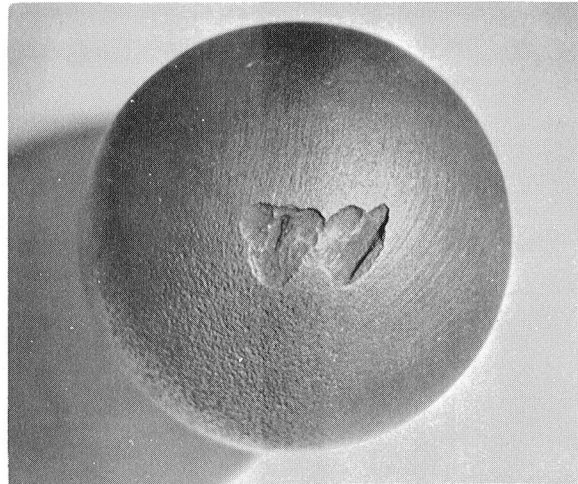
a. Overall view of spall on a ball (4X)

Some of the fatigue spalls were unusually deep, especially on the balls, so the structure and heat treatment of the steel was analyzed. The hardness measured 62-63 R_C, and metallographic examination showed a fine martensitic structure with less than 1% retained austenite and no soft constituents, all within expected proper M50 steel bearing specifications. Nital etch and hot acid etch analysis also checked out satisfactorily, with no evidence of nonmetallic inclusions found at any spall initiation sites. As shown in Figure F7, however, hot acid etching of the spalls on the balls (see Figure F7-a) revealed that the spall initiation area followed the steel grain flow lines, as confirmed by metallographic sectioning (see Figures F7-b and F7-c).

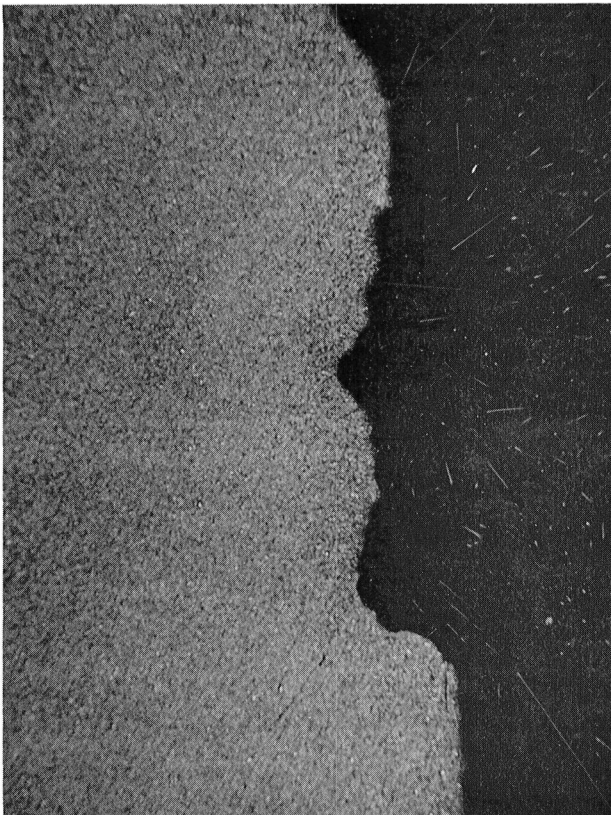
b. Section through spall with original ball surface at lower right (100X)

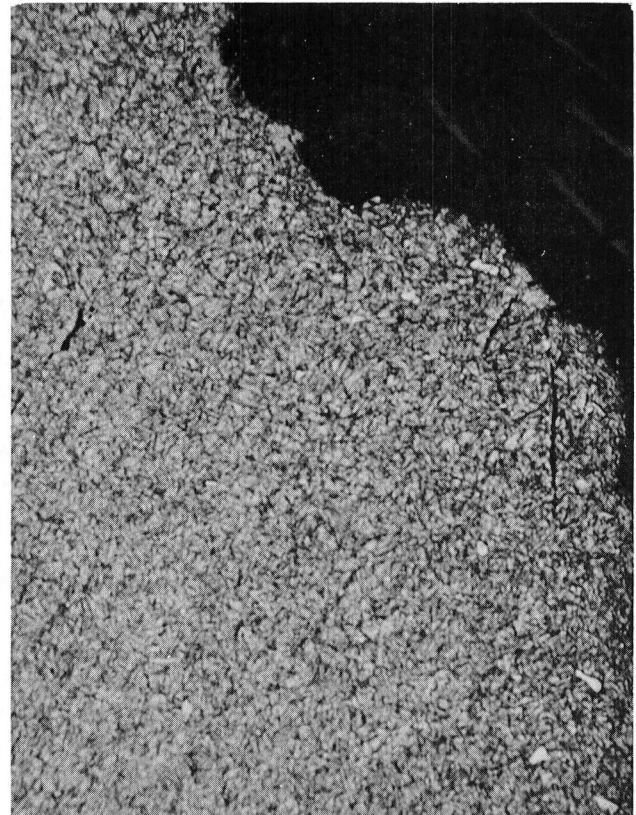
c. High magnification of view b showing spall cracks following steel grain flow lines (300X)
