HOT CORROSION OF Co-Cr, Co-Cr-Al,
AND Ni-Cr ALLOYS IN THE
TEMPERATURE RANGE OF 700 - 750°C

Third Semi-Annual Report
on
Grant No. NSG-3214

K. T. Chiang
G. H. Meier

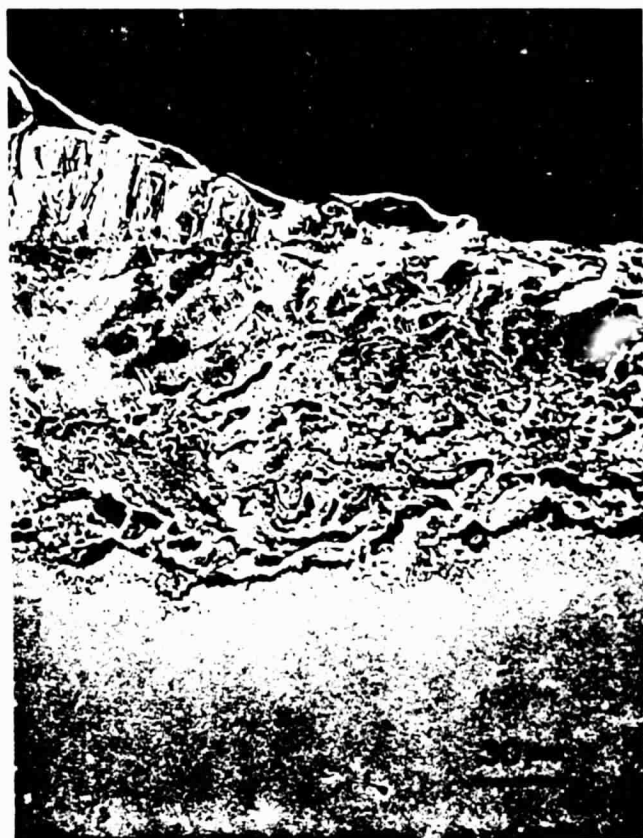
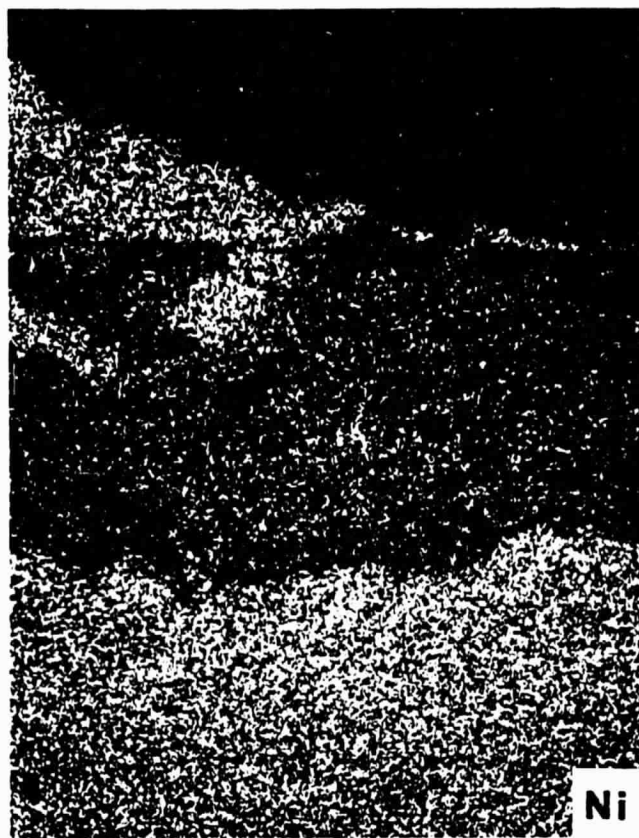
Figure 4. Scanning electron micrograph of specimen in Fig. 3(a) and Ni (b), Cr (c), and S (d), X-ray maps.

Figure 3 shows severe corrosion at the corner of a Ni-20Cr specimen exposed under the same conditions as the Co-Cr alloy in Figures 1 and 2. The specimen has gained about ten times more weight than that exposed in the absence of SO_3 , Table 1. In this case considerable quantities of Cr sulfide are present at the scale-alloy interface. Figure 4 shows a micrograph and X-ray images of the corrosion product on the same specimen. Nickel may transport through a liquid $\text{Na}_2\text{SO}_4\text{-NiSO}_4$ melt (There is an eutectic between the extended solid solution of NiSO_4 in Na_2SO_4 and $\text{NiSO}_4 \cdot \text{Na}_2\text{SO}_4$ at about 670°C , 35% Ni/NiSO_4 .) and precipitate as NiO or NiSO_4 near the gas interface. Chromium remains essentially below the initial alloy/salt interface and is oxidized in-situ. The EDAX spectrum of Figure 3d verifies that the outer regions of the pit are rich in Cr, Ni, and S. The result coupled with the micrograph,
