NASA CR-159832

# CF6 JET ENGINE PERFORMANCE IMPROVEMENT PROGRAM

## HIGH PRESSURE TURBINE AERO- DYNAMIC PERFORMANCE IMPROVEMENT

GENERAL ELECTRIC COMPANY

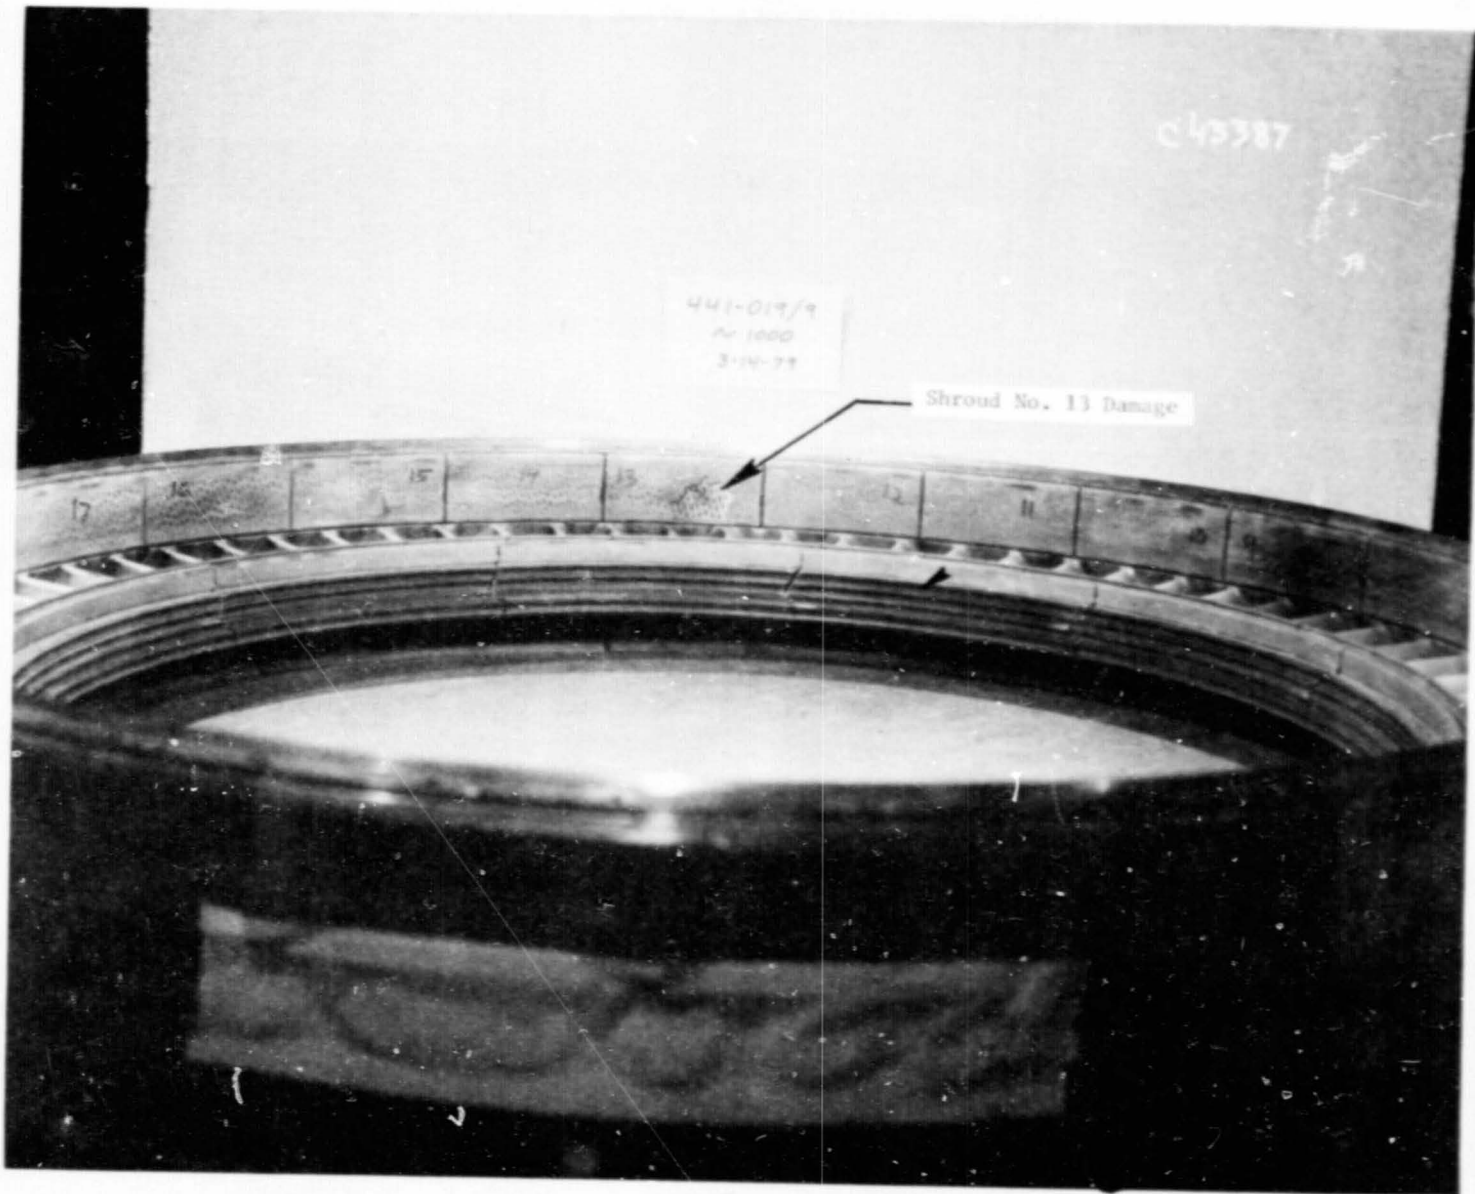
Figure 93. Stage 2 Nozzle Assembly and Stage 1 Shrouds After 1000 Cycles.
