FINAL REPORT

**A STUDY OF POULTRY PROCESSING PLANT
NOISE CHARACTERISTICS AND
POTENTIAL NOISE CONTROL TECHNIQUES**

GEORGIA INSTITUTE OF TECHNOLOGY

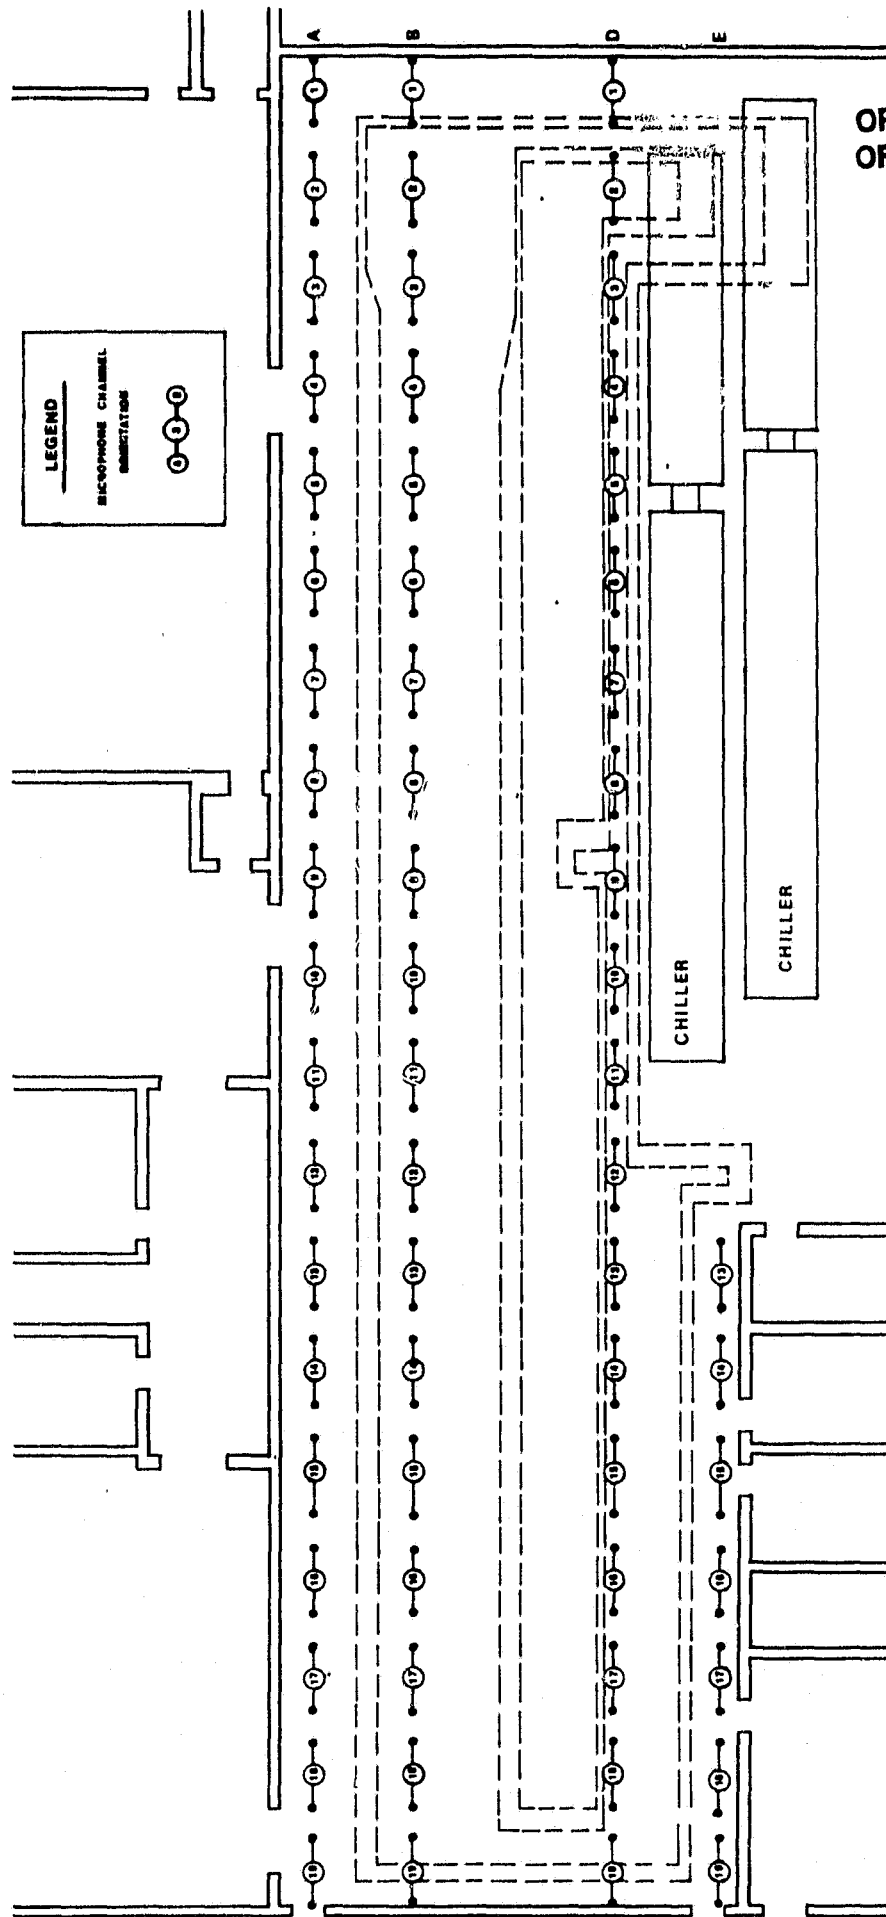
FIG. 1 LOCATION OF MEASUREMENT POINTS IN CENTRAL SOYA PLANT

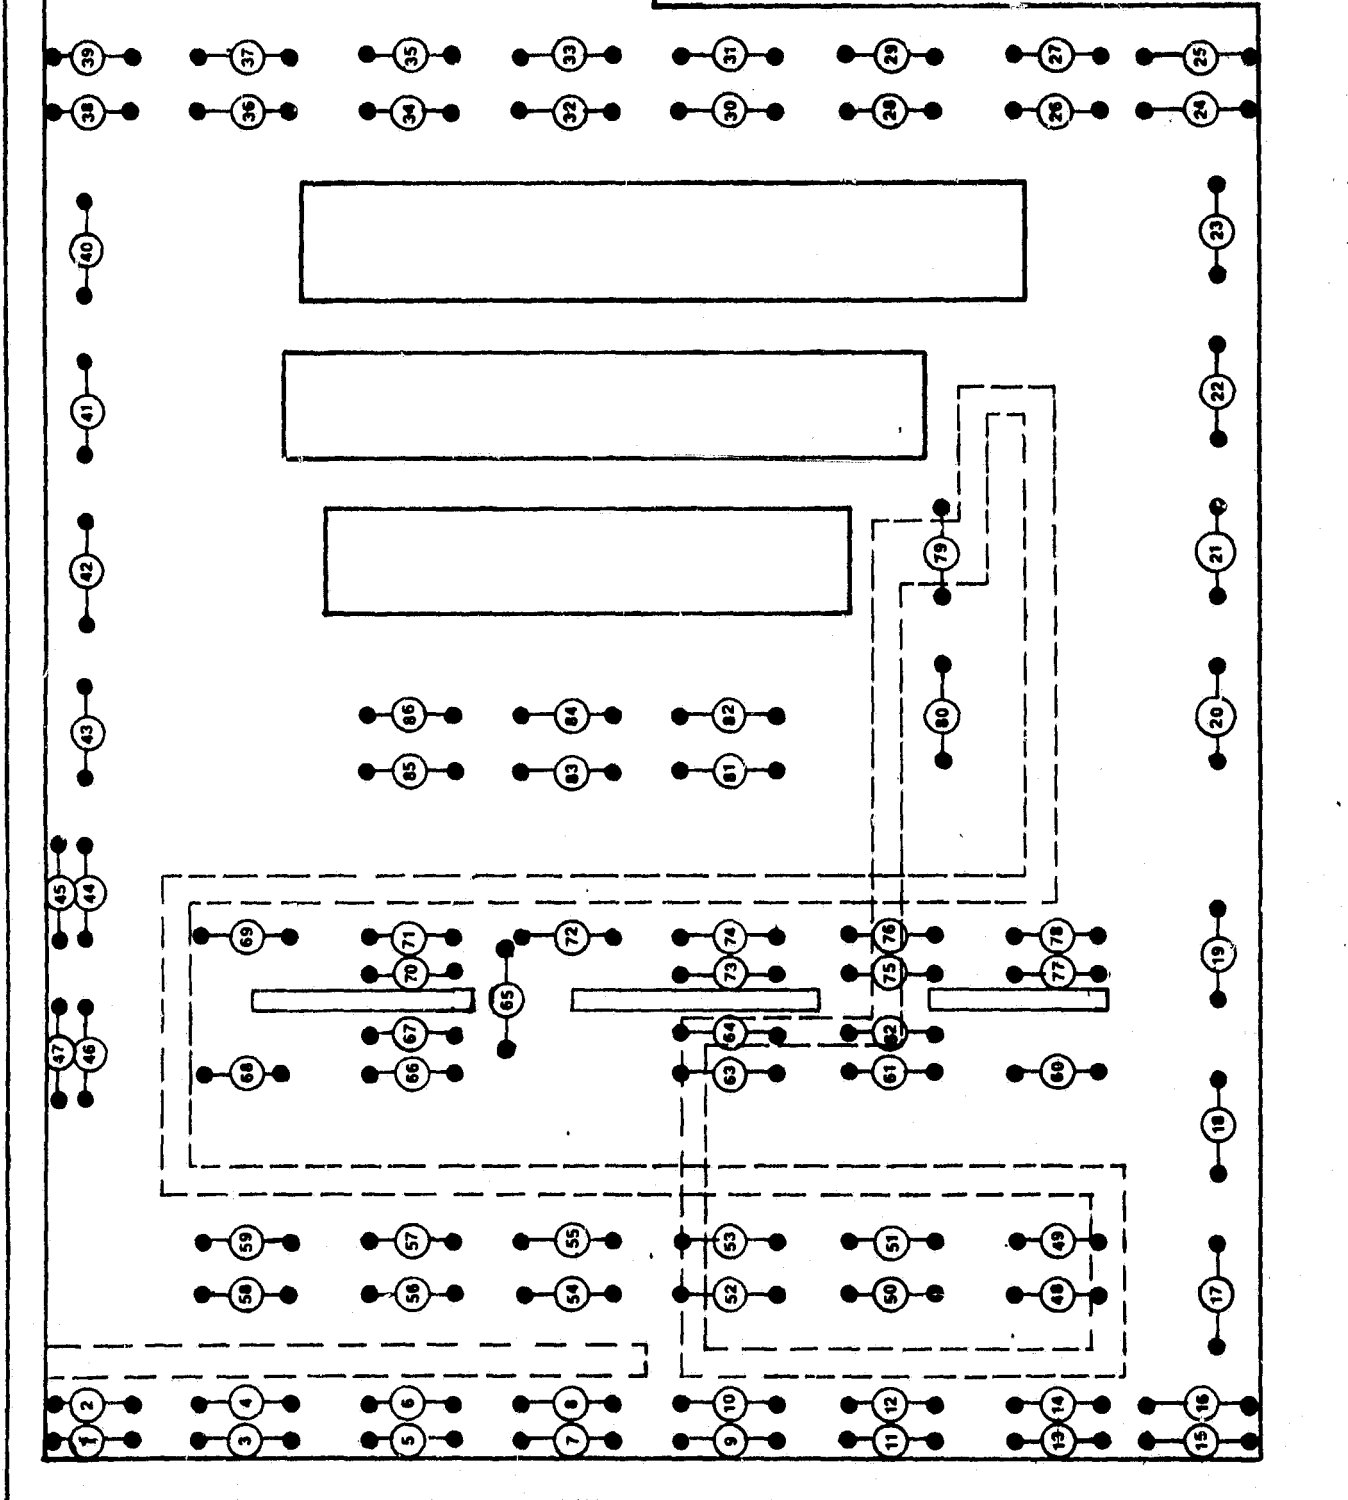
FIG. 2 LOCATION OF MEASUREMENT POINTS IN TIP TOP PLANT

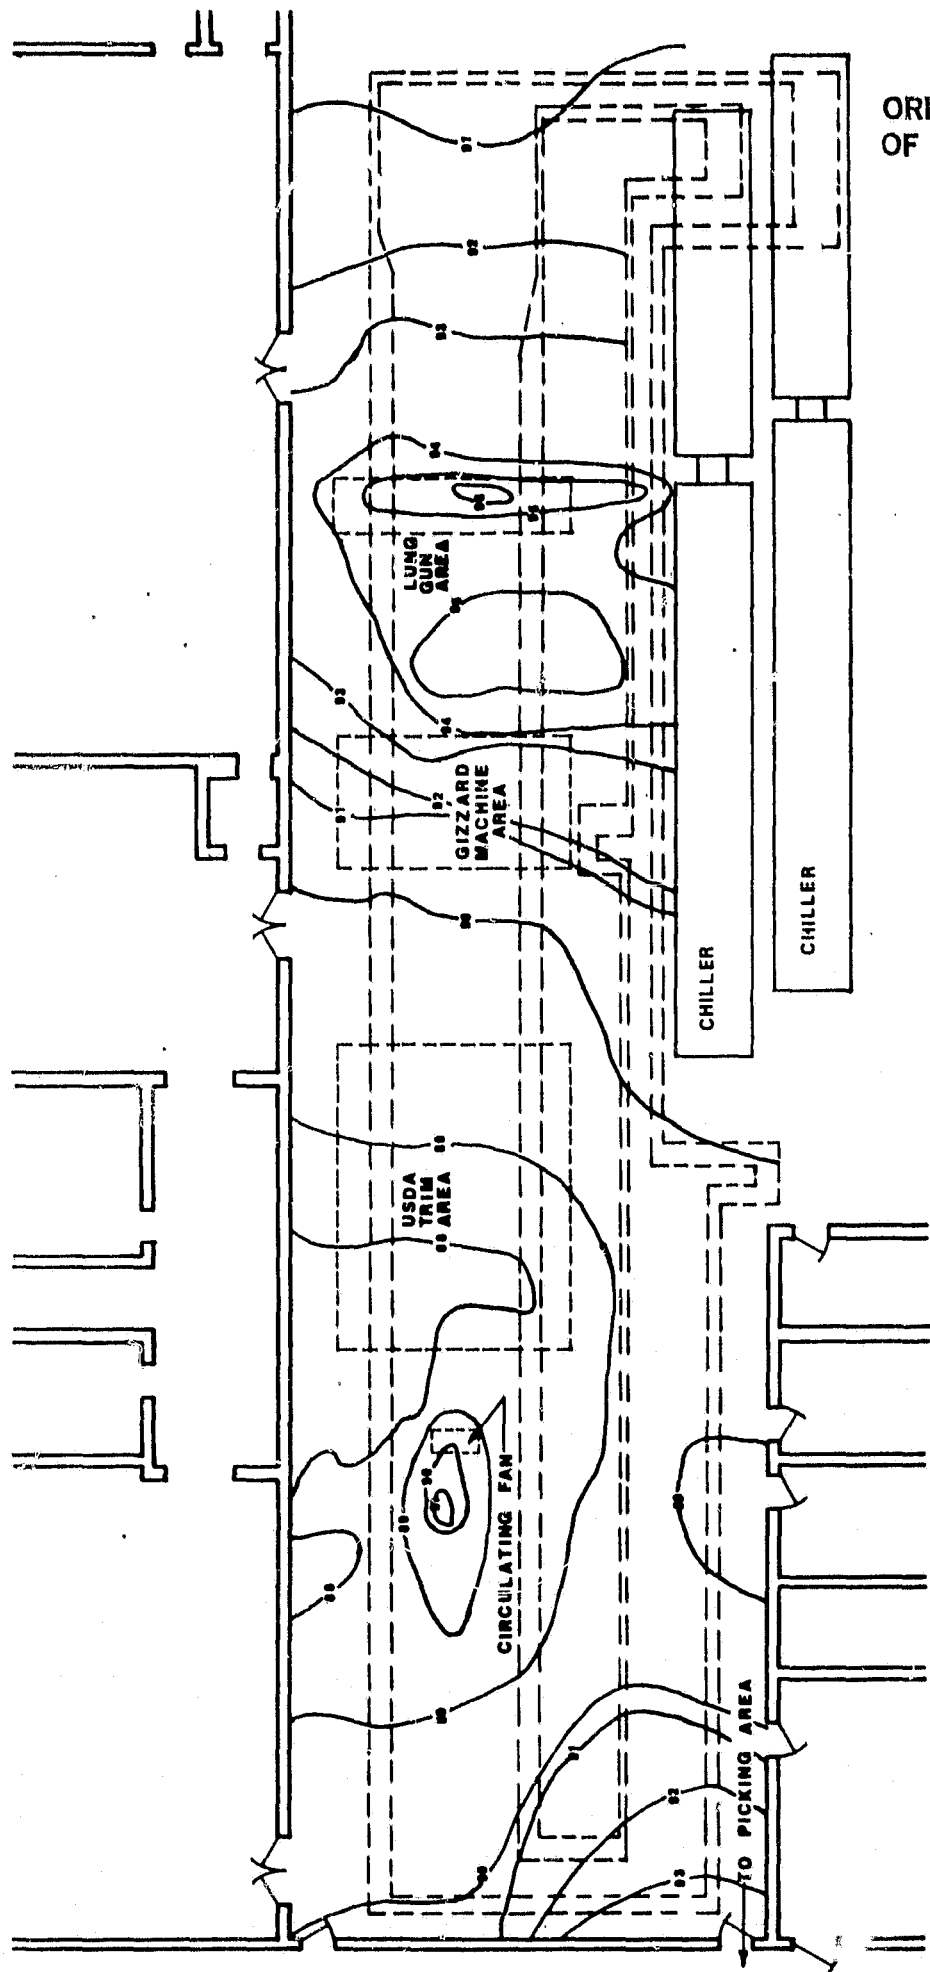
FIG. 4 NOISE CONTOURS FOR CENTRAL SOYA PLANT

The contours also provide information on the type of noise fields throughout the plant. Since the surfaces of the plant were composed of hard materials, it is probable that a reverberant noise field exists throughout much of the plant. Since this plant is irregular in shape, having one dimension many times that of another, it is expected that the reverberant noise field will not be uniform in level, but rather will decay in level with increasing distance from those sources contributing to it.* The noise field observed in Figure 4 does exhibit a continual but gradual decrease in levels well below the free field rate of 6 dB/doubling distance with increasing distance from the primary noise source areas. Consequently, it is probable that much of the noise field being observed is predominantly reverberant.

These values were reasonably close to the A-weighted sound pressure levels observed in the reverberant field of each plant per Figures 4 and 5:

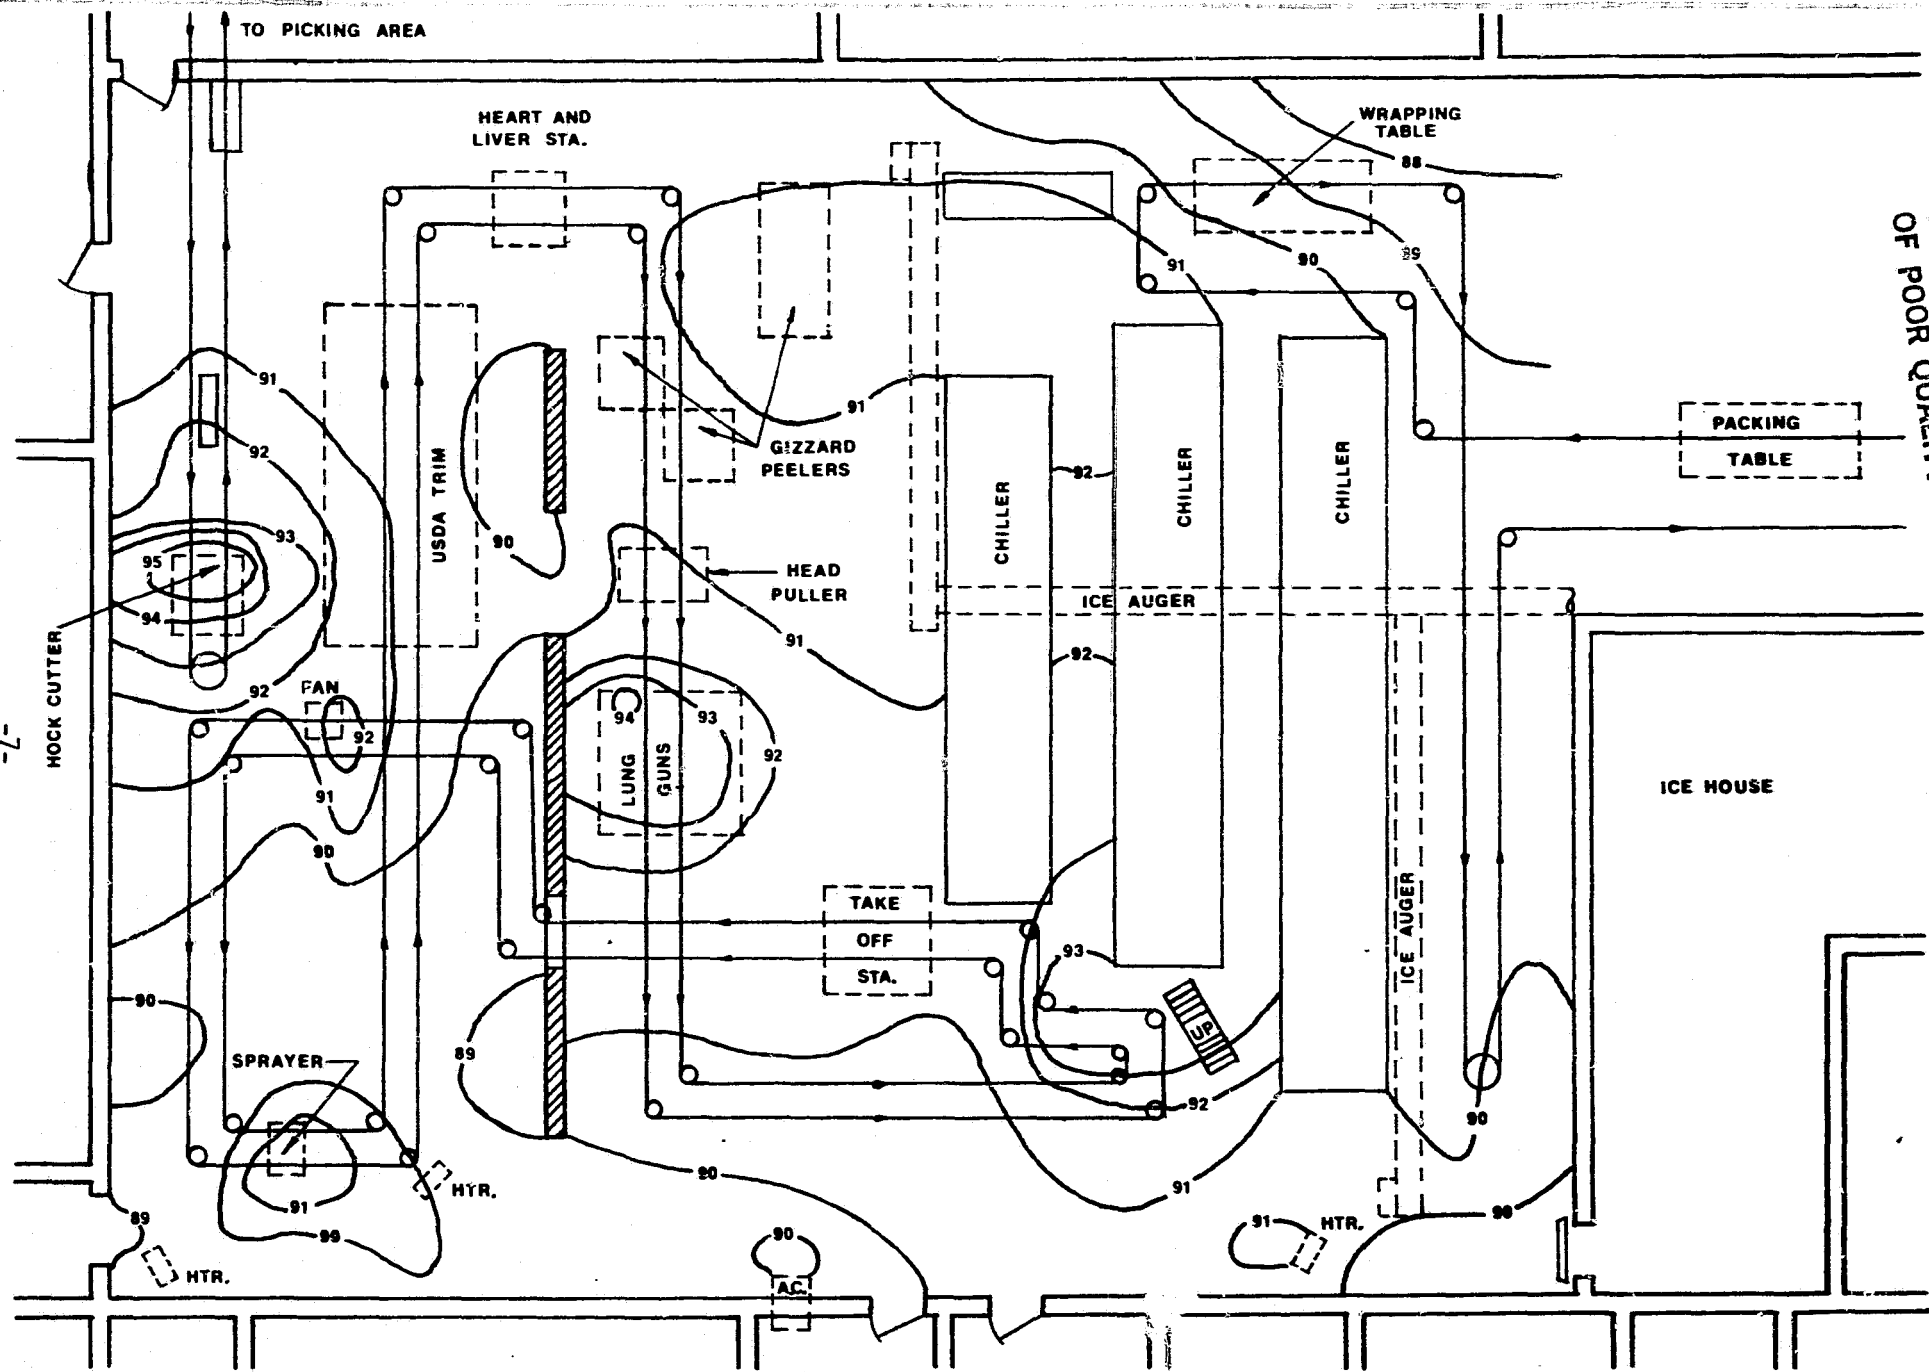
FIG. 5 NOISE CONTOURS FOR TIP TOP PLANT

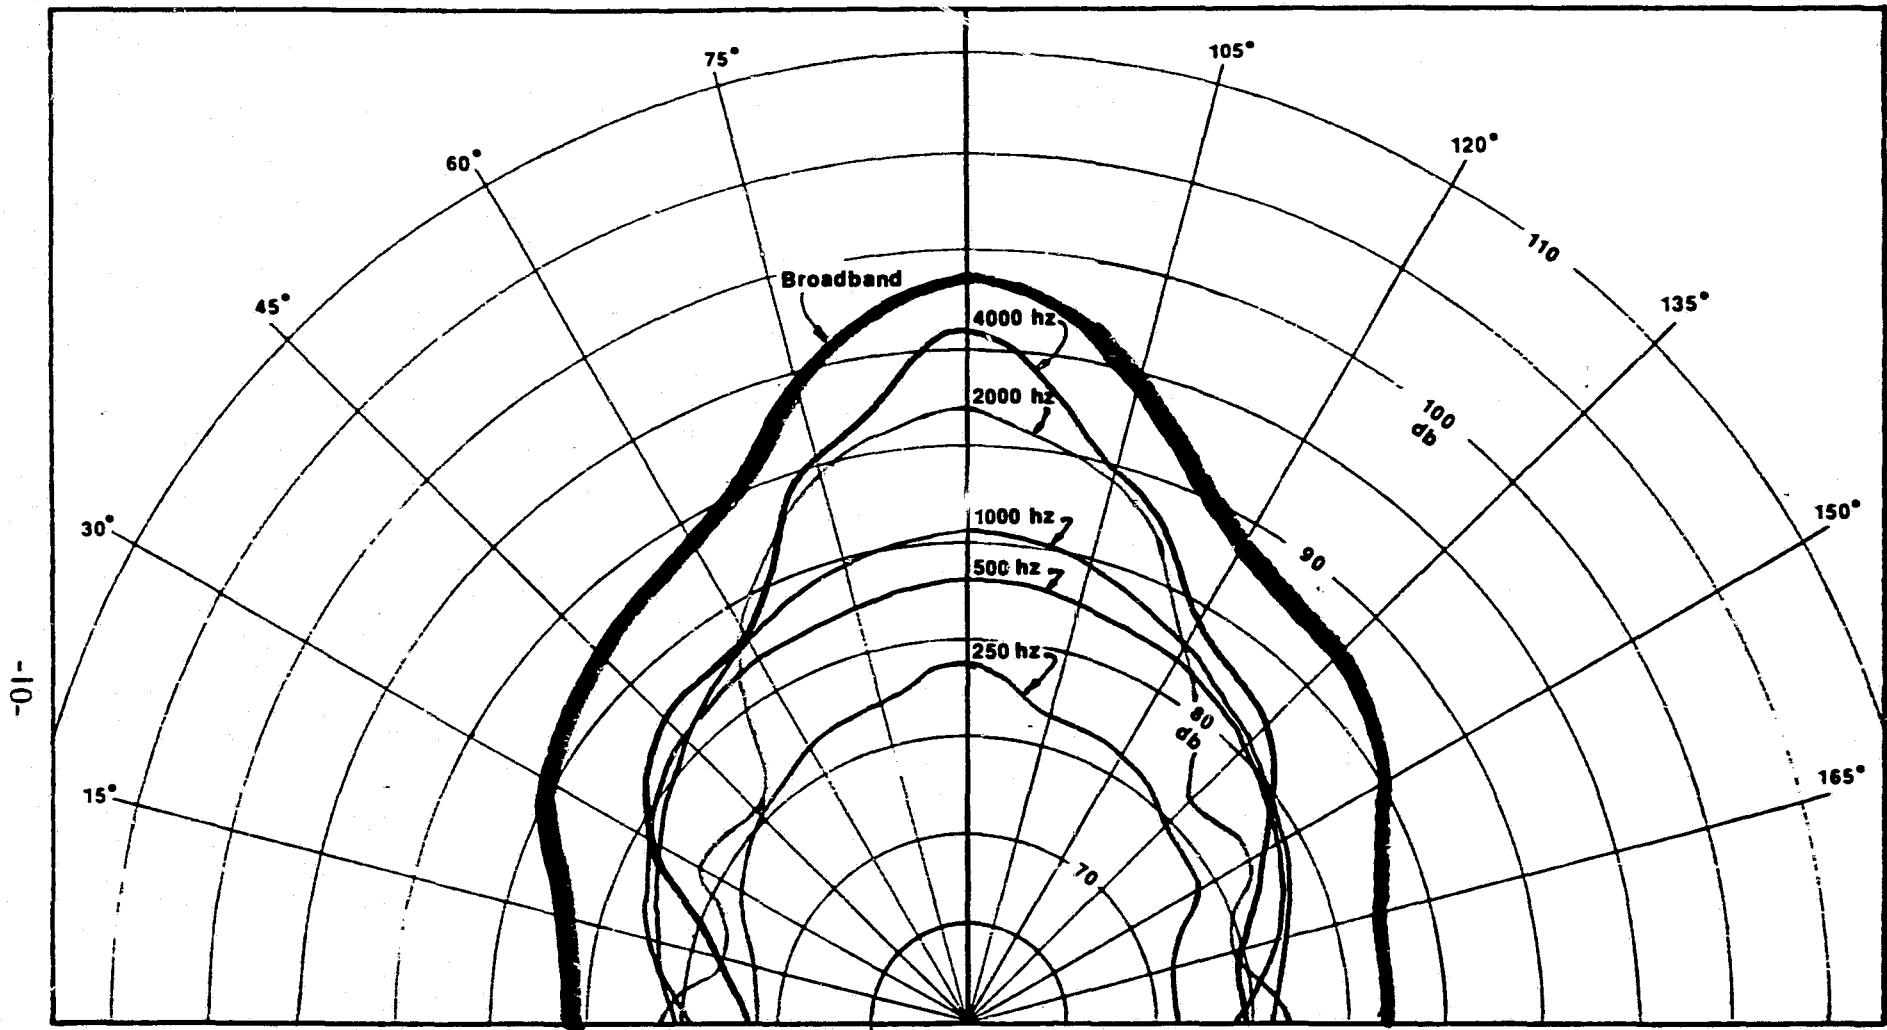
Fig. 6 Speaker Directivity Pattern *

* Observed at a radius of 1.83 meters from center of speaker

To complete the characterization of the speaker's response, the sound power output related to each response curve was calculated. Since each response pattern was symmetrical about the perpendicular axis to the speaker, it was assumed that the three dimensional response pattern would essentially bear the same characteristics observed in Figure 6 in any plane rotated about this perpendicular axis. Using coordinates for the midpoint of 10 equilateral triangles forming the surface of a hemisphere around the front of the source, the average sound pressure level over the hemisphere was calculated, using the following formula:

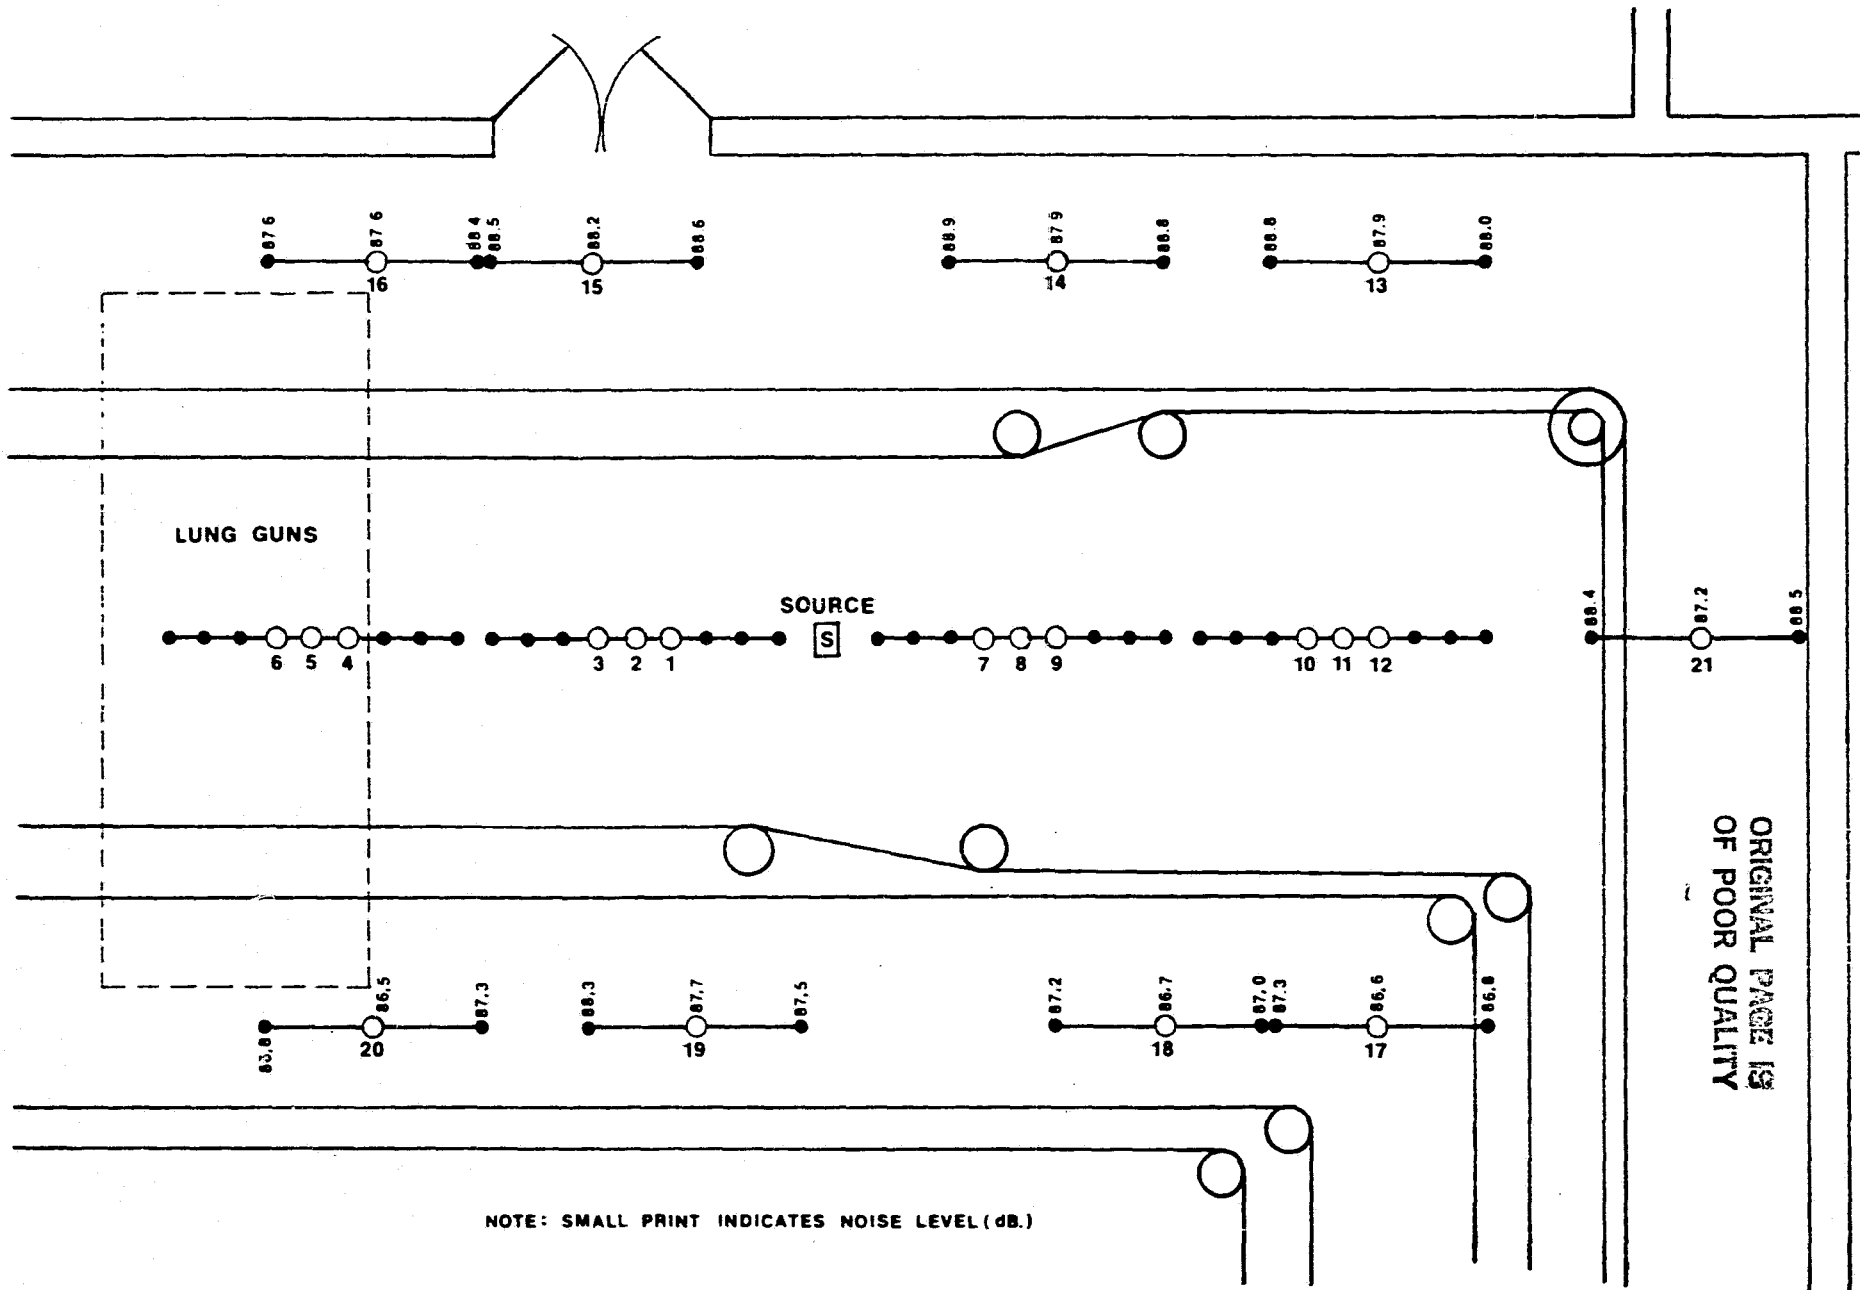
FIG. 7 LOCATION OF MEASUREMENT POINTS FOR
DIRECT-REVERBERANT TEST
CENTRAL SOYA PLANT

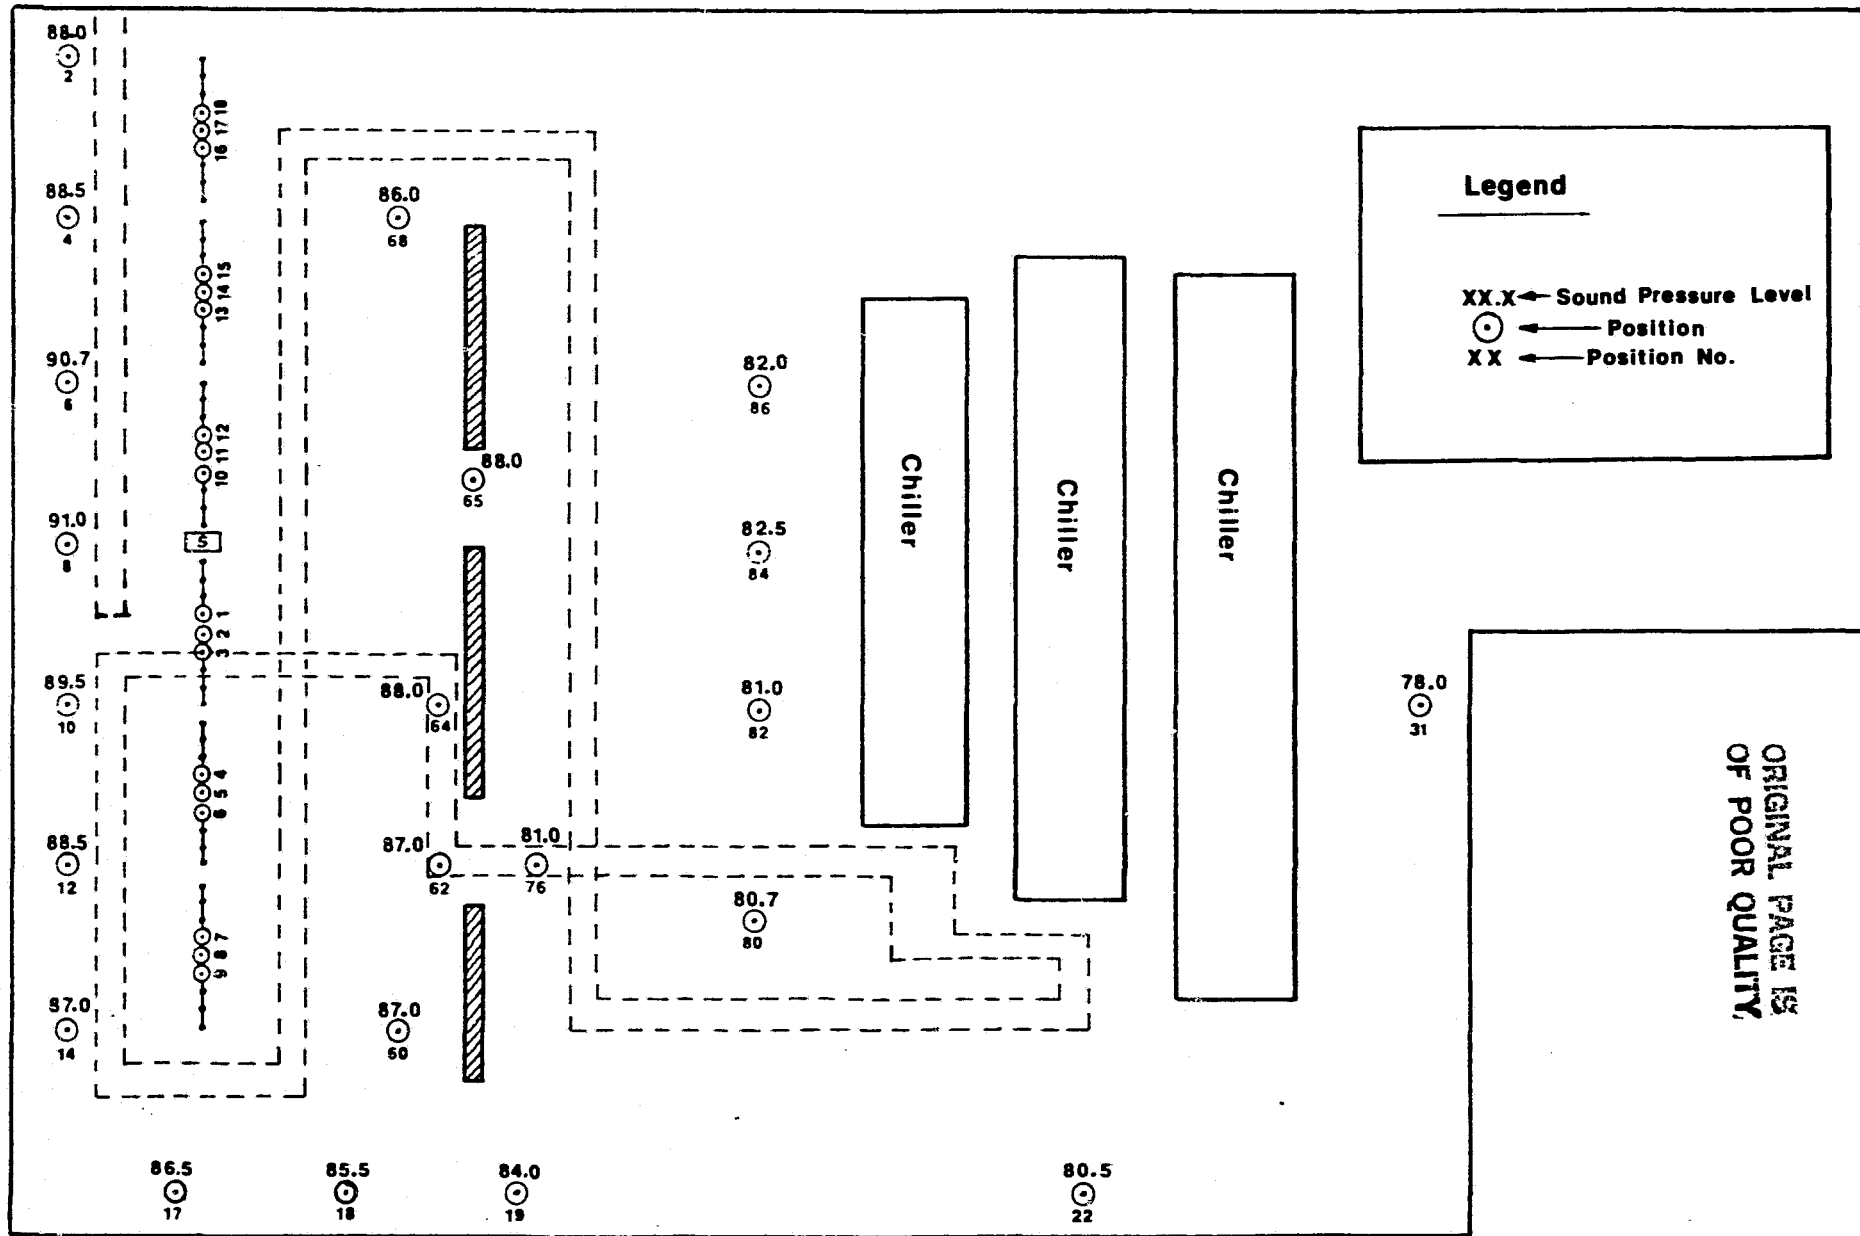
FIG. 8 LOCATION OF MEASUREMENT POINTS FOR DIRECT-REVERBERANT TEST TIP TOP PLANT

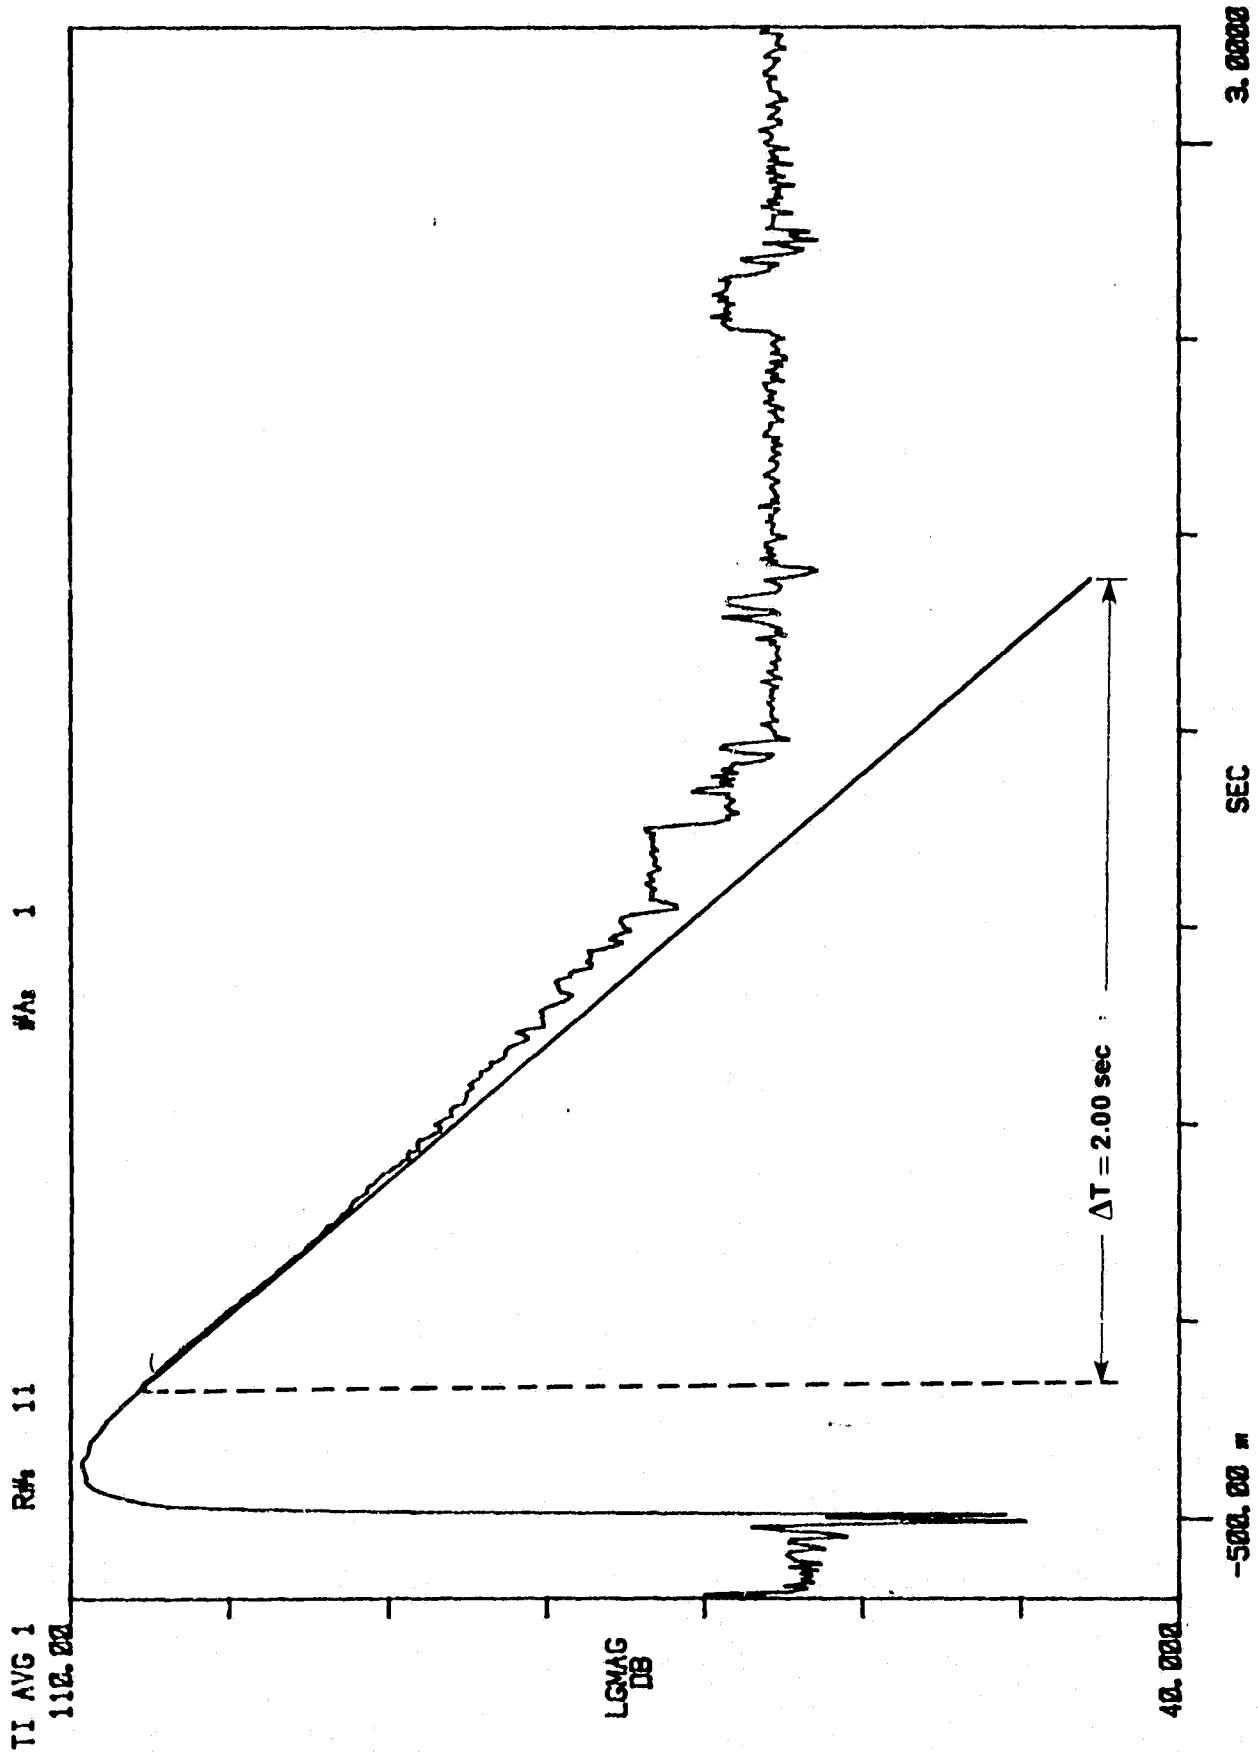
Fig. 11 Time History of Reverberant Noise Field Decay

The second test used to confirm the values obtained from the direct/reverberant test consisted of exciting each plant with noise, then terminating the source of the noise and measuring the time needed for the noise level in the room to decay 60 decibels.

Each plant was excited with noise from a 22 caliber, blank pistol for the test. This source provided sufficient sound power to thoroughly excite the test area but unfortunately provided only broadband comparative values. It was positioned at the location of the speaker in Figures 7 and 8 and was pointed toward the ceiling. Measurements were taken nine feet from the source. Figures 11 and 12 show the time history of the measured decay rate of the sound field in each plant following the pistol shot. The full 60 dB reverberant decay time was determined from these figures, using straight line extrapolation. These values were then inserted into the above equation, using the room statistics for each test area given in Table 6.

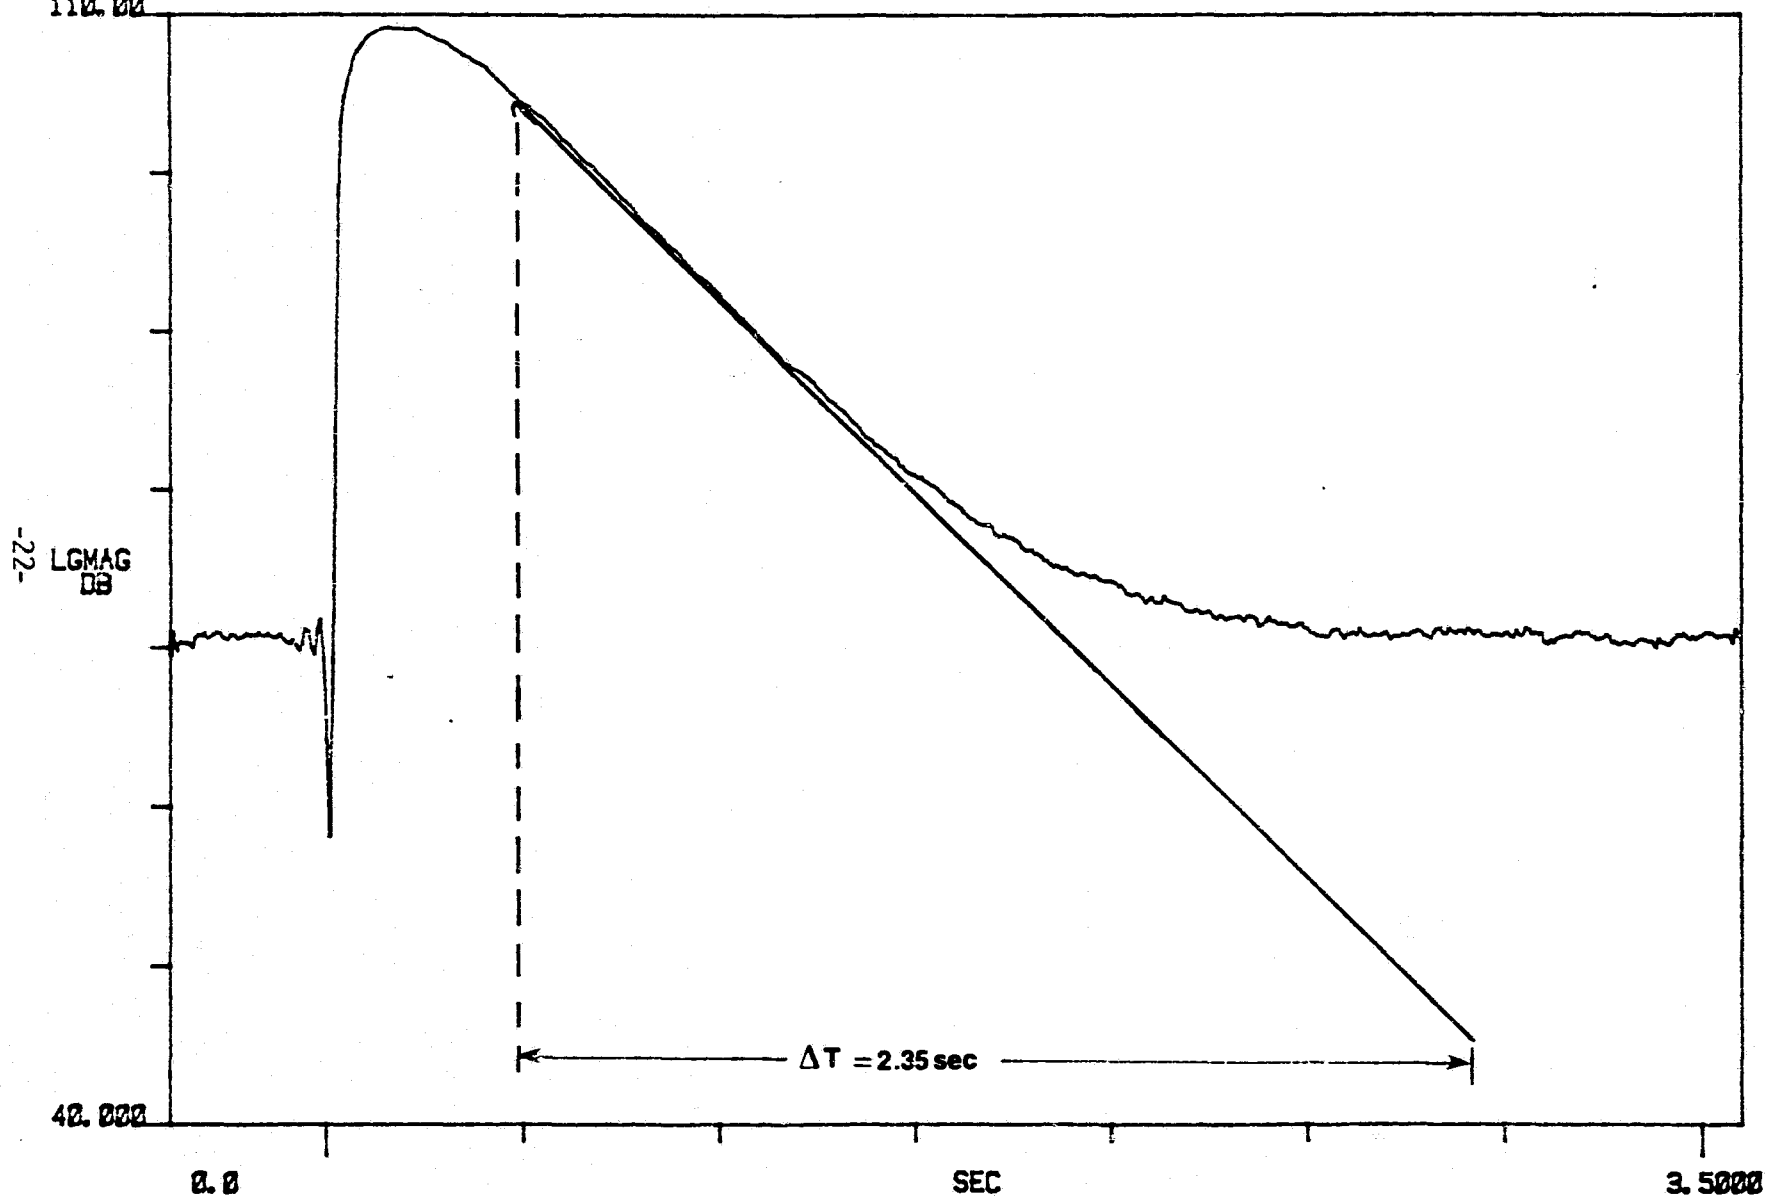
Fig. 12 Time History of Reverberant Noise Field Decay
TIP TOP PLANT

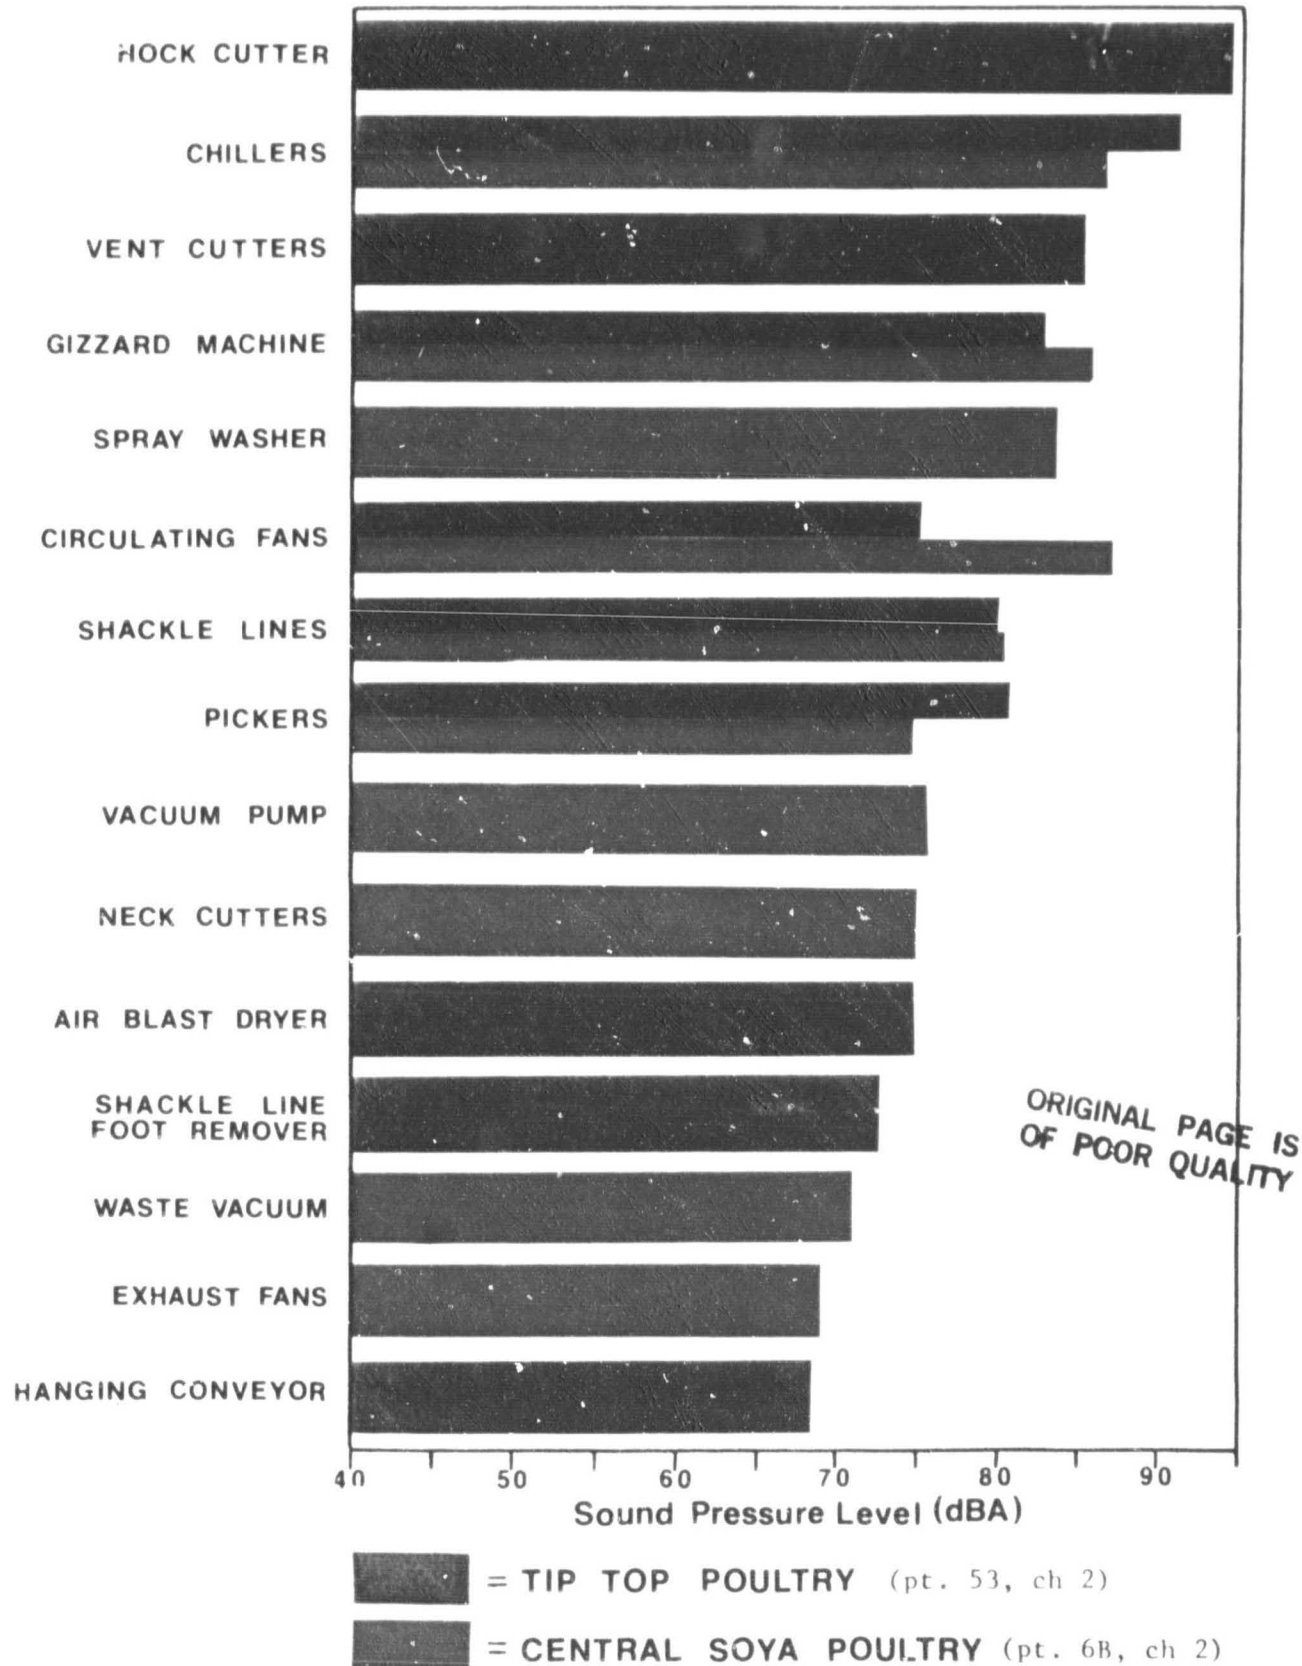
Fig. 13 Source Contribution A-Weighted Sound Pressure Level at a Single Point in Each Plant

As a means of evaluating the contribution of all sources to a locally observed sound pressure level in the noise contour of Figures 4 and 5, a microphone was located at point 6B, channel 2, in the Central Soya plant (see Figure 1) and point 53, channel 2, in the Tip Top plant (see Figure 2). With all sources turned off in each plant, individual sources were turned on and off one at a time. Figure 13 presents the A-weighted sound pressure levels observed for each source tested in each plant. Appendix D provides frequency contribution information about each source in addition to a comparison of the combined frequency spectra of all sources tested to that observed at

that point in each plant under normal operating conditions. It should be noted at this time that a few major sources were not operated in each plant because of difficulties encountered at the time of testing.

These findings provide information which must be interpreted cautiously. For instance, the measurement point was close to some sources and far away from others implying care be taken in comparing source levels. Also, many of the sources were operated under conditions not typical to normal usage, such as the chillers, which were operated without ice or water, and the neck cutter, which lacked animal fat from the chickens to prevent an uncharacteristic whine.
