FINAL REPORT

**A STUDY OF POULTRY PROCESSING PLANT
NOISE CHARACTERISTICS AND
POTENTIAL NOISE CONTROL TECHNIQUES**

GEORGIA INSTITUTE OF TECHNOLOGY

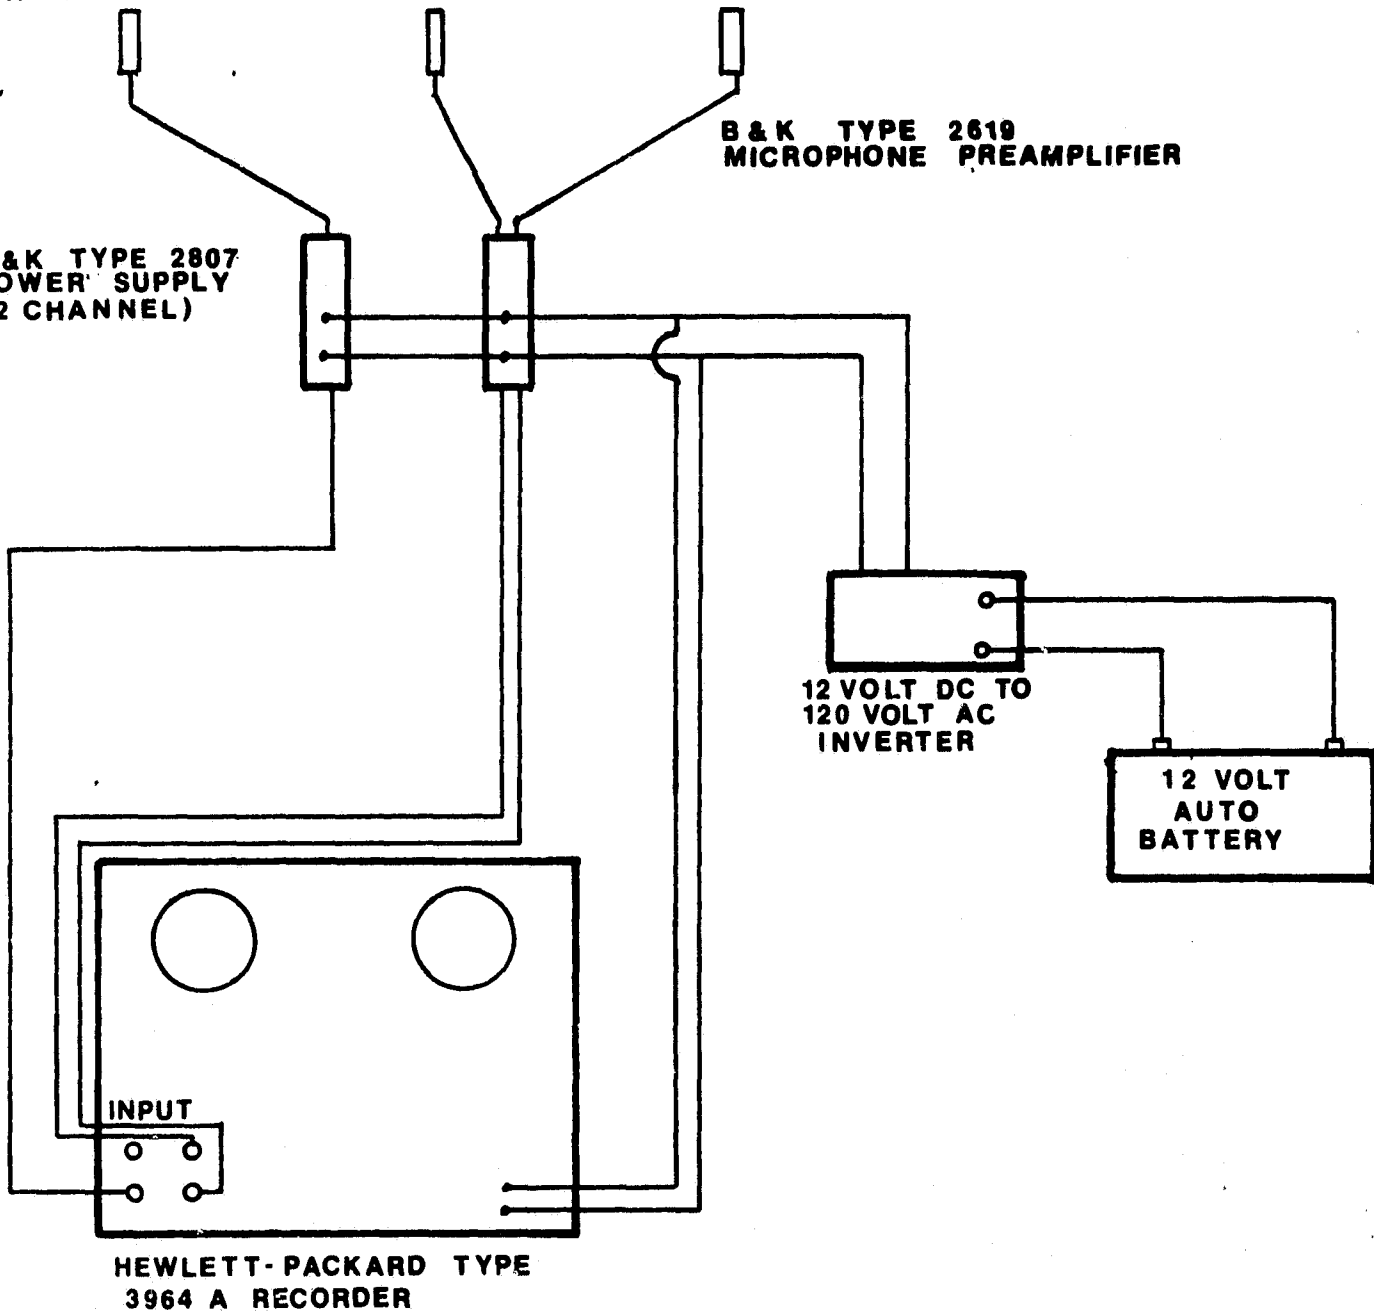
DATA RECORDING CONFIGURATION

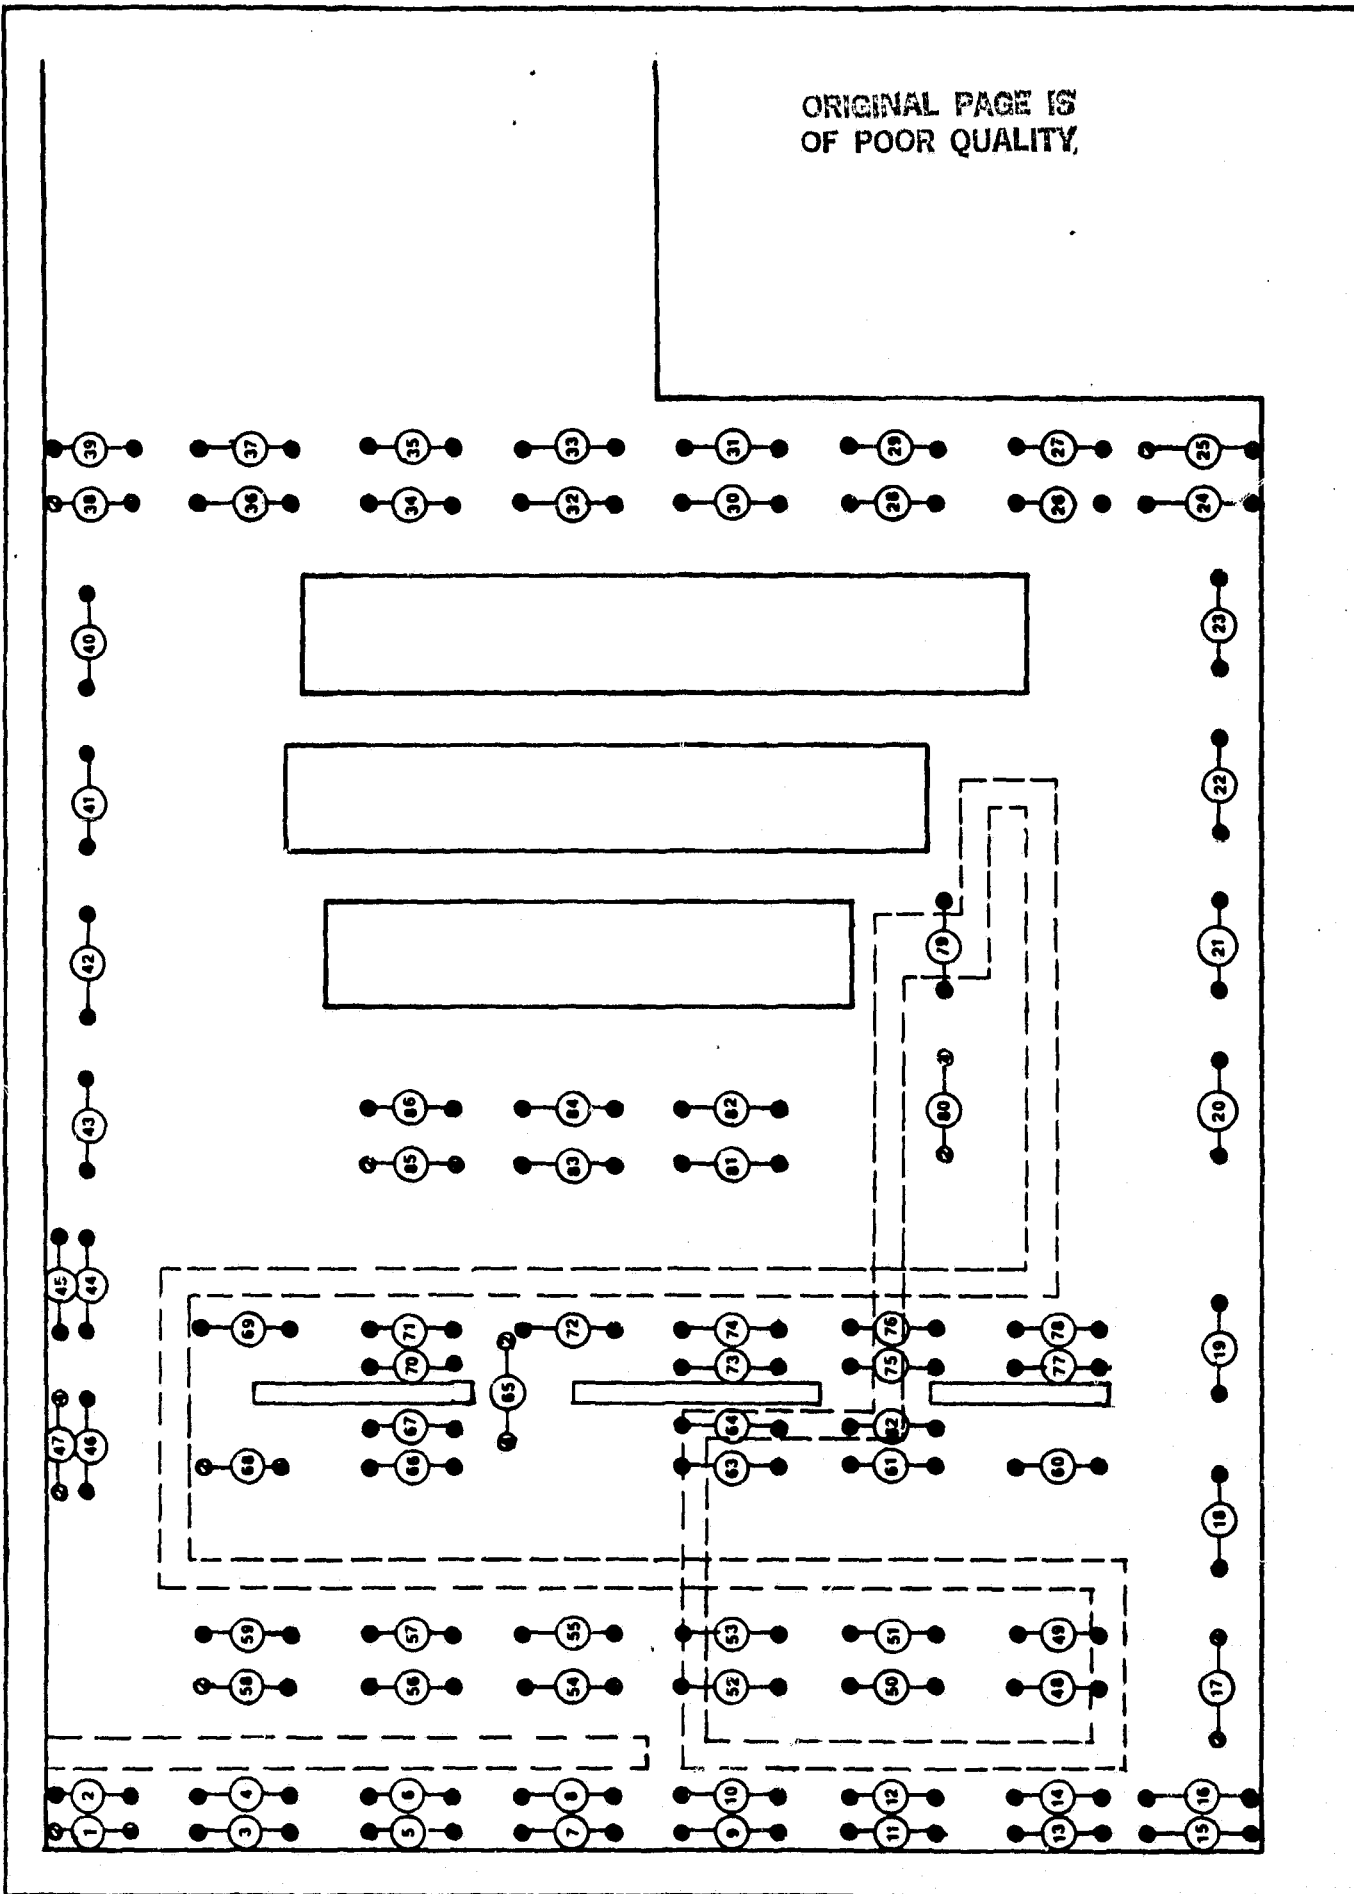
FIG. 2B LOCATION OF MEASUREMENT POINTS IN TIP TOP

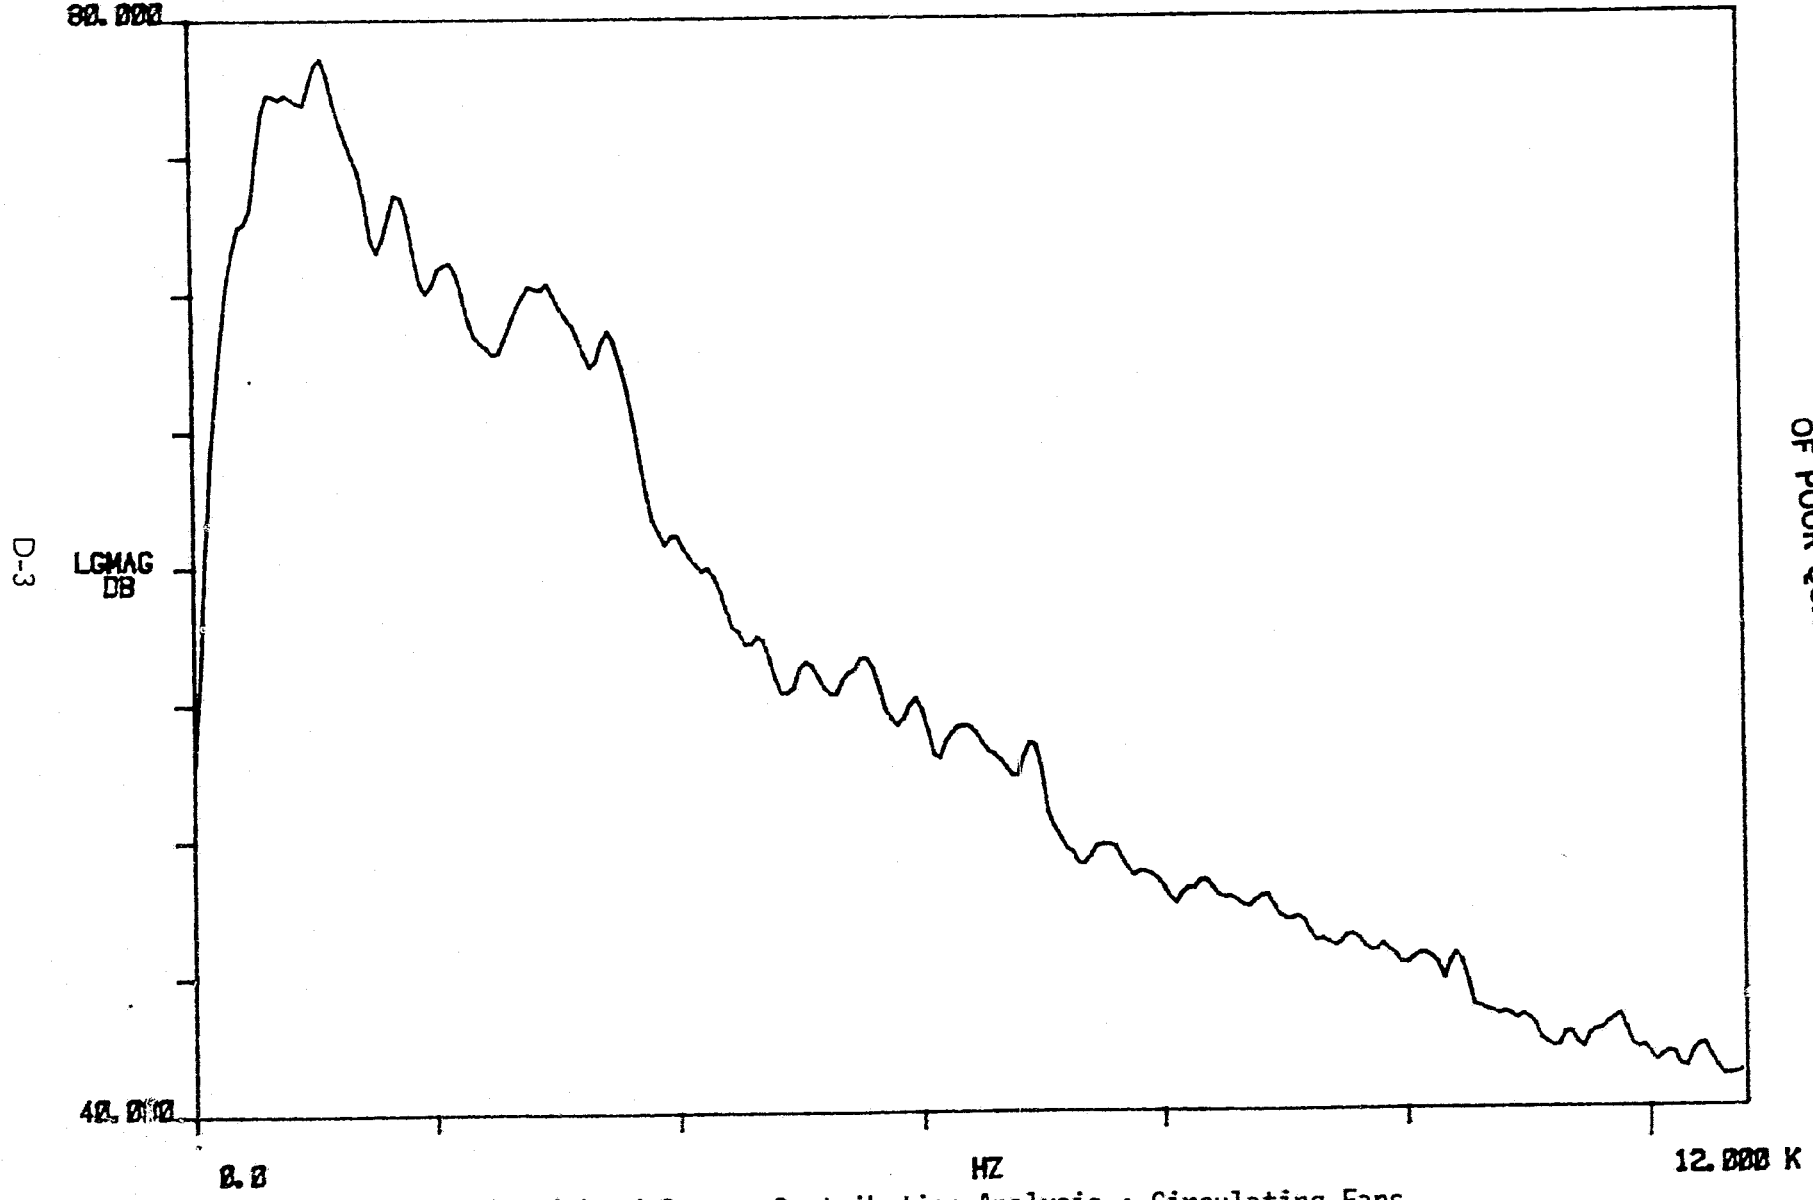
Fig. 1D - A-Weighted Source Contribution Analysis : Circulating Fans
CENTRAL SOYA PLANT (pt. 6B, ch.2)

The data gathered to evaluate the contribution of various sources to the observed sound pressure level at a point in each plant were also analyzed for frequency content. This was done to distinguish qualities about the sources which might be useful in any subsequent source abatement efforts. Unfortunately, as mentioned in the text, the data must be reviewed very carefully since the measurements were taken with some of the sources operating under conditions which were other than typical.

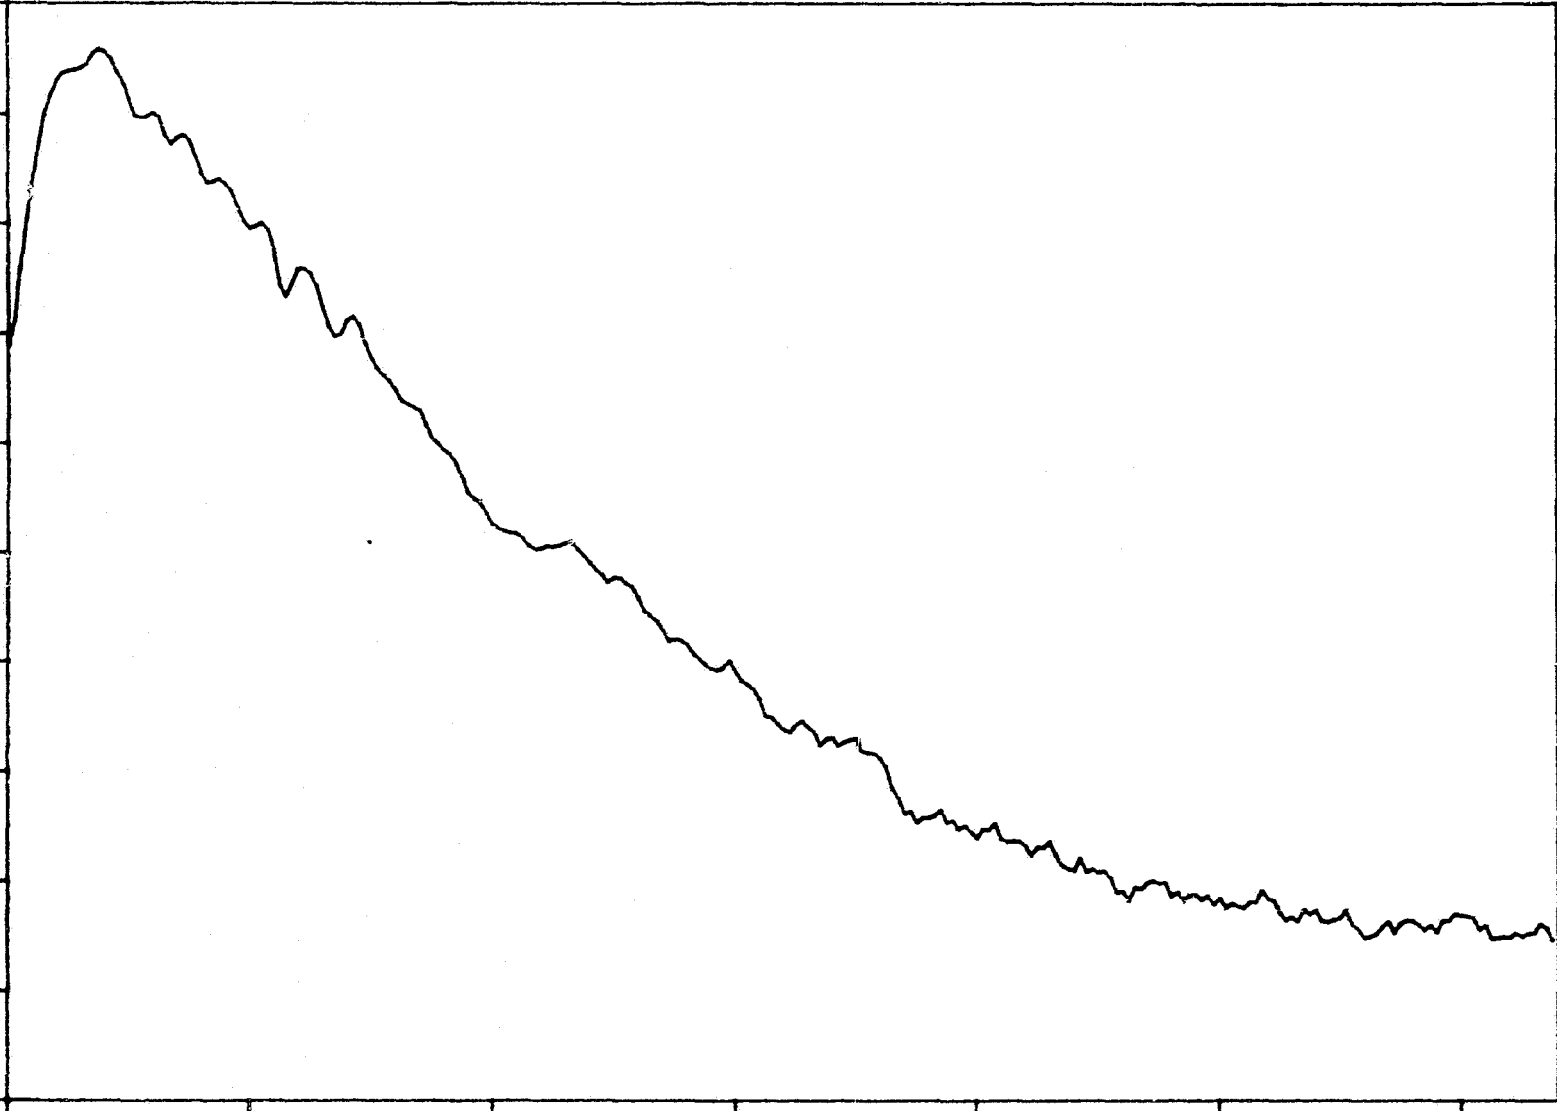
Fig. 2D - A-Weighted Source Contribution Analysis : Chillers
CENTRAL SOYA PLANT (pt. 6B, ch.2)

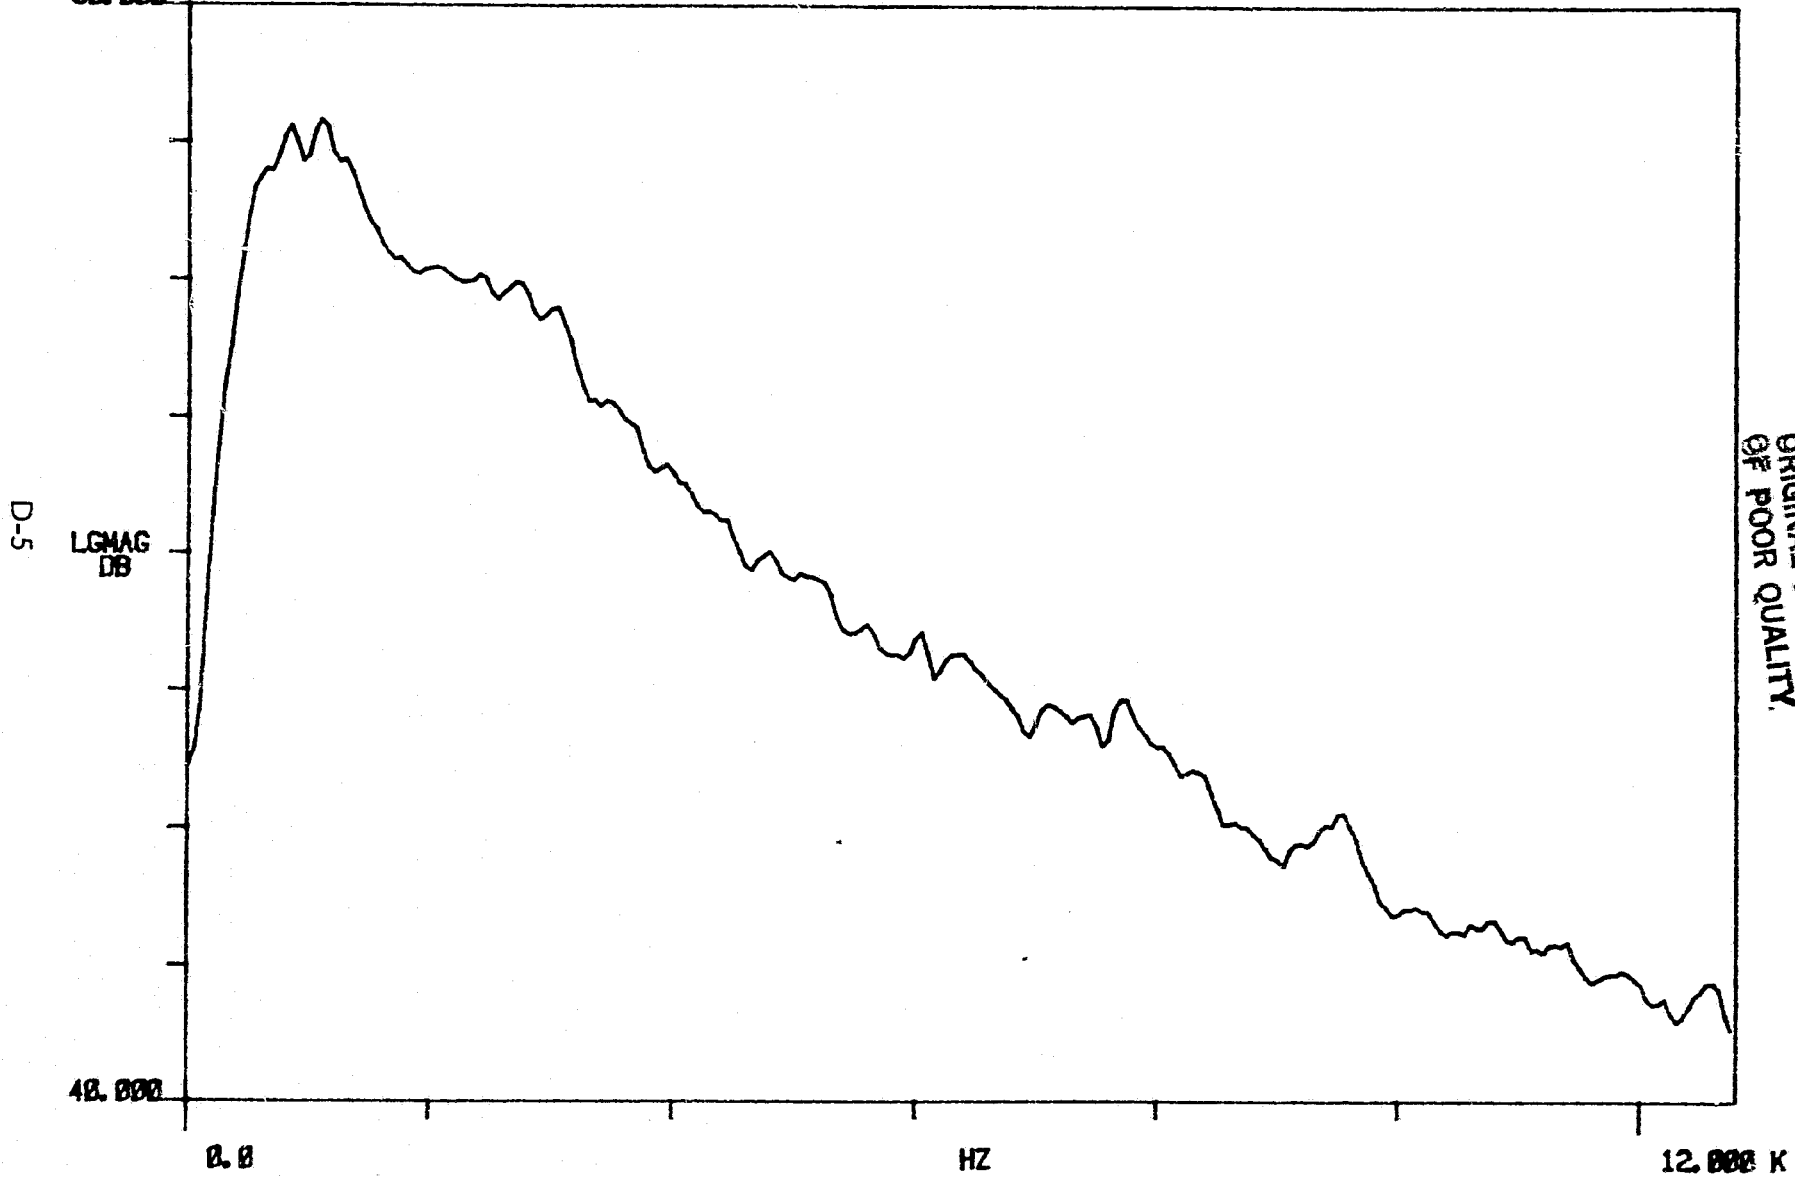
Fig. 3D - A-Weighted Source Contribution Analysis : Gizzard Machine
CENTRAL SOYA PLANT (pt. 6B, ch.2)

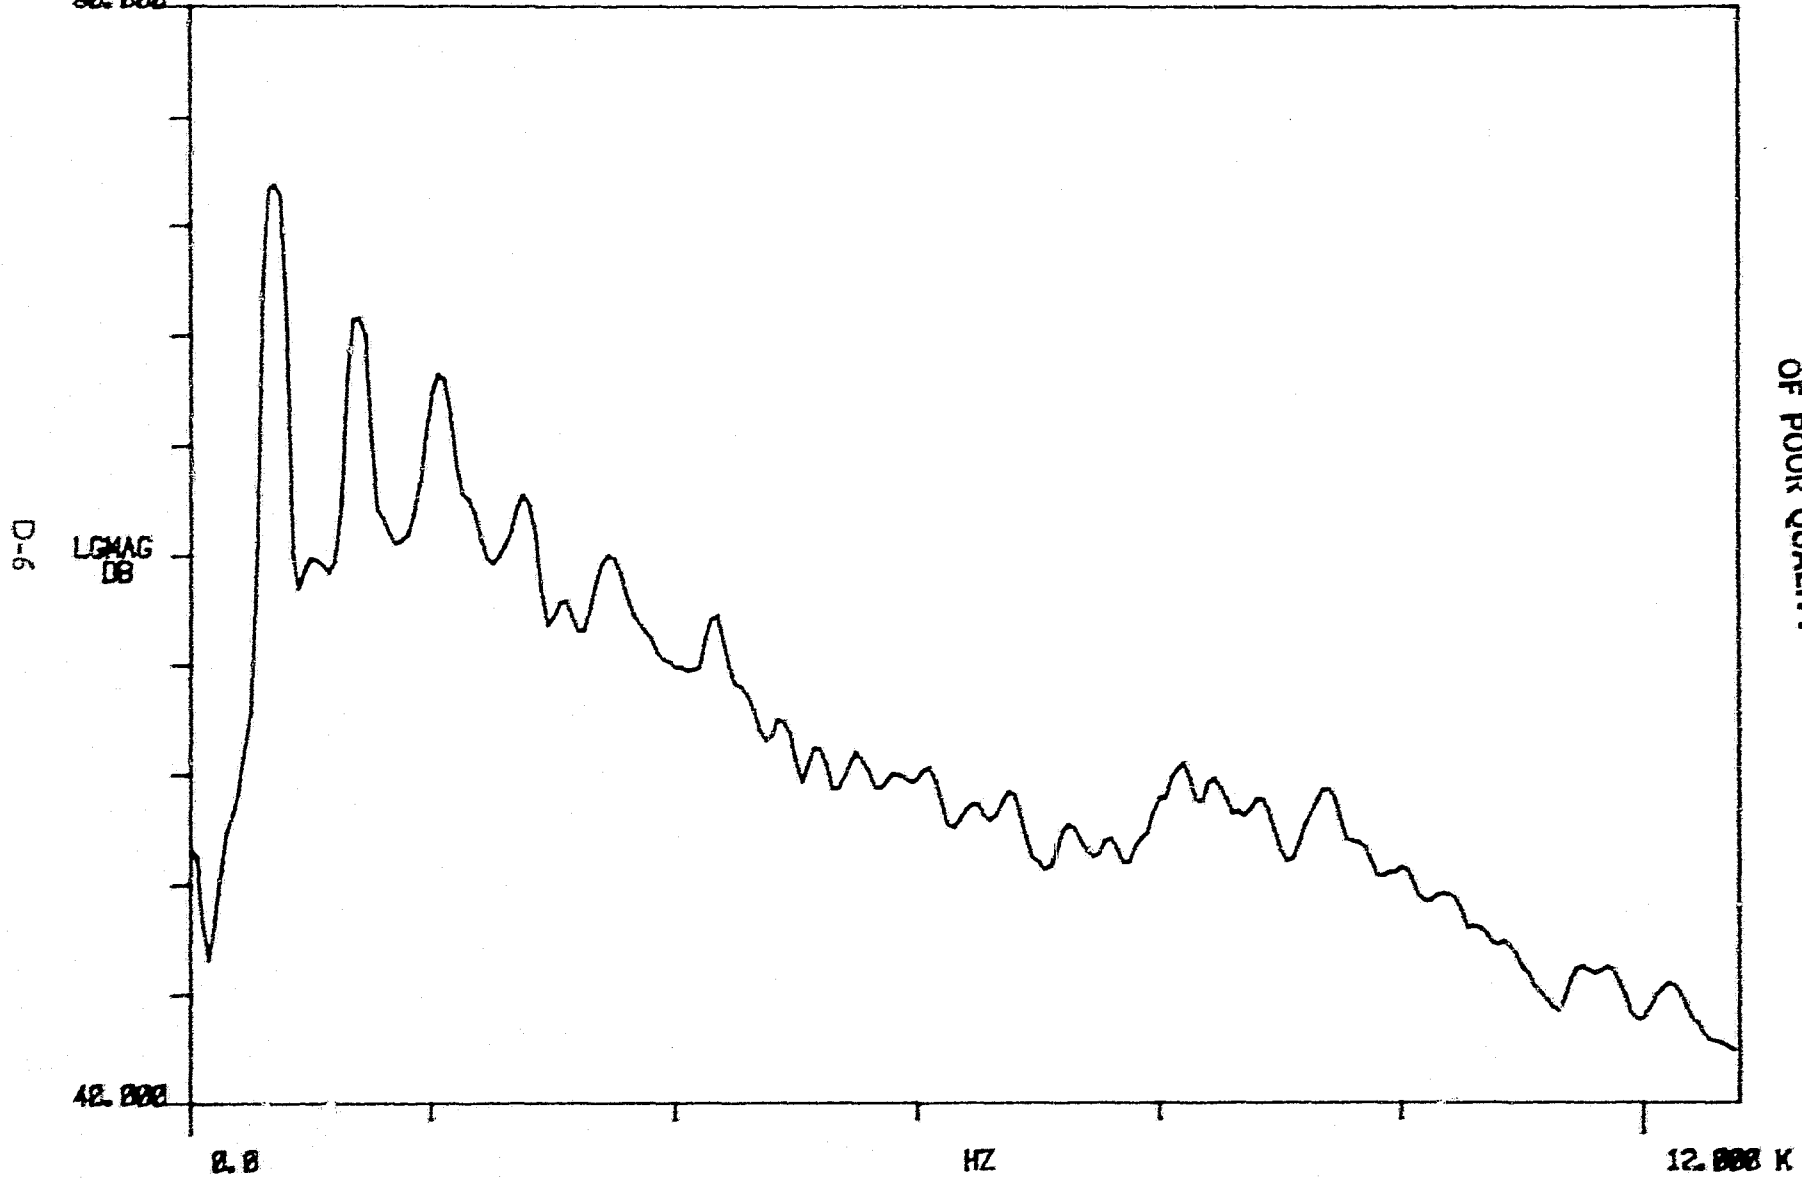
Fig. 4D - A-Weighted Source Contribution Analysis : Spray Washer
CENTRAL SOYA PLANT (pt. 6B, ch.2)

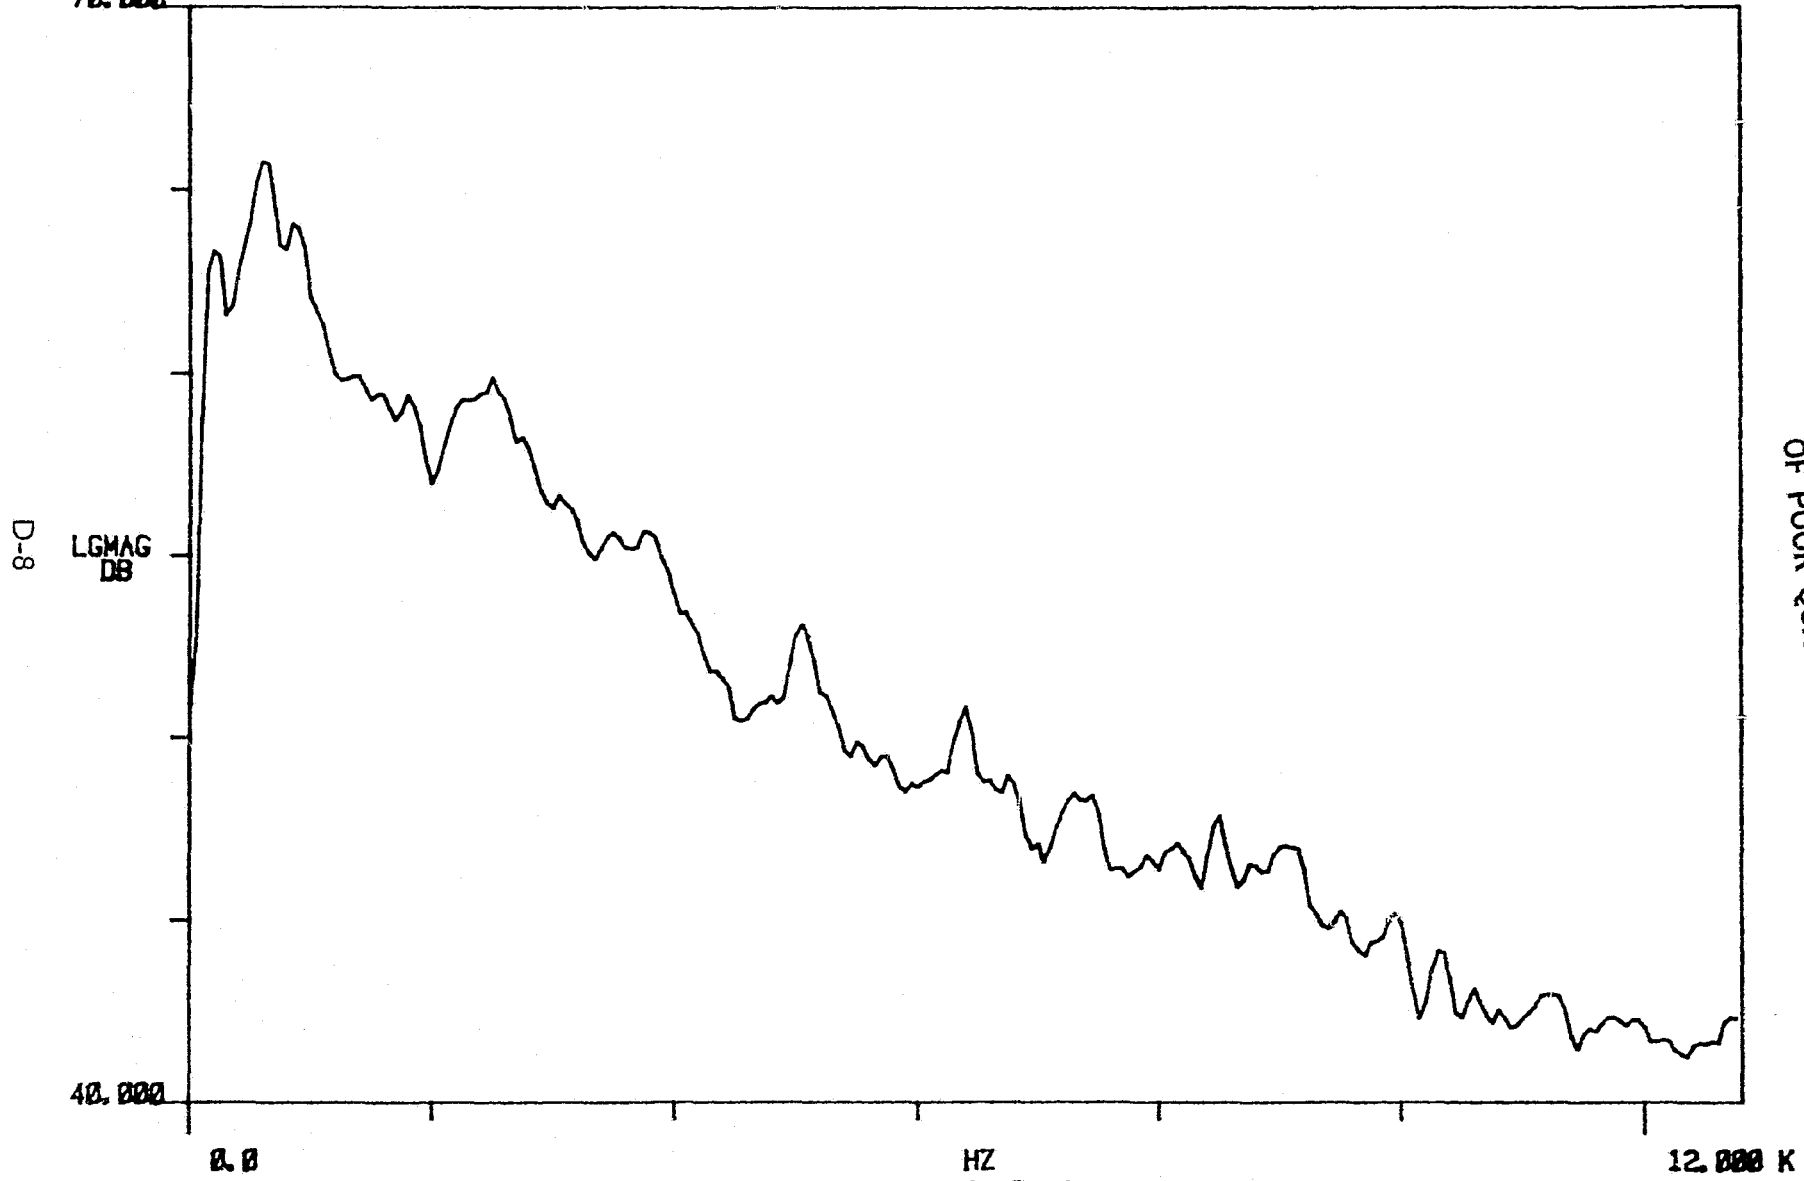
Fig 6D - A-Weighted Source Contribution Analysis : Vacuum Pump
CENTRAL SOYA PLANT (pt. 6B, ch.2)

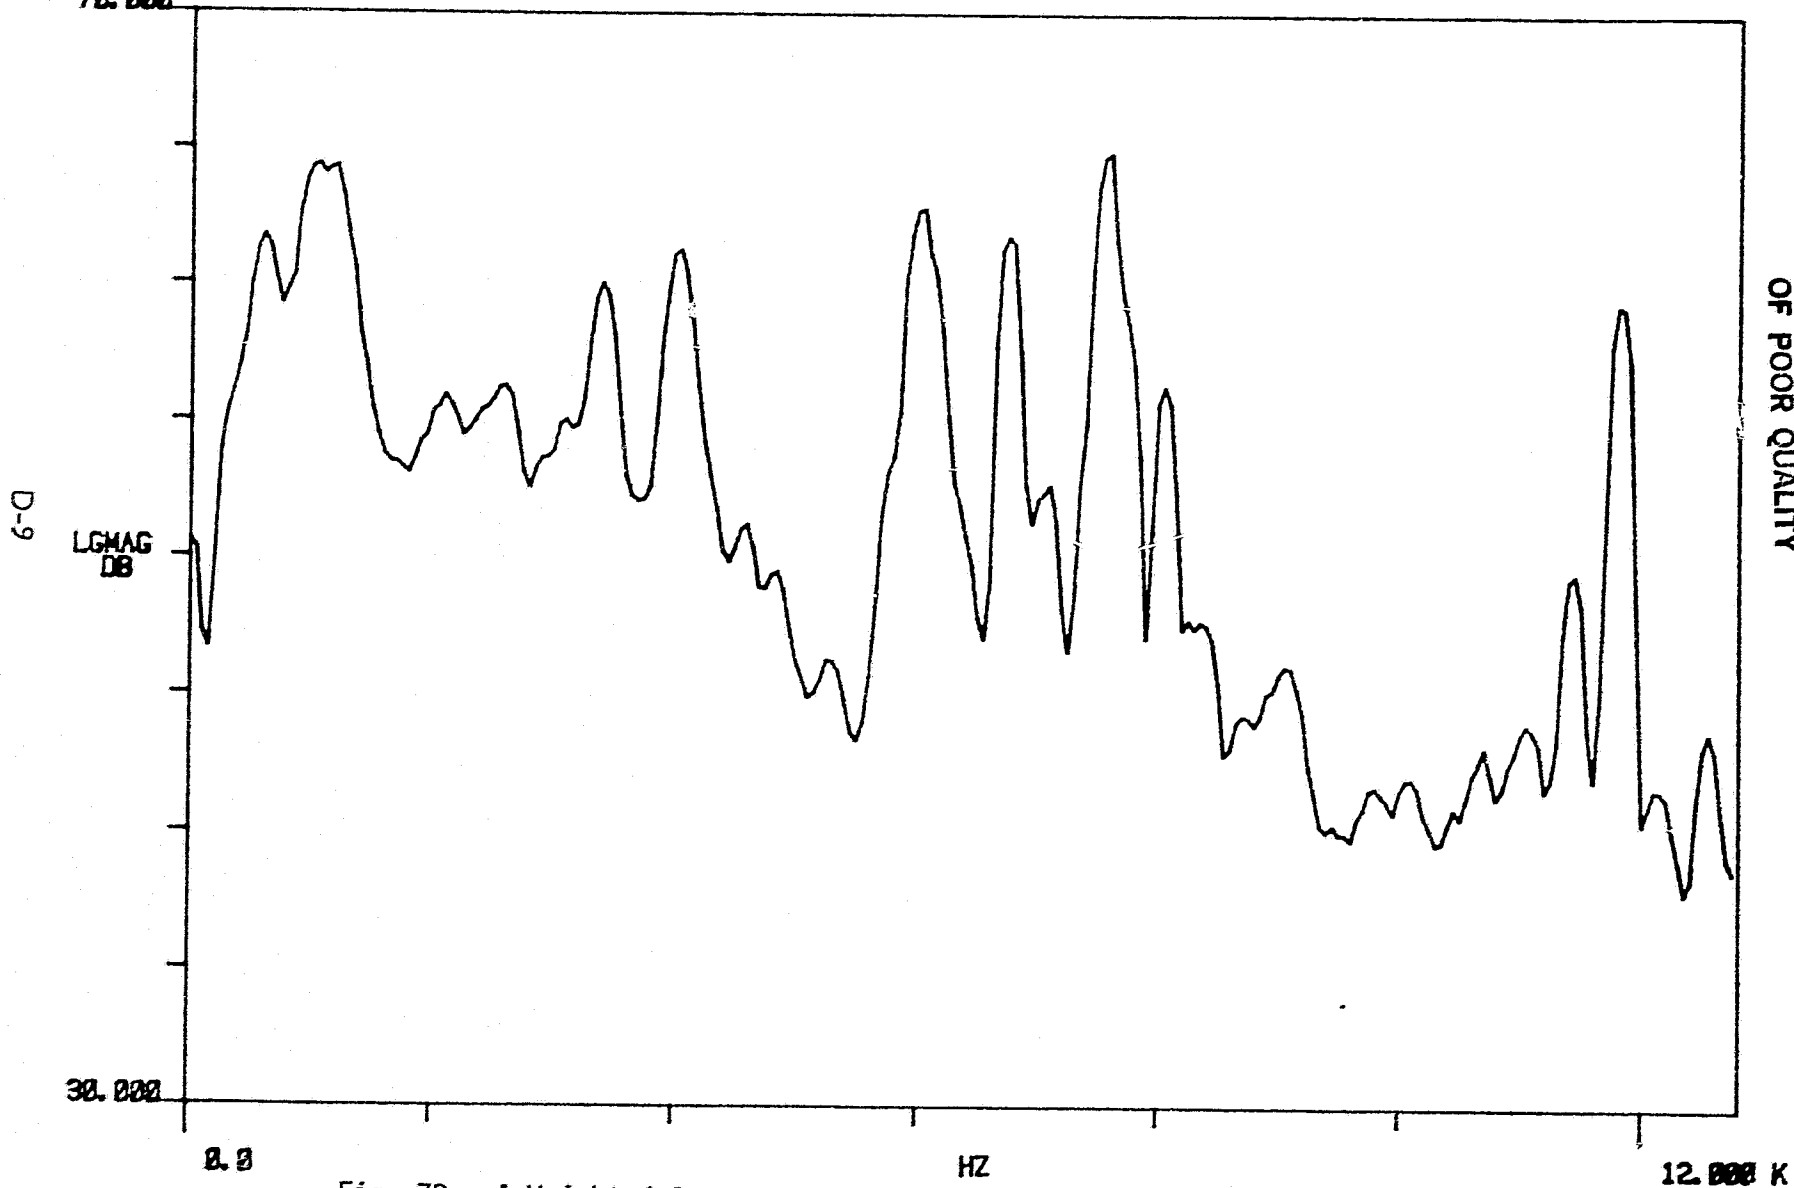
Fig. 7D - A-Weighted Source Contribution Analysis : Neck Cutters
CENTRAL SOYA PLANT (pt. 6B, ch.2)

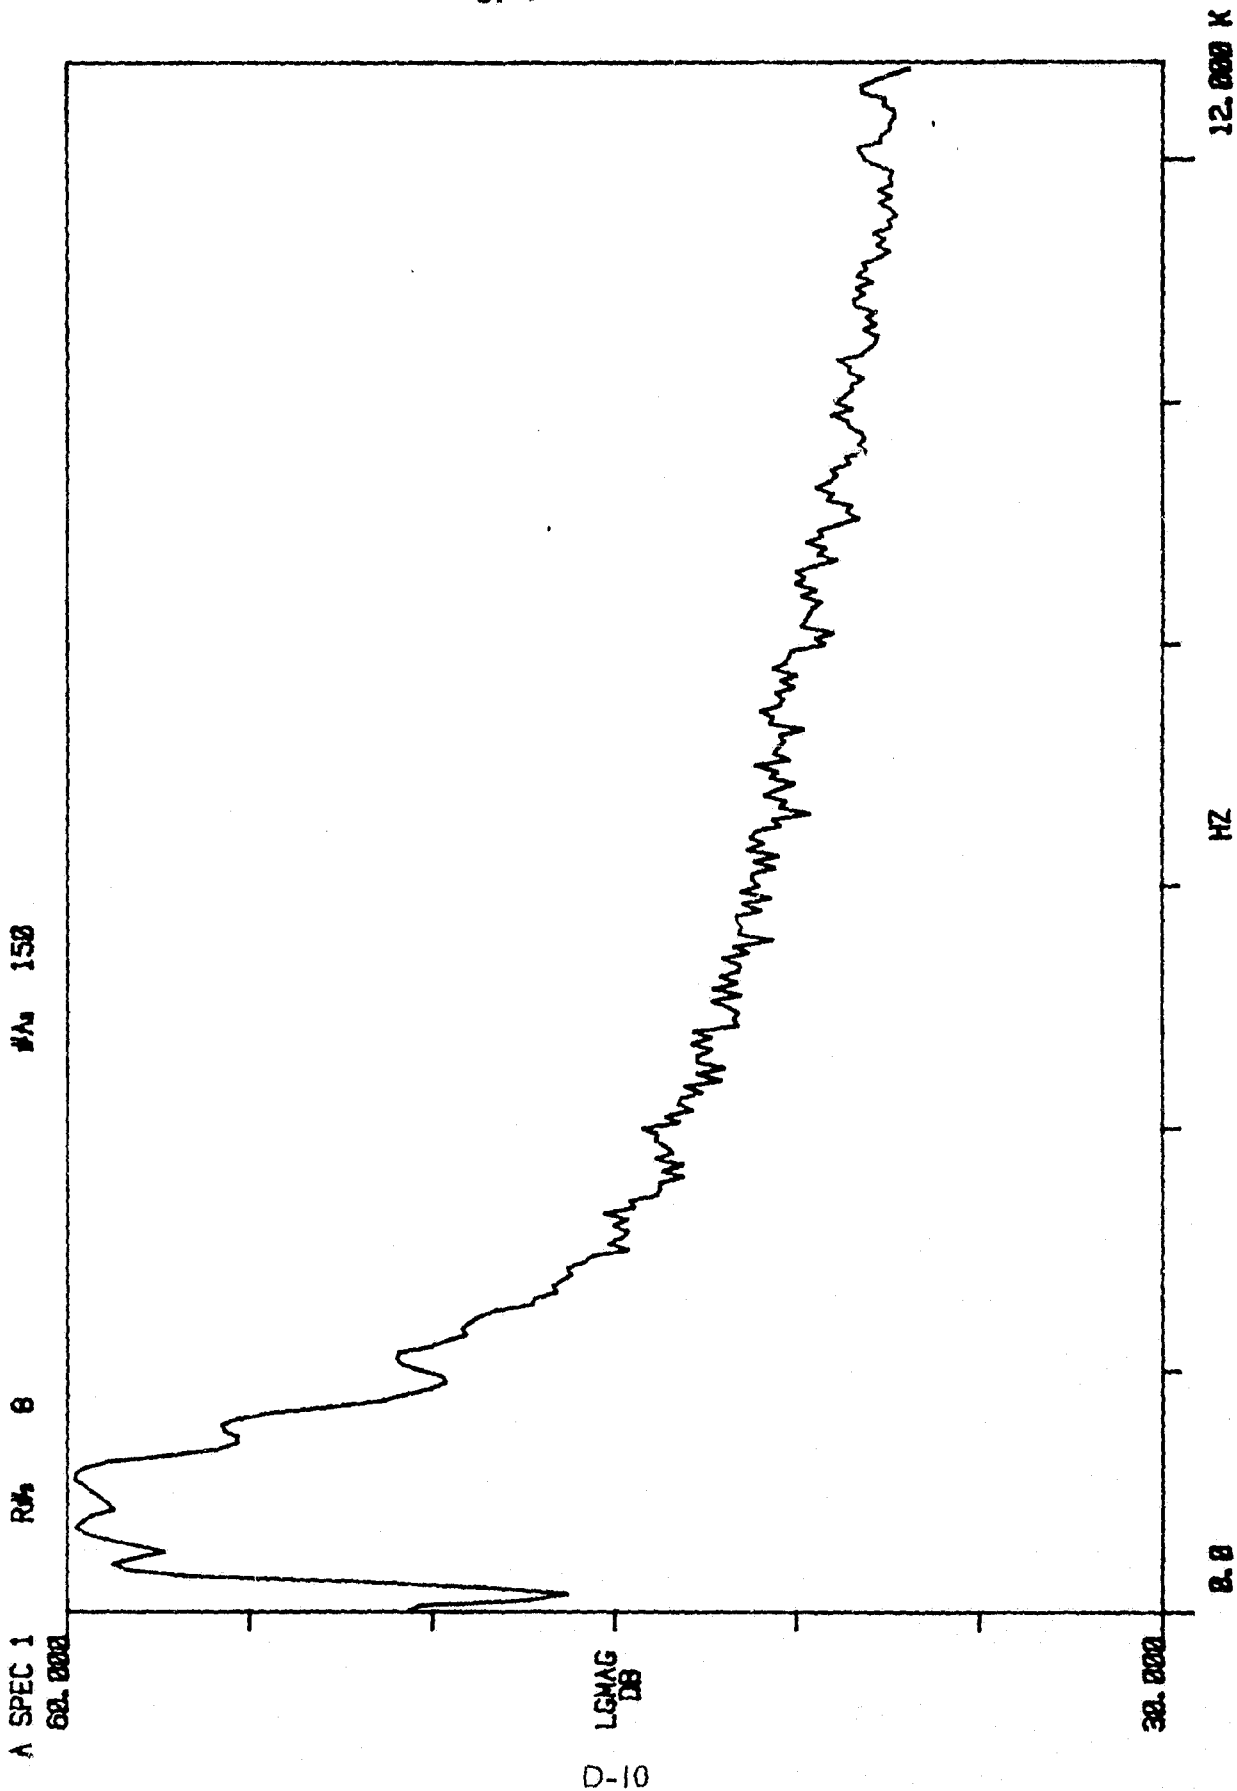
Fig. 8D - A-Weighted Source Contribution Analysis : Pickers
CENTRAL SOYA PLANT (pt. 6B, ch.2)

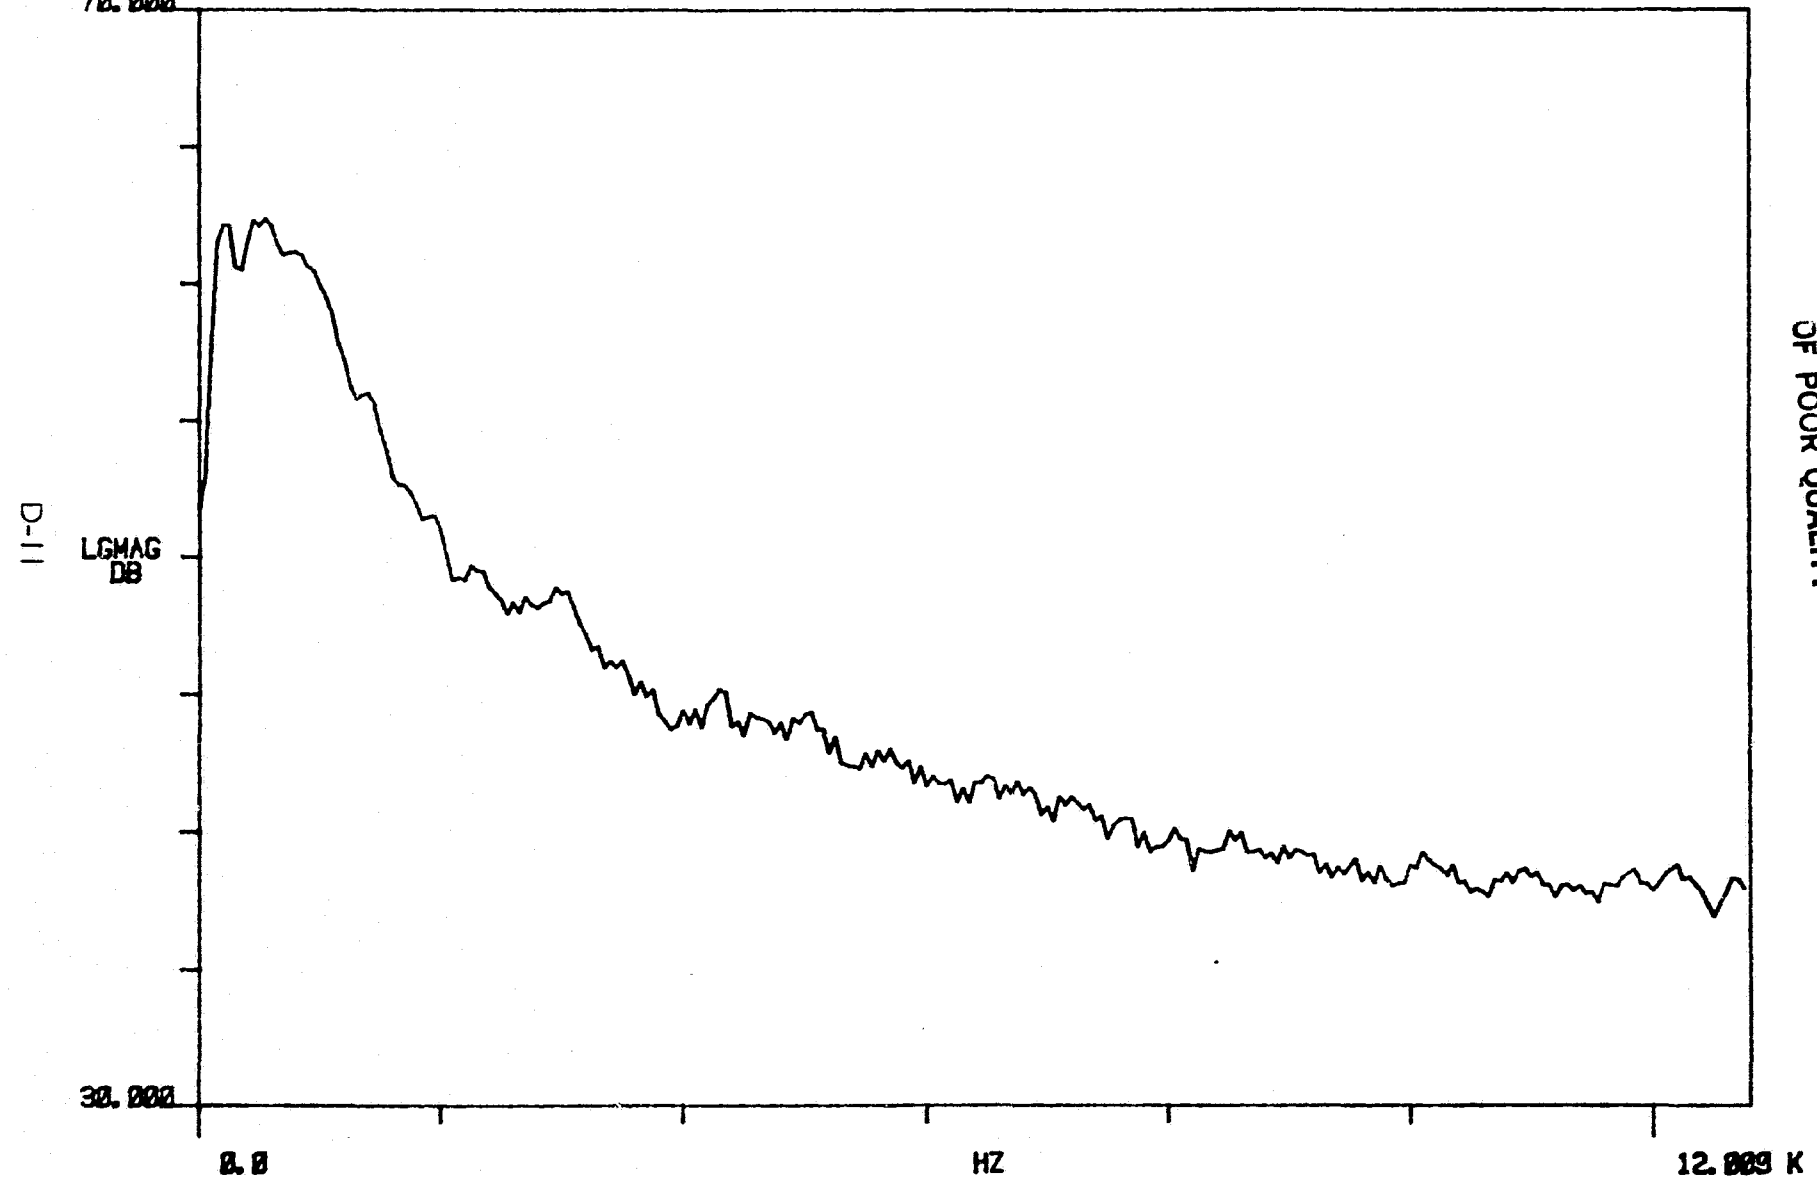
Fig. 9D - A-Weighted Source Contribution Analysis : Waste Vacuum
CENTRAL SOYA PLANT (pt. 6B, ch.2)
