FINAL REPORT

**A STUDY OF POULTRY PROCESSING PLANT
NOISE CHARACTERISTICS AND
POTENTIAL NOISE CONTROL TECHNIQUES**

GEORGIA INSTITUTE OF TECHNOLOGY

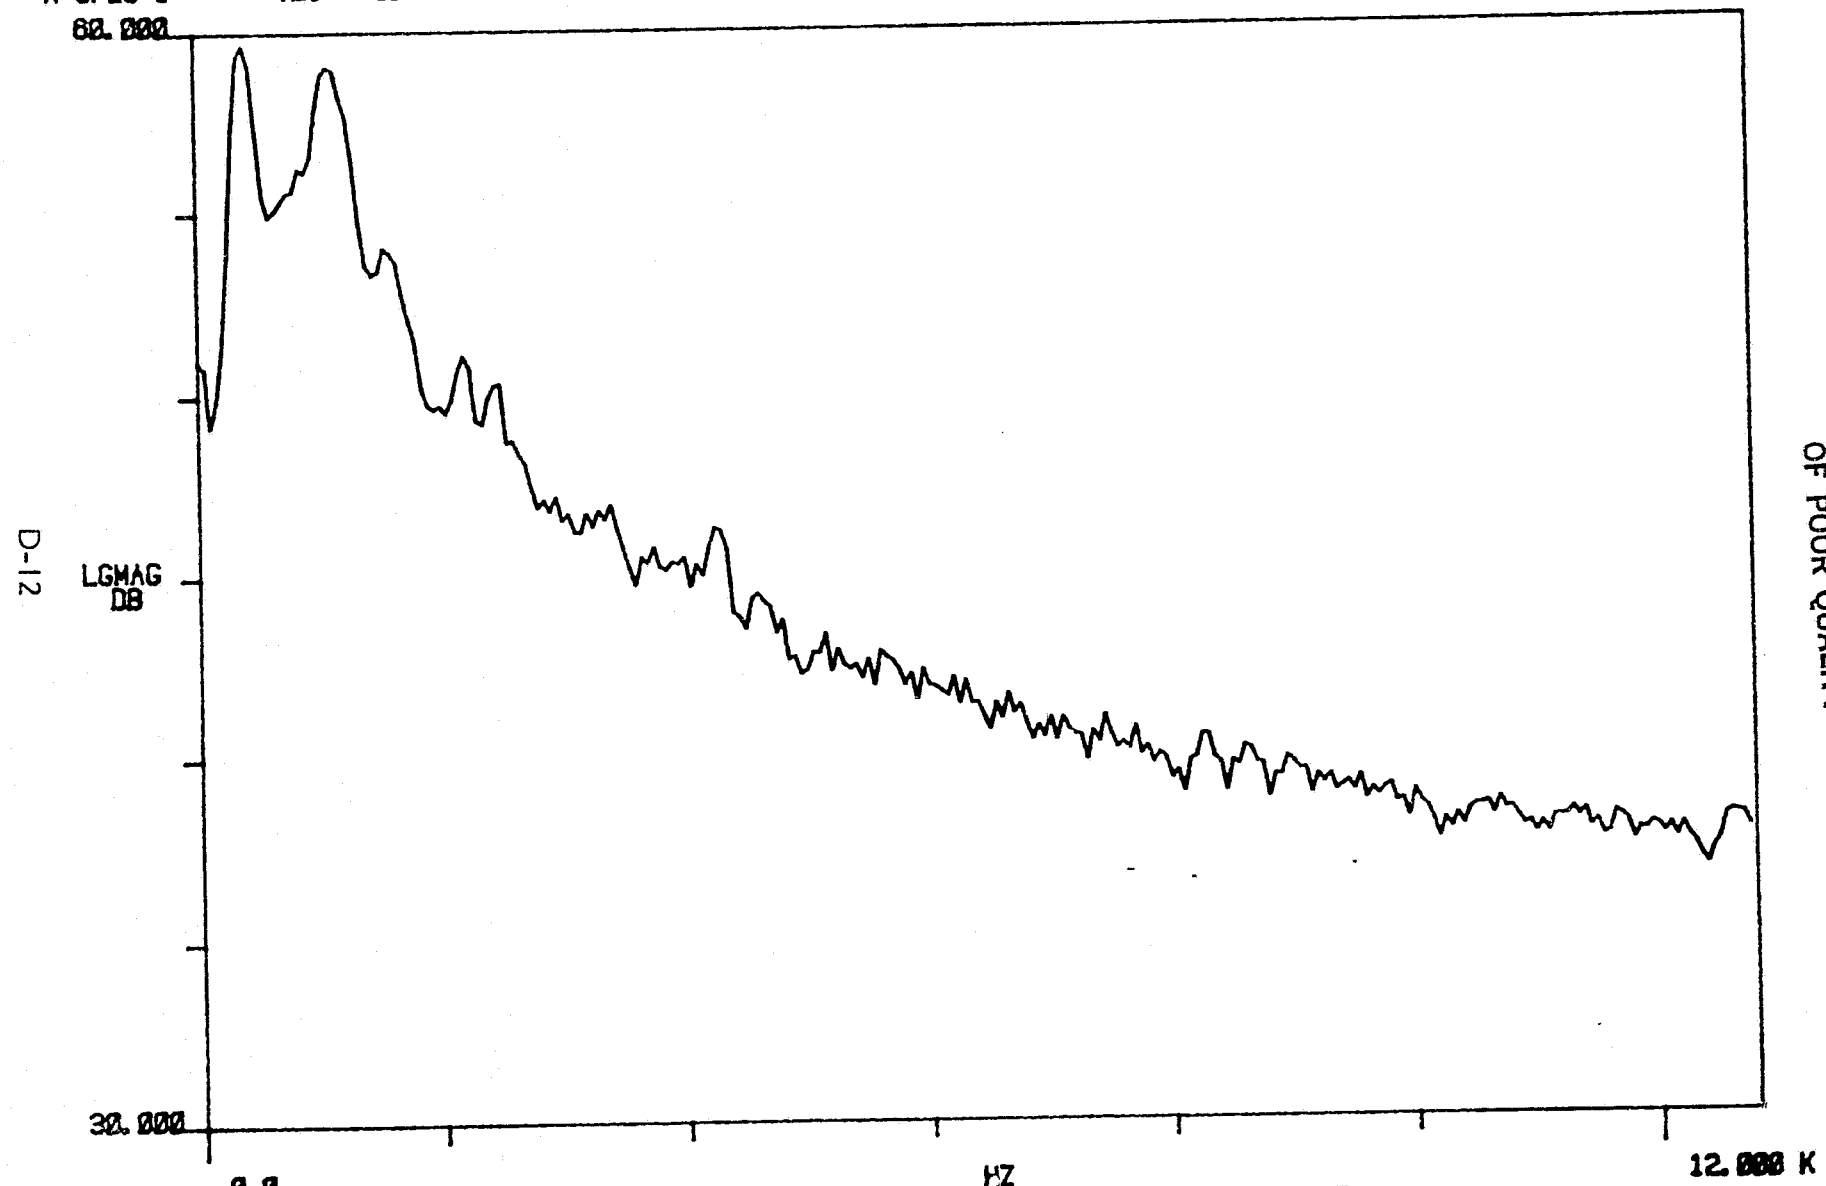
Fig. 10D - A-Weighted Source Contribution Analysis : Exhaust Fans
CENTRAL SOYA PLANT (pt. 6B, ch.2)

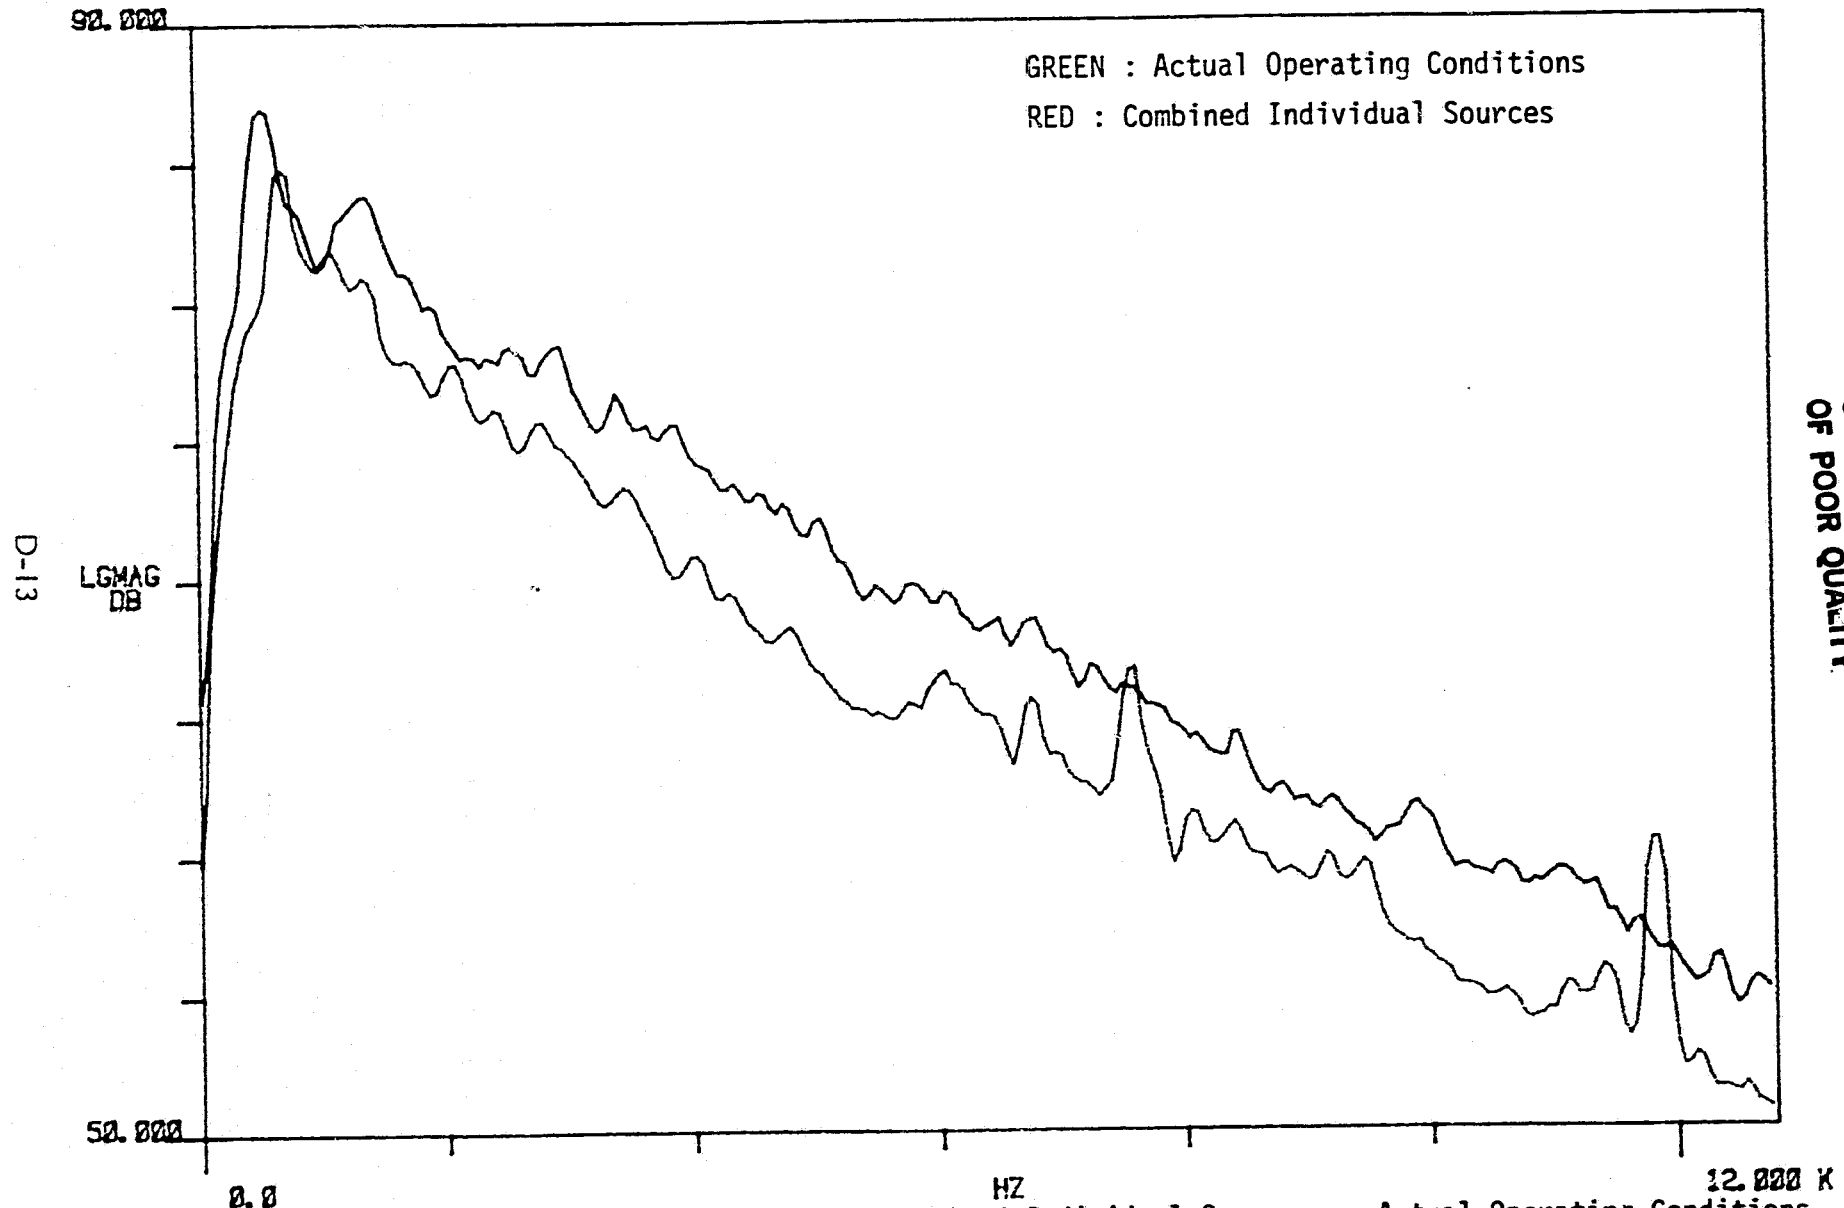
Fig. 11D - A-Weighted Comparison of Combined Individual Sources vs Actual Operating Conditions
CENTRAL SOYA PLANT (pt.6B, ch.2)

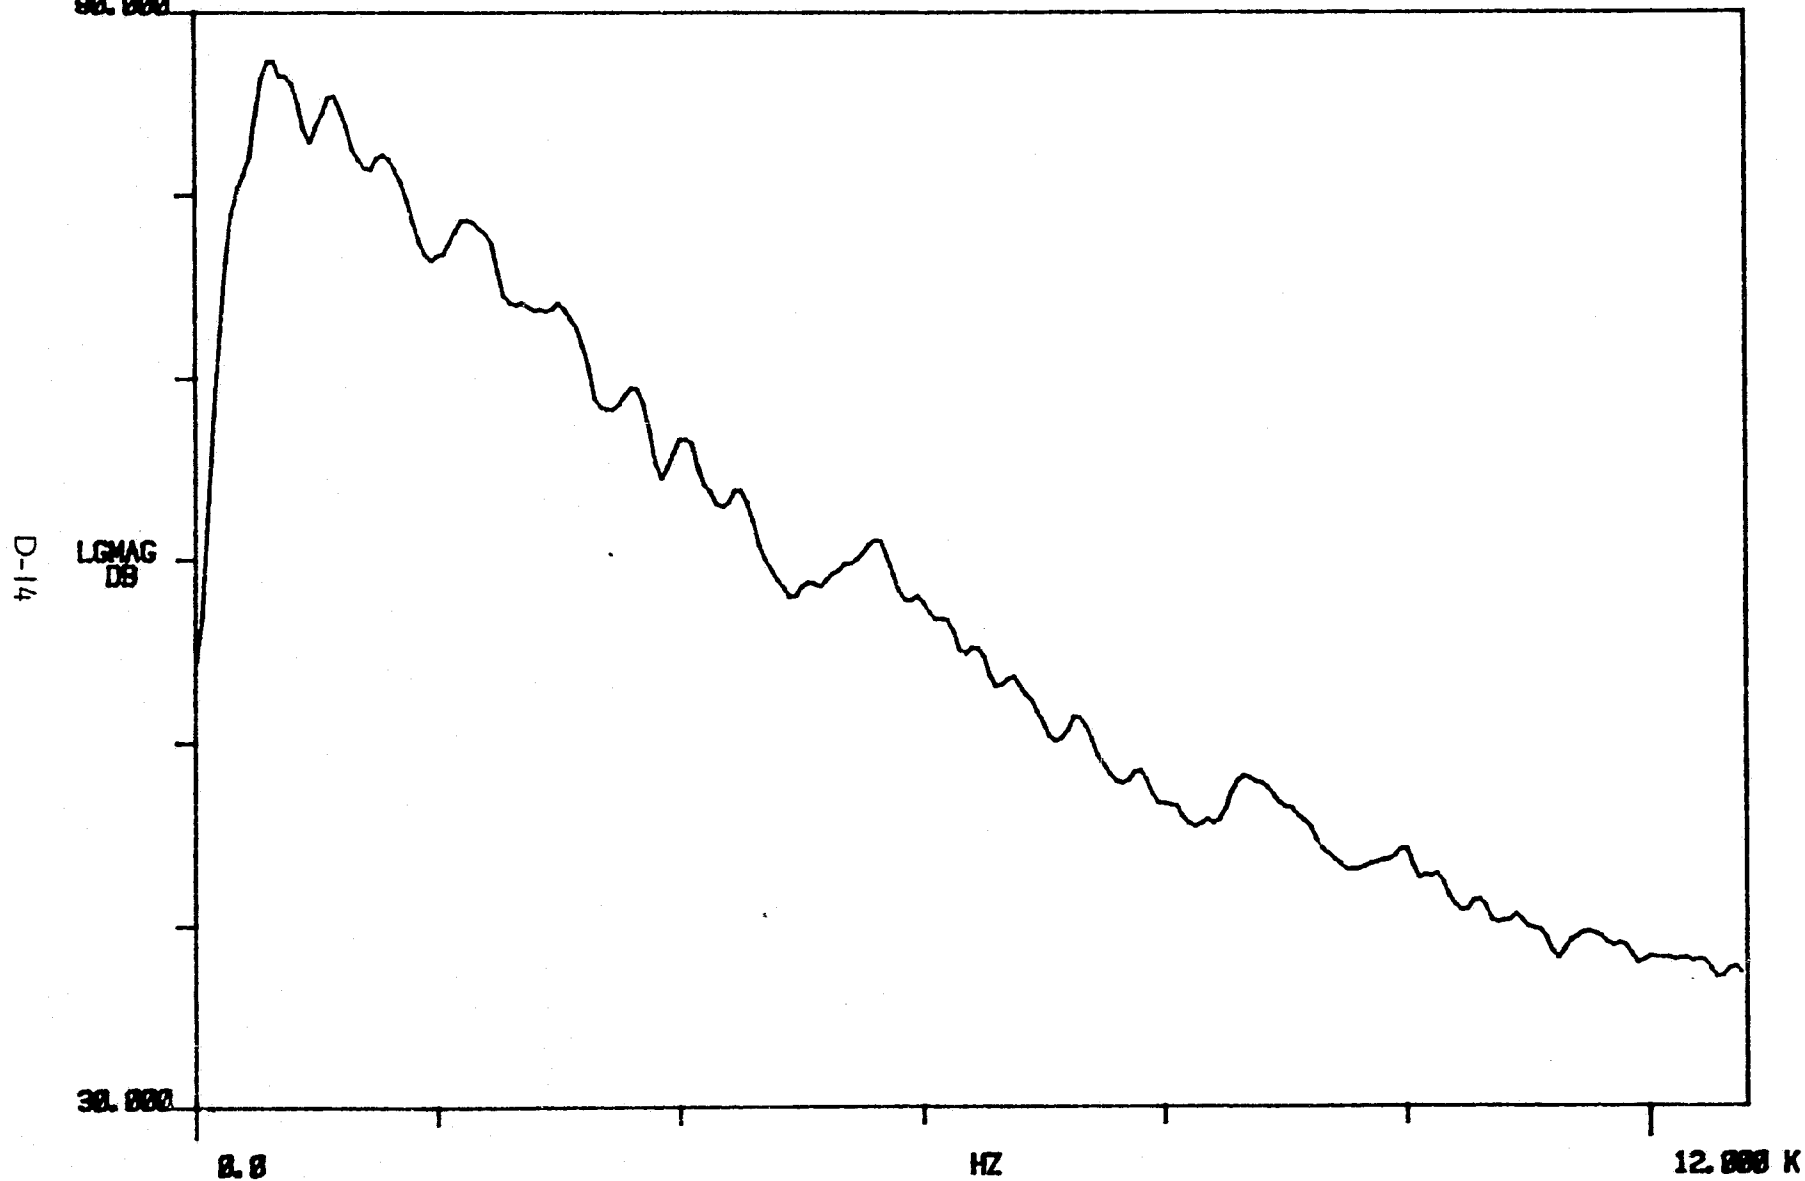
Fig. 12D - A-Weighted Source Contribution Analysis : Hock Cutter
TIP TOP PLANT (pt. 53, ch.2)

Regarding the Tip Top plant sources, the fans, at least in this area of the plant, are very quiet. But both the hock cutter and the chillers are intense sources which unfortunately during this test are suspected of producing noise levels not typical of those observed under normal operating conditions. Figure 22D seems to bear this out. When a comparison is made between the observed level of the combined sources versus the observed level during normal operations, the former is higher. This is probably again because the chillers were operated without water or ice and because the hock cutter was operated without birds. In addition to level differences, the two spectra also exhibit substantial differences in shape at several points, which further raise questions regarding the representativeness of the source signatures observed from these two machines.

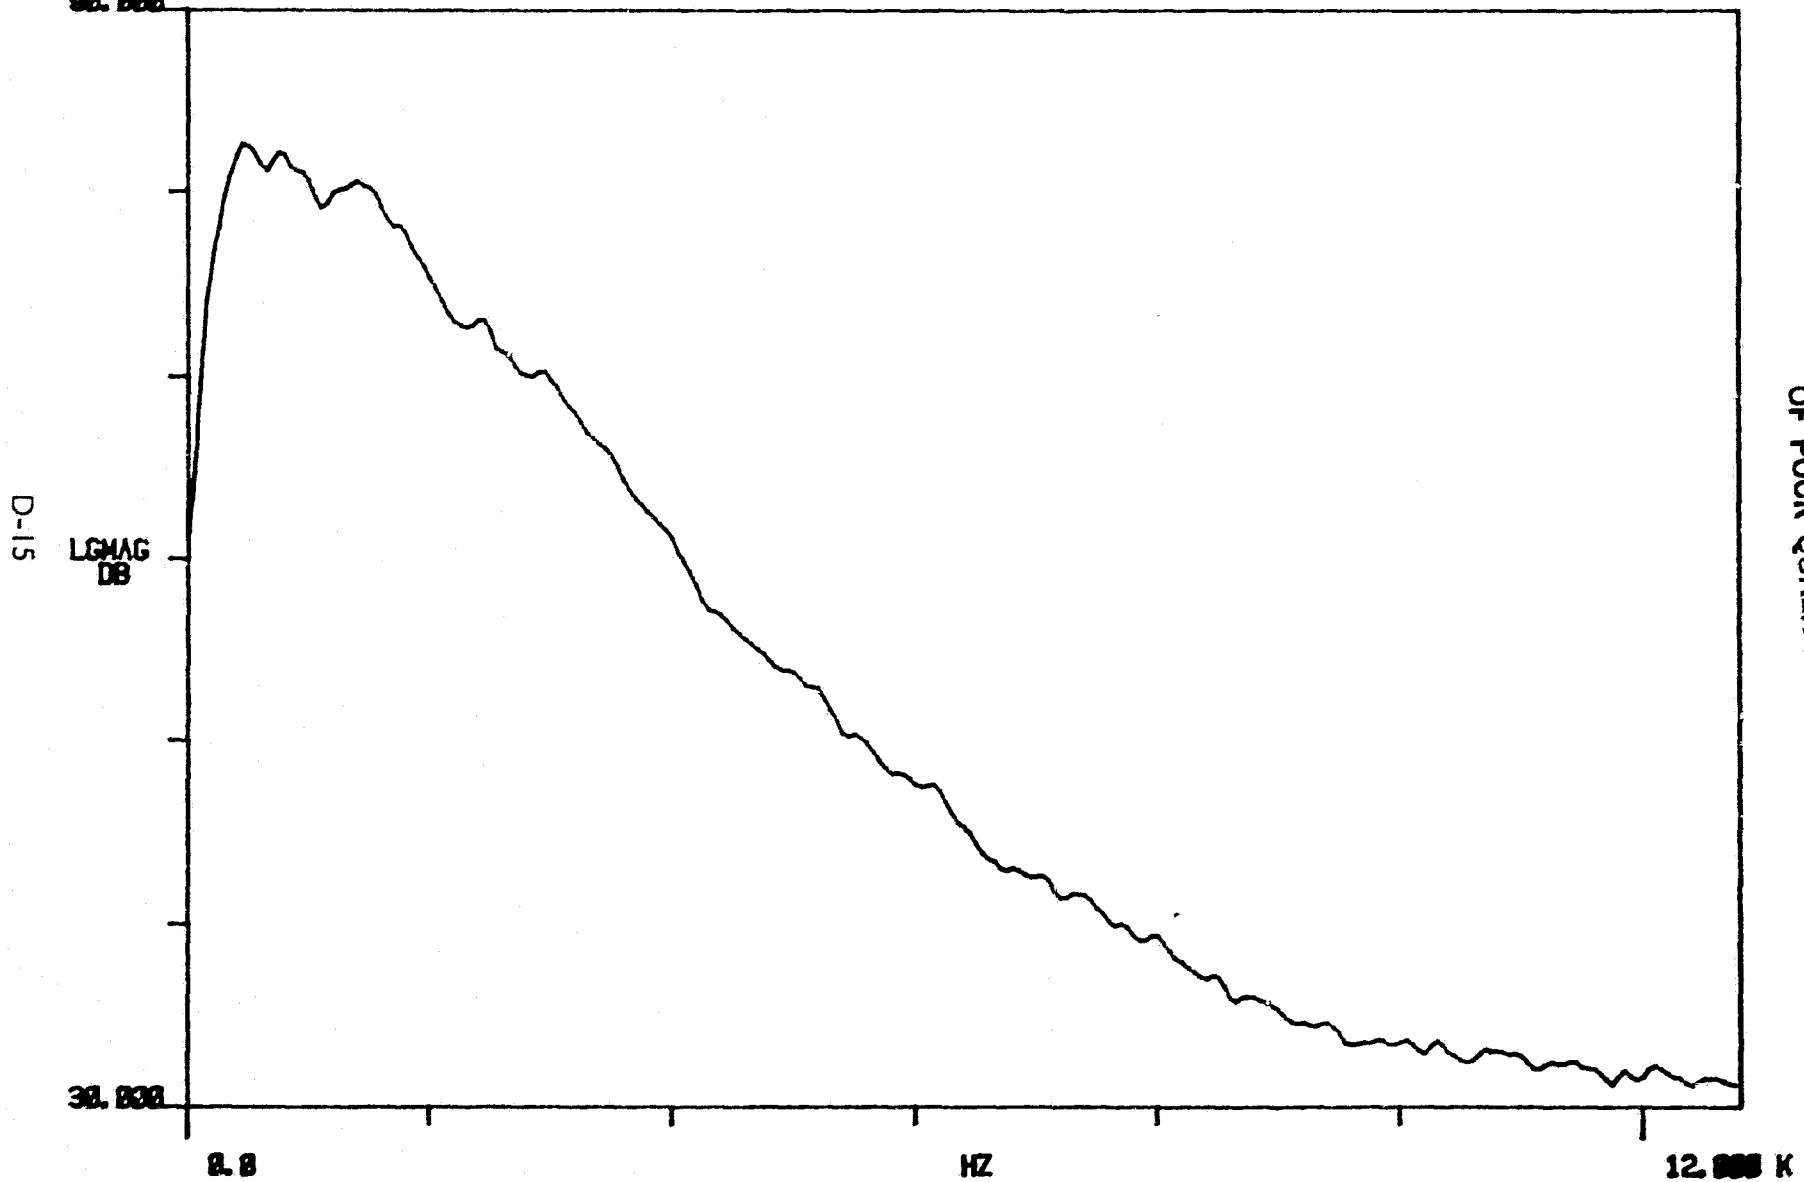
Fig. 13D - A-Weighted Source Contribution Analysis : Chillers
TIP TOP PLANT (pt. 53, ch.2)

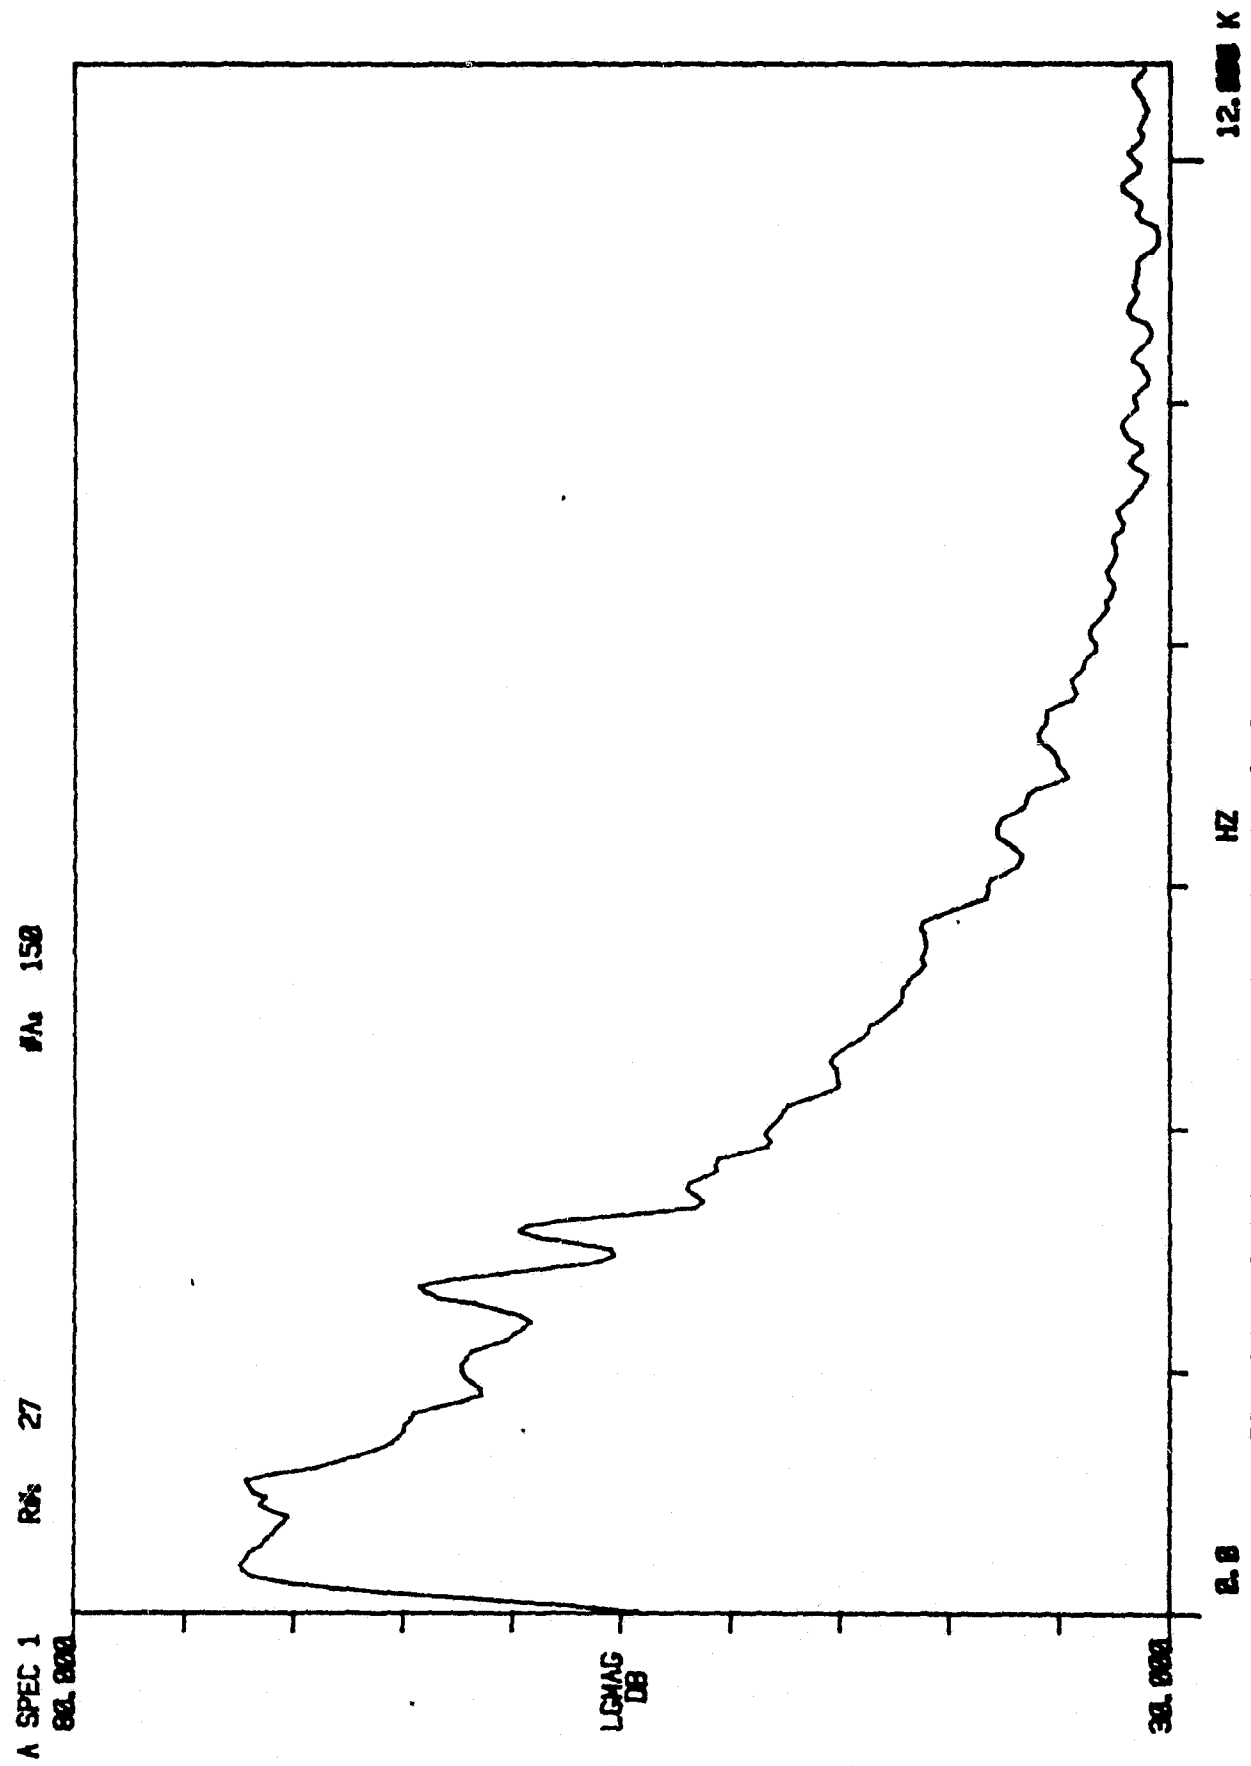
Fig. 15D - A-Weighted Source Contribution Analysis : Pickers
TIP TOP PLANT (pt. 53, ch.2)

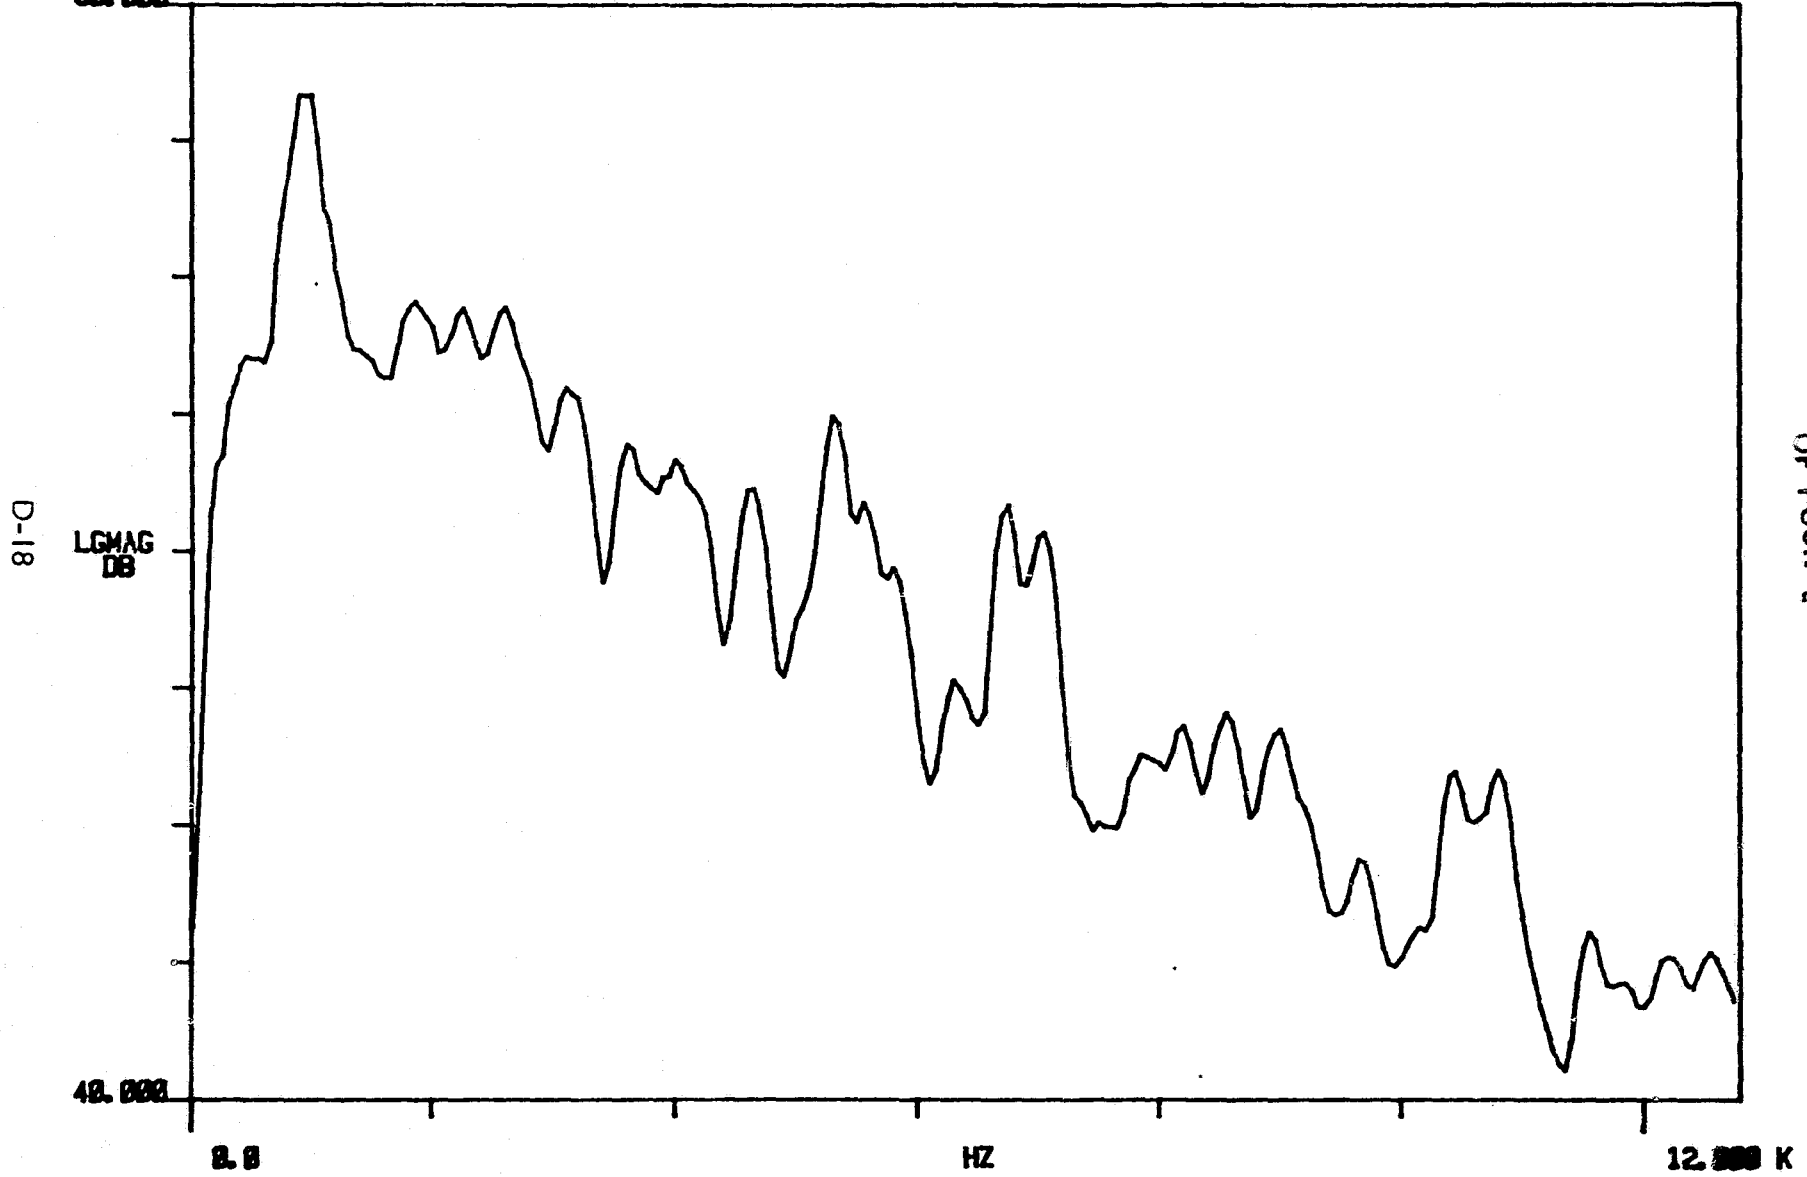
Fig. 16D - A-Weighted Source Contribution Analysis : Gizzard Machine
TIP TOP PLANT (pt. 53, ch.2)

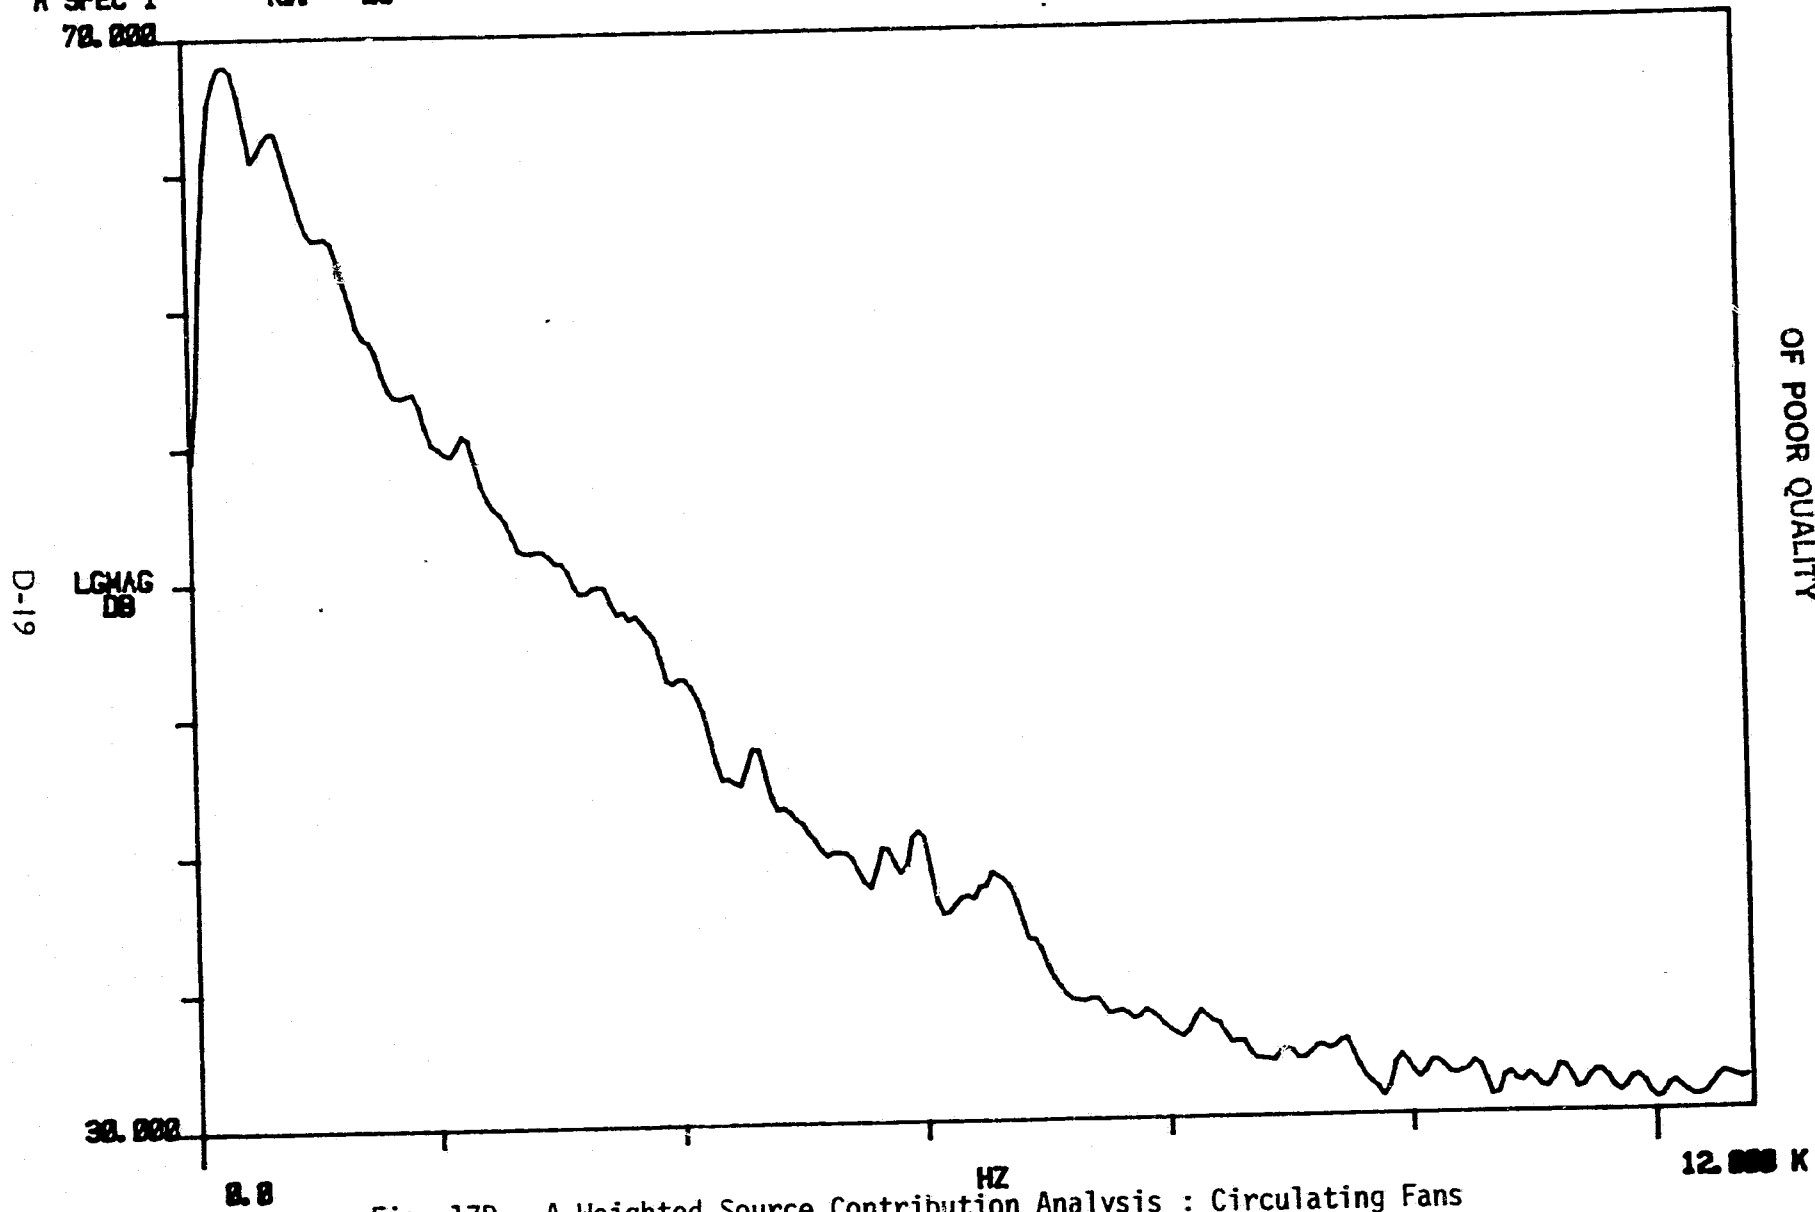
Fig. 17D - A-Weighted Source Contribution Analysis : Circulating Fans
TIP TOP PLANT (pt. 53, ch.2)

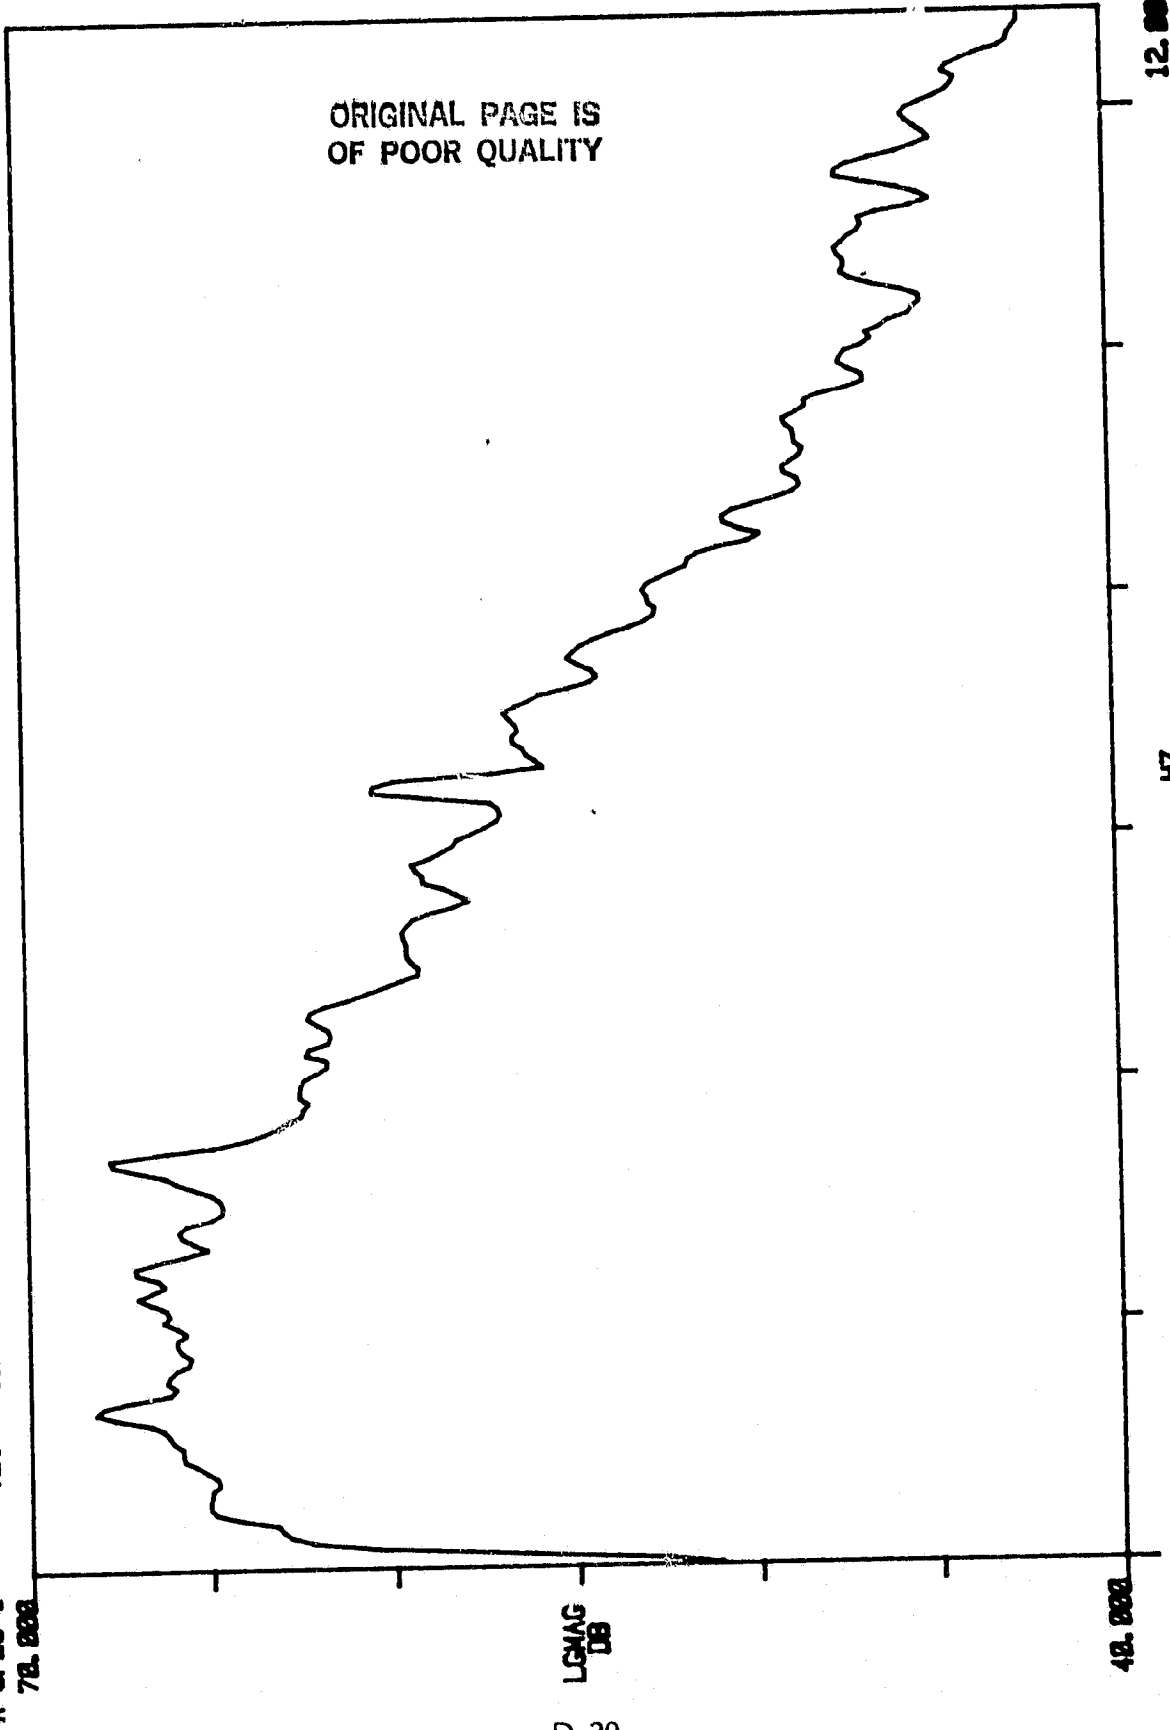
Fig. 18D - A-Weighted Source Contribution Analysis : Shackle Lines
TIP TOP PLANT (pt. 53, ch.2)

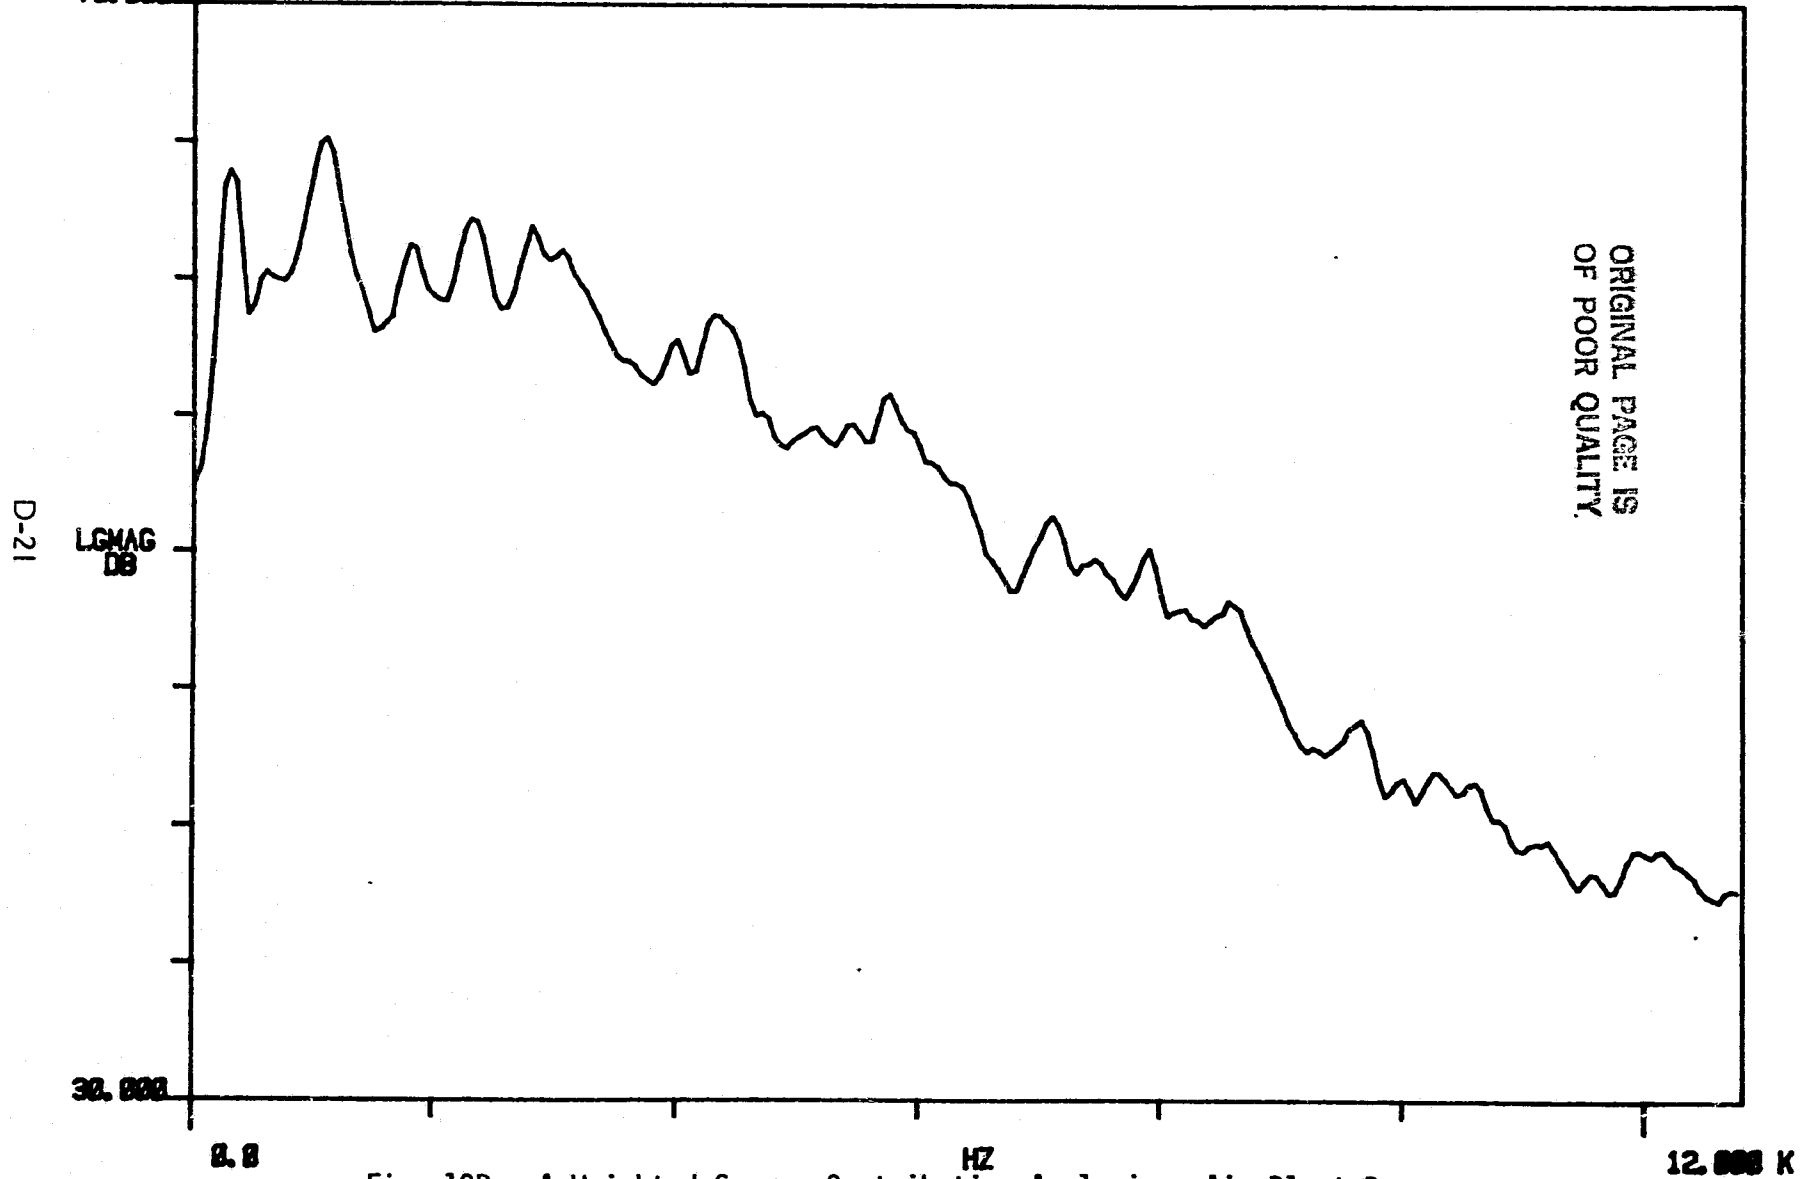
Fig. 19D - A-Weighted Source Contribution Analysis : Air Blast Dryer
TIP TOP PLANT (pt. 53, ch.2)

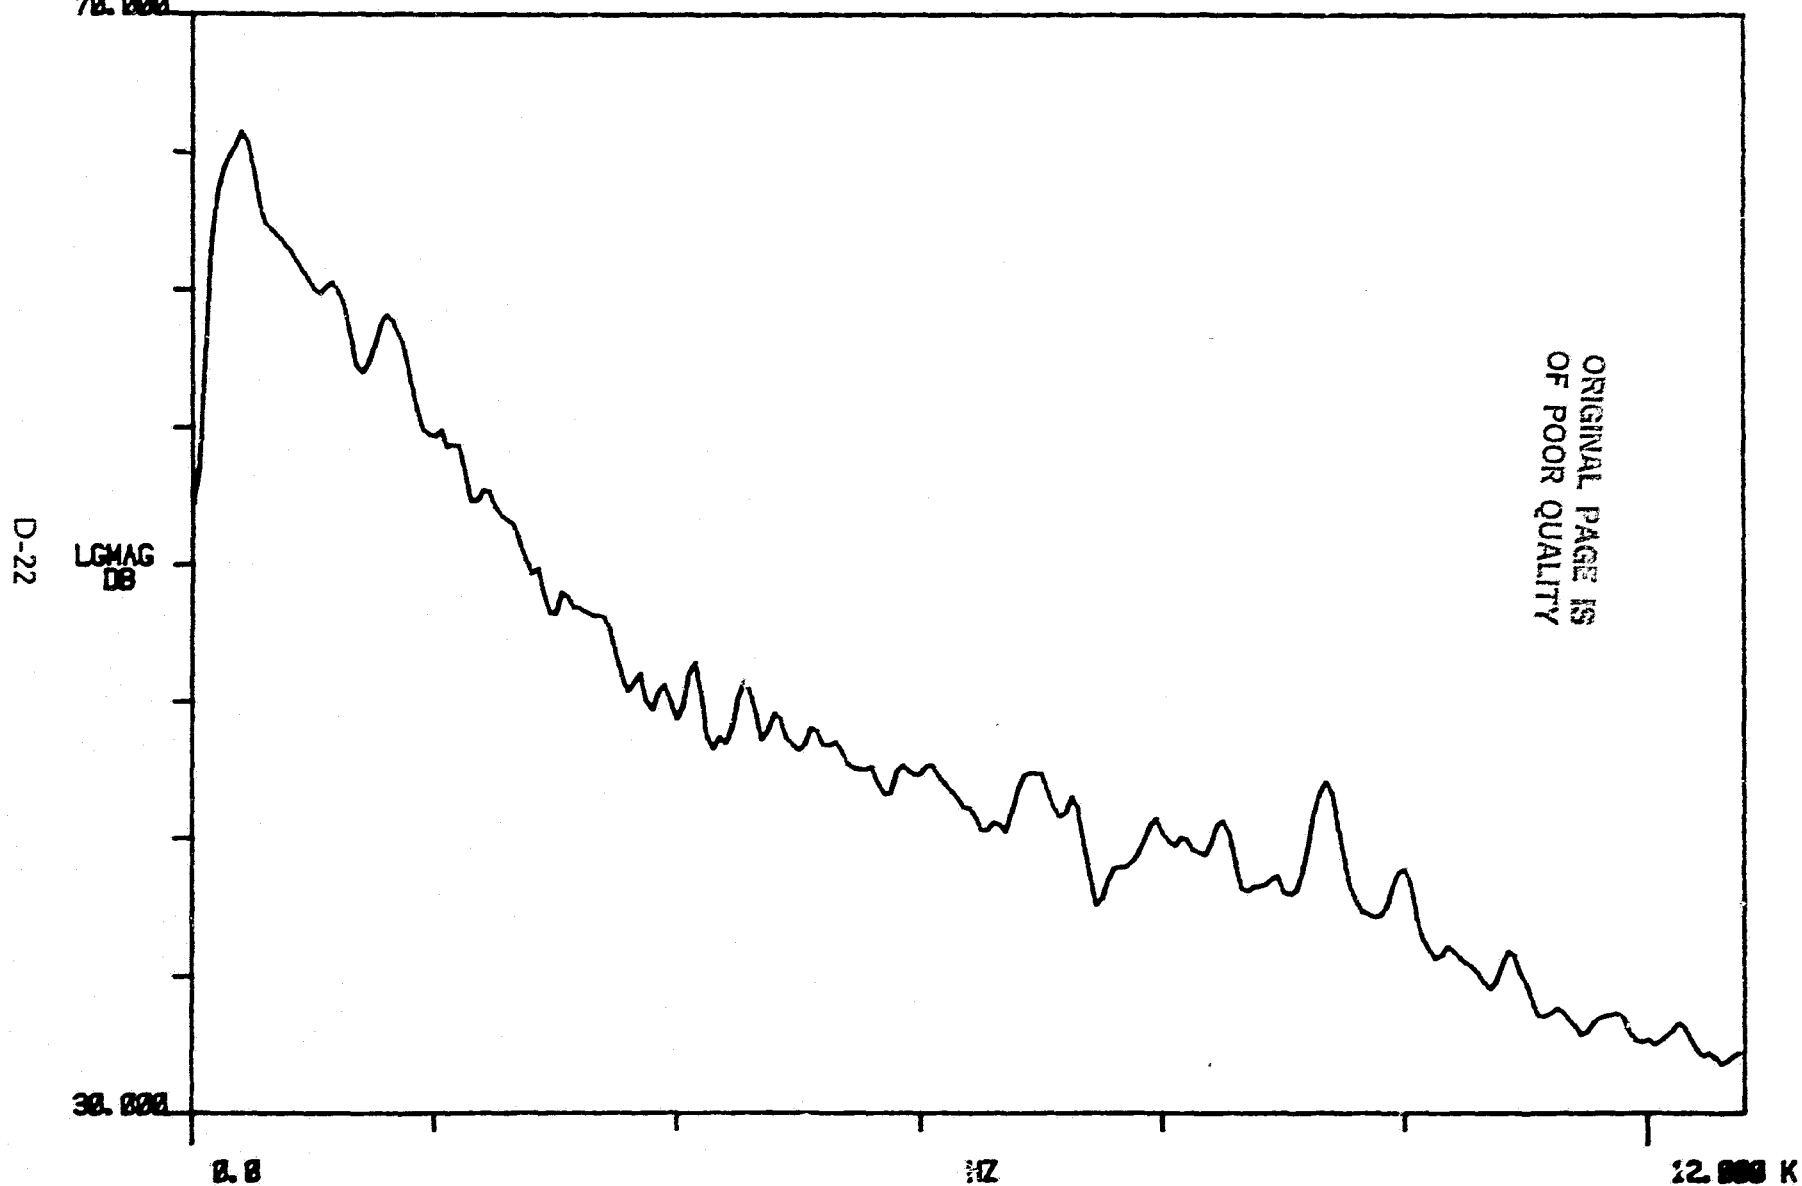
Fig. 20D - A-Weighted Source Contribution Analysis : Shackle Line Foot Remover
TIP TOP PLANT (pt. 53, ch.2)
