FINAL REPORT

**A STUDY OF POULTRY PROCESSING PLANT
NOISE CHARACTERISTICS AND
POTENTIAL NOISE CONTROL TECHNIQUES**

GEORGIA INSTITUTE OF TECHNOLOGY

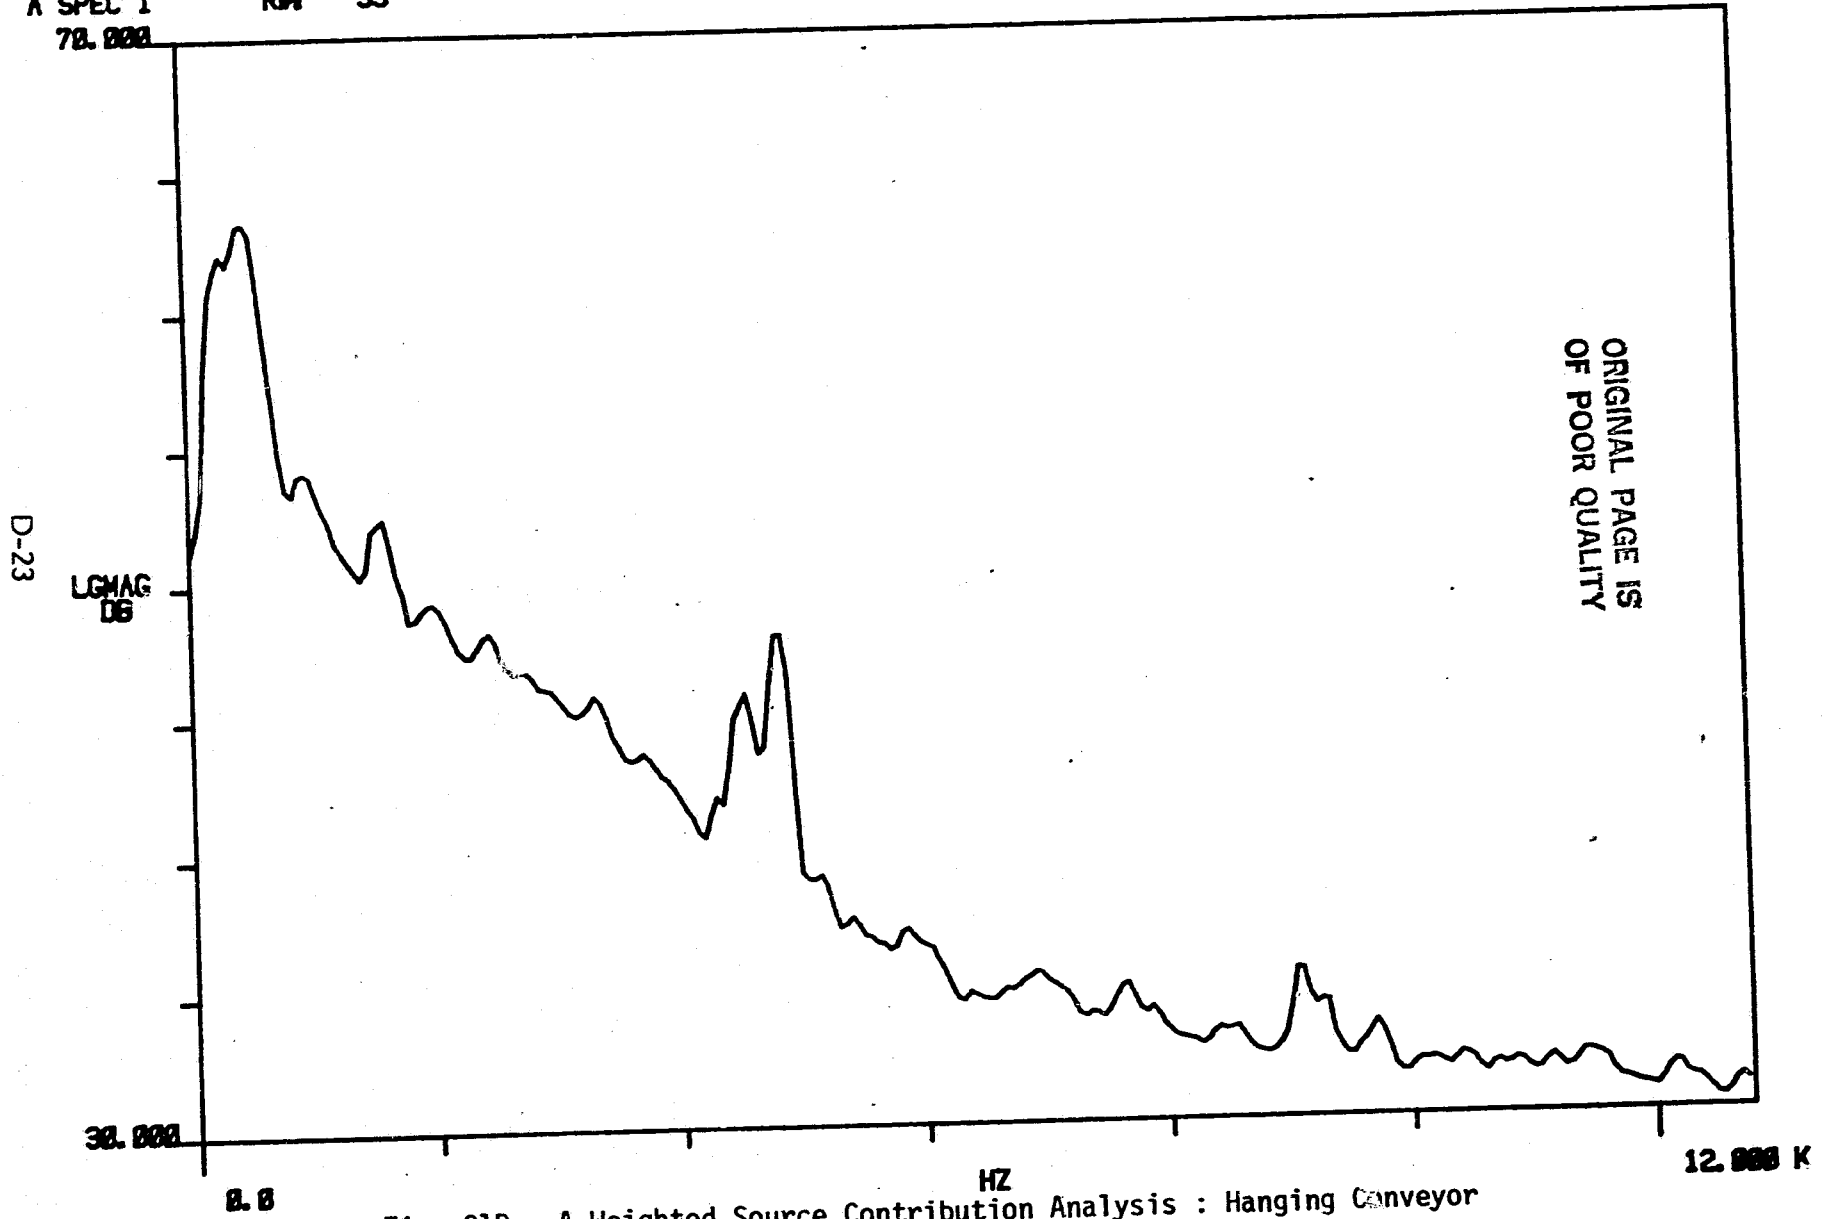
Fig. 21D - A-Weighted Source Contribution Analysis : Hanging Conveyor
TIP TOP PLANT (pt. 53, ch.2)

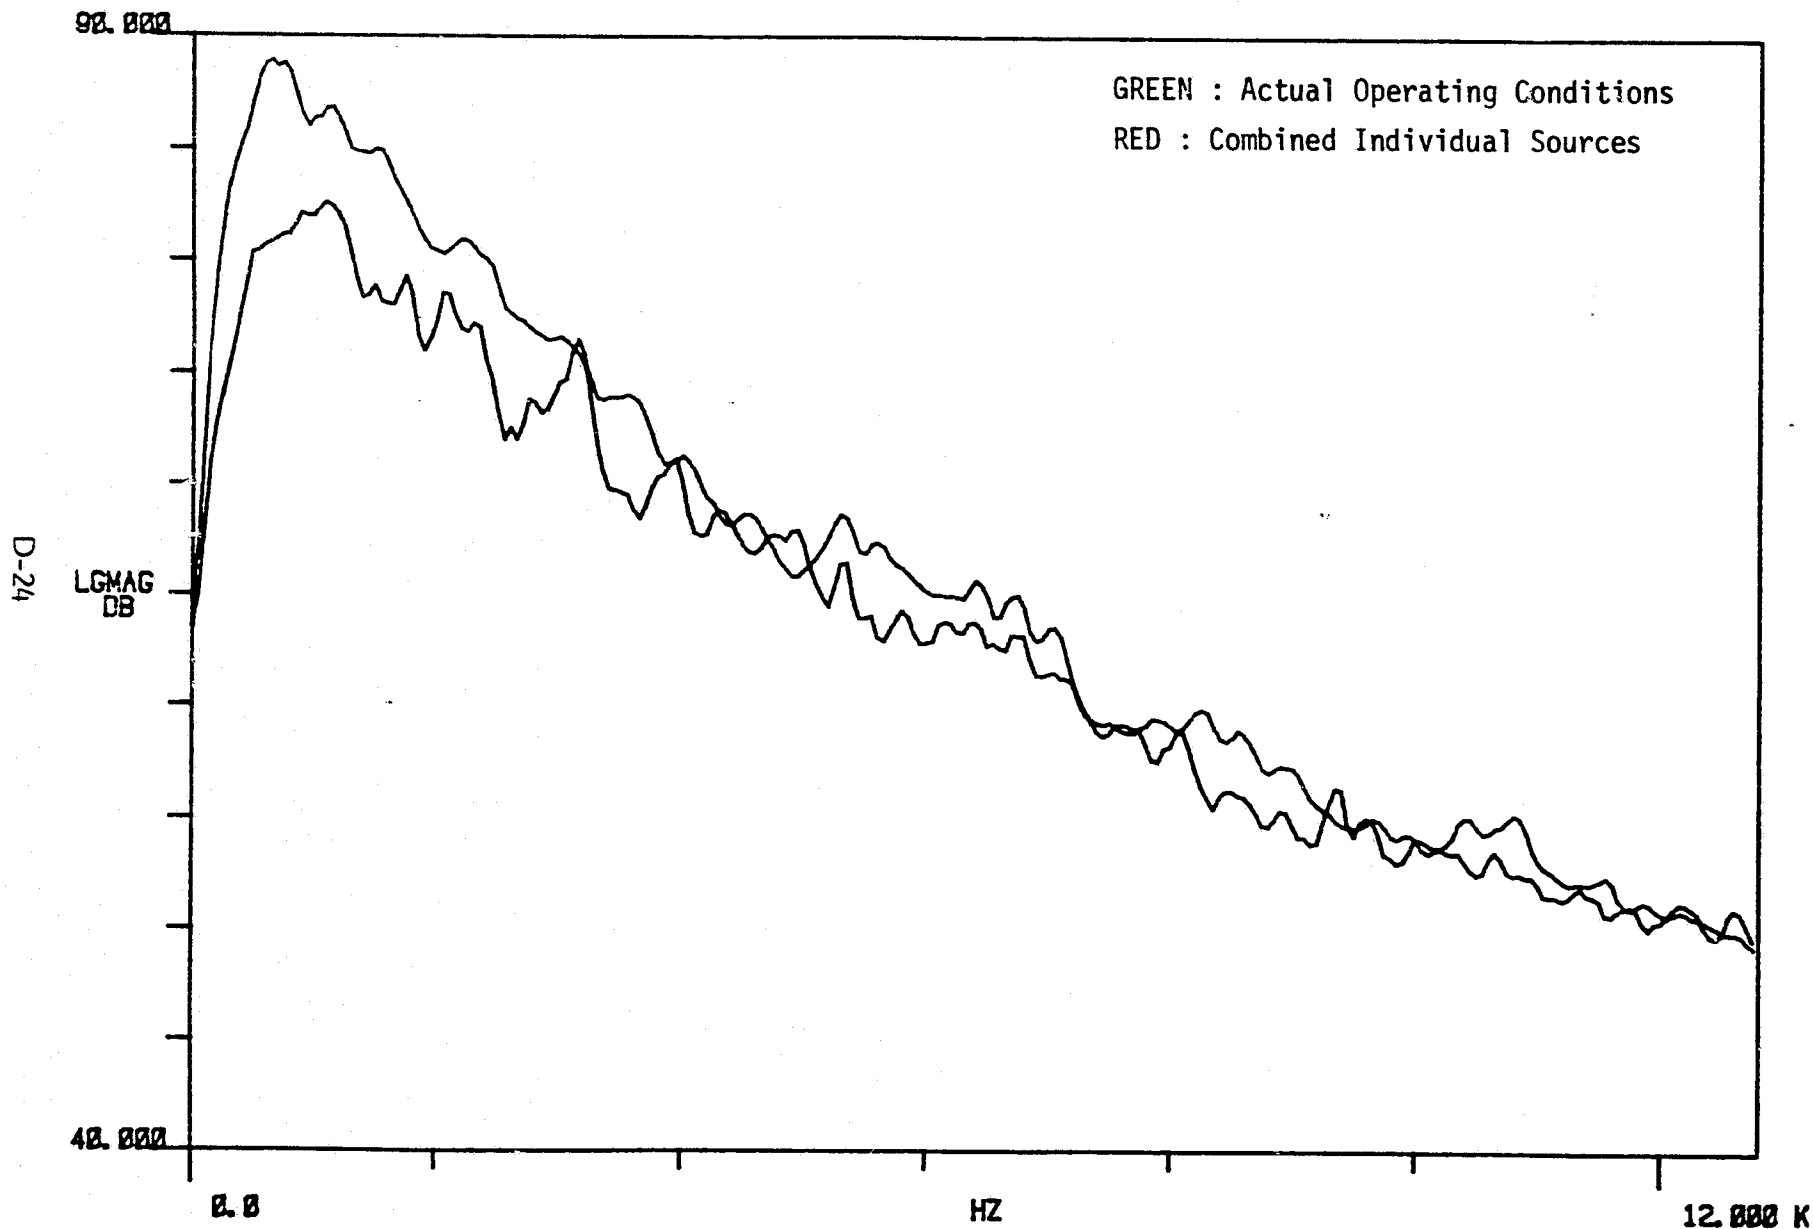
Fig. 22D - A-Weighted Comparison of Combined Individual Sources vs Actual Operating Conditions
TIP TOP PLANT (pt. 53, ch.2)
