NASA Technical Memorandum 81512

DEVELOPMENT OF IMPROVED-DURABILITY
PLASMA SPRAYED CERAMIC COATINGS
FOR GAS TURBINE ENGINES

Prepared for the
Sixteenth Joint Propulsion Conference
cosponsored by the AIAA, ASME, and SAE
Hartford, Connecticut, June 30-July 2, 1980

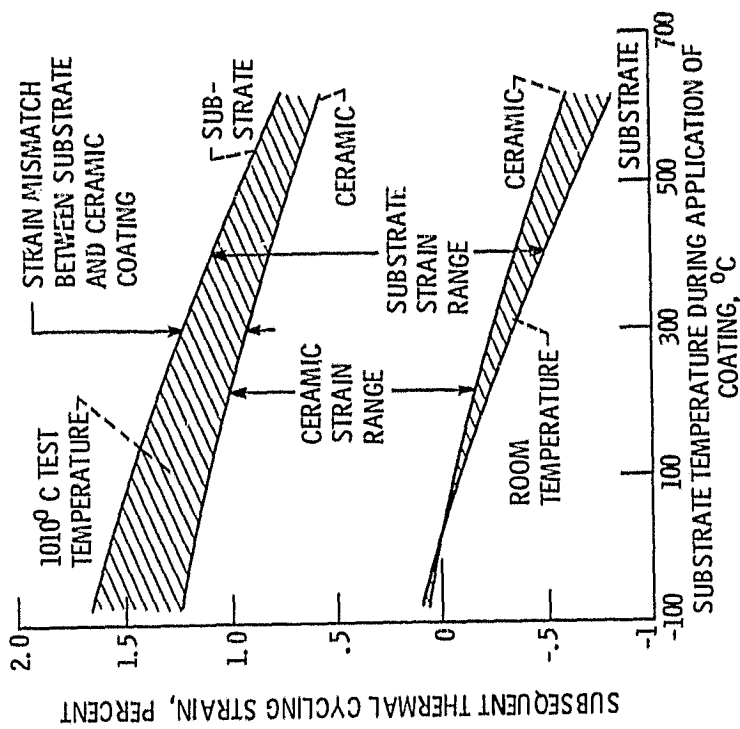
Figure 1. - Variation of interface strain mismatch with substrate temperature during application of thermal barrier coating (one dimensional analysis).

The durability limitations of plasma sprayed (PS) ceramic coatings applied to metallic engine components are due, in part, to the wide differences in the coefficient of thermal expansion of the metallic and ceramic materials.⁴ This results in significant strain mismatches between the metallic substrate and the ceramic coating that may cause the coating to spall. Figure 1 shows the ranges of strain mismatch that would be expected at both room temperature and a temperature condition of 1010° C (1850° F) as a function of the substrate temperature achieved when the ceramic coating was applied. For the nominal PS parameters and the burner rig bars used in the durability tests in this investigation, for example, the substrate temperature would approach approximately 425° C (800° F) during the application of the PS coating. Therefore, a compressive strain in the plane of the coating would be imposed on the coating when the test specimen was cooled to room temperature. Similarly, a somewhat larger tensile strain would be imposed on the coating when the test specimen was heated to the normal test temperature of 1010° C (1850° F).

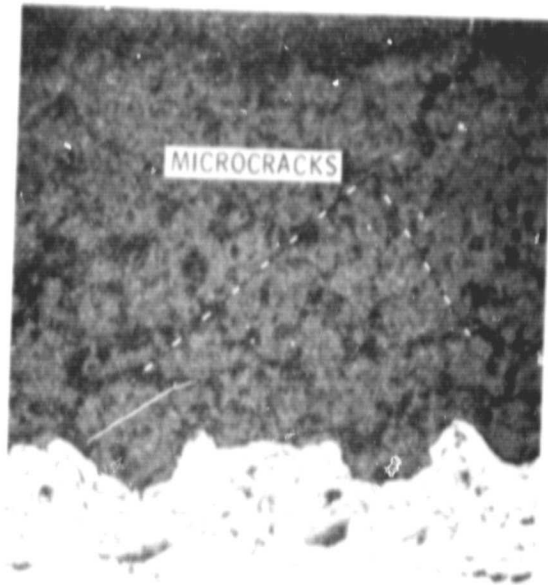
(a) PRE-TEST.

(b) POST-TEST.

Figure 6. - Porous microstructure of 20 w/o YSZ TBC using coarse (-170 mesh) powder.

This 20 w/o YSZ TBC was applied using a coarser -170 mesh powder. The resulting coating was less dense than the baseline, having a porosity of approximately 15-20 percent. A comparison of the microstructures of the coating representative of the pre-test and post-test conditions is shown in Fig. 6. The durability of this coating (6000 cycles) was due to the strain tolerance provided by the porous microstructure which effec-

tively reduced the modulus of elasticity from that of a more dense structure. Some limited microcracking of the ceramic microstructure can also be seen, both before and after testing. The microcracks lying in the plane of the coating (parallel to the ceramic/bond coat interface) might be expected to propagate and eventually lead to spallation of the coating.

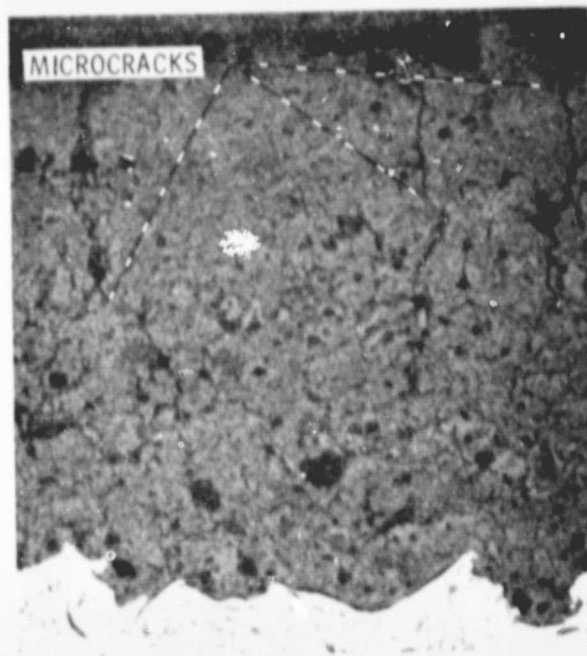
(a) PRE-TEST.

(b) POST-TEST.

Figure 8. - Microcracked microstructures of 21 w/o MSZ TBC.

An increased level of microcracking in the ceramic structure was obtained by varying the baseline chemistry from 20 w/o YSZ to 21 w/o MSZ. All other plasma spray parameters remained the same. The microstructure for this coating is shown in Fig. 8. The 21 w/o MSZ coating has a partially stabilized cubic structure which may undergo a phase transformation to a tetragonal structure with a considerable fraction of the monoclinic phase. Some free magnesium oxide (MgO) particles may also be found. Both the monoclinic ZrO₂ and the free MgO contribute to the extensive microcracking in the coating. The microcracking was essentially discontinuous and random in direction. These microcracks, in general, did not tend to propagate, although the start of two larger cracks, one normal to and one in the plane of the coating, could be noted after testing (Fig. 8(b)). The crack in the plane of the coating could ultimately lead to a failure of the coating. For this coating system, the microcracking apparently acted as an effective strain relief mechanism as evidenced by the 5230 cycle durability determined in the burner rig test.

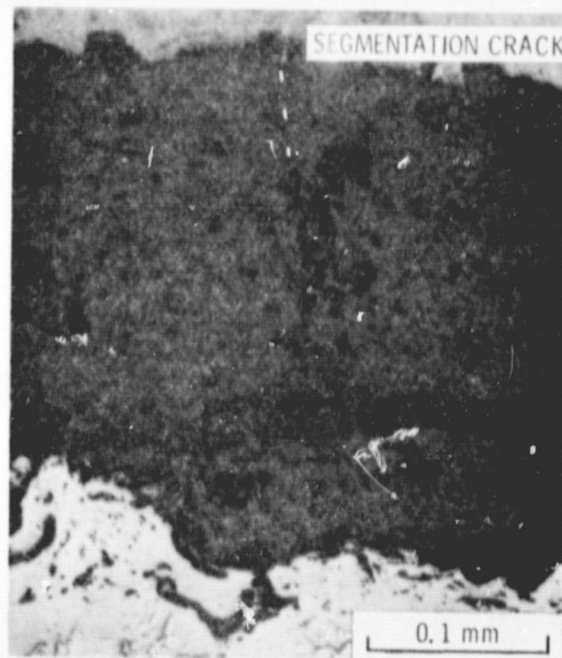
(a) PRE-TEST.

(b) POST-TEST.

Figure 10. - Segmented microstructures of 6 w/o YSZ TBC with fine powder.

A second technique of creating a PS segmented ceramic structure was the 6 w/o YSZ coating where a fine particle size powder (~325 mesh) had been used (Fig. 10). The 6 w/o YSZ was only partially stabilized and underwent a partial transformation from a cubic to a tetragonal phase upon cooling. The segmentation was believed to be due to a volume reduction associated with the phase transformation, thereby creating tensile stresses which resulted in cracking of the coating normal to the interface. Two of the test specimens exhibited a relatively long life (4410 and 5040 cycles) while the third specimen failed at 1570 cycles. However, the 6 w/o YSZ was considered to be one of the more promising systems tested. For this particular segmented coating, the characteristic size of a typical segmented column was about 1 mm (40 mil). The remnant segmentation pattern remaining on the burner rig bar after testing was completed is shown in Fig. 11. Further investigation is required, particularly to develop a more porous microstructure using a coarser particle size powder as used in some previous investigations.⁶

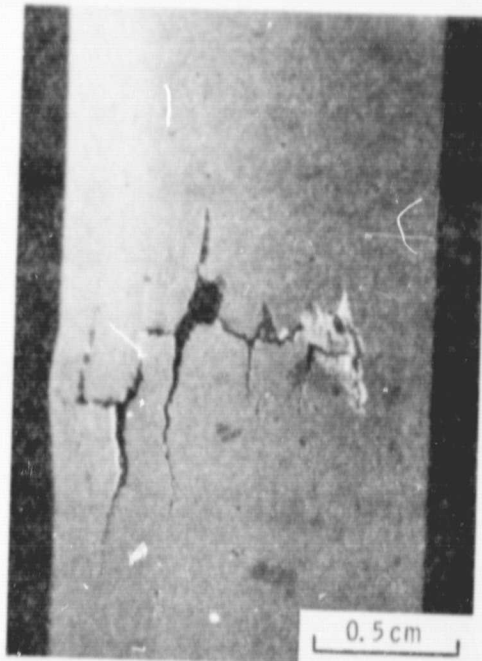
(a) FAILED REGION ON BURNER RIG BAR.

(b) CROSS-SECTION OF COATING SYSTEM FAILURE.

Figure 14. - Failure of MCrAlY bond coating for EB/PVD 20 w/o YSZ TBC specimen.

The last technique employed to achieve a segmented coating was to apply a 20 w/o YSZ coating with an electron beam/physical vapor deposition (EB/PVD) process. This technique required the use of a vacuum chamber and was relatively complex compared to the PS technique. However, the EB/PVD process produced a coating with a finely segmented structure consisting of long, thin columns (Fig. 13). This columnar structure probably represented a near optimum size and spacing for a segmented coating. The durability of the EB/PVD coating (10 420 cycles) in the burner rig tests confirmed that the EB/PVD coating was very strain tolerant. The post-test examination of the failed coating (Fig. 14) revealed that internal oxidation of the bond coating had occurred. This led to debonding of the bond coating from the Mar-M 509 substrate. Therefore, the performance of the bond coating precluded an evaluation of the full potential durability of the EB/PVD coating.
