# NASA Technical Memorandum 81779

STORM HAZARDS '79 - F-106B OPERATIONS SUMMARY

Bruce D. Fisher, Gerald L. Keyser, Jr.,  
Perry L. Deal, Mitchel E. Thomas, and  
Felix L. Pitts

MARCH 1980

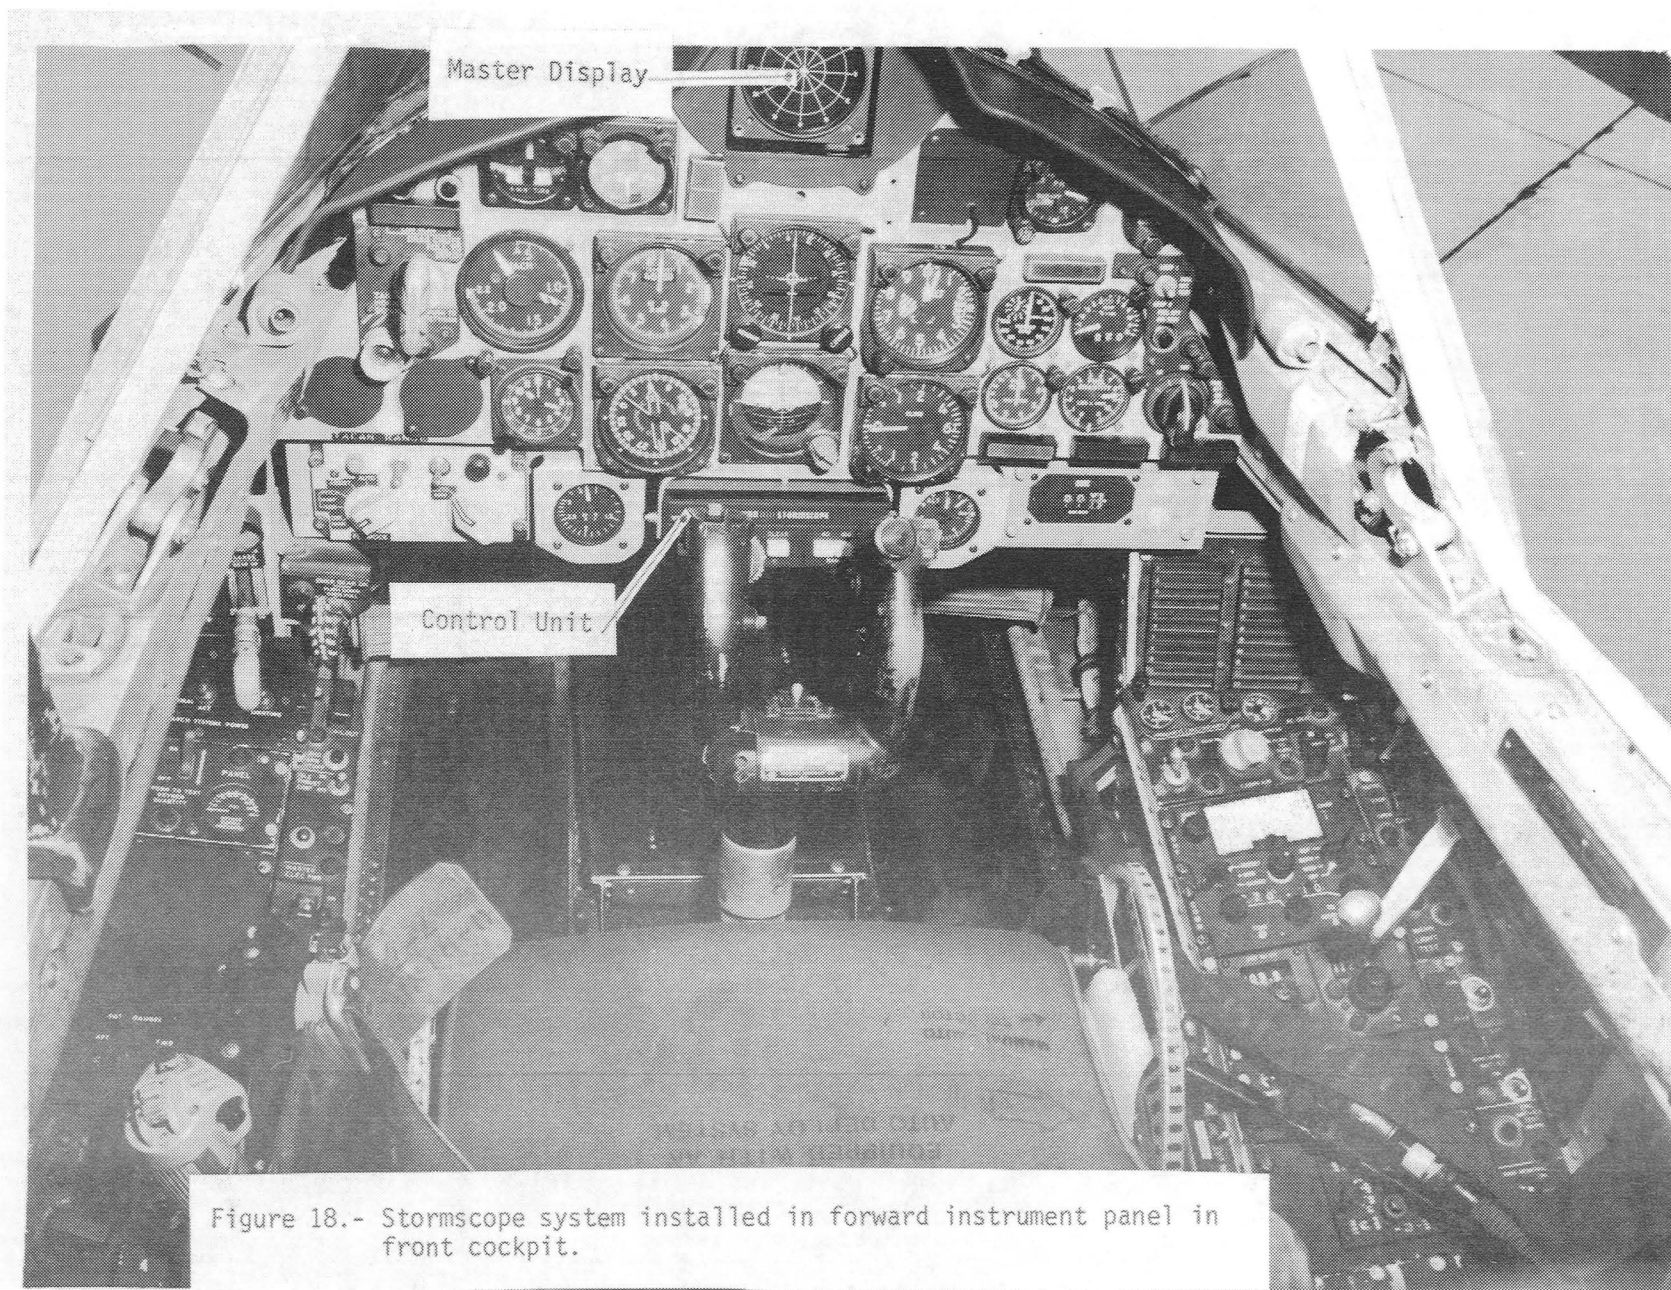
Figure 18.- Stormscope system installed in forward instrument panel in front cockpit.
