DOE/NASA/0612-80/1 NASA CR-159820 BCAC D6-48915

# TESTING OF RECIPROCATING SEALS FOR APPLICATION IN A STIRLING CYCLE ENGINE

J. F. Curulla and T. L. Beck Boeing Commercial Airplane Company

FEBRUARY 1980

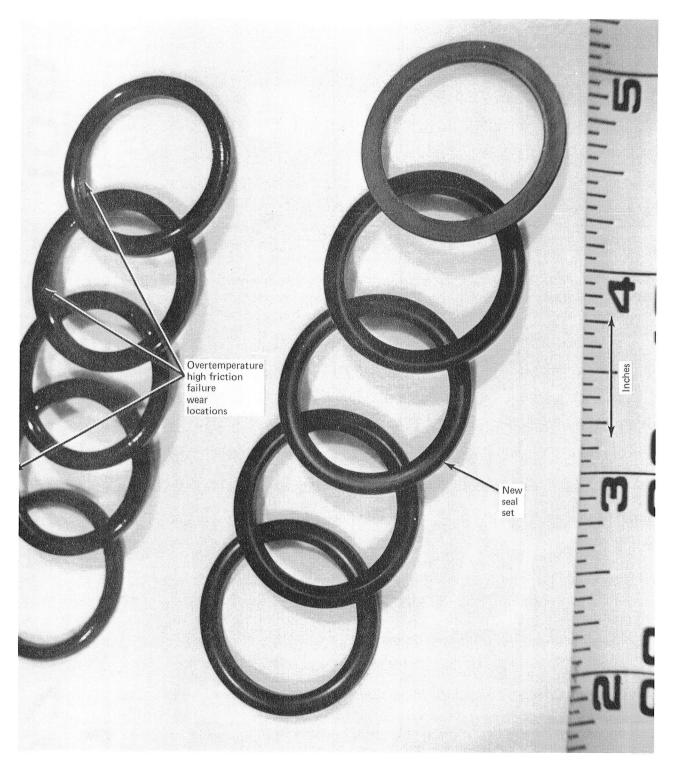
Three sets of NASA Chevron seals were evaluated, with two failures resulting in breakdown of the seal. The NASA Chevron polyimide five-piece leg seal showed improved leakage

Figure 17. – NASA Chevron Seal Failure

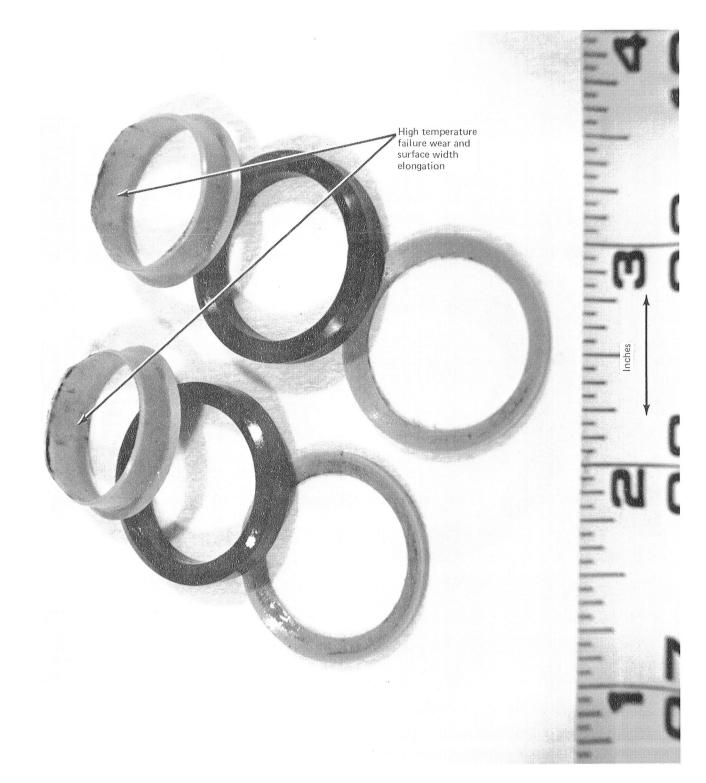
Four sets of Bell seals were evaluated during this program. The majority of leakage rates obtained for seal set #1 had values between 0.01 and 0.04 cc/sec. A total of five test readings were taken of rates below 0.005 cc/sec. Of course, three were at or below the 0.002 cc/sec leakage goal. A minimum rate of 0.0010 cc/sec (fig. 31, Appendix B) was obtained from seal #1 after 84 minutes of testing at conditions of  $1.22 \times 10^7$  PA (1750 psig) and 2.16 m/sec peak (900 rpm). This rate and the post test value 0.0012 cc/sec at 54.48 hours into the test were the only values obtained below 0.002 cc/sec for the entire seal set. The second set of Bell seals indicated leakage rates below 0.03 cc/sec. This test was initiated at 2.16 m/sec peak (900 rpm) and after 4.62 hours was accelerated to 7.19 m/sec peak (3000 rpm). As the peak rod speed was obtained, the leakage rate increased dramatically to 0.78 cc/sec. This was the largest rate obtained by this seal set. Bell seal set #3 provided leakage rates from .0033 to .0100 cc/sec at test conditions of 5.28 x  $10^6$  PA (750 psig) and 2.09 m/sec peak (1750 rpm). The Bell seal set #4 was the final set run with pressure at  $5.28 \times 10^6$  PA (750 psig), and the rod speed was step-incremented between 1.03 m/sec peak and 4.79 m/sec peak (430 and 2000 rpm) to allow seal temperatures to remain near 408 K (275°F). The most promising leakage results were obtained from this seal set with the majority of leakage data for both seals below 0.02 cc/sec. Also, a large set of data was obtained below the 0.002 cc/sec leakage goal with some values as low as 0.001 cc/sec over 5-minute time increments.

Figure 18. – Bell Seal Failure
