NASA Technical Memorandum 81430

FERROGRAPHIC AND SPECTROMETRIC
ANALYSIS OF OIL SAMPLED BEFORE
AND AFTER FAILURE OF A JET ENGINE

William R. Jones, Jr.
Lewis Research Center
Cleveland, Ohio

February 1980

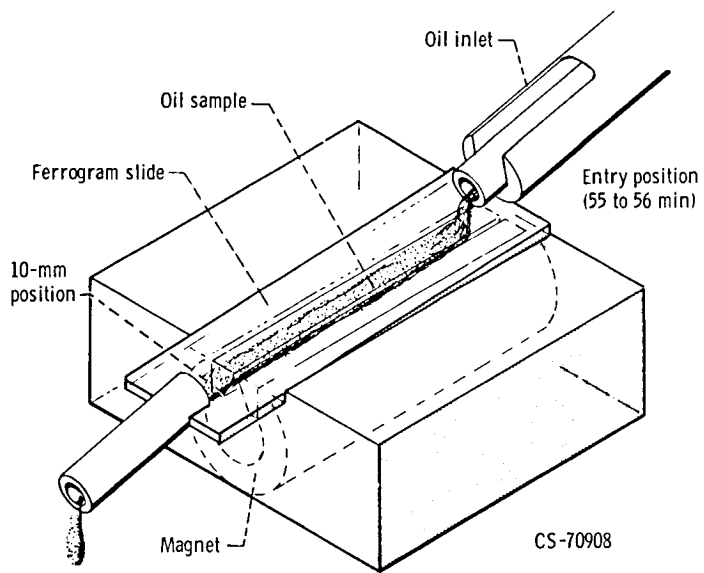
Figure 1. - Ferrograph analyzer.

The Ferrograph (refs. 2 to 4) is an instrument used to magnetically precipitate wear particles from a used oil onto a specially prepared glass slide. A mixture of 3 ml of used oil and 1 ml of solvent is prepared. This mixture is then slowly pumped over the slide as shown in figure 1. A solvent wash and fixing cycle follows which removes residual oil and permanently attaches the particles to the slide. The resulting slide with its associated particles is called a Ferrogram.

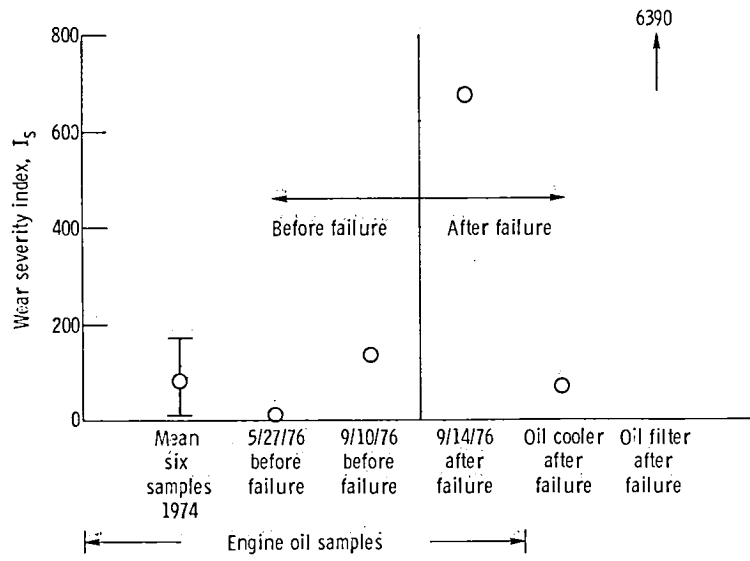
Wear severity index. - A parameter, the wear severity index, has been advocated by Bowen and Westcott (ref. 7). This parameter is calculated from optical density measurements made at the entry position of the Ferrogram (A_L) and at the 50-millimeter position (A_S). These are the areas covered by the large and small particles. Their sum ($A_L + A_S$) yields the general level of wear, while their difference ($A_L - A_S$) gives an indication of abnormality. These two quantities multiplied together ($A_L + A_S$)($A_L - A_S$) yield the wear severity index $A_L^2 - A_S^2$, usually abbreviated I_S .

I_S values for all of the oil samples, including the mean of six engine samples from 1974, are shown in figure 9. The I_S increased from about 10 to 140 from the May 27, 1976, sample to the September 10, 1976, sample. Although this is a large increase, prior to failure, it is not significant when compared to the range of I_S values obtained from this engine in the past (i.e., 1974 samples). After failure, I_S values increase dramatically. This, of course, is expected. An especially large value was obtained from the oil filter sample.

Figure 9: - Wear severity index (I_s) for various oil samples.
