**NASA Technical Memorandum 81403**

**ANALYSIS OF WEAR DEBRIS FROM  
FULL-SCALE BEARING FATIGUE  
TESTS USING THE FERROGRAPH**

**William R. Jones, Jr. and Stuart H. Loewenthal  
Lewis Research Center  
Cleveland, Ohio**

**Prepared for the  
Annual Meeting of the American Society of Lubrication Engineers  
Anaheim, California, May 5-8, 1980**

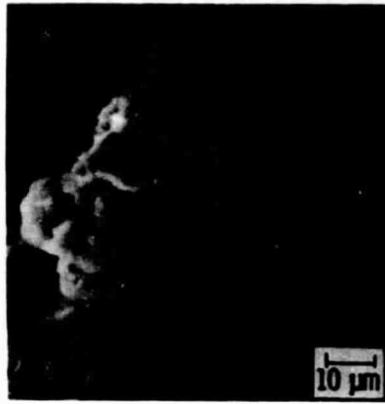
(a) STRING OF WEAR PARTICLES AND 8 micrometer DIAMETER SPHERE FROM 530-hour SAMPLE.

(b) AREA (a) AT HIGHER MAGNIFICATION.

(c) X-RAY ENERGY MAPS OF (b) FOR IRON.

Figure 6. - Scanning electron micrographs.

Normal rubbing wear particles. - Normal rubbing wear particles (ref. 10) are observed in almost all oil samples from lubrication systems. This study was no exception as most samples yielded at least a few such particles. Typically, these particles are small asymmetrical metallic flakes (<15 μm in major dimension and <1 μm thick). They are produced anytime that sliding wear takes place. Electron micrographs of some normal rubbing wear particles appear in figures 6(a) and (b). An X-ray energy map for iron appears in figure 6(c) and indicates that most of the particles are predominately iron.

Spherical particles. - Microspheres (1- to 10-  $\mu$  diam) were observed in many samples. An 8-micrometer sphere is shown in figure 6(a). Although most of the spheres appeared metallic when observed in the bichromatic microscope, an X-ray energy analysis indicated that there were two types present. These types are illustrated in figure 7 where two different 4-micrometer-diameter spheres are shown. An iron X-ray energy map for the sphere of figure 7(a) appears in figure 7(b). This is the normal iron map one would obtain from a solid iron or steel microscope. However, the 4-micrometer-diameter sphere of figure 7(c) indicates a much lower concentration of iron. This type of sphere may contain a large amount of organic material (ref. 14) or may be a compound of iron (an inclusion) (ref. 15) or perhaps even be hollow (ref. 16). Although an analysis of all the spheres observed during this study was not possible, measurements on a number of Ferrograms indicated about half of them contained a high concentration of iron and the remaining half a much lower concentration.

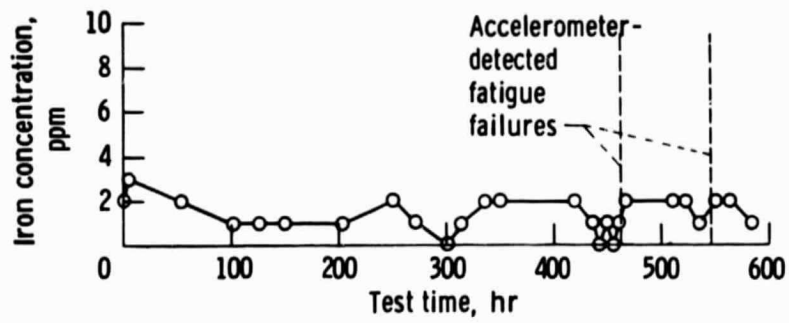
Figure 10. - Iron concentration in oil in ppm as function of time from spectrographic oil analysis (SOAP).

One other parameter was studied for possible failure correlation. This parameter was the change in concentration of iron in the oil samples measured by ordinary spectrographic analysis (SOAP). Measurements were only made on selected oil samples from test startup to 566 hours, thus encompassing the first two fatigue failures. The iron concentration in parts per million appears as a function of test time in figure 10. Rather low values were observed (0 to 3 ppm), and there was no correlation with the two failures.
