PROGRAM TO DEVELOP SPRAYED, PLASTICALLY DEFORMABLE COMPRESSOR SHROUD SEAL MATERIALS

INTERIM TECHNICAL PROGRESS REPORT NO. 1

MATERIALS AND PROCESS TECHNOLOGY LABORATORIES
AIRCRAFT ENGINE GROUP
GENERAL ELECTRIC COMPANY
CINCINNATI, OHIO 45215

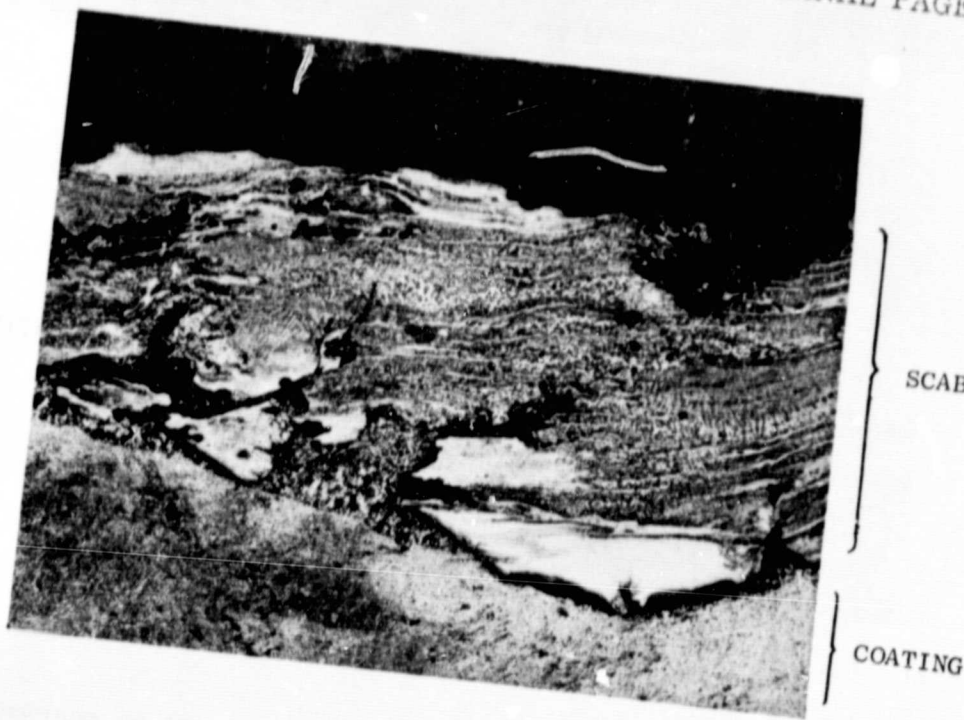
Figure 7. Microstructure of Cu coating (hot rub) in a scabbed area showing the variety of phases present

- 6) Reactions between the transferred blade metal and the coating were evident in the variety of phases present in the microstructure of the scabbed areas (Figure 7). The reaction zones of Cu-5Al and Cu-9Al coatings were primarily at the edges and corner of the rub paths where scabbing usually initiated. Microprobe analysis normal to the surface and under the rub paths indicated that the phases found ranged in composition from pure coating to pure blade metal. The Cu/Ti ratios in the intermediate regions were similar to that of the Cu-Ti eutectic. Exact phase identification was not attempted since the coating-blade metal mixtures were quaternary alloys with unknown phase diagrams.

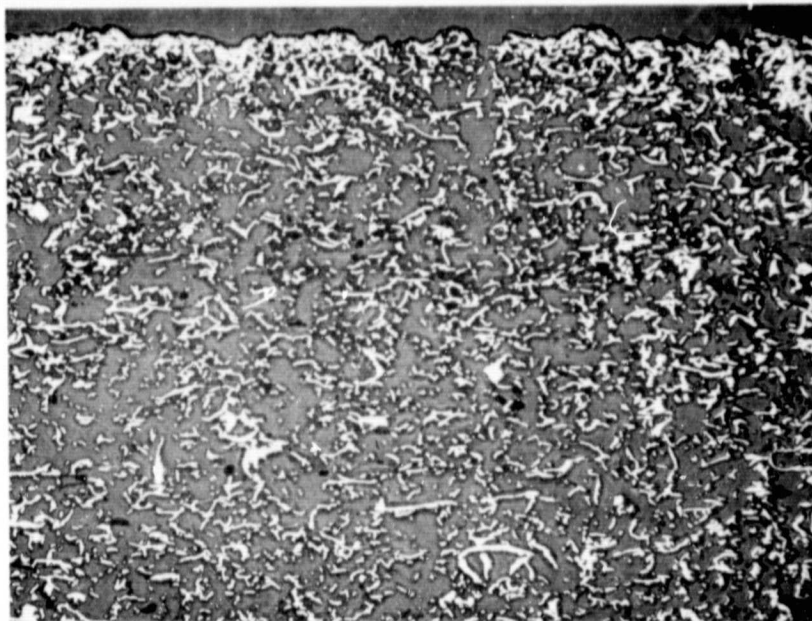
a) Cold Rub, 100°F

b) Hot Rub, 950°F

Figure 16. Cross-sections of rub paths showing minor compaction of Feltmetal 515B

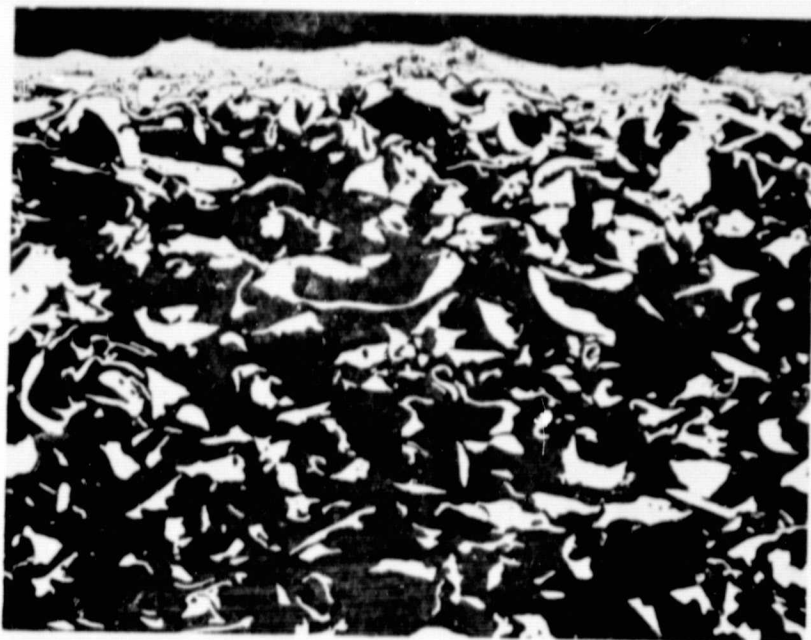
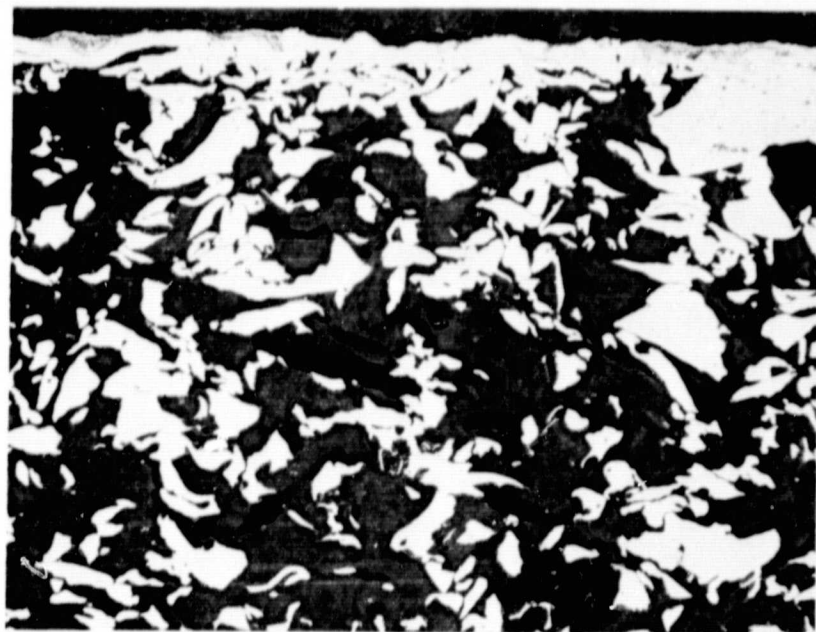
a) Al/Feltmetal - Cold Rub, 100°F

b) AlBr/Feltmetal - Hot Rub, 900°F 100X

Figure 18. Cross-section of rub paths from metal spray/Feltmetal materials

The most unique coating microstructure was that of the Al/Feltmetal and AlBr/Feltmetal materials supplied by NASA. The spray materials on the Feltmetals remained essentially intact during rubs, resulting in smooth, dense rub surfaces with only minor compaction of the supporting Feltmetal (Figure 18.). Approximately one-half of the AlBr spalled from the Feltmetal during the rub, but the remaining material had a smooth finish. The reason for the AlBr spallation has not been established.

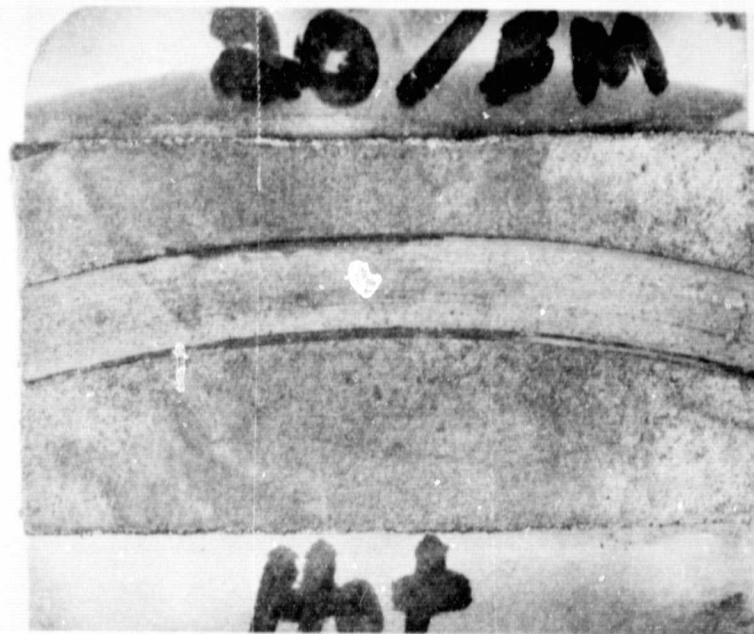
a) Without Feltmetal Underlayer

b) With Feltmetal Underlayer

Figure 20. The hot rub surfaces of the Cu-9Al + 20% Ekonol

- ii) Significant substrate temperature rise rates occur only for Cu-9Al+20% Ekonol specimens.
- iii) The highest rub forces are associated with either blade wear or pick-up.
- iv) The presence of a Feltmetal underlayer does not cause a significant reduction in rub forces in relation to the spray coating materials.
- v) Cu-9Al+20% Ekonol spray coatings with and without the Feltmetal interlayer yielded partially or completely smooth, smeared rub surfaces (≈ 150 RMS) after 900F rubs (Figure 20).
