NASA Technical Memorandum 81396

MECHANISMS OF LUBRICATION
AND WEAR OF A BONDED
SOLID LUBRICANT FILM

Robert L. Fusaro
Lewis Research Center
Cleveland, Ohio

Prepared for the
Thirty-fifth Annual Meeting of the
American Society of Lubrication Engineers
Anaheim, California, May 5-8, 1980

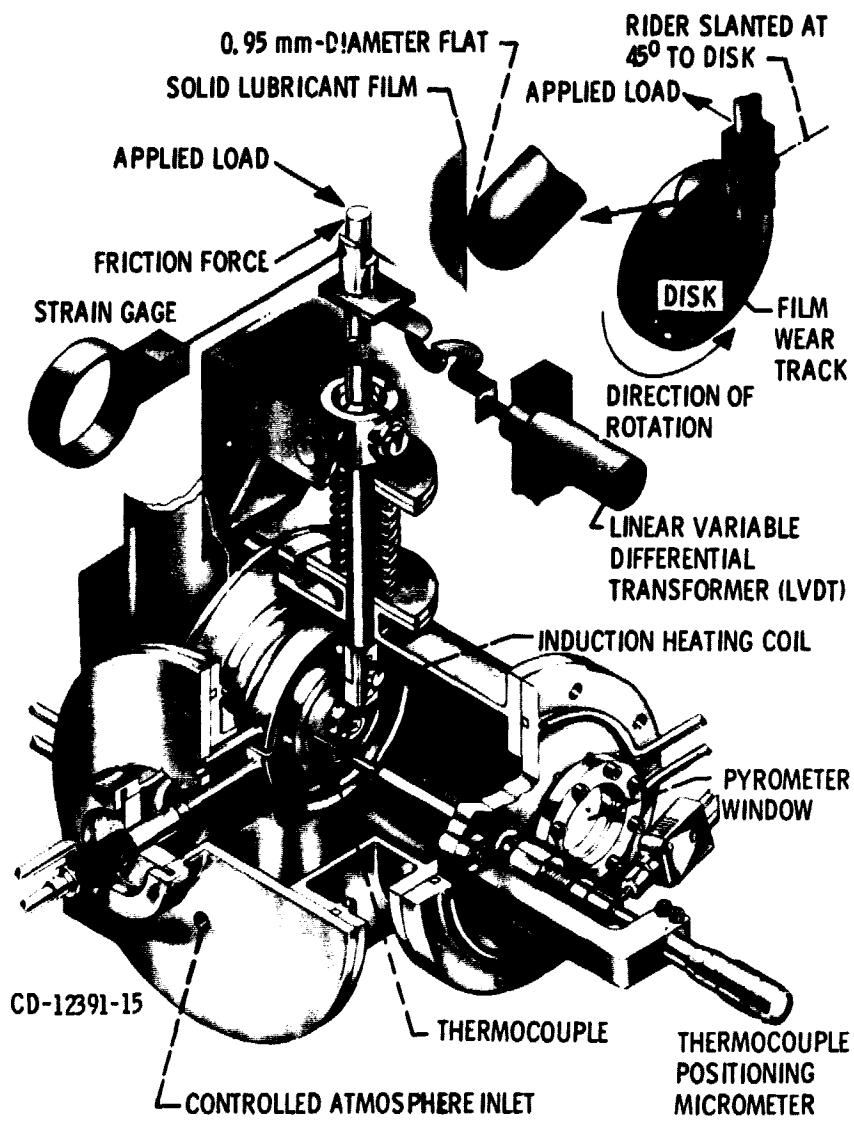
Figure 1. - Friction and wear apparatus.

A conventional type of pin-on-disk friction and wear apparatus was used in this study (fig. 1). The riders were either hemispherically tipped pins with a radius of 0.476 cm or the same hemispherically tipped pins with a 0.95 mm-diameter flat worn on the hemisphere (see insert fig. 1). They were loaded with a 1-kilogram deadweight against the film which was applied to a flat, 6.3-cm-diameter disk. The disk was rotated at 1000 rpm, and the rider slid on the disk

The flat on the 0.476 cm-radius hemispherically tipped rider (pin) was generated prior to conducting the friction and wear experiments by sliding it against a rubbed graphite fluoride film which was applied to a sandblasted AISI 440C HT stainless steel sandblasted disk. The rider was not removed from the holder after the flat was generated or while it was cleaned; and it and the disk (with applied polyimide-bonded graphite fluoride film) were positioned and indexed in the apparatus by using a linear variable differential transformer (LVDT) so that a flat-on-flat configuration occurred with minimal misalignment being introduced (fig. 1).

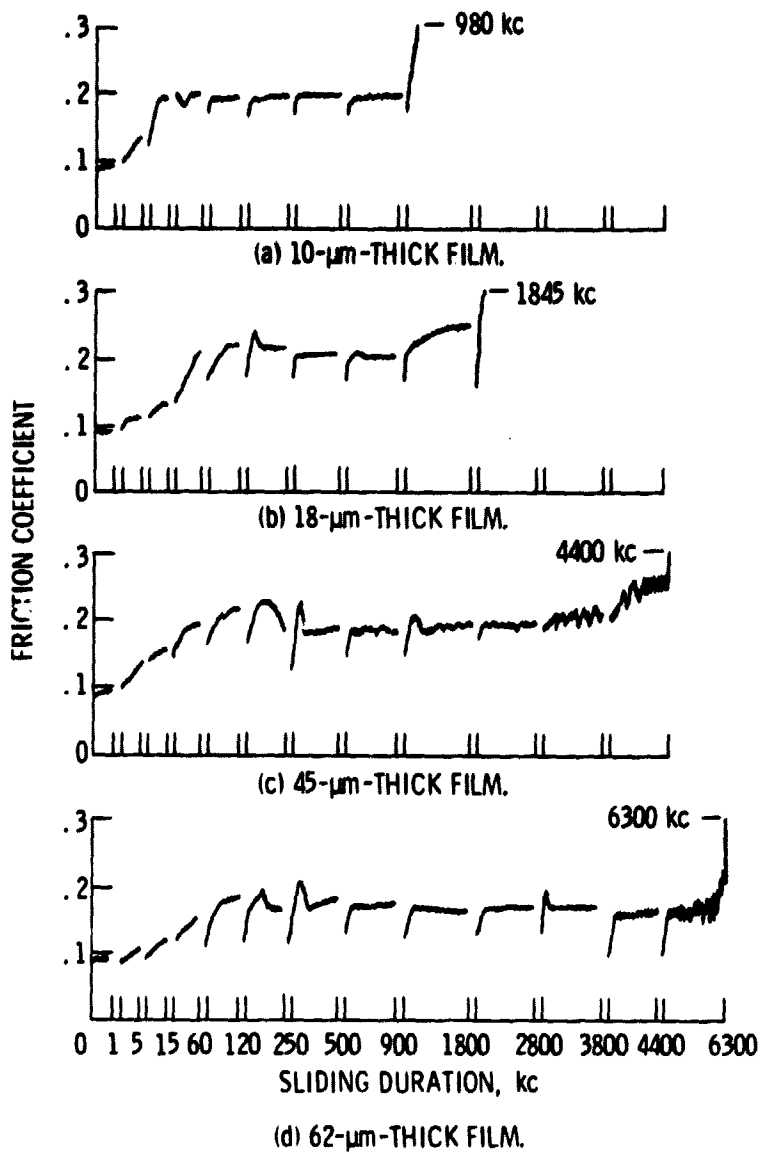
Figure 2. - Friction traces for 440C HT stainless-steel hemispherically tipped riders sliding on polyimide-bonded graphite fluoride films 10, 18, 45, and 62 μm thick.

Friction traces for hemispherically tipped 440C HT stainless-steel riders ($0.476\ \text{cm}$ radius) sliding on polyimide-bonded graphite fluoride films of four thicknesses (10, 18, 45, and $62\ \mu\text{m}$) are shown in figure 2. The friction traces are discontinuous because the tests were stopped at various intervals to make wear measurements and to observe the sliding surfaces with an optical microscope. The experiments were terminated when the friction coefficient reached

0.30, and wear life was defined as the number of sliding revolutions to reach this friction coefficient. For all four film thicknesses evaluated, the friction coefficient started out at 0.08 to 0.09 and then rose gradually with sliding duration. Eventually the friction coefficient leveled off at a steady-state value of 0.20 ± 0.02 . On restart, after the tests had been stopped to measure wear, the friction coefficient was usually lower than it had been at the end of the previous interval. A continuous increase in friction coefficient (from the steady-state value) signified that the films were approaching failure (fig. 2).

Figure 2 shows that as film thickness increased, so did wear life. The 10-micrometer-thick film gave a wear life of 980 kilocycles, the 18-micrometer-thick film gave a wear life of 1845 kilocycles, the 45-micrometer-thick film gave a wear life of 4400 kilocycles, and the 62-micrometer-thick film gave a wear life of 6300 kilocycles. Wear life is shown to be directly proportional to film thickness in figure 3. This result agreed with results of previous experiments conducted on polyimide-bonded molybdenum disulfide films (ref. 6). The wear life of the polyimide-bonded graphite fluoride film was found to be about 100 kilocycles per micrometer of film thickness.

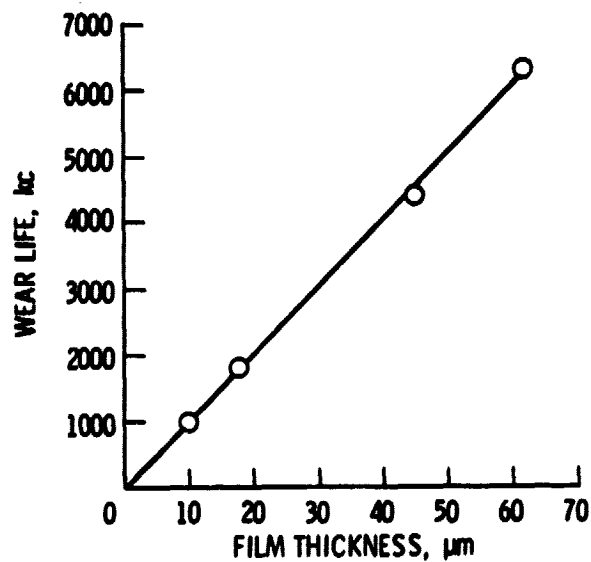
Figure 3. - Wear life as a function of polyimide-bonded graphite fluoride film thickness.

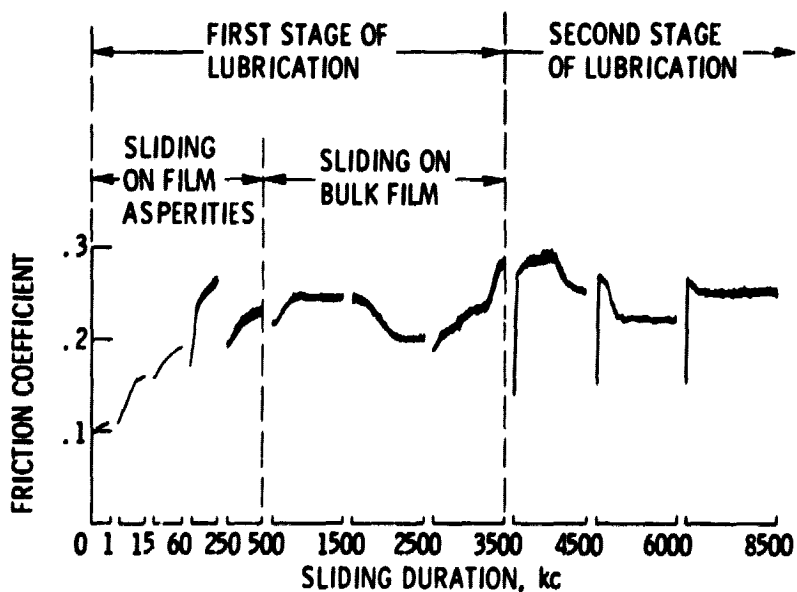
Figure 4. - Friction trace for a 440C HT stainless-steel hemispherically tipped rider (with a 0.95 mm diameter flat on it) sliding on polyimide-bonded graphite fluoride film.

A friction trace for a 0.95-mm-diameter flat sliding against the 45 μm -thick polyimide-bonded graphite fluoride film is shown in figure 4. As found for the hemispherically tipped rider sliding on the same film (fig. 2), the friction coefficient started at a low value of 0.08 to 0.09, then rose gradually with sliding distance, and eventually leveled off at 0.24 ± 0.02 . This was slightly higher than the friction coefficient found for the hemisphere on film experiments (0.20 ± 0.02). For the 0.95-mm-diameter flat sliding on the 45 μm -thick film, failure did not occur after 8500 kilocycles of sliding (which was arbitrarily chosen as the time duration of this test).

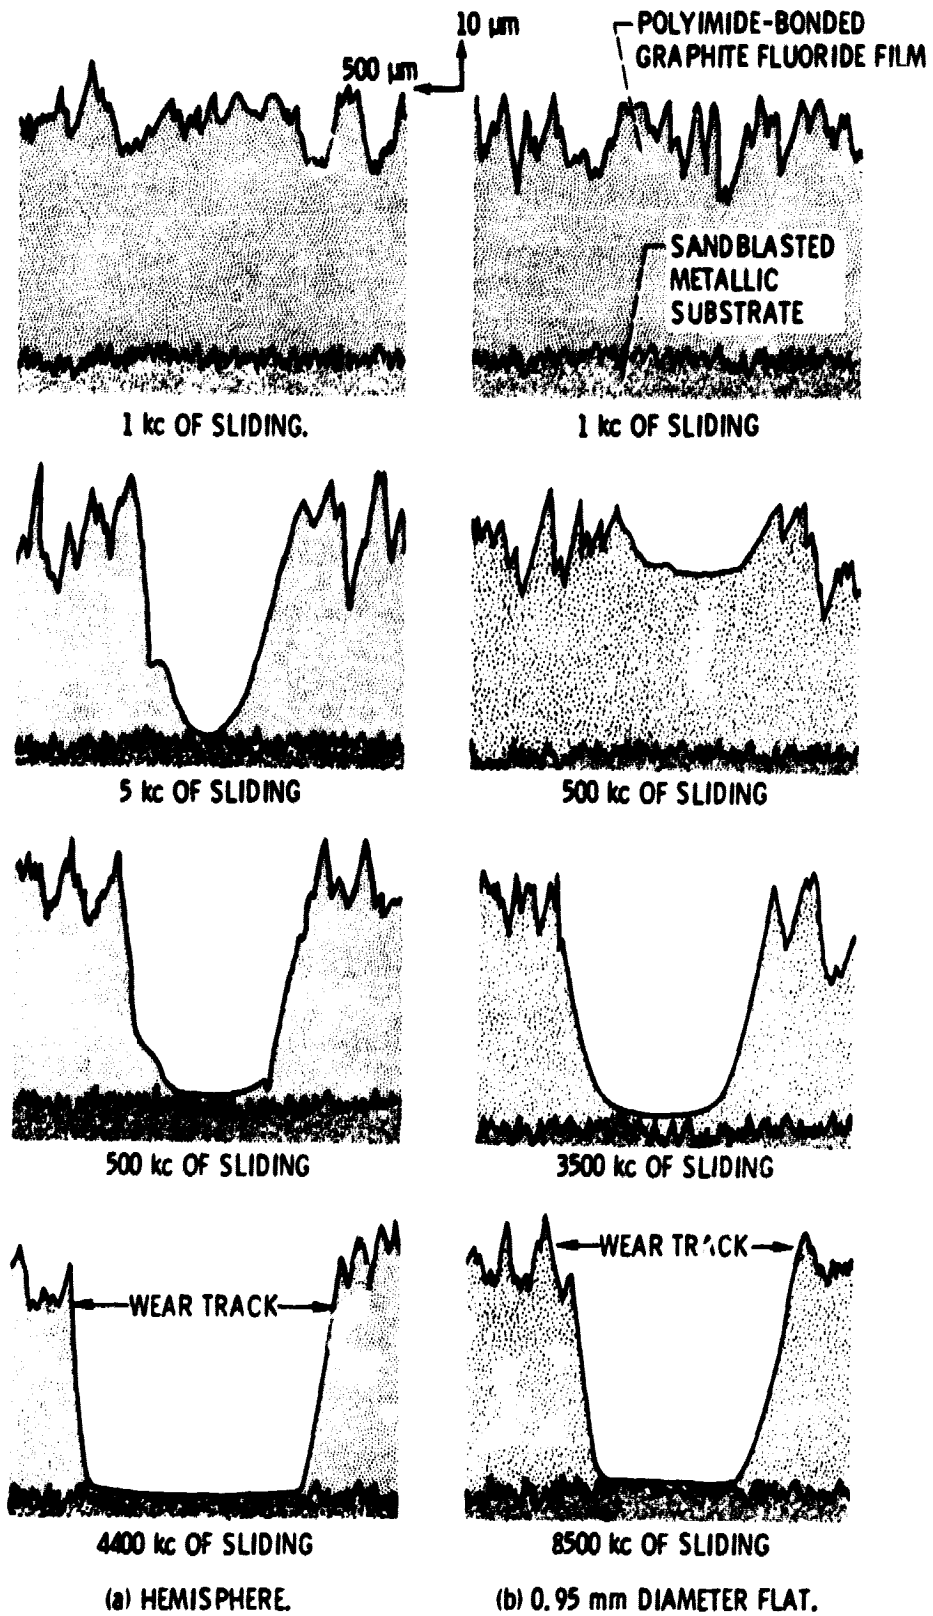
Figure 5. - Comparison of surface profiles of the wear tracks on polyimide-bonded graphite fluoride films for a hemisphere and for a 0.95 mm diameter flat after various intervals of sliding on the film.

Film wear was studied by taking surface profiles of the film wear track after each sliding interval. Figure 5 compares surface profiles of the wear traces on 45 μm -thick polyimide-bonded graphite fluoride films for (a) a hemisphere and for (b) a 0.95-mm-diameter flat after various intervals of sliding. Superimposed on each trace in figure 5 is a surface profile of the 440C HT stainless-steel substrate to show the topography and the location of the coating-substrate interface.

Because the vertical magnification of the surface profiles is about 50 times the horizontal magnification, the view of the surface is distorted. The surface profiles show that after 1 kilocycle of sliding very little wear had occurred on the film surfaces. But after only 5 kilocycles of sliding, the hemisphere had worn through the film and contact with the sandblasted metallic substrate had occurred. A similar result occurred with the three other film thicknesses. Thus, regardless of film thickness, the hemisphere had worn through the film to the metal after 5 kilocycles of sliding. From this point onward, wear was characterized by the gradual increase in wear track width.

The surface profiles of figure 5(b) indicate that the wear process for the flat sliding on the film was one of gradual wear through the film. It took approximately 3500 kilocycles of sliding for the rider to wear through the 45 μm -thick film and make contact with the metallic substrate. Once the metallic substrate was reached, the wear track gradually increased in width as was found for the hemisphere.

After 500 kilocycles of sliding, the film asperities were worn away. As figure 5 shows, the rider continued to wear gradually through the film until the metallic asperities on the substrate were reached at approximately 3500 kilocycles of sliding. The film wear mechanism (after the film asperities had been worn away), was very similar to the mechanism when sliding was only on the film asperity plateaus. Figure 11 shows an area of the film wear track after 1500 kilocycles of sliding. In general, the track was smooth and lustrous, but there were blistered areas and areas where a very thin layer of the film had spalled from the surface (fig. 11) and exposed unrubbed polyimide-bonded graphite fluoride. The area exposed after the film fragment had spalled (fig. 11) was not lustrous and appeared rough. The thickness of layers that spalled varied somewhat; usually they were less than 1 to 2 μm thick but occasionally they were as thick as 6 μm .

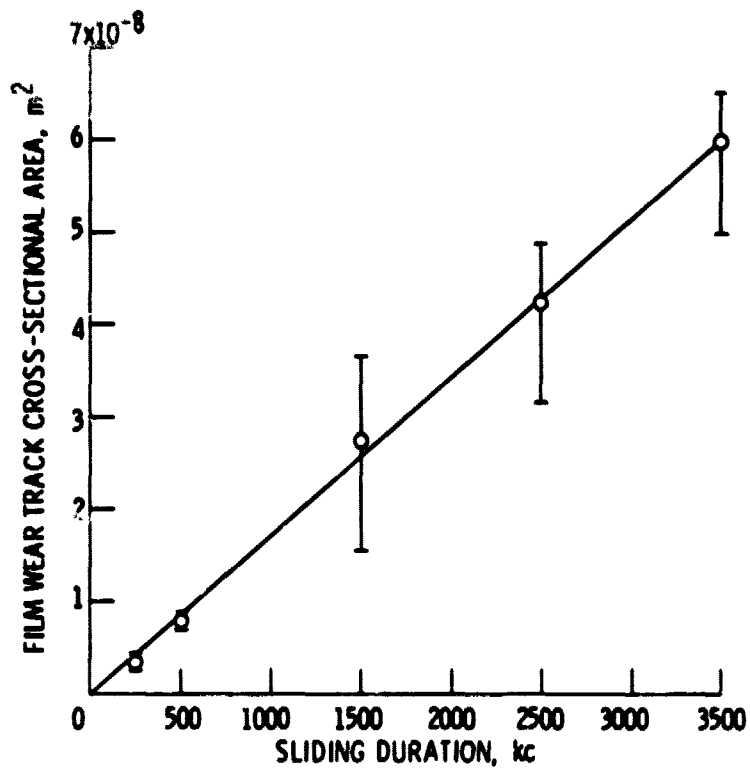
Figure 6. - Wear of polyimide-bonded graphite fluoride film as a function of sliding duration for a 0.95 mm diameter flat sliding on the film.

To quantify the wear process for the flat sliding on the film under a 1-kilogram load, film wear (for the first 3500 kilocycles of sliding) was calculated by measuring the cross-sectional area of the film wear tracks (from the surface profiles) after each sliding interval. At least four traces were taken at each interval. Figure 6 plots the average and the range of these values as a function of the number of sliding revolutions (expressed in kilocycles). The general

trend was that the film wear increased linearly (from zero) as a function of sliding revolutions. A linear regression fit (least squares) of the points gave an average film wear rate of $1.7 \pm 0.3 \times 10^{-7} \text{ cm}^2/\text{kc}$, or in terms of wear volume per unit sliding distance the wear rate was $1.7 \pm 0.3 \times 10^{-10} \text{ cm}^3/\text{cm}$. The wear rate for the hemisphere sliding on the film was $1.2 \pm 0.4 \times 10^{-7} \text{ cm}^3/\text{cm}$. Thus, wear was reduced about 700 times at the lower contact stress with a flat rider.

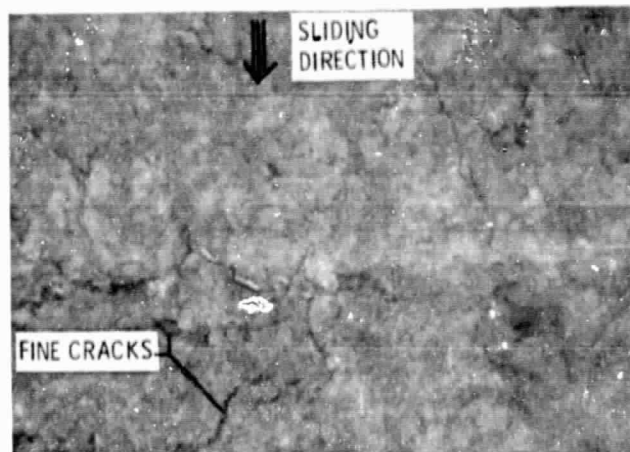
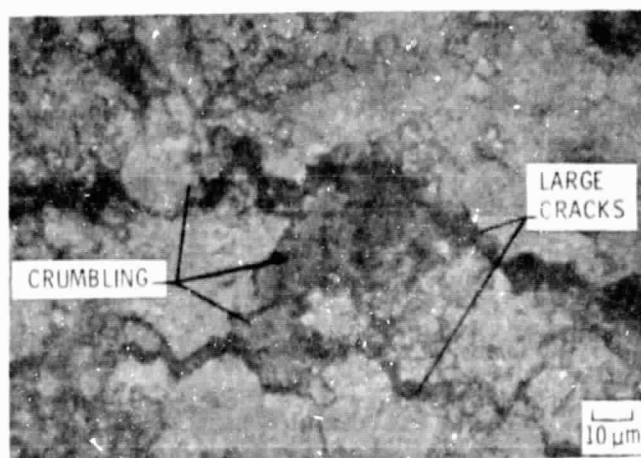
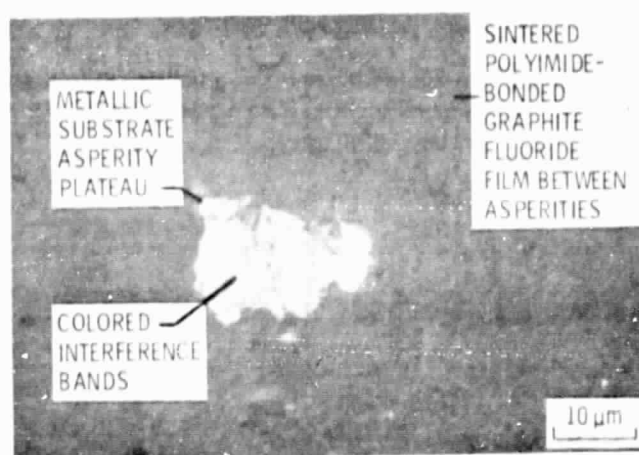
(a) 1/4 kc OF SLIDING.

(b) 5 kc OF SLIDING.

(c) 15 kc OF SLIDING

Figure 7. - High magnification photomicrographs of the central area of the wear track (for the hemisphere sliding of the 45-micrometer-thick polyimide-bonded graphite fluoride film) after sliding intervals of 1/4, 5, and 15 kilocycles.

The surface profiles of figure 5(a) show that on initial contact of the hemisphere on the film very little wear of the film occurred. However, figure 7 shows that the contact stress and the stresses induced by sliding caused cracking of the film to occur. At first, the cracks were very small (fig. 7(a)); but as sliding progressed, they propagated and enlarged (fig. 7(b)) and eventually led to crumbling and the complete breakup of the film on the wear track.

Once the original film was worn away, however, asperities on the 440C HT stainless-steel substrate interacted with the rider and helped support the load (fig. 7(d)). The polyimide-bonded graphite fluoride material tended to compact and sinter into a very smooth, continuous film in the regions between the asperities, and flat plateaus were worn on the tips of the metallic asperities (fig. 7(c)).

The second stage occurred after the film had been worn through to the metal surface. The rider interacted with the asperities on the sandblasted metallic substrate and caused flats to be worn on the tips of those asperities (fig. 7(c)). The lubricating mechanism then became the shear of very thin lubricant films ($<0.8 \mu\text{m}$) between the rider flat and flat plateaus on the metallic asperities. The polyimide-bonded graphite fluoride could be discerned on the plateaus by color changes and interference fringes.

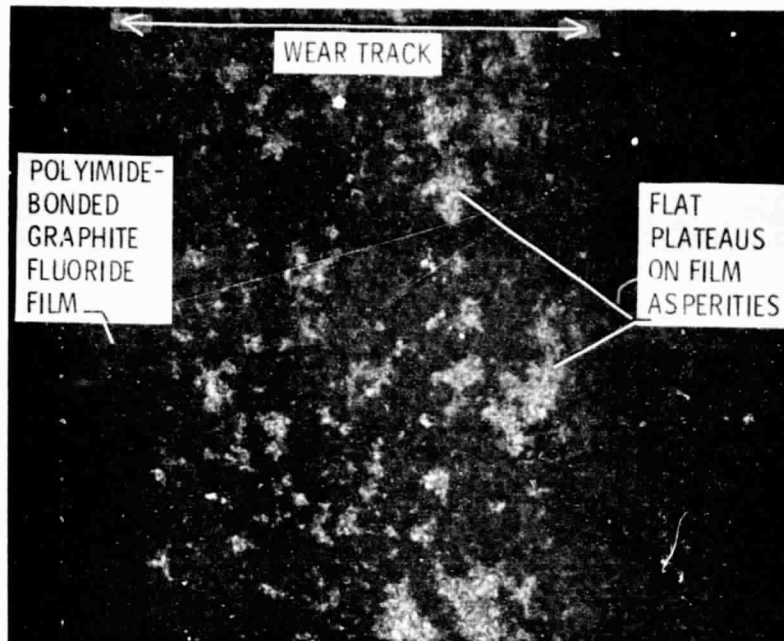
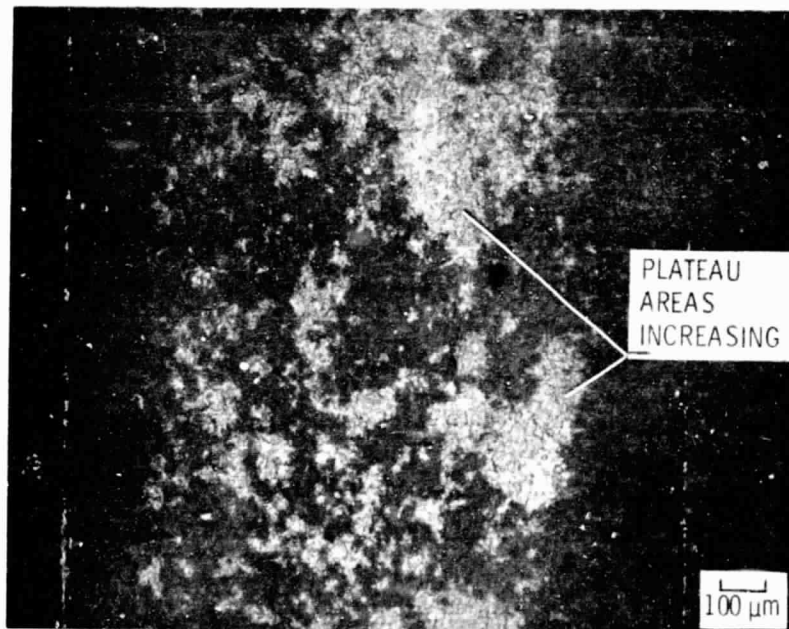
(a) 1 kc OF SLIDING.

(b) 60 kc OF SLIDING.

Figure 8. - Photomicrographs of the same area of the wear track after 1 and 60 kc of sliding for a 0.95 mm diameter flat sliding on a polyimide-bonded graphite fluoride film.

Figure 8 gives photomicrographs of the same area on the film wear track (for the flat sliding on the film) after sliding intervals of 1 and 60 kilocycles. The bright areas seen in the photomicrographs are flat plateaus worn on the film asperities. With repeated passes over the wear track, the ratio of bright areas to dark areas increased, indicating the gradual wear and truncation of the asperities. It took approximately 500 kilocycles of sliding to wear the film asperities down to the bulk film.

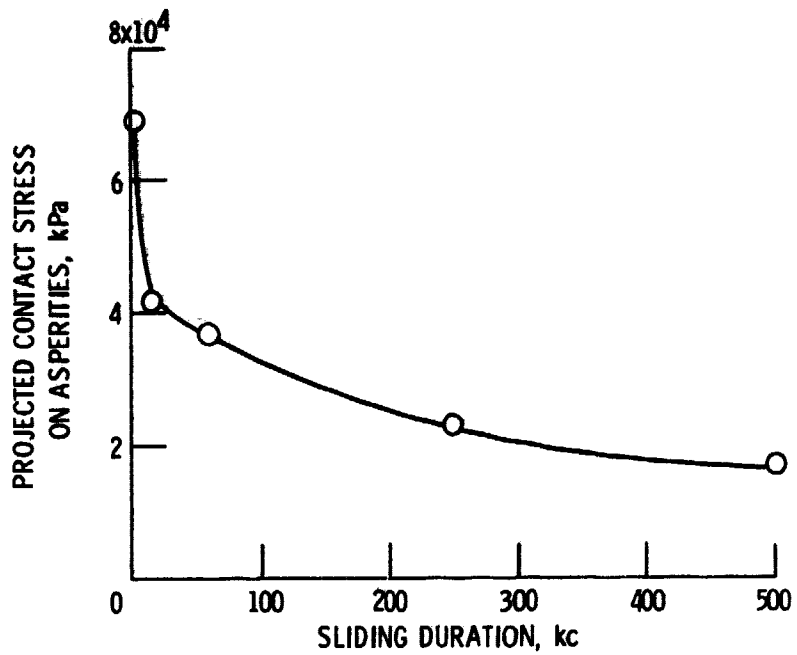
Figure 9. - Projected contact stress on the asperities of a polyimide-bonded graphite fluoride film as a function of sliding duration for a 0.95 mm diameter flat sliding on the film.

In order to quantify the contact stresses involved, the wear track was observed using an image analysis system. Table I shows how the estimated area of contact increased (in percent) as a function of sliding duration and the corresponding calculated values of stress. Figure 9 gives the estimated contact stress on the film asperities as a function of sliding duration. The stress was calculated by assuming that all bright areas were contacting the rider tip at any particular interval. However, this may not have been the case, and these values of contact stress may be low. Nevertheless, the data give an estimate of the contact stresses involved.

Assuming full contact on the film asperity tips, the rider contact after 1 kilocycle of sliding was estimated to be approximately 20%. Thus, the contact stress supported by the film asperities was at least 69 000 kPa (10 000 psi). Because of film asperity wear, the contact stress decreased very rapidly during the first 15 kilocycles of sliding (fig. 9) to a value of 42 000 kPa (6100 psi). After 15 kilocycles of sliding, the rate of decrease slowed and it took approximately 500 kilocycles of sliding to reach a "steady" value of approximately 17 000 kPa (2500 psi). This represents a contact area of ap-

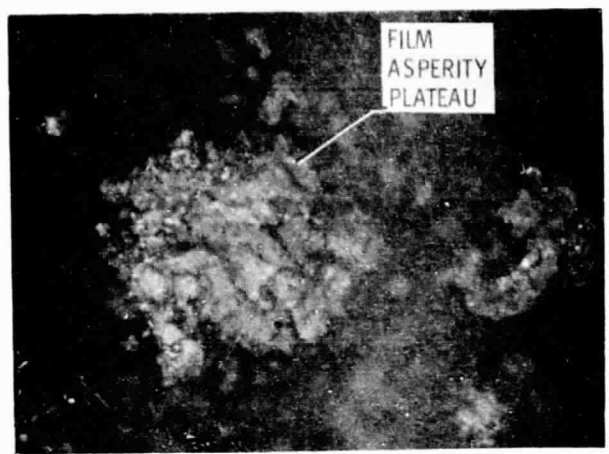
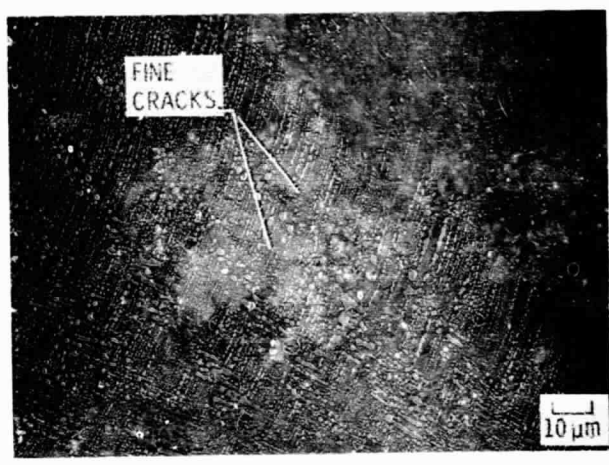
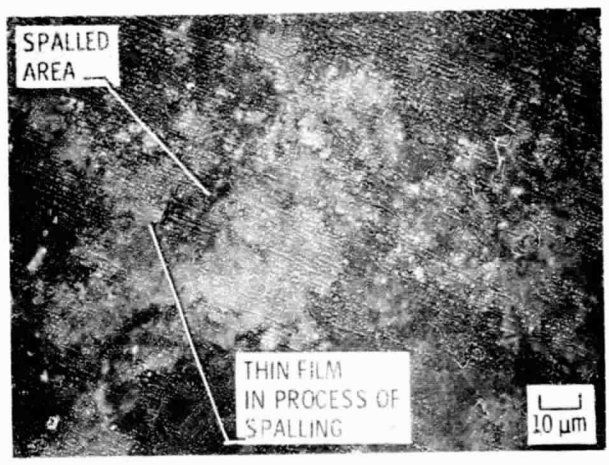
Figure 10. - High magnification photomicrographs of the same polyimide-bonded graphite fluoride film asperity, showing the wear progression which occurred when a 0.95 mm-diam flat slid against the film.

The wear progression of an individual film asperity is shown in figure 10 after intervals of 1, 5, and 60 kilocycles of sliding. The high-magnification photomicrographs show the truncation of a film asperity and its merging together with other asperities as wear occurred. The plateau on the film asperity was very smooth and reflective; however, there were some very fine cracks present and areas where a film fragment has spalled from the plateau. High magnification optical observation of the film wear track suggested that spalling of very thin layers on the plateaus was the primary wear mechanism while sliding was on the film asperities.

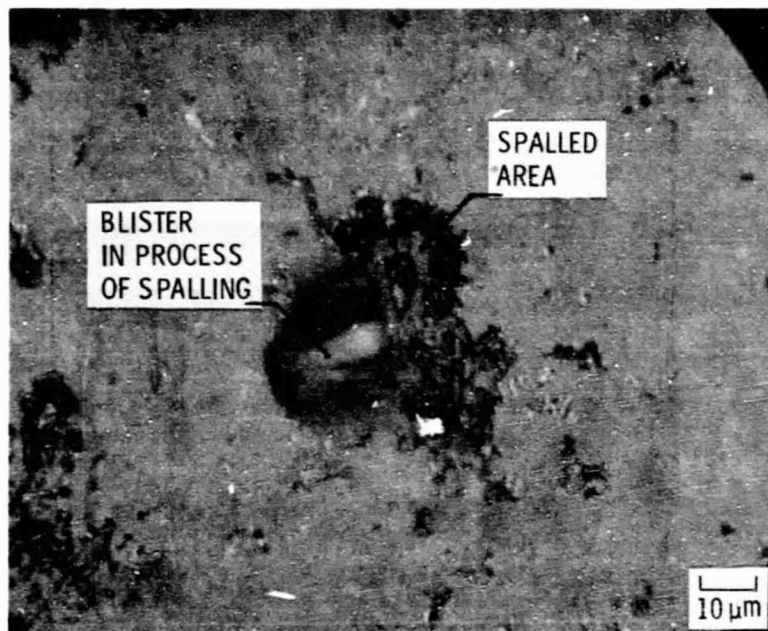
Figure 11. - High magnification photomicrograph of the wear track which was taken after the 0.95 mm diameter flat had slid for 1500 kc on the polyimide-bonded graphite fluoride film, showing blistering and spalling of a thin layer of the film.

One mechanism by which spalling occurred, appeared to be due to texturing of the wear track. Texturing means that the individual constituents (polyimide and graphite fluoride) plastically flowed and coalesced on the wear track

into a very thin smooth layer at the surface of the film. After repeated passes were made over this layer, it tended to disengage from the bulk film by blistering and spalling. Another wear mechanism (not shown in the figures) appeared to originate in the bulk of the film, since the textured layers were up to 1 to 2 μm thick and some spalled areas were as much as 6 μm thick. These spalled areas were most likely caused by crack propagation due to defects in the bulk, while the thinner spalled layers were caused by scaling of the textured layer.

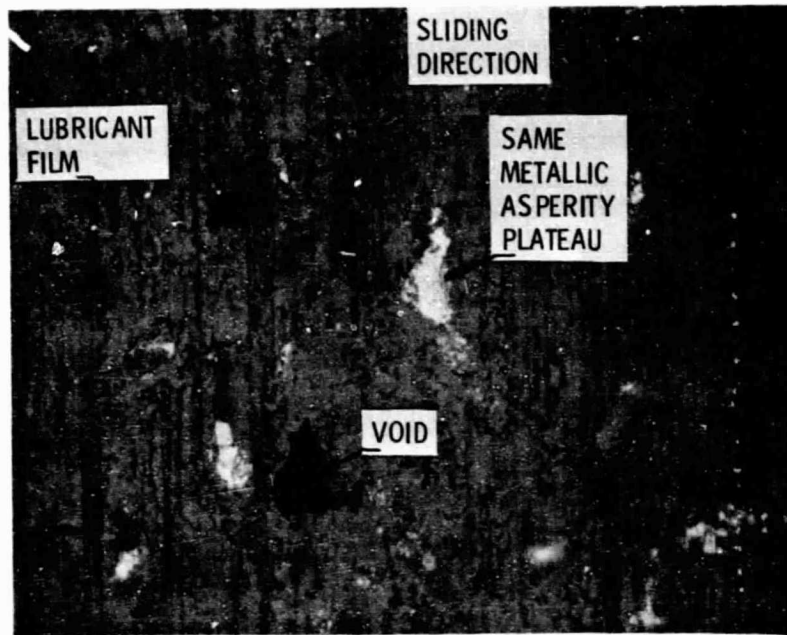
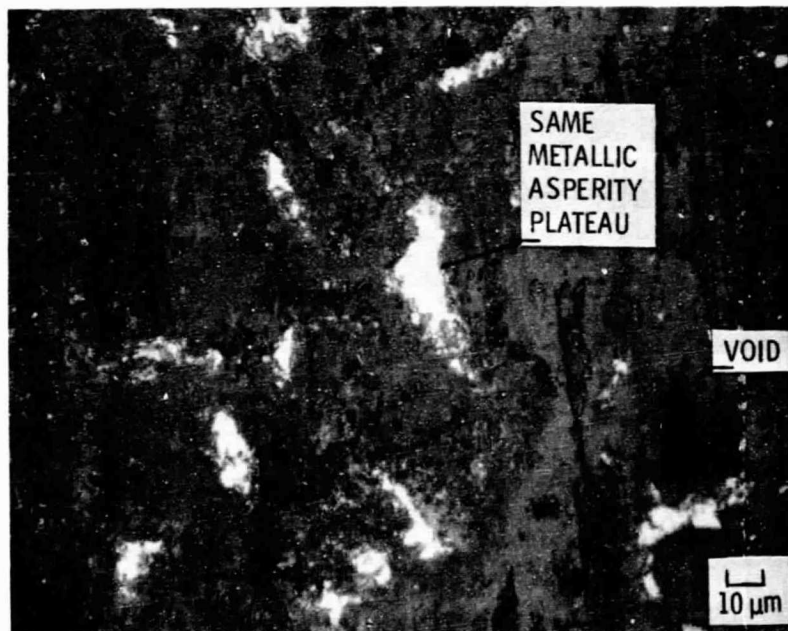
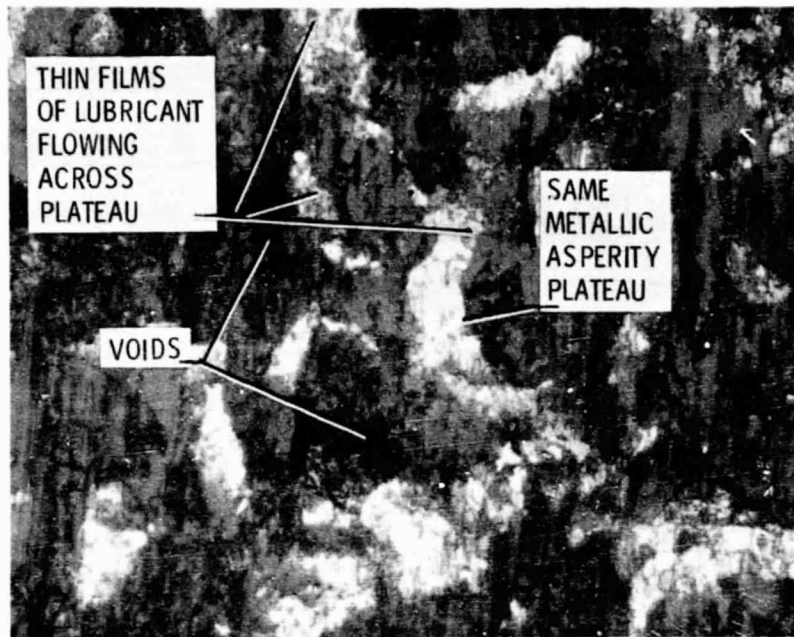
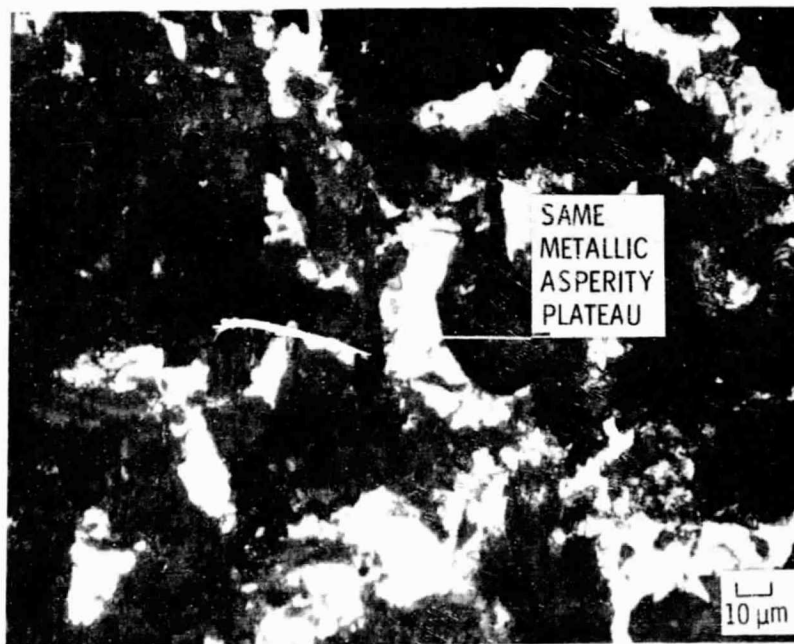
(a) 120 kc OF SLIDING.

(b) 500 kc OF SLIDING.

Figure 12. - High magnification photomicrographs of the same area on the polyimide-bonded graphite fluoride film wear track (for the hemisphere sliding on the 45 μ m thick film) after sliding intervals of 120, 500, 1800, and 2800 kc.

(c) 1800 kc OF SLIDING.

(d) 2800 kc OF SLIDING.

Figure 12 gives high magnification photomicrographs of the same area of the film wear track (for the hemisphere sliding on the 45 μm thick film) after sliding intervals of 120, 500, 1800, and 2800 kilocycles. The bright areas of figure 12 are flat metallic plateaus. The figure illustrates that the interaction of the rider with the sandblasted asperities was a gradual process. As sliding duration increased, the number of and the area of the individual asperity plateaus increased. Figure 12 also shows a number of voids (or depleted areas) in

the wear track. The dynamic nature of the lubrication process is evidenced by observing the movement of voids with sliding duration. Figure 13 gives an idealized schematic drawing of the sliding surfaces, illustrating this lubricating mechanism. The lubricant was supplied to the plateaus from the valleys between the asperities, and thin films of the lubricant essentially flowed across the plateaus and were deposited in a following valley.

It is believed this band resulted from depletion of the lubricant. Figure 12(d) shows valleys in the wear track becoming depleted of lubricant. When too many of these valleys became depleted, an excessive quantity of metallic wear particles was produced (from both the rider and disk substrate). These particles mixed with the lubricant and a powdery mixture of the two constituents resulted. It is interesting to note that the surfaces underneath this powdery buildup were still very smooth and no galling wear had taken place

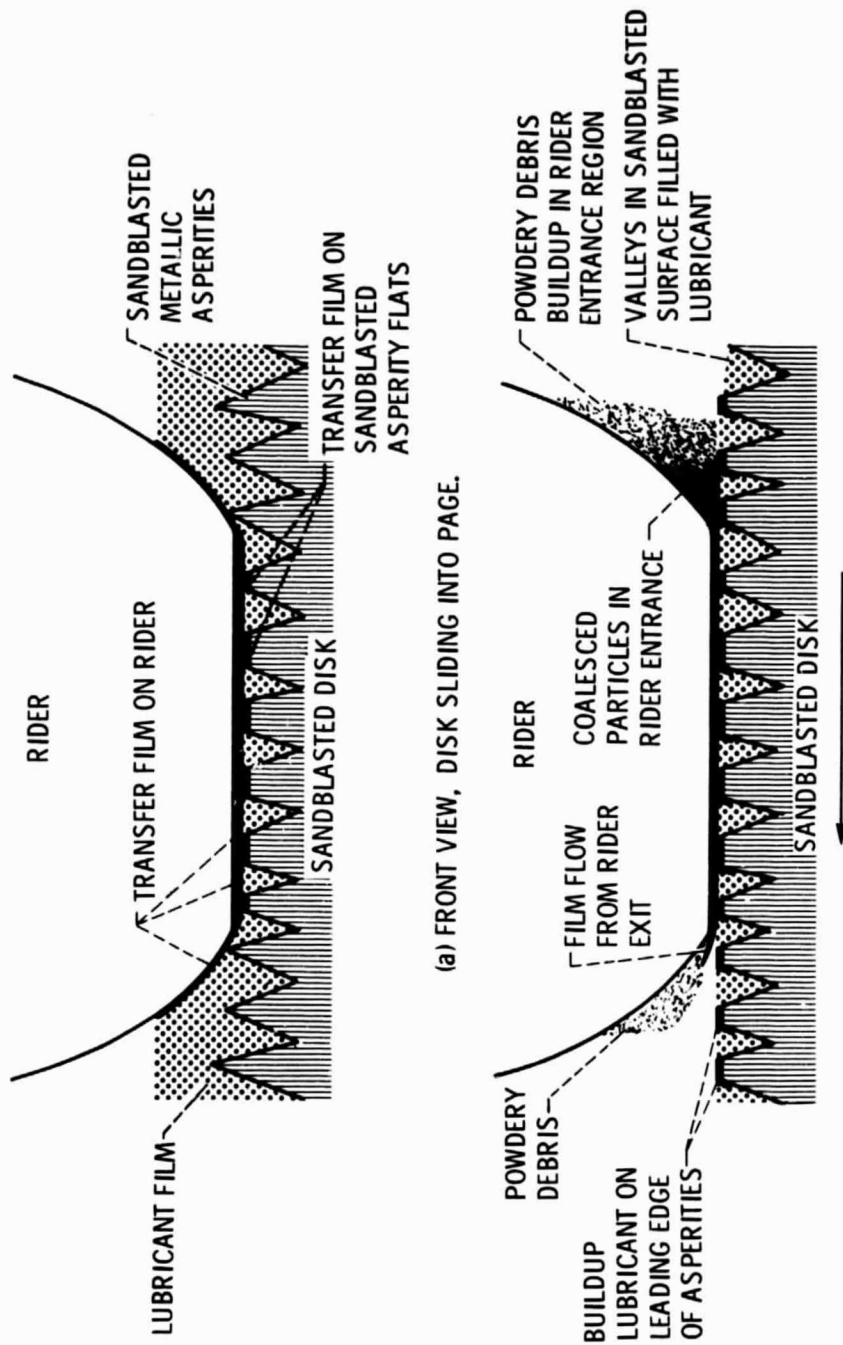
Figure 13. - Idealized schematic drawing of sliding surfaces, illustrating lubricating mechanism in the second stage of lubrication.

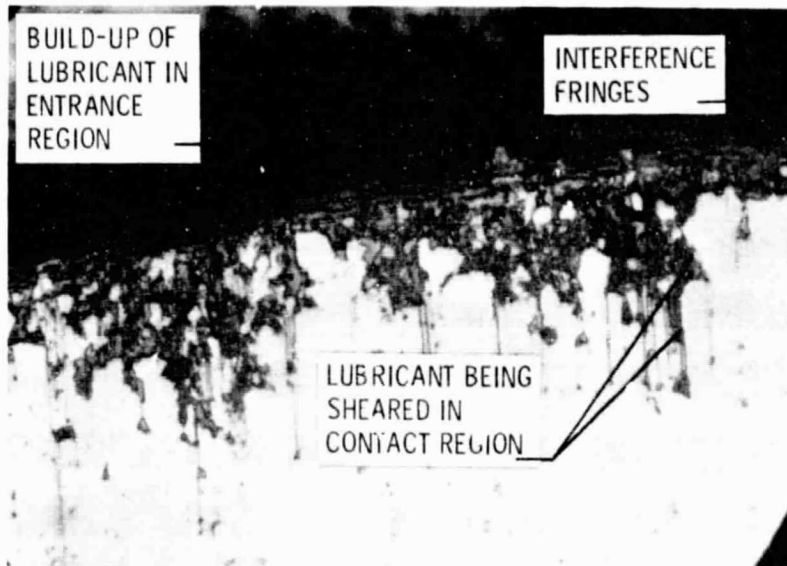
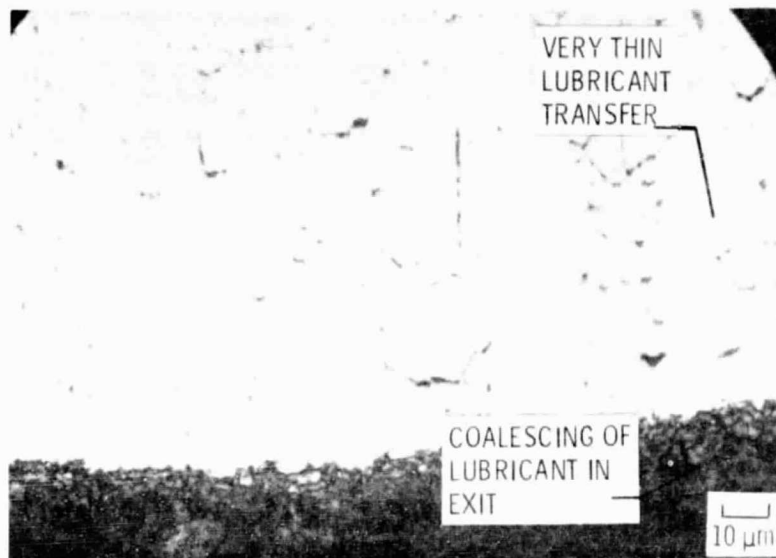
(a) RIDER INLET AREA.

(b) RIDER EXIT AREA.

Figure 14. - High magnification photomicrographs of the rider wear scar inlet and exit areas of the 0.476 cm radius hemispherically-tipped rider after 2800 kc of sliding on the 45 μm thick film.

The polyimide-bonded graphite fluoride tended to build up in the entrance region and was sheared thinner as it entered the contact zone. Interference fringes were observed in the entrance region and suggested that the polyimide-bonded graphite fluoride wear debris had coalesced into a very smooth, continuous film in the inlet area.

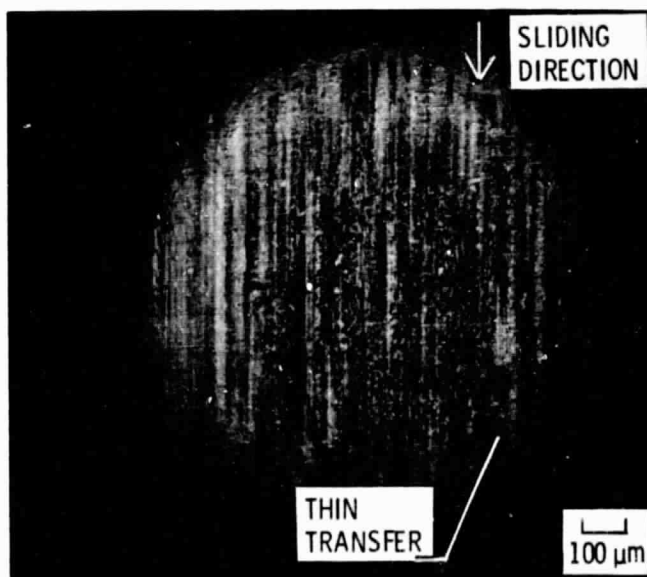
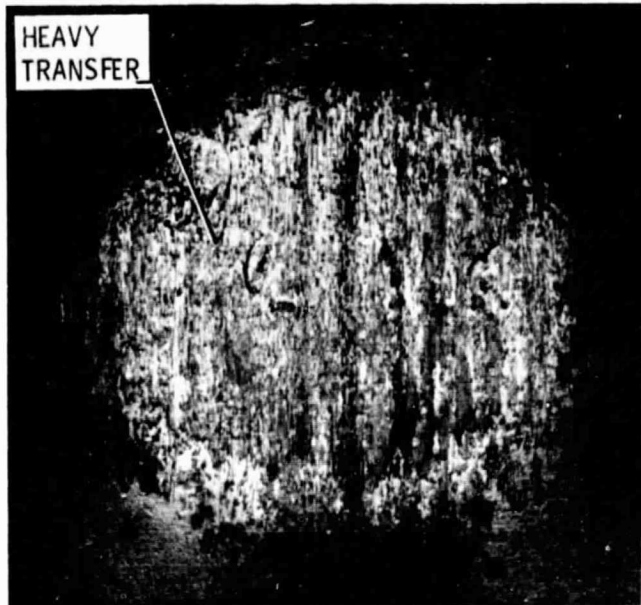
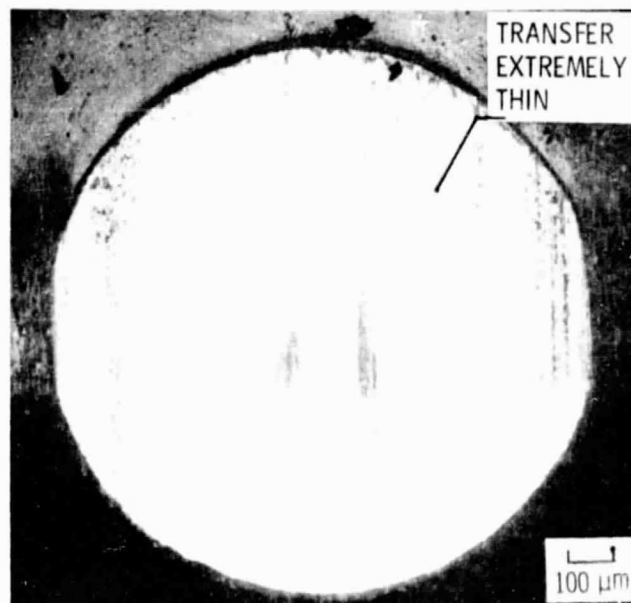
(a) FLAT AREA BEFORE SLIDING.

(b) 1/4 kc OF SLIDING.

Figure 15. - Photomicrographs of the 440C HT stainless steel rider (with the 0.95 mm diam flat) after various sliding intervals.

(c) 250 kc OF SLIDING.

(d) 8500 kc OF SLIDING

Figure 15(d) shows the wear scar after 8500 kilocycles of sliding. The transfer and the wear results were found to be identical to those experiments in which the hemisphere slid on the film.

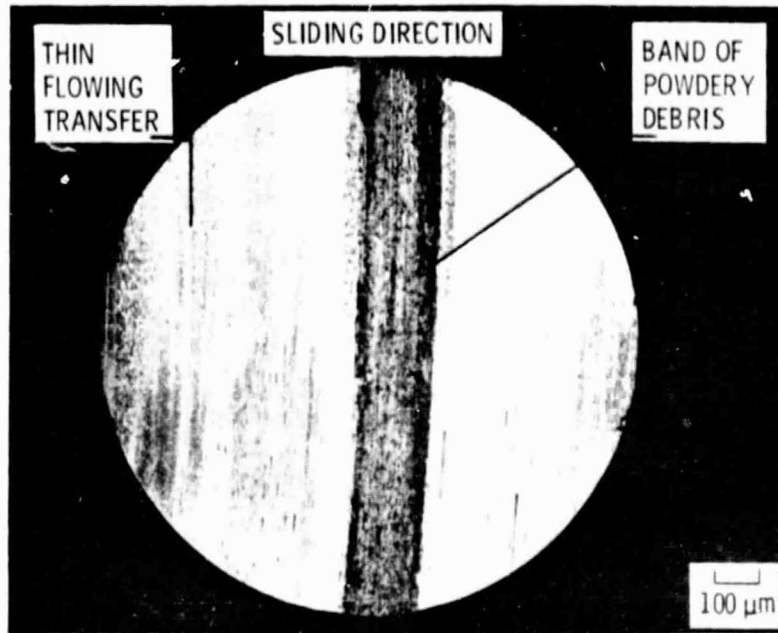
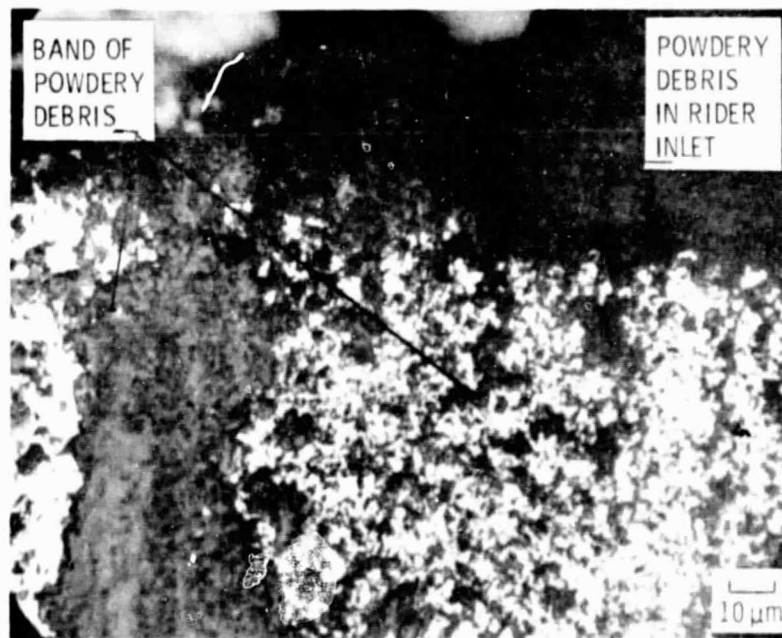
(a) OVERVIEW OF RIDER CONTACT AREA.

(b) HIGH MAG. VIEW OF POWDERY DEBRIS IN THE RIDER INLET AREA.

Figure 17. - Photomicrographs of a typical rider contact area after failure had occurred.

Figure 17 shows photomicrographs of the rider contact area from the test on the $45 \mu\text{m}$ thick film after failure occurred. The photomicrographs typify what happened with the films of other thicknesses. A powdery band was found to extend from the rider inlet region to the exit region (fig. 17(a)). A similar band was found on the disk wear track.
