# NASA TECHNICAL MEMORANDUM

NASA TM-78257

STRESS CORROSION CRACKING EVALUATION OF  
MARTENSITIC PRECIPITATION HARDENING  
STAINLESS STEELS

By T. S. Humphries and E. E. Nelson  
Materials and Processes Laboratory

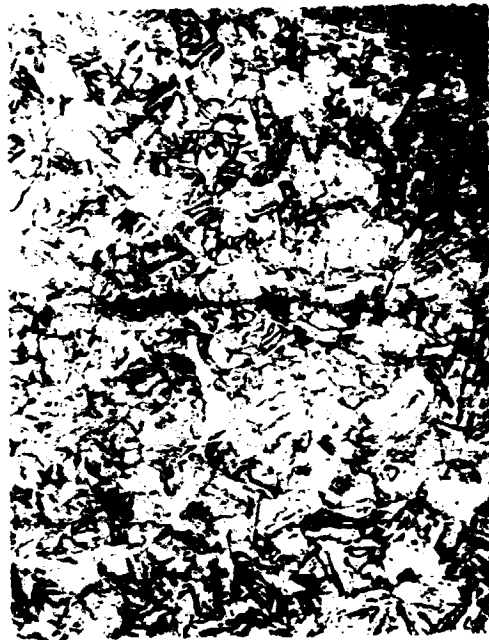
Figure 2. Microstructure of 7.6 cm diameter PH13-8Mo bar showing two stringers.

Metallographic examinations of all the test materials revealed the presence of a segregated phase compound of delta ferrite stringers, and grain boundary carbides in the microstructures of the PH13-8Mo and 17-4PH stainless steels. As illustrated in Figures 1 through 9, the microstructure varied significantly among the various heats of both alloys. For example, no stringers were detected in the 7.6 by 15 cm bar or 13 cm diameter bar of PH13-8Mo (Fig. 1), but numerous stringers and carbides were present in the 18 by 38 by 61 cm forging and the 5.4 by 15 cm bar as shown in Figure 4 and the top view of Figure 5. The variation in the frequency and size of the stringers present in the microstructures of several heats of 17-4PH stainless steel is illustrated in Figure 7.

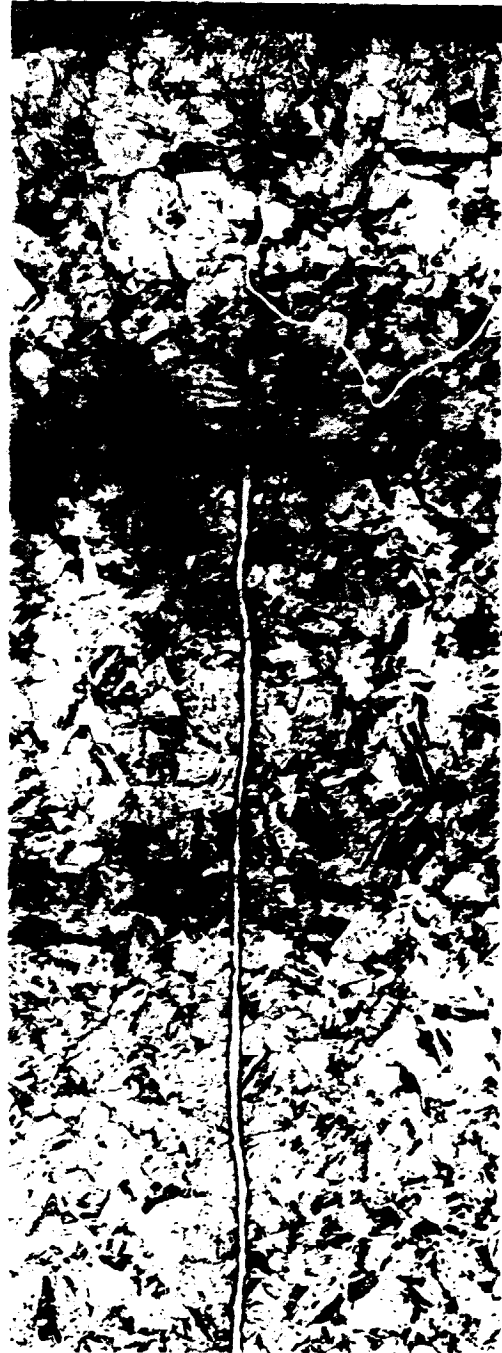
Figure 3. Microstructure of 2.5 by 15 cm PH13-8Mo bar showing a single stringer.

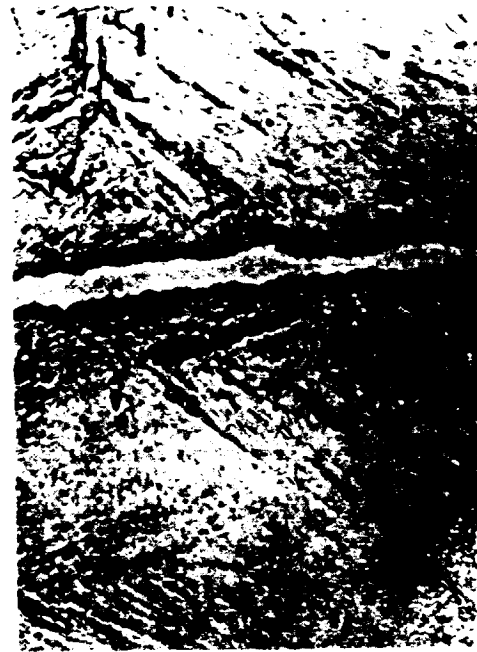
a. 18 cm Diameter Bar Mag. 50X

b. 18 x 38 x 61 cm Forging Mag. 800X

c. 5.7 x 15 cm Bar Mag. 1600X

Figure 4. Photomicrographs of PH13-8Mo bars showing (a) areas of non-uniform martensitic structure, (b,c) stringers and chromium carbides.

An attempt to correlate the SCC resistance with the microstructures of the various heats of the three PH stainless steels was only partially successful. In general, the heats (2W0328, 1X1285, and 690254 - Figures 4, 5, 7, 9) that contained the most stringers and carbide participate were the most susceptible to SCC. The major exception was the 3.8 cm square bar (Fig. 7) which contained numerous small stringers but was resistant to SCC. The microstructures of the 7.6 by 6 cm and 13 cm diameter PH13-8Mo bars appear to be practically free of stringers and precipitates (Fig. 1), but failures were encountered in the former and not the latter bar (Table 3). The 15-5PH material which was highly resistant to SCC was practically free of stringers and precipitates (Fig. 6). The brittle nature of stringer failure is shown in Figure 5 which is indicative of SCC as illustrated in Figure 10.

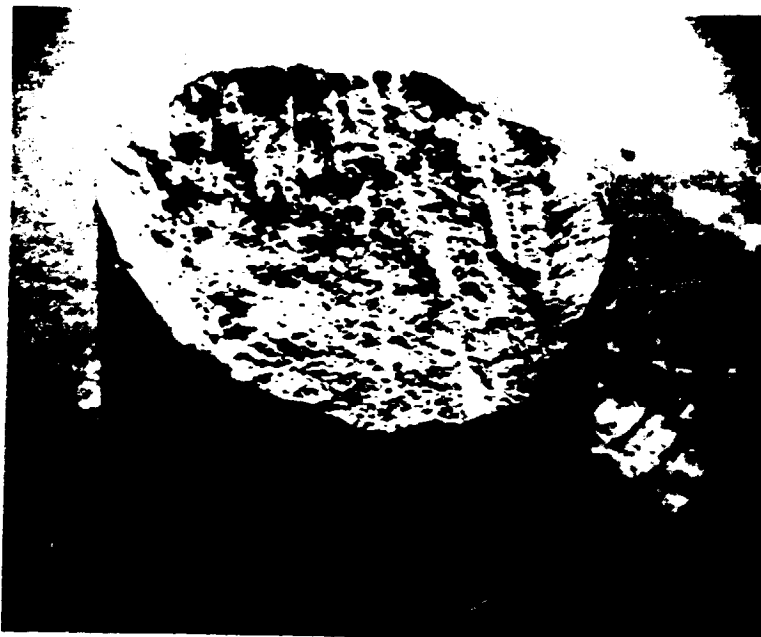
a. 5.7 x 15 cm Diameter Bar

b. 5.7 x 15 cm Diameter Bar

Figure 5. SEM micrographs of PH13-8Mo bar showing (a) the presence of stringers on fracture surface and (b) the brittle nature of stringers relative to adjacent ductile area.

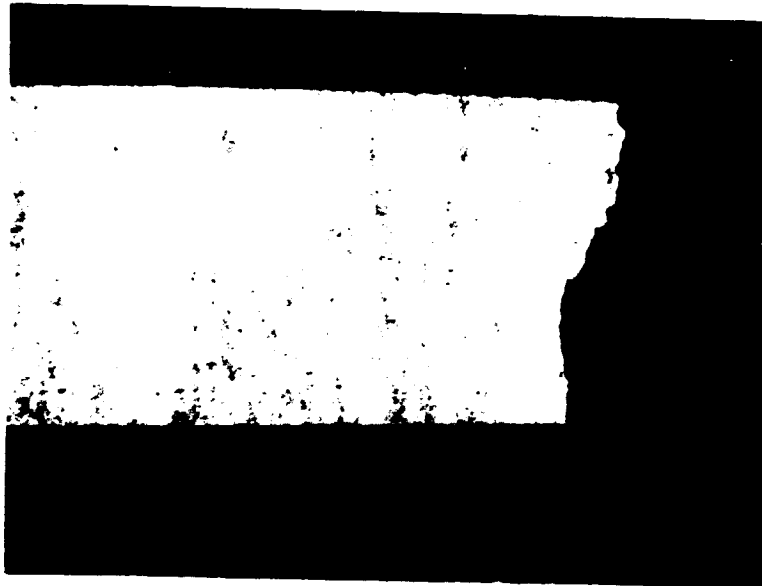
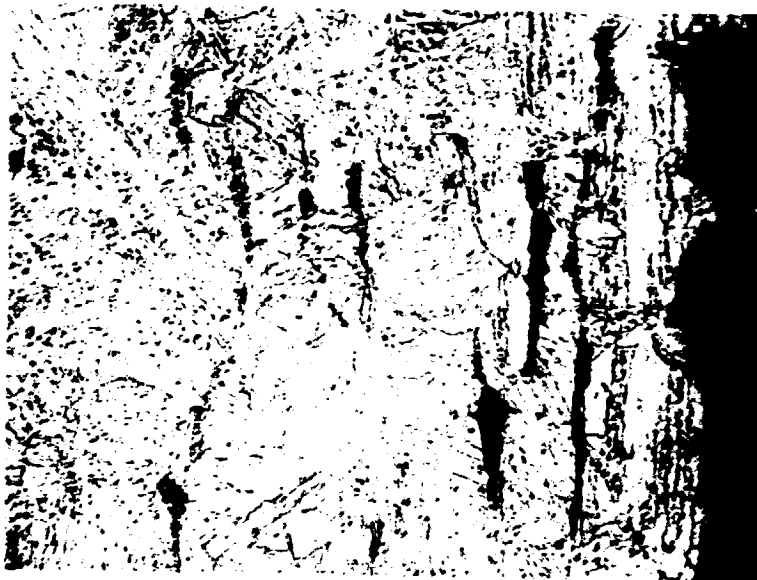
a. 5.4 cm Thick Plate

b. 5.4 cm Thick Plate

Figure 9. Photomicrographs of 17-4PH plate showing (a) the presence of banding and (b) delta ferrite stringers.
