NASA Technical Paper 1605

Nitrogen Dioxide Vapor Penetration of Chlorobutyl Rubber SCAPE Suits Under Operational Conditions

Thomas A. Schehl and Thomas W. Beall

FEBRUARY 1980

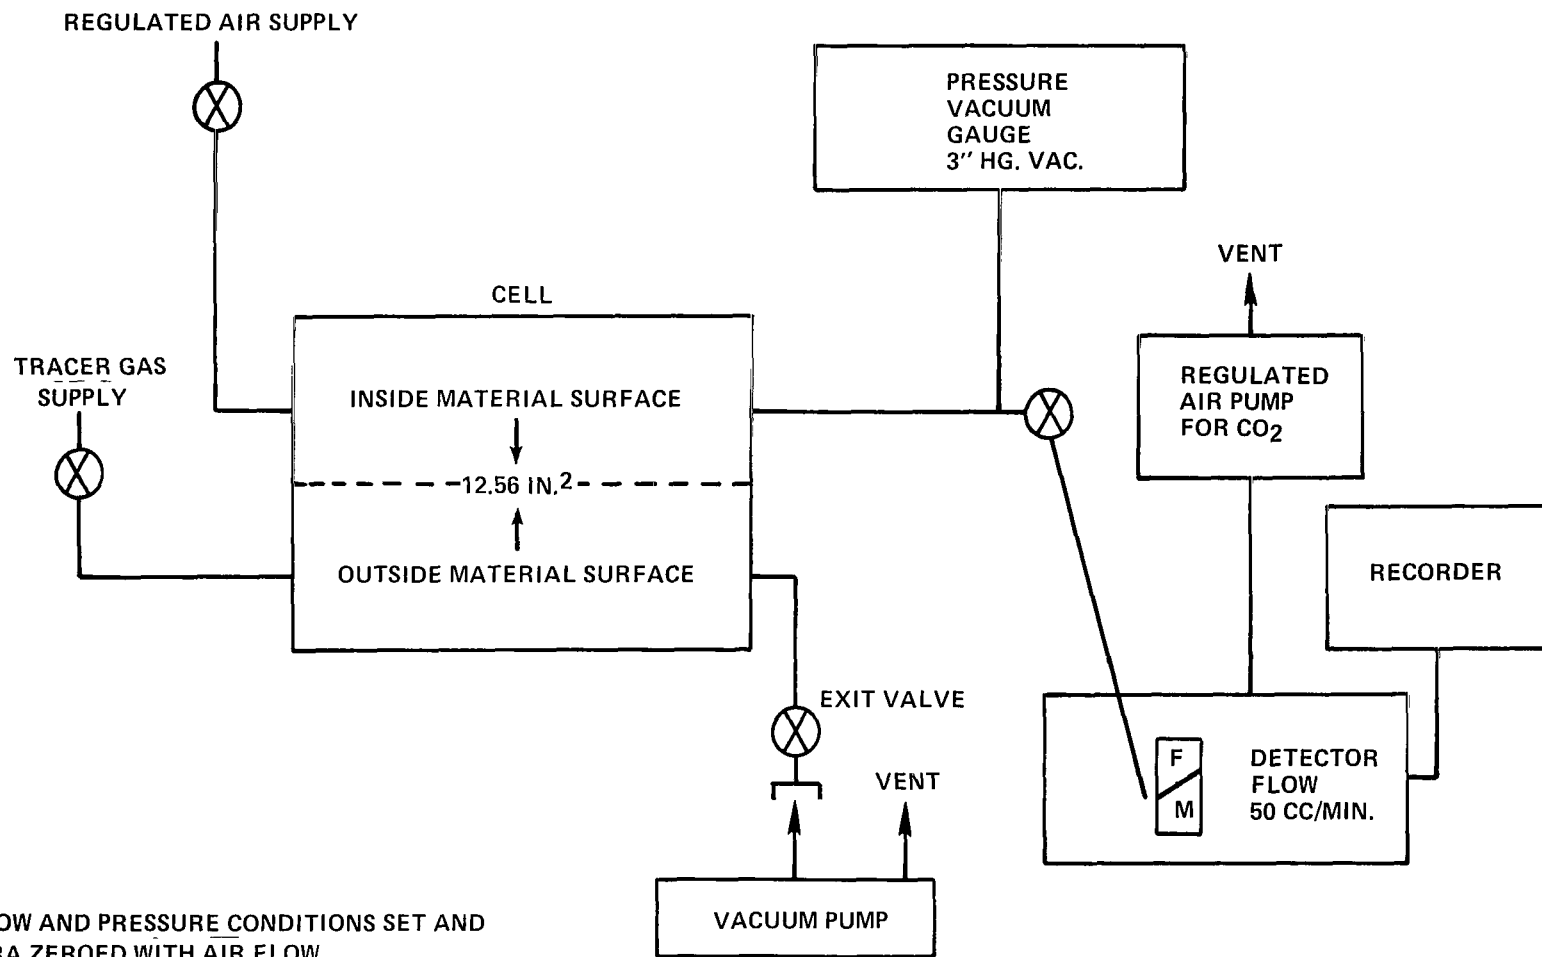
FIGURE 1.

CELL TEST APPARATUS

FLOW AND PRESSURE CONDITIONS SET AND
LIRA ZEROED WITH AIR FLOW.

The cell was mounted in the test apparatus shown in Figure 1. A Lira Model 300 CO₂ Analyzer was used to measure the CO₂ concentration. The sensitivity of the instrument was improved by increasing the gain almost to its maximum and zeroing the recorder using breathing air as the zero gas. A standard of CO₂ in breathing air was run under the same flow conditions as the zero gas.

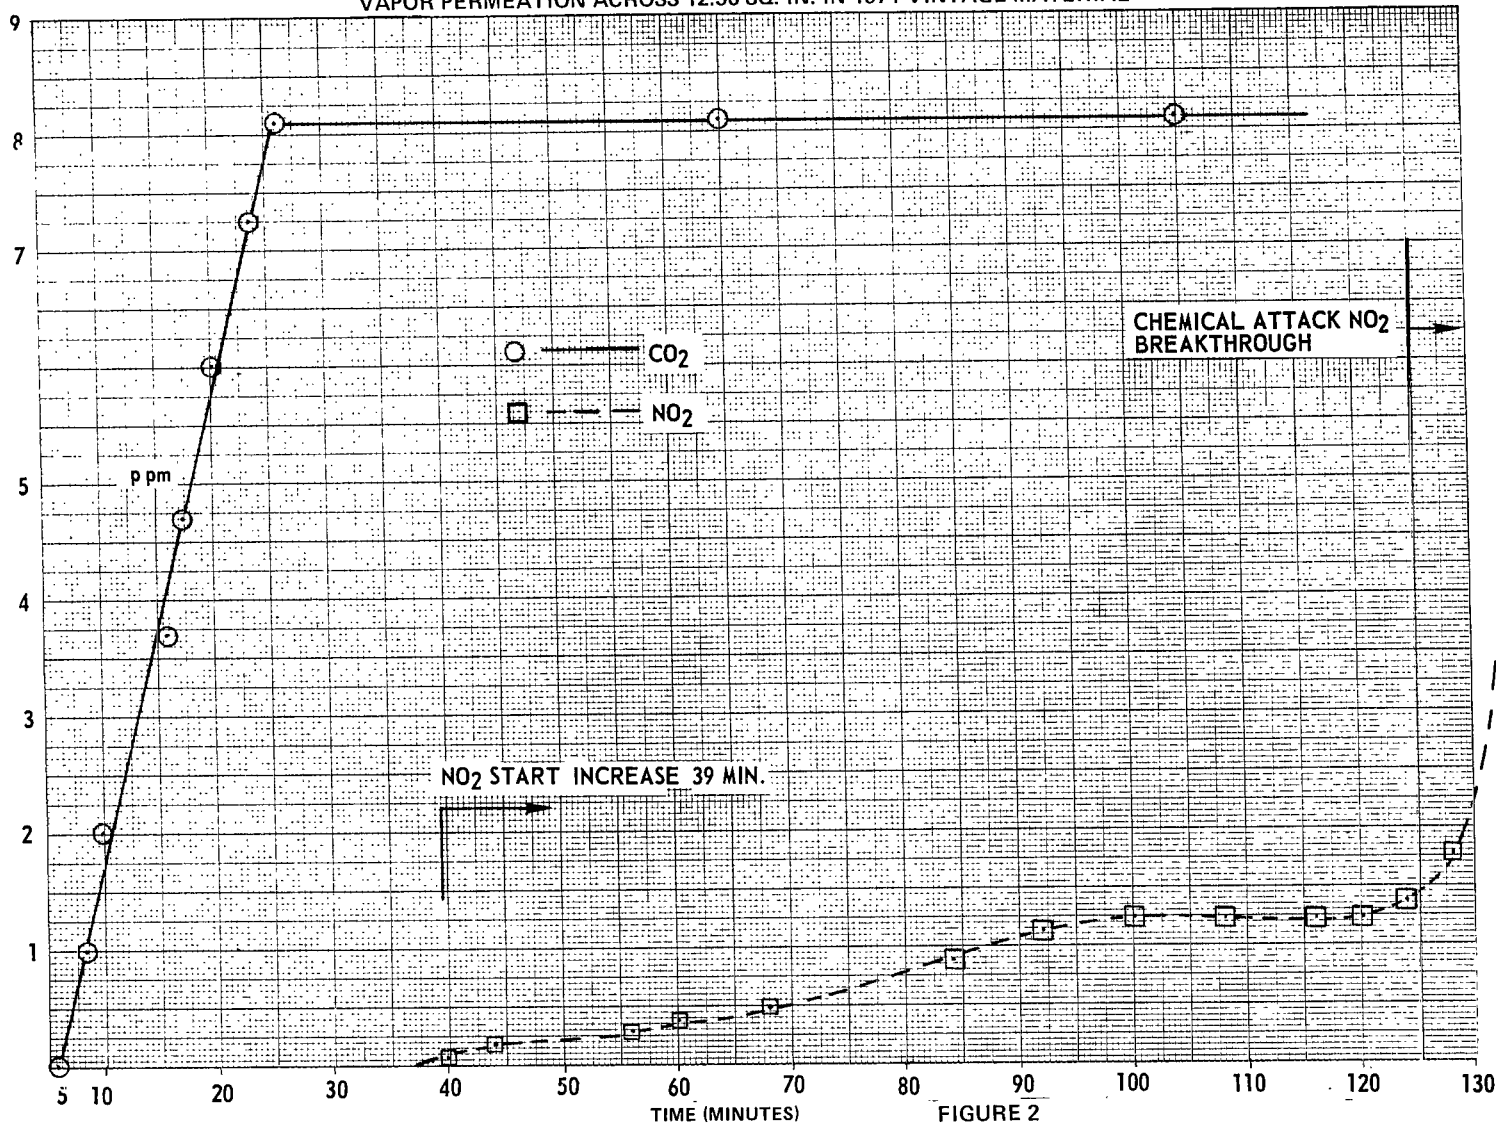
FIGURE 2

VAPOR PERMEATION ACROSS 12.56 SQ. IN. IN 1971 VINTAGE MATERIAL

cell. A very sharp rise in NO2 concentration noted after 122 minutes was attributed to chemical breakthrough.

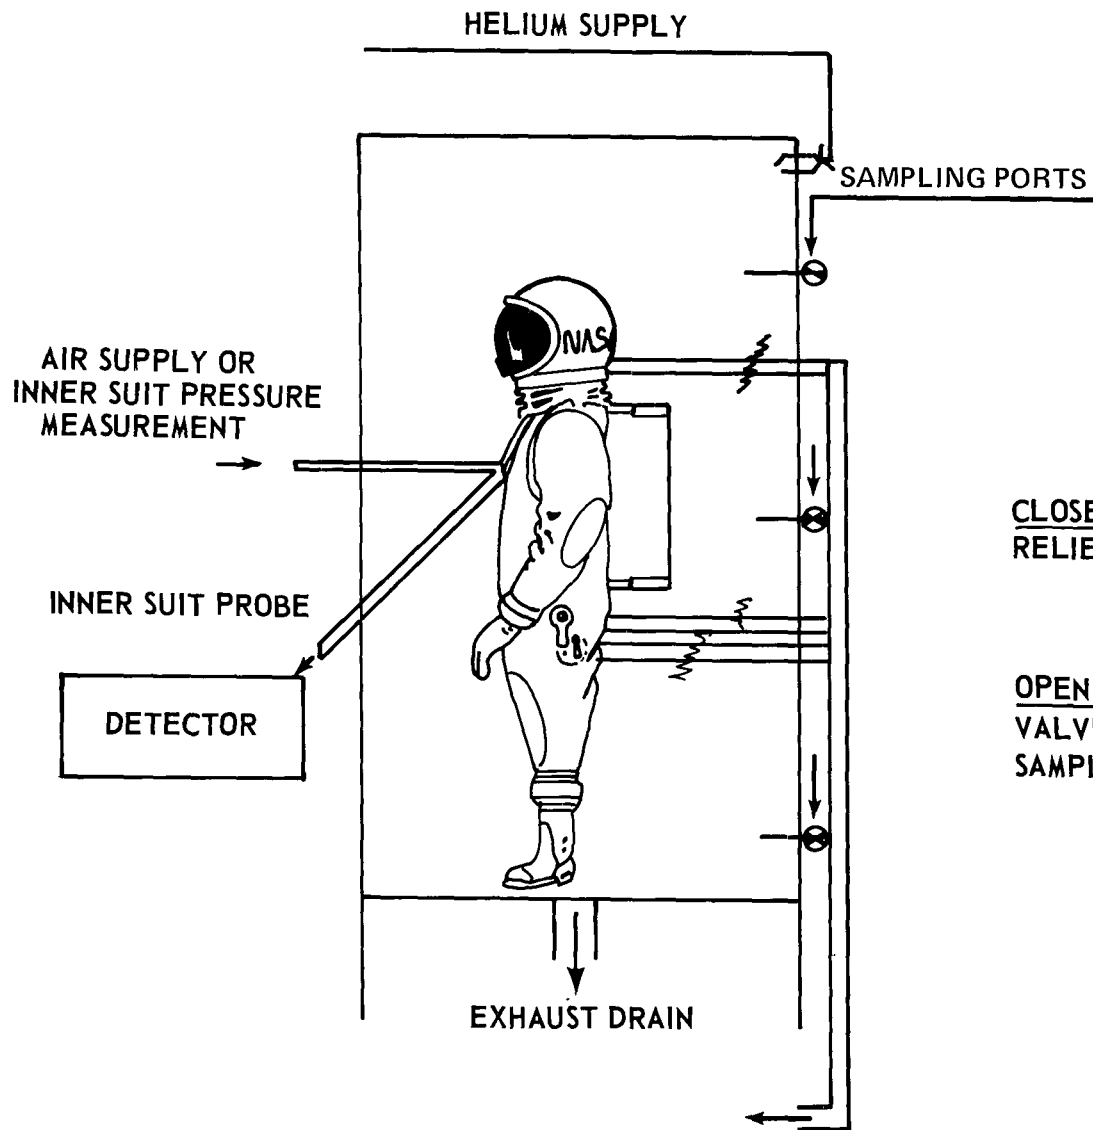
FIGURE 4.

SEALED CHAMBER SCAPE SUIT TEST

CLOSED LOOP TESTING – EXHAUST OF SUIT RELIEF VALVES EXTERIOR OF CHAMBER.

OPEN DUMP – HOSES REMOVED FROM SUIT RELIEF VALVES – EXHAUST DIRECTLY INTO CHAMBER. SAMPLING PROBE IN HELMET.

Two standard operational SCAPE suits, numbers 607 and 627, were selected at random for nondestructive complete ensemble testing. A test chamber was constructed as illustrated in Figure 4 using CO₂ as the tracer gas. It was fabricated of stainless steel, measuring 4 feet square by 8 feet high with a 4 foot square air-tight door containing a large plexiglass window on the front. Several port connectors were mounted on the side for gas inlets, sampling, and monitoring equipment. There was a large closable vent in the base and three port connectors on the side for venting the suit's interior gases. A seven foot tall stand pipe was inserted into the floor vent to insure maximum CO₂ concentration around the suit. Both breathing air and carbon dioxide were supplied from "K" bottles for the test. The exterior CO₂ concentration was monitored at helmet level by an MSA Lira 300 CO₂ Detector with a 0 - 100% range. For interior CO₂ concentration a 0 - 50 ppm Lira 300 was used with the sampling probe mounted at the communication microphone. Interior suit pressure was measured from the same probe with a 0 - 20 inch inclined water gauge. A series of valves in both interior and exterior sampling lines allowed known CO₂ standards to be

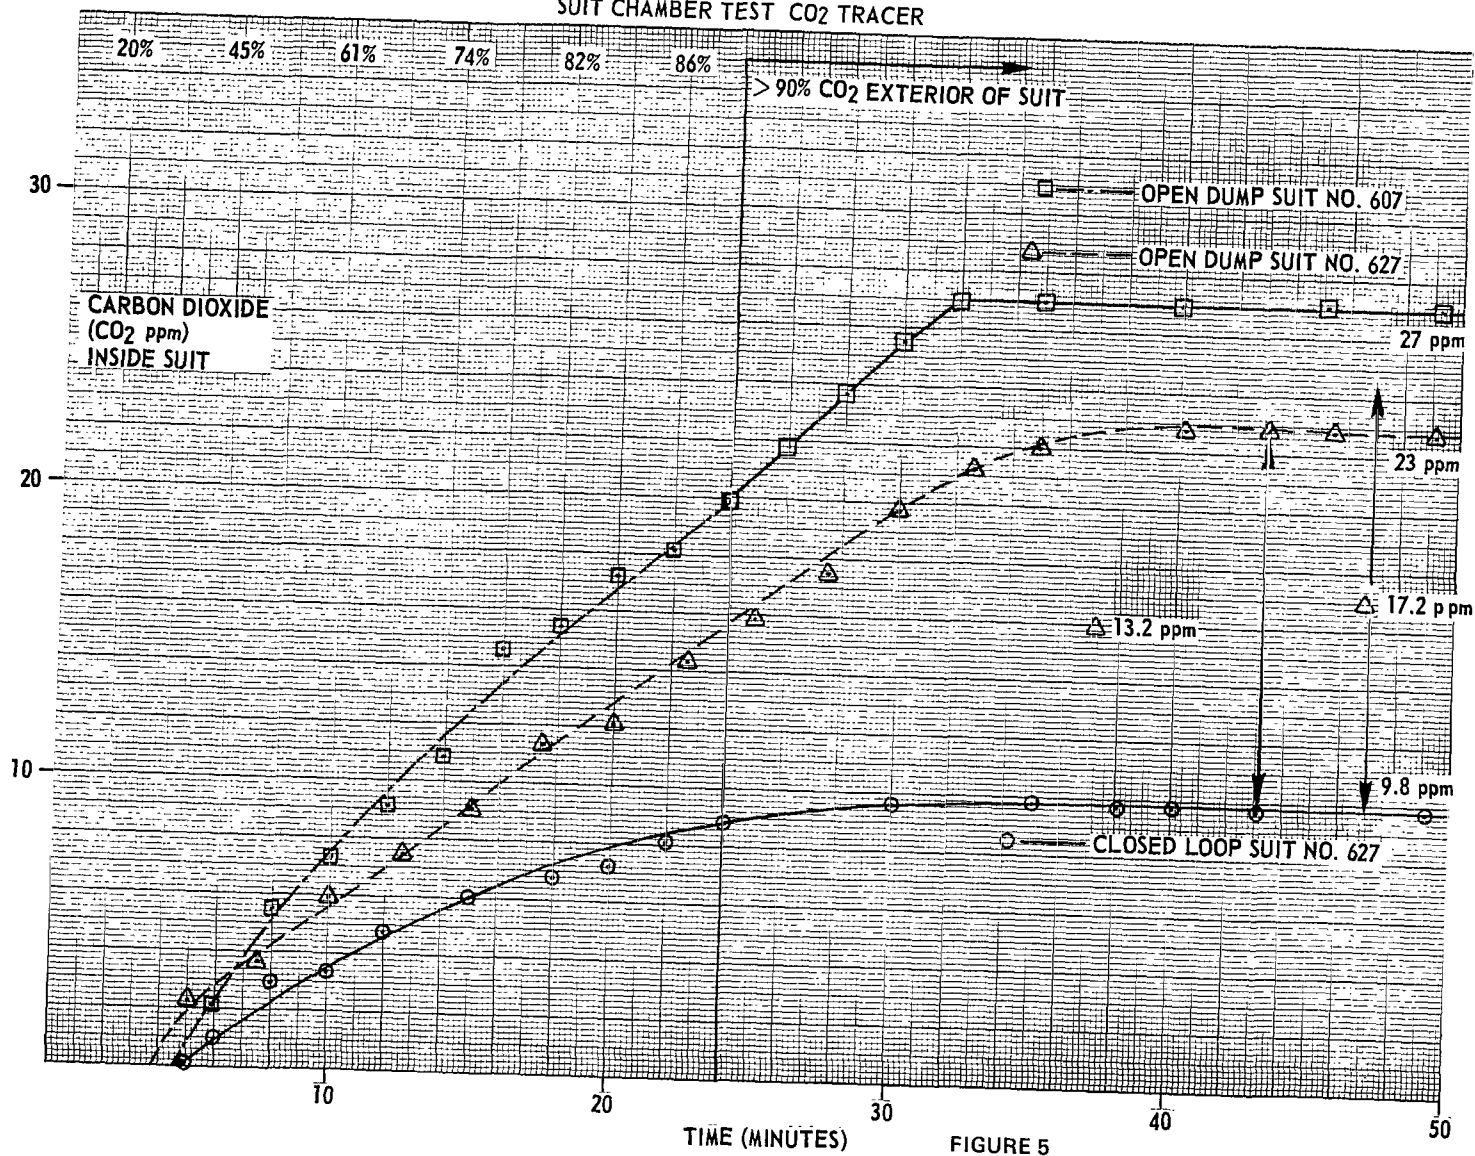
FIGURE 5

SUIT CHAMBER TEST CO₂ TRACER

The first noticeable rise in CO₂ level came after 6 minutes when the interior concentration was 40% (Figure 5). A maximum concentration within the suit of 27 ppm was observed after 32 minutes when the exterior concentration at the top of the chamber was 90% CO₂. The CO₂ level in the top of the chamber continued to rise to 94% at 44 minutes but no increase in the interior concentration was observed.

The test was repeated with suit number 627. Breathing air flow was set at 1.05 CFM (36 l/min) with relief valves operating rhythmically as before. First indication of CO2 inside the suit was observed at 4 minutes while the maximum of 23 ppm was not reached until 40 minutes had passed (Figure 5).

Suit 627 was set up in the closed loop configuration to measure the effect of the valves on the overall leak rate. Air flow was kept at 1.05 CFM so that the face valve would operate normally. An increase in interior CO2 concentration began after 5 minutes and reached a maximum of 9.8 ppm after 30 minutes. Exterior CO2 concentration reached 100% (Figure 5) after 36 minutes of flushing.

only a 10 ppm level was reached inside the suit. The close agreement of these values with the open dump and closed loop tests (Figure 5) indicate that most of the leakage into the suits was occurring at the hip relief valves which are in a closed position during normal suit operation.

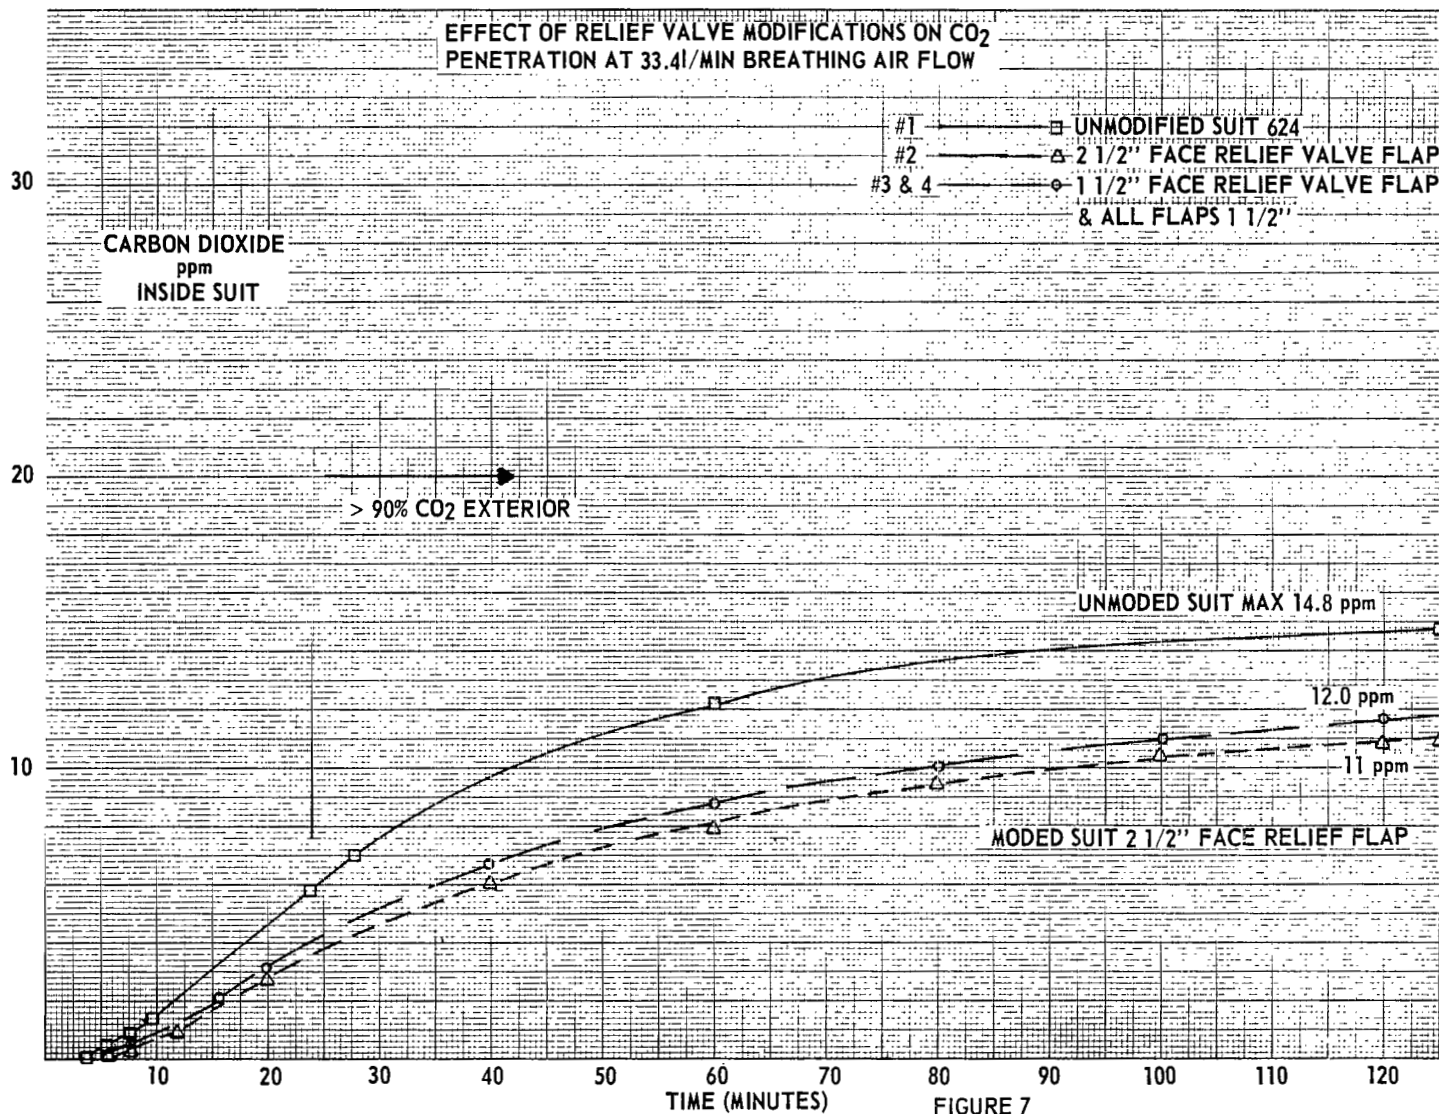
FIGURE 7

SUIT CHAMBER TEST SUIT 624

EFFECT OF RELIEF VALVE MODIFICATIONS ON CO₂ PENETRATION AT 33.4l/MIN BREATHING AIR FLOW

Comparing the maximum interior concentration observed in 2 hours reconfirms results obtained in Helium Penetration Test. Adding the flaps to the suit relief valves with the face flap being 2 1/2" long and hip flaps 3 1/2" long lowers the concentration by about 20%. Additional cutting of 1 inch from the face relief valve making it 1 1/2" long increases the concentration by 7% while cutting the hip flaps to the same length, 1 1/2", has no effect.

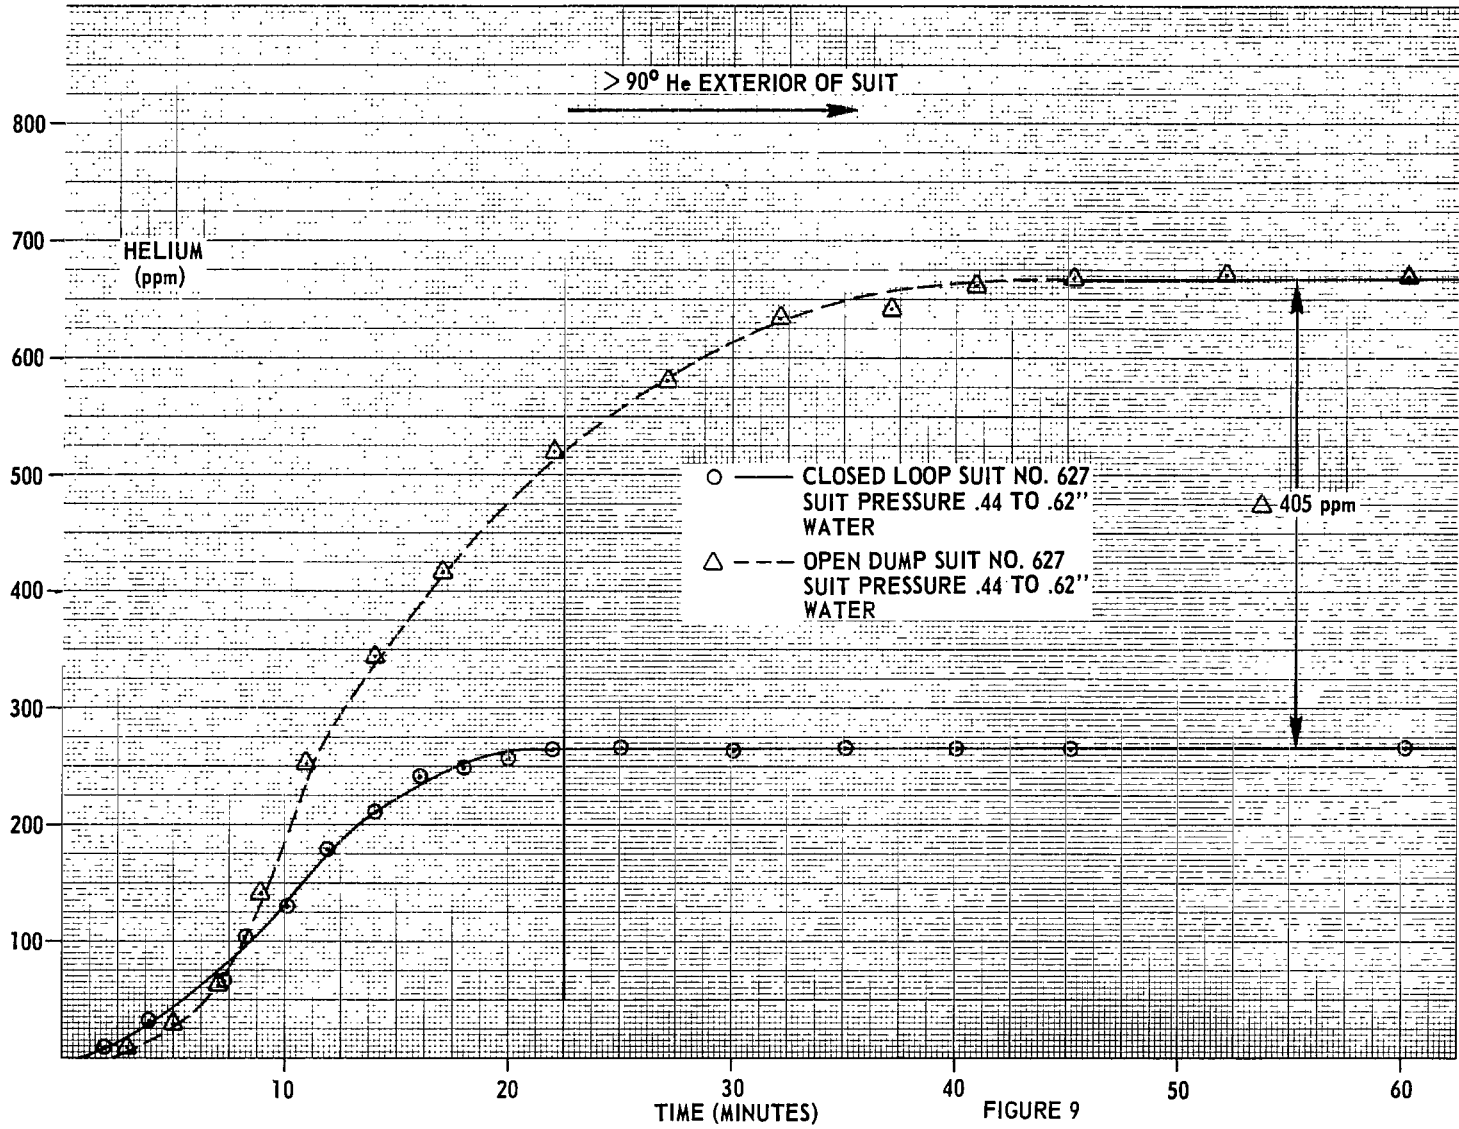
FIGURE 9

UNMANNED CHAMBER TEST, HELIUM TRACER

The initial test performed was a comparison of closed loop (relief valve exhaust vented out of the chamber) to open dump (relief valve exhaust emptying into the chamber) using "K" bottle, regulated, breathing air as the purge supply. The observed difference again indicated a major portion of the leakage was occurring at the non-operating relief valves (Figure 9). Ratioing the maximum concentration of CO₂ found in the

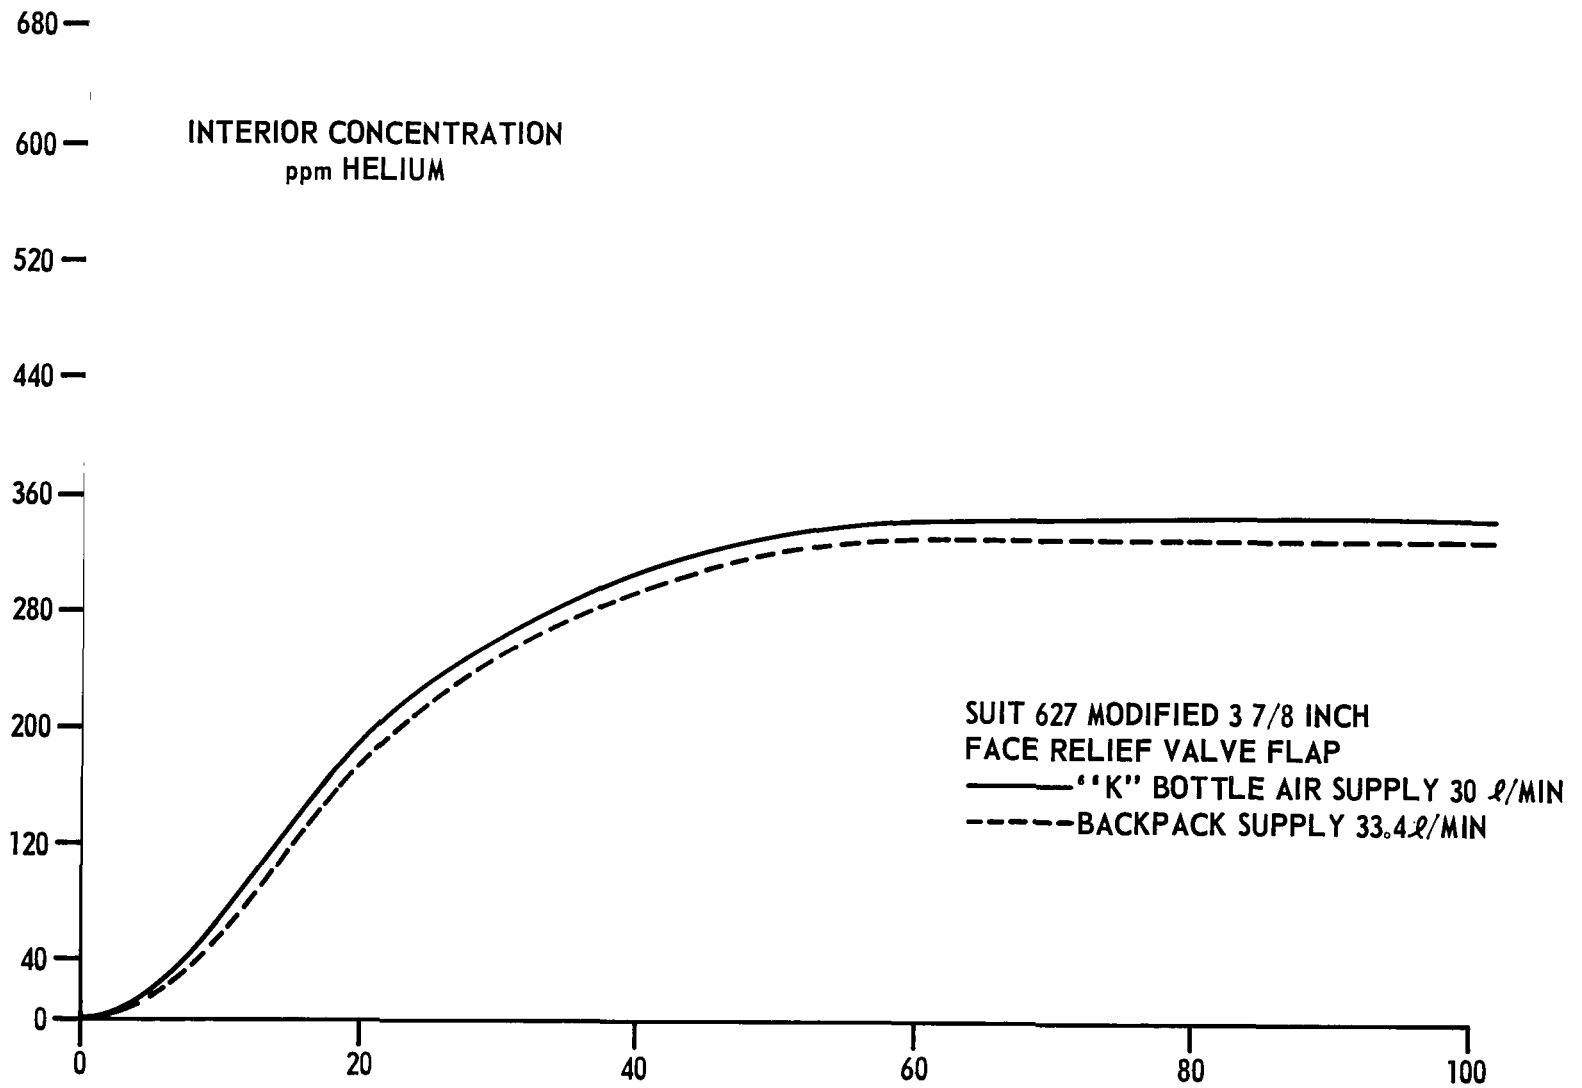
TIME MINUTES
FIGURE 11

INTERIOR CONCENTRATION
ppm HELIUM

SUIT 627 MODIFIED 3 7/8 INCH
FACE RELIEF VALVE FLAP
——— "K" BOTTLE AIR SUPPLY 30 l/MIN
- - - - BACKPACK SUPPLY 33.4 l/MIN

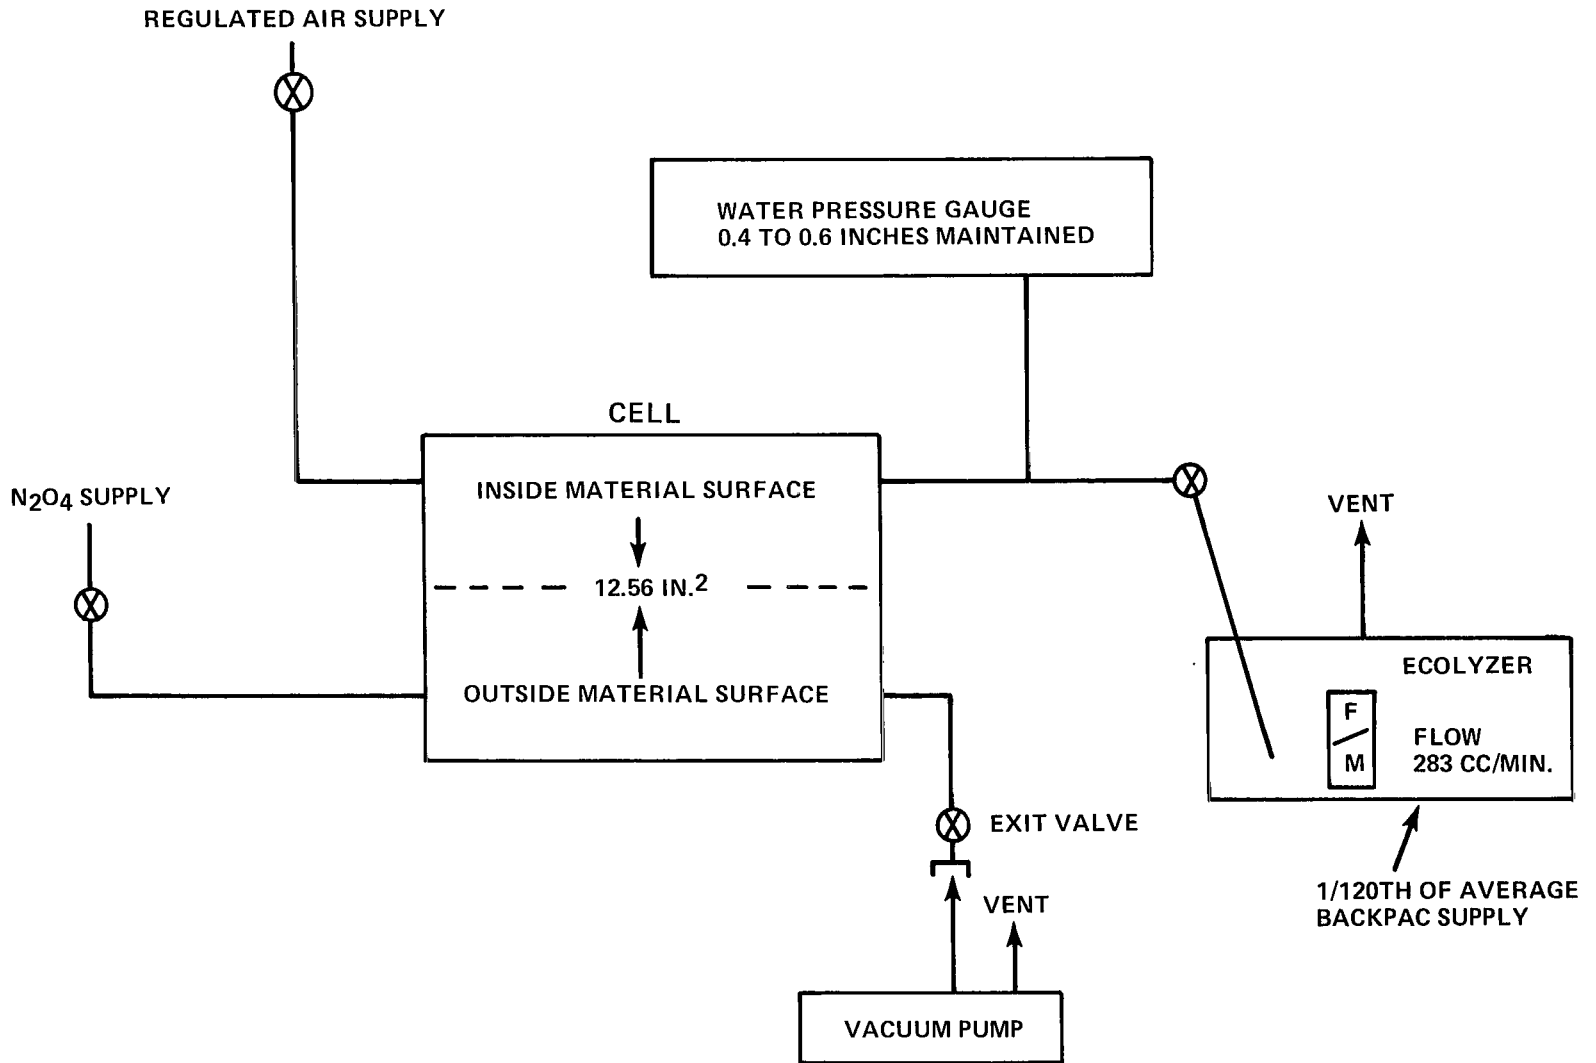
NO₂ CELL TEST APPARATUS

FLOW AND PRESSURE CONDITIONS SET AND ECOLYZER ZEROED WITH AIR FLOW.

AIR REMOVED FROM LOWER CHAMBER AND N₂O₄ FLOW ESTABLISHED.
FLUSH WITH N₂O₄ 5 MINUTES. SECURE SUPPLY VALVE THEN EXIT VALVE.
1 ATM N₂O₄ IN LOWER CELL.

An Energetics Science Inc. Ecolyzer NO₂ Analyzer was plumbed into the apparatus in place of the Lira. A NO₂ standard was run under the same flow conditions used for the CO₂ standard. The SCAPE material was then analyzed using a N₂O₄ supply to the lower

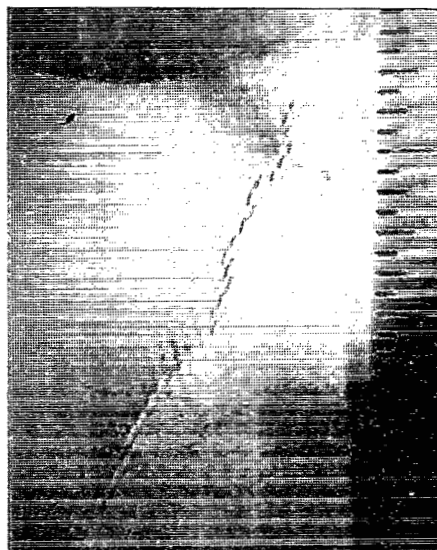
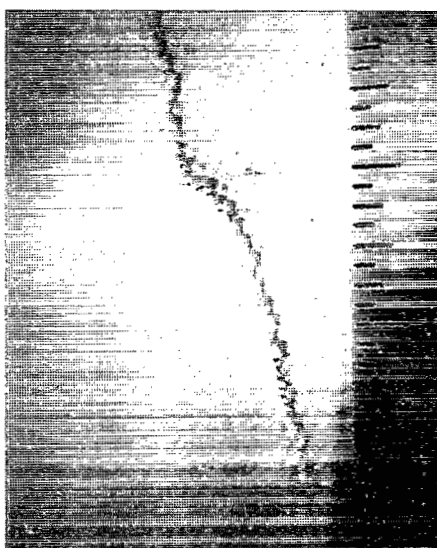
FIGURE 17

INSIDE SURFACE

BEFORE EXPOSURE

AFTER 2 HR. VAPOR EXPOSURE

OUTSIDE SURFACE

AFTER EXPOSURE

Portions of inventory suits which exhibited visual anomalies were removed and subjected to 100% N₂O₄ vapor exposure for 2 hours under simulated conditions of 283 l/min air flow on the inside of the material at 0.4 to 0.6 inches of water pressure as shown in Figure 16. Exposed Nomex and tunneling with pronounced creasing appear to be the sites in the material where attack is most damaging. Table 3 lists the description and results of the testing. Figures 17, 18 and 19 are photographs of some of the defects.
