NASA CR-135046
R77AEG177

QUIET CLEAN SHORT-HAUL EXPERIMENTAL ENGINE
(QCSEE)
UNDER-THE-WING ENGINE COMPOSITE FAN BLADE
FINAL DESIGN TEST REPORT

February 1977

Advanced Engineering & Technology Programs Department
General Electric Company

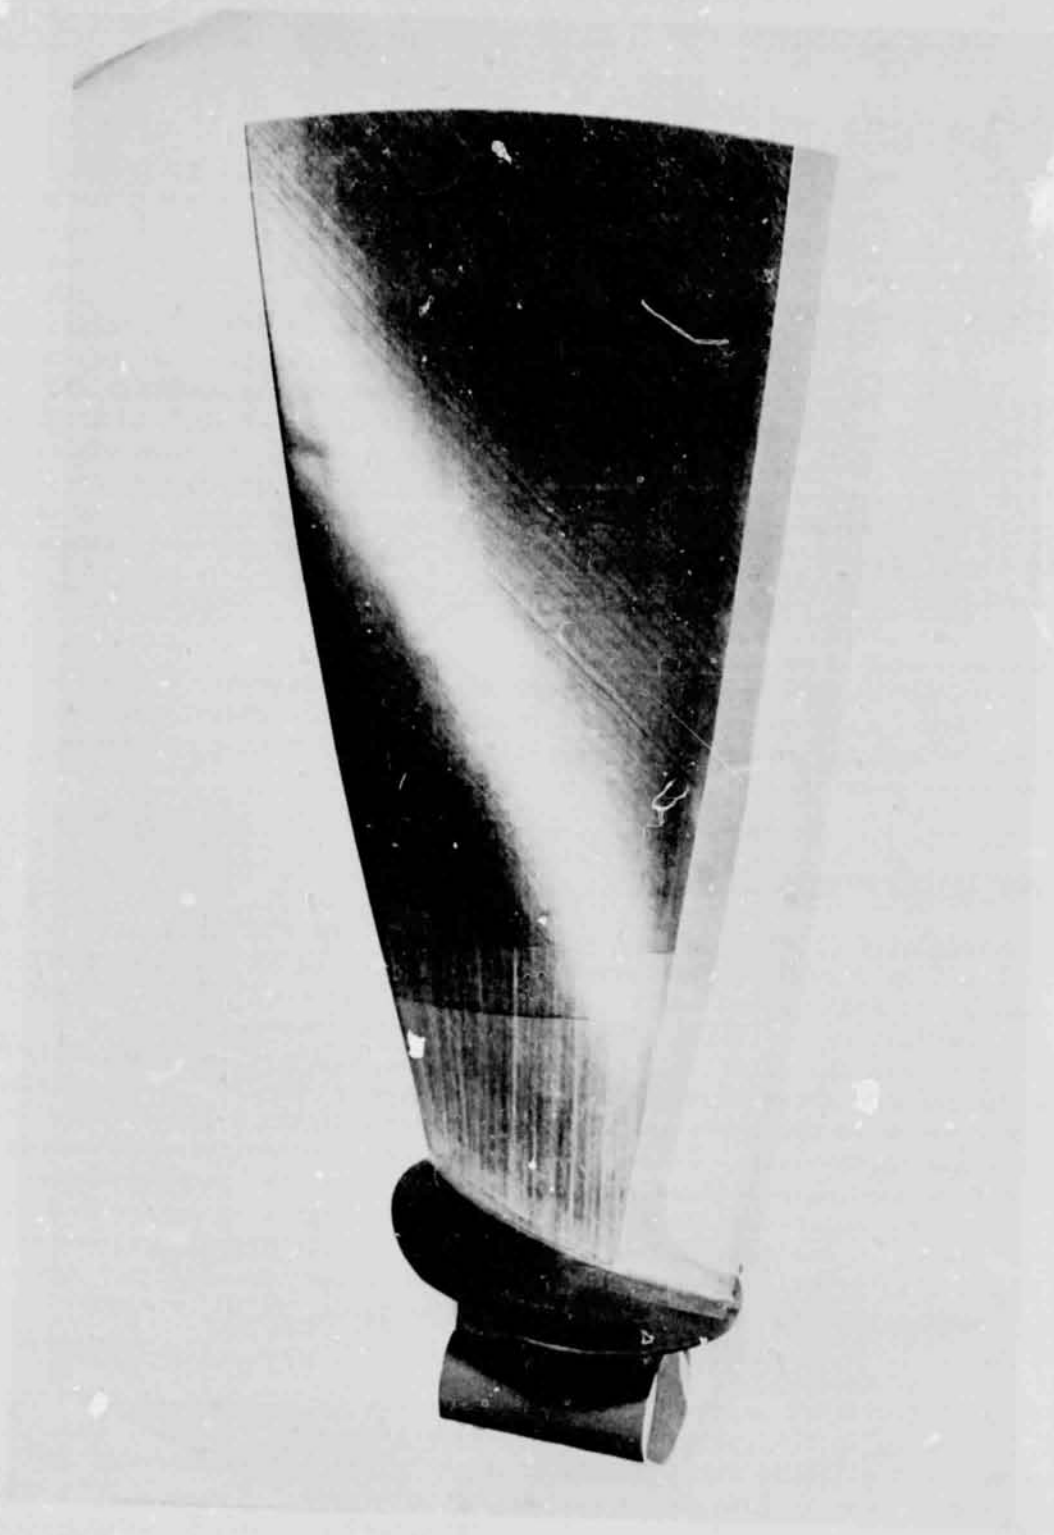
Figure 1. QCSEE UTW Composite Blade with Platform (C76011062).

The finished QCSEE Composite fan blade is shown in Figure 1. It consists of a molded composite blade, a molded composite platform and a metal outsert on the dovetail. The molded blade configuration is shown in Figure 2 and is made up of a solid composite airfoil and a straight bell-shaped composite dovetail. The dovetail is undercut at the leading and trailing edges to permit better transitioning of the cambered airfoil section into the straight dovetail. The airfoil definition is described by 15 radially spaced airfoil cross sections which are stacked on a common axis as shown in Figure 3. The dovetail axial centerline is offset from the stacking axis by 0.254 cm (0.1 in.) to provide a smooth airfoil-to-dovetail transition. The molded blade is provided with a reduced leading edge thickness to allow a final coating of wire mesh/nickel plate for leading edge protection. The blade leading edge protection is shown on the finished blade drawing (see Figure 4). The platform construction is shown in Figure 5.

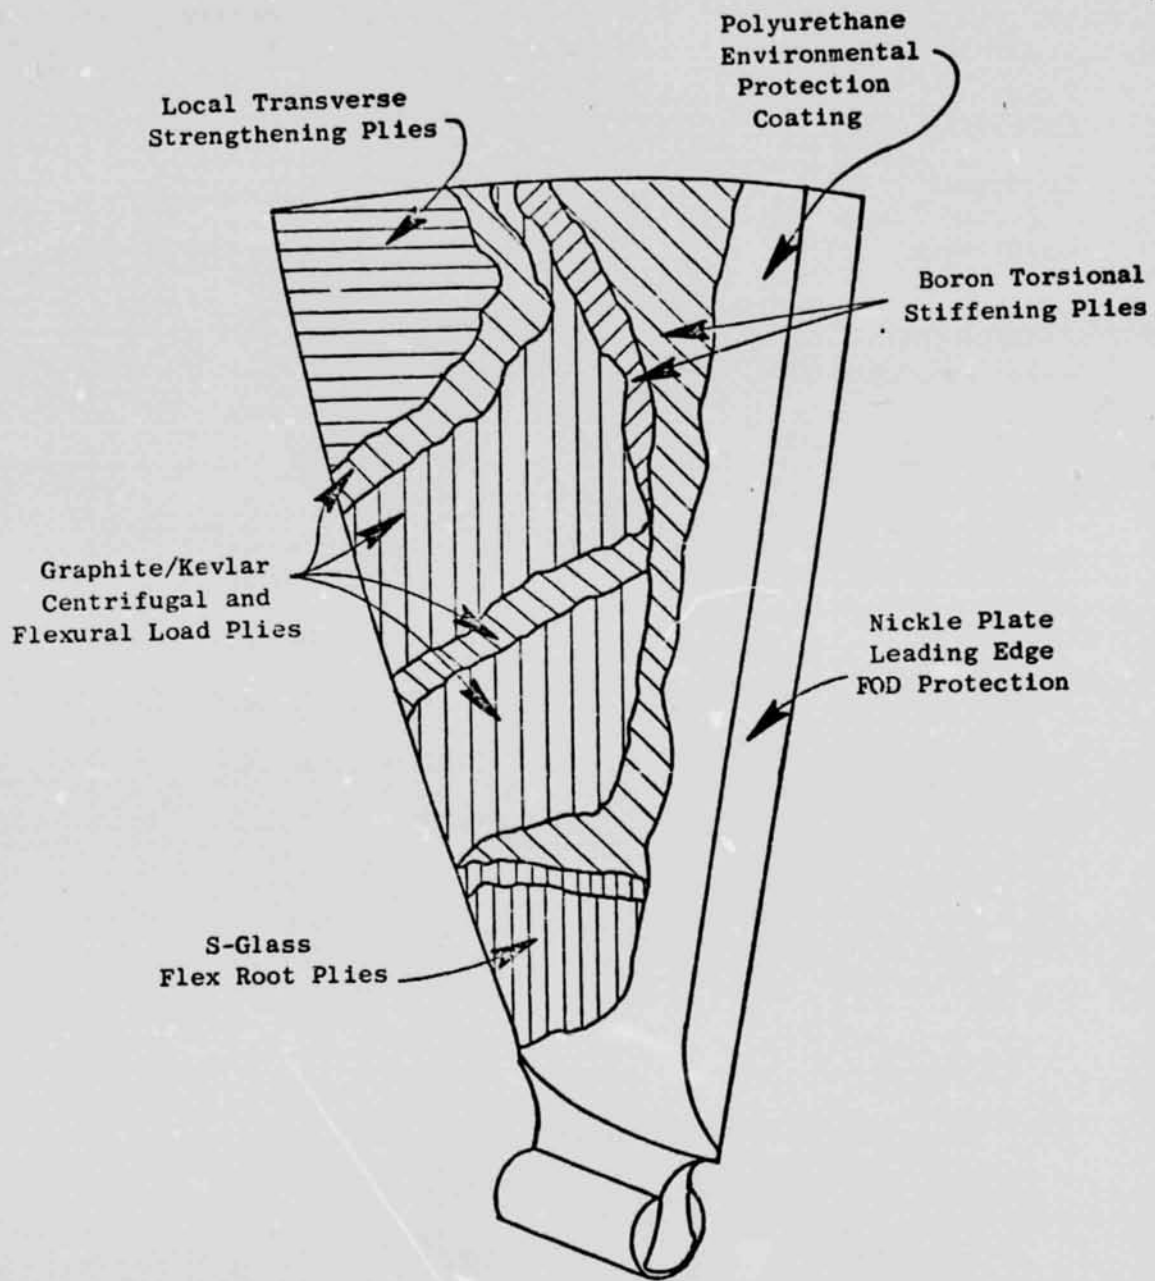
Figure 6. General Arrangement of Plies, QCSEE-UTW Blade.

Plies of Kevlar-49 are interspersed throughout the blade with the majority of them being in the spanwise (radial) direction of the blade. Several of the Kevlar-49 plies in the tip region of the blade are oriented at 90° to the spanwise axis to provide chordwise strength and stiffness to the blade.

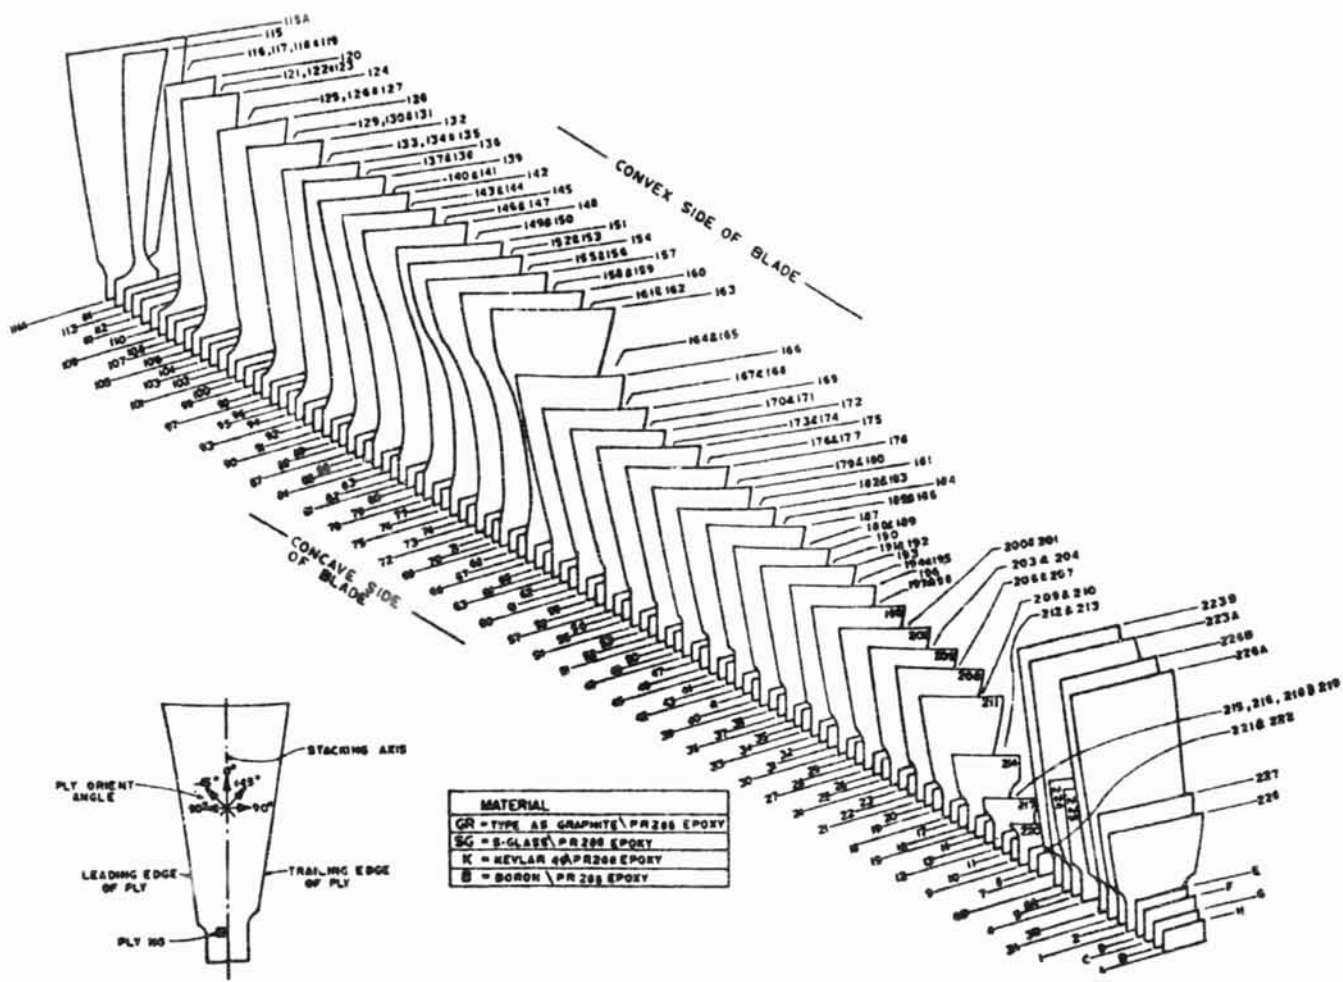
Figure 7. Ply Layup and Material

The general ply shapes, layup arrangement, fiber orientations and material in each ply of the blade is shown in Figure 7. This final design blade has essentially the same configuration and ply layup arrangement as tested with the preliminary blades. The material systems were changed to reflect the results of analyses and testing conducted on the preliminary blades. The preliminary blade materials are outlined in the QCSEE UTW Engine Composite Fan Blade Preliminary Test Report NASA CR-134846 (Reference 2).

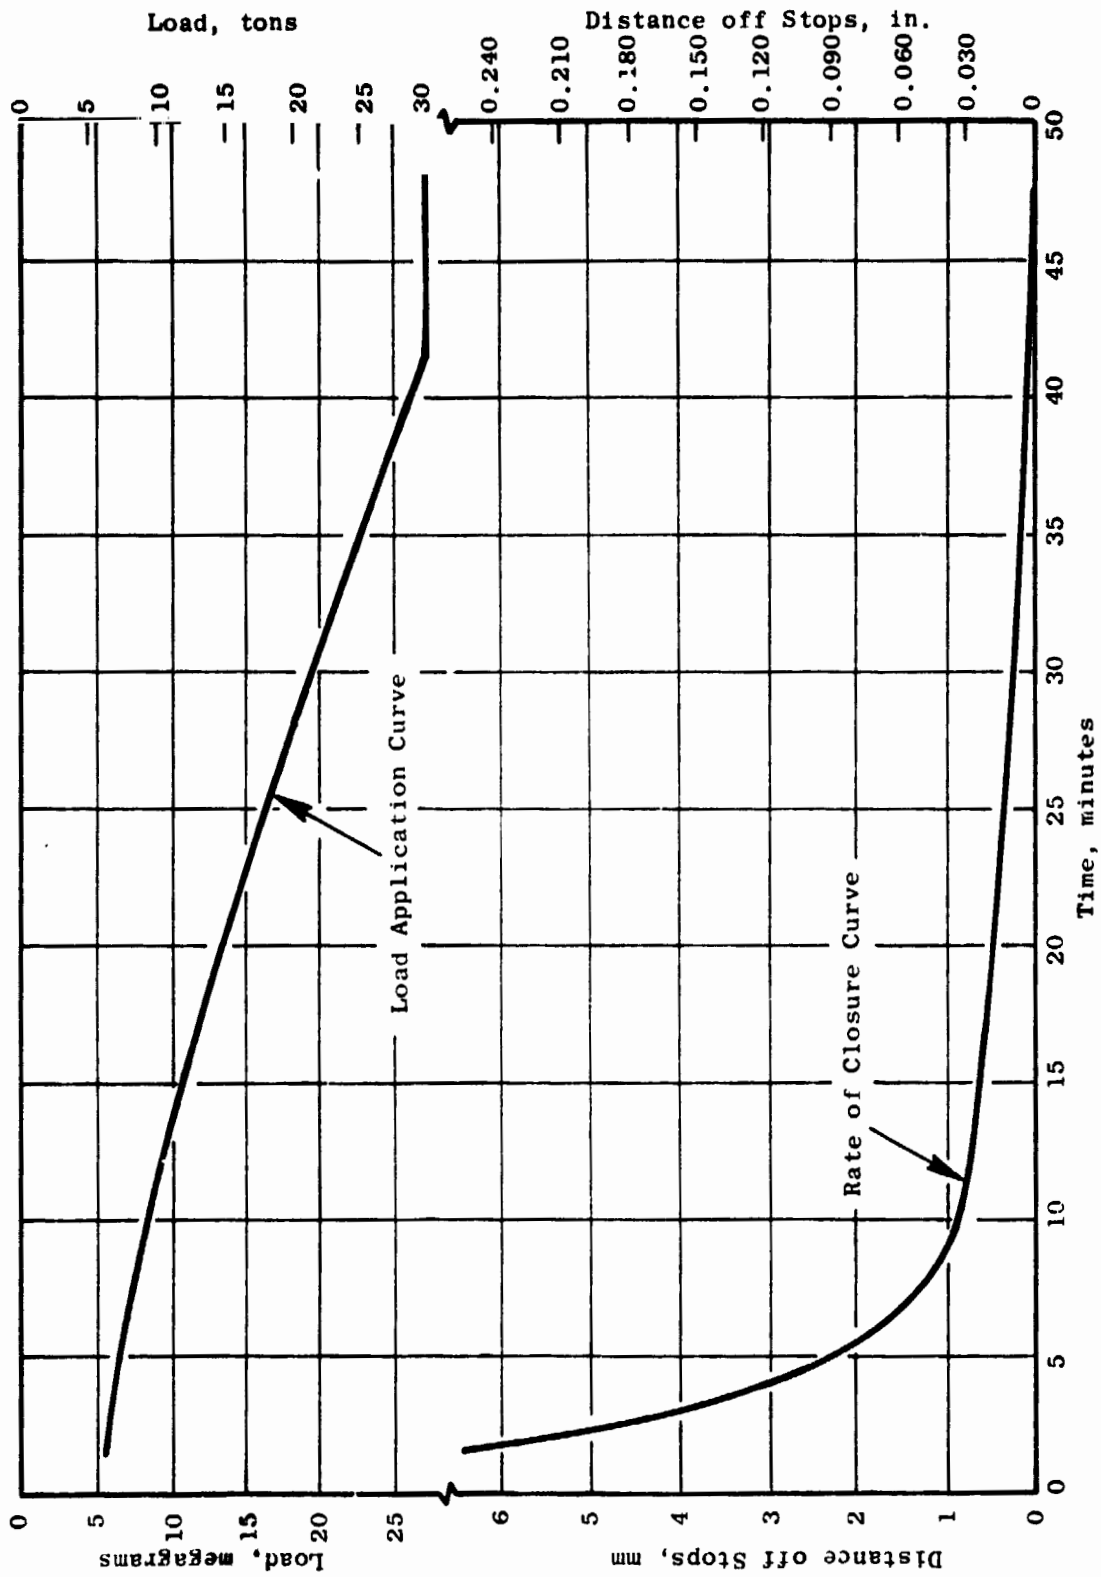
6. The dies continued to close at a preselected, slow rate. The movement continued until the die was closed and the prescribed molding load/pressure attained. Figure 8 shows a typical rate of closure and load application curve for molding a PR 288/ Type AS composite blade with a gel time of 60 ± 5 minutes at the constant molding temperature 383 K (230° F).

Figure 8. Molding Procedure for PR 288/Type AS Blade with Gel Time at 124 K (230° F).

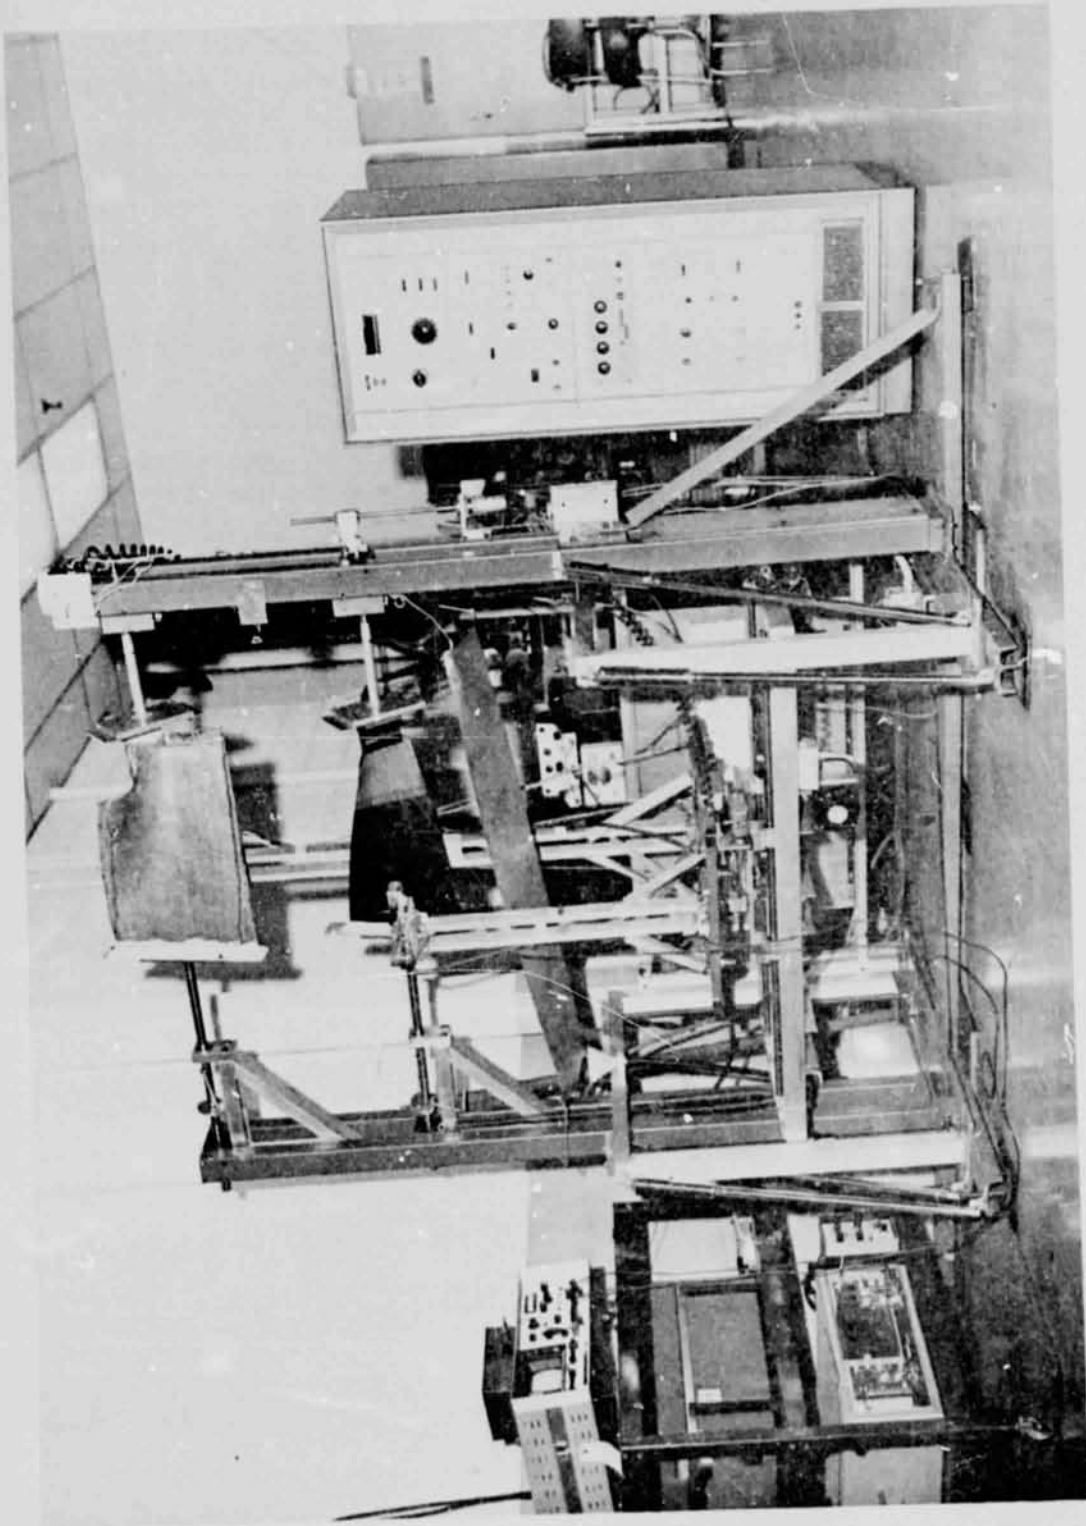
High-resolution scanning (50 lines per inch index and 100 pulses per inch scan for 5,000 units of data per square inch), combined with 10 shades-of-gray (5% to 95% on the oscilloscope) recording on dry facsimile paper, provides an "attenugraph" image which is read much in the same manner as a radiograph.

Figure 9. Test Technique for Ultrasonic C-Scan of Composite Blades.

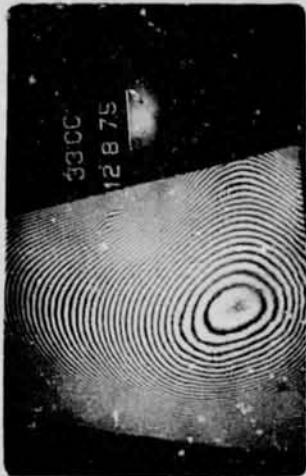
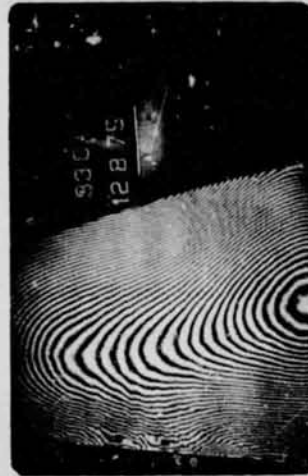
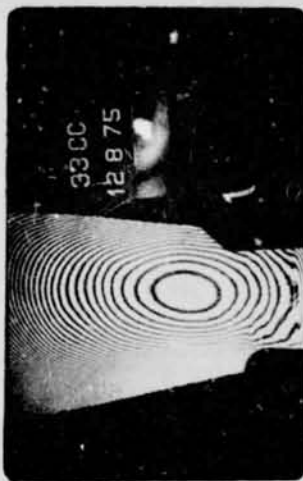
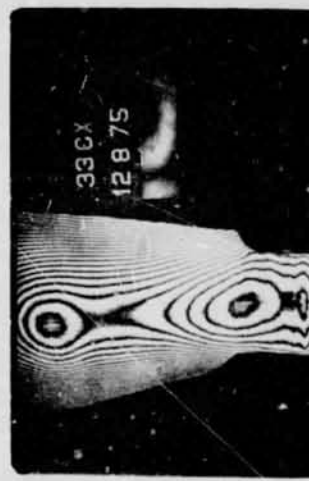
Figure 11. Holograph NDT of QCSEE Blade.

(a) Concave - Tip
No Discontinuity

(b) Convex - Tip
Discontinuity at
LE Caused by Foreign
Inclusion
(Cause for Rejection)

(c) Concave - Root
Slight Discontinuity Due to Ply
Endings

(d) Convex - Root
Slight Discontinuity Due to Ply
Endings

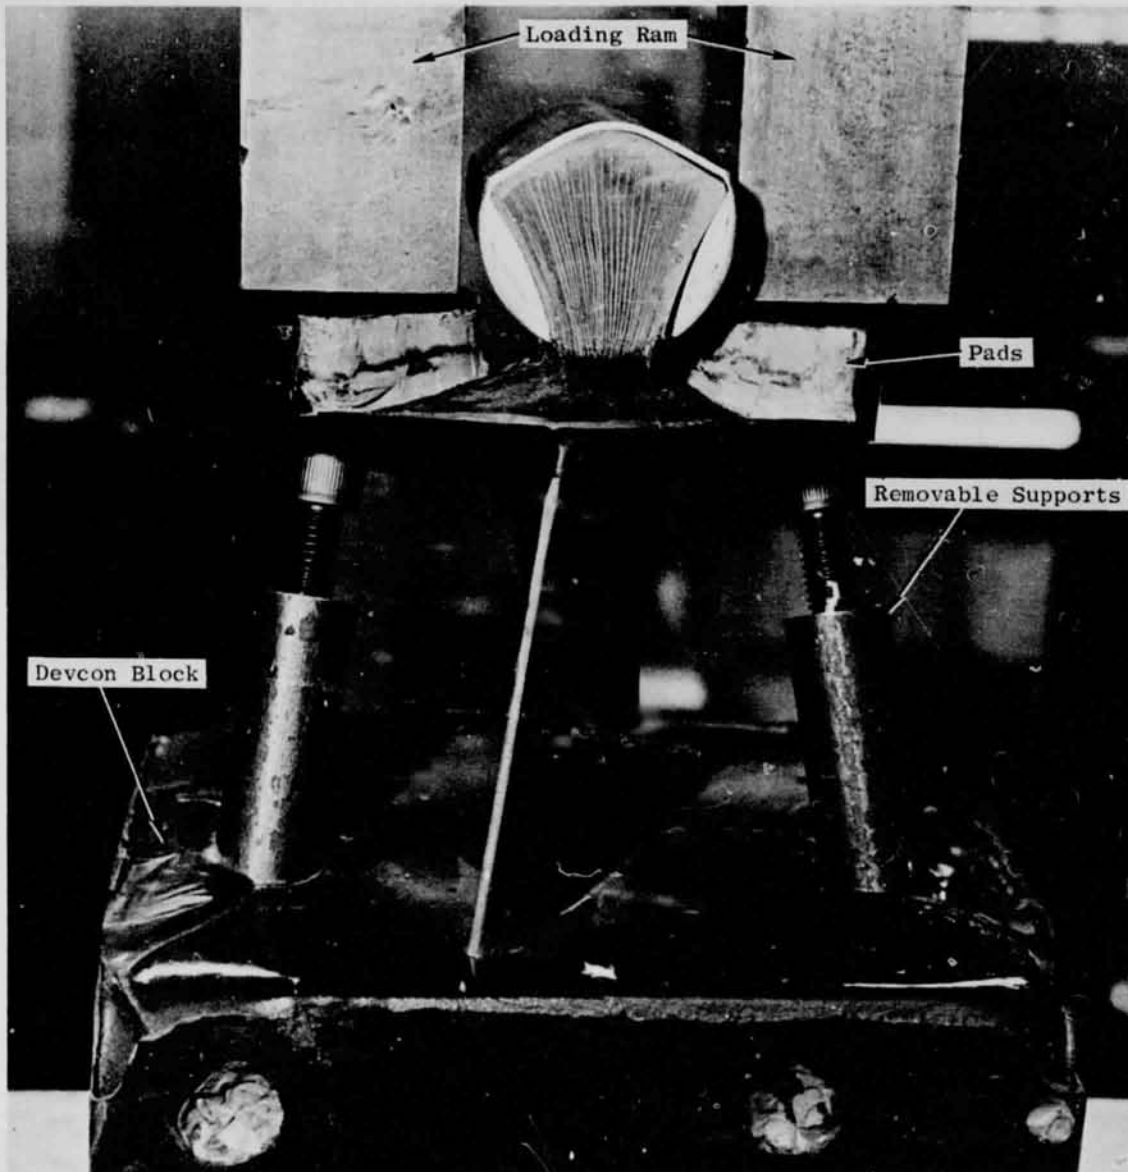
Figure 12. Blade Platform Load Test Setup (C7507477).

The static load testing consisted of evaluating the load-deflection capability of the platform and determining the load required to totally separate the platform from the blade. A point static loading was used to simulate centrifugal loading. The setup is shown in Figure 12. An Instron testing machine applied an equal compressive load to the bottom of each side of the platform. The load was applied near the platform maximum overhang. Loading was stopped prior to failure of the end straps that retain the platform to the blade. Next, the load was repositioned to bear on the centrifugal loading center of pressure for each half platform and the loading continued until the end straps failed and the platform halves separated from the blade. A test load of 8.0 kN (1800 lb) applied at the platform maximum overhang position caused bond separation of platform from blade. Figure 13 shows a plot of the platform deflection as a function of this loading. A final test load of 17.1 kN (3850 lb) applied at the center of pressure of the half platforms caused the end straps to break and the platform halves to separate from the blade.

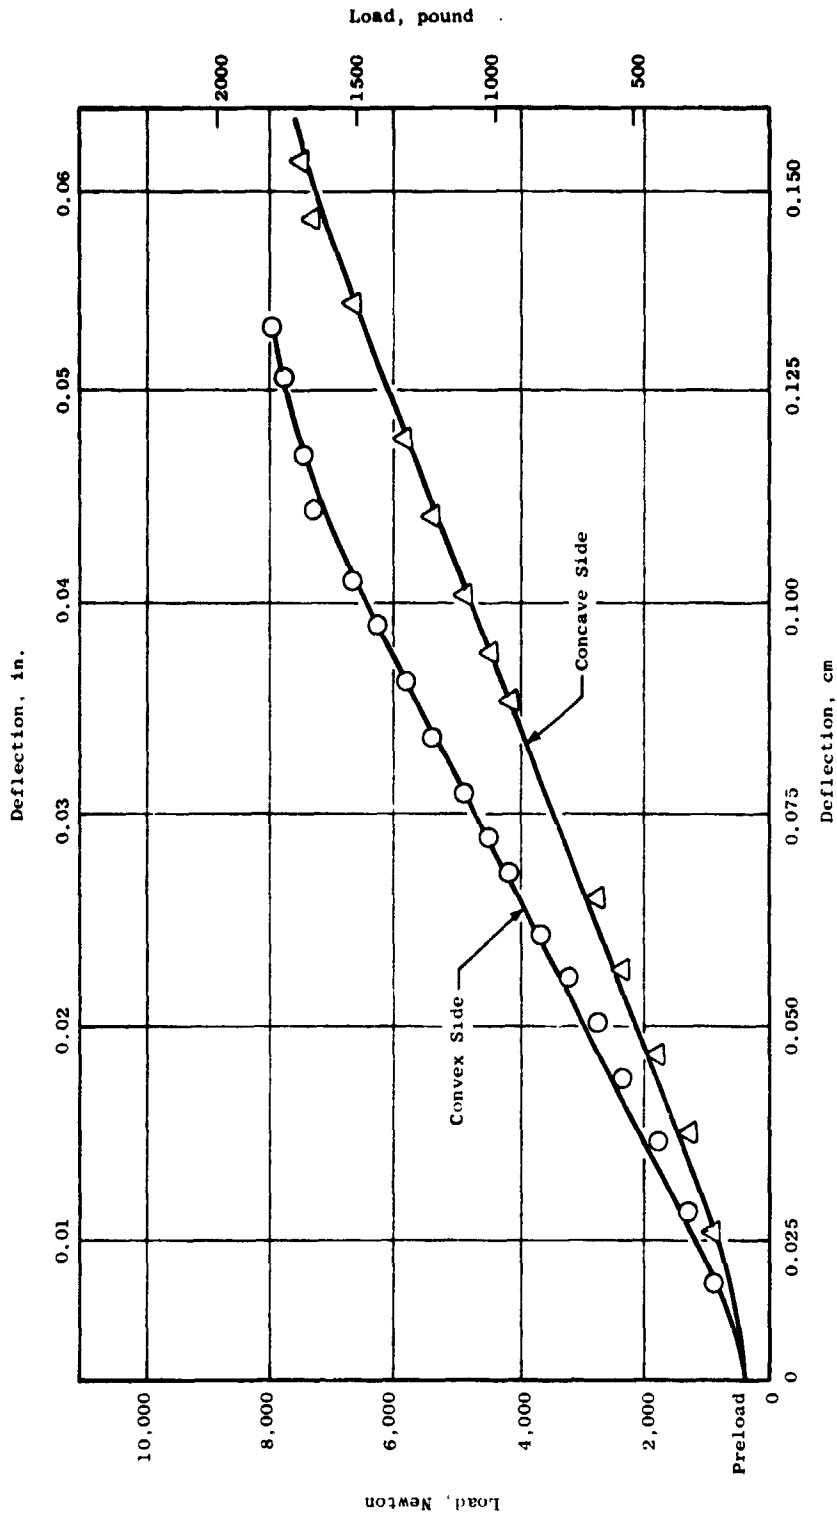
Figure 13. Platform Load Test Deflections.

The total operating centrifugal load of the platform is calculated to be 5.3 kN (1200 lb) acting at the platform CG. The test load of 8.0 kN (1800 lb) applied at the maximum overhang position and required to cause bond separation shows a margin of safety of over 2.0 on this loading when considered on an equivalent moment basis. The load of 17.1 kN (3850 lb) applied at the center of pressure of the platform shows a margin of safety of over 2.0 on the capability of the end straps to retain the platform on the blade in the event of the platform debonding from the blade. These margins demonstrate that the platform is satisfactory for engine operation.

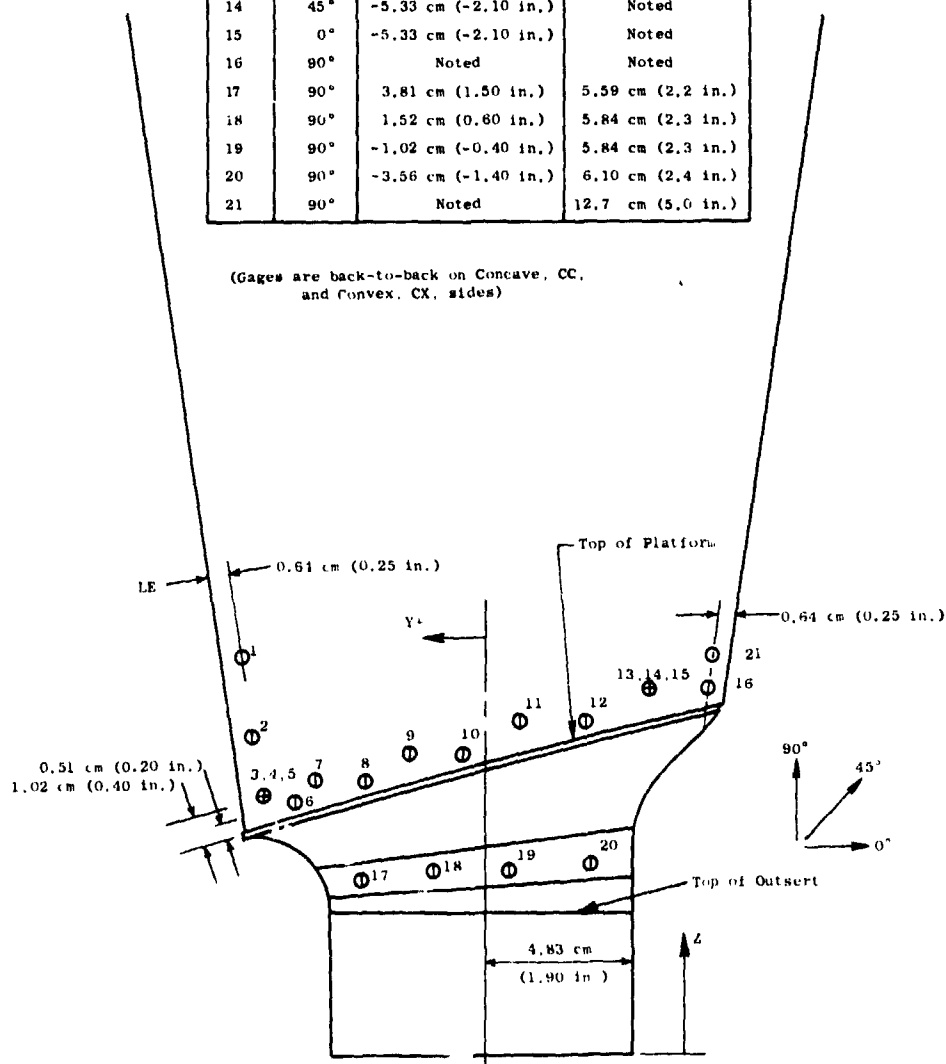
(Gages are back-to-back on Concave, CC,
and Convex, CX, sides)

Figure 14. Bench Test Blade Instrumentation, Blade S/N Q11.

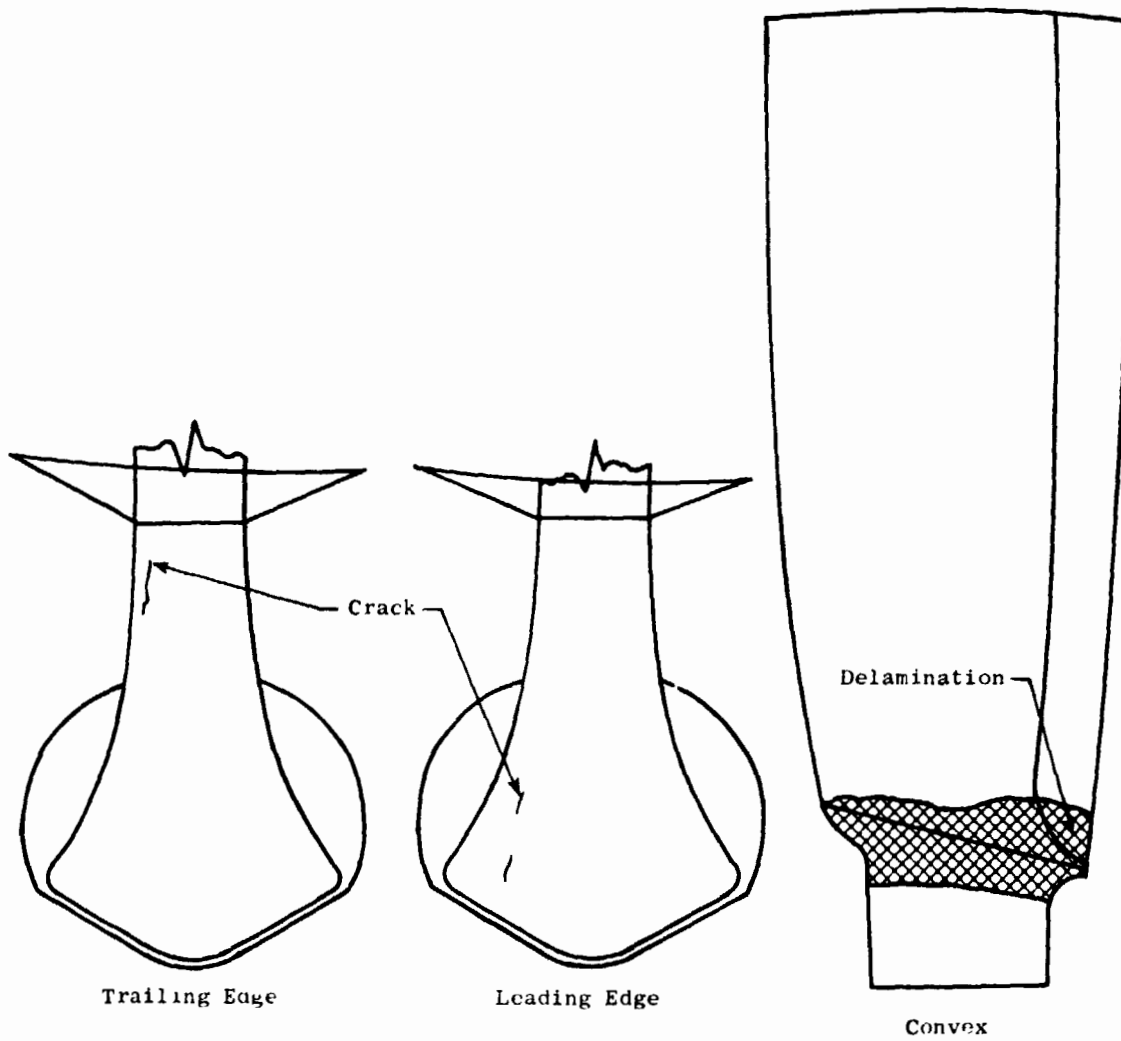
Damage in both blades Q9 and Q11 consisted of delamination in the blade airfoil to root transient area and some debonding of the platform's lower attachment. Figure 16 shows the result of ultrasonic and die penetrant examination of the root and dovetail of blade Q9 and Figure 17 shows this for blade Q11.

Figure 16. Posttest Evaluation, Blade S/N Q9.

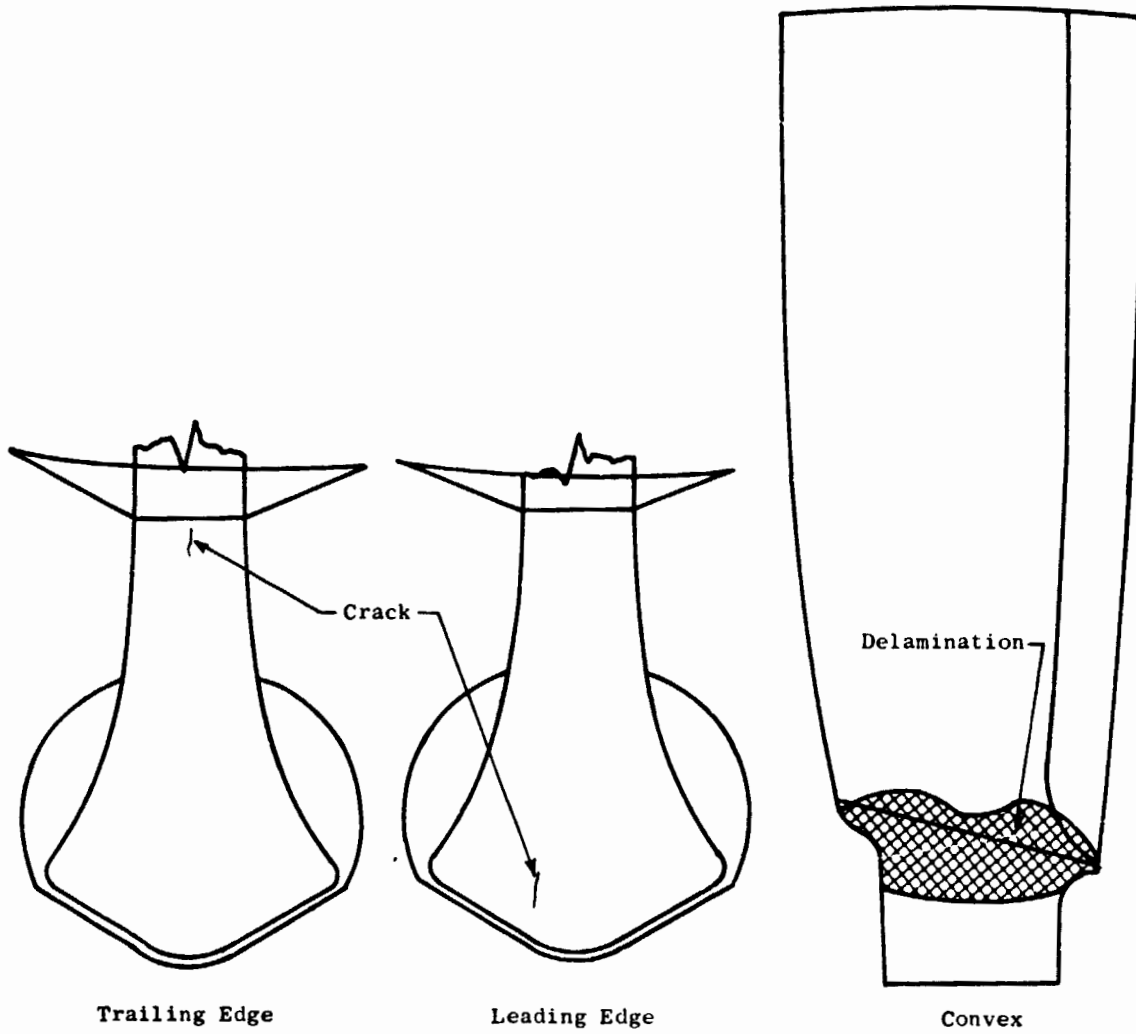
Figure 17. Posttest Evaluation, Blade S/N Q11.

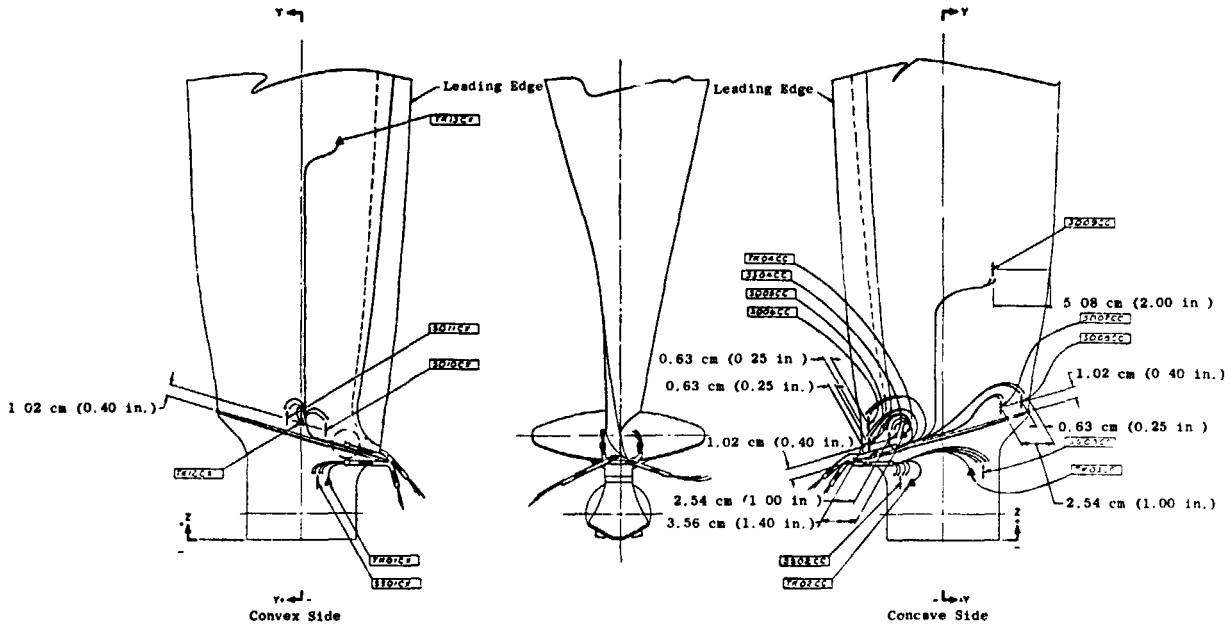
Gage No.	Y	Z
SS01CX	-1.27 cm (-0.50 in.)	5.08 cm (2.00 in.)
TK01CX	-2.54 cm (-1.00 in.)	5.08 cm (2.00 in.)
SS02CC	-3.68 cm (-1.45 in.)	5.08 cm (2.00 in.)
TK02CC	-2.79 cm (-1.10 in.)	5.08 cm (2.00 in.)
SS03CC	3.56 cm (1.40 in.)	6.10 cm (2.40 in.)
TK03CC	2.54 cm (1.00 in.)	6.10 cm (2.40 in.)
SS04CC	Noted	Noted
TK04CC	Noted	Noted
SD05CC	Noted	Noted
SD06CC	Noted	10.16 cm (4.00 in.)
SD07CC	Noted	Noted
SD08CC	Noted	Noted
SD09CC	Noted	23.88 cm (9.40 in.)
SD10CX	-2.29 cm (-0.90 in.)	Noted
SD11CX	1.27 cm (0.50 in.)	Noted
TK12CX	0	Noted
TK13CX	3.45 cm (1.36 in.)	35.31 cm (13.90 in.)

Figure 18. Whirligig Test Blade Instrumentation, Blade S/N Q7.

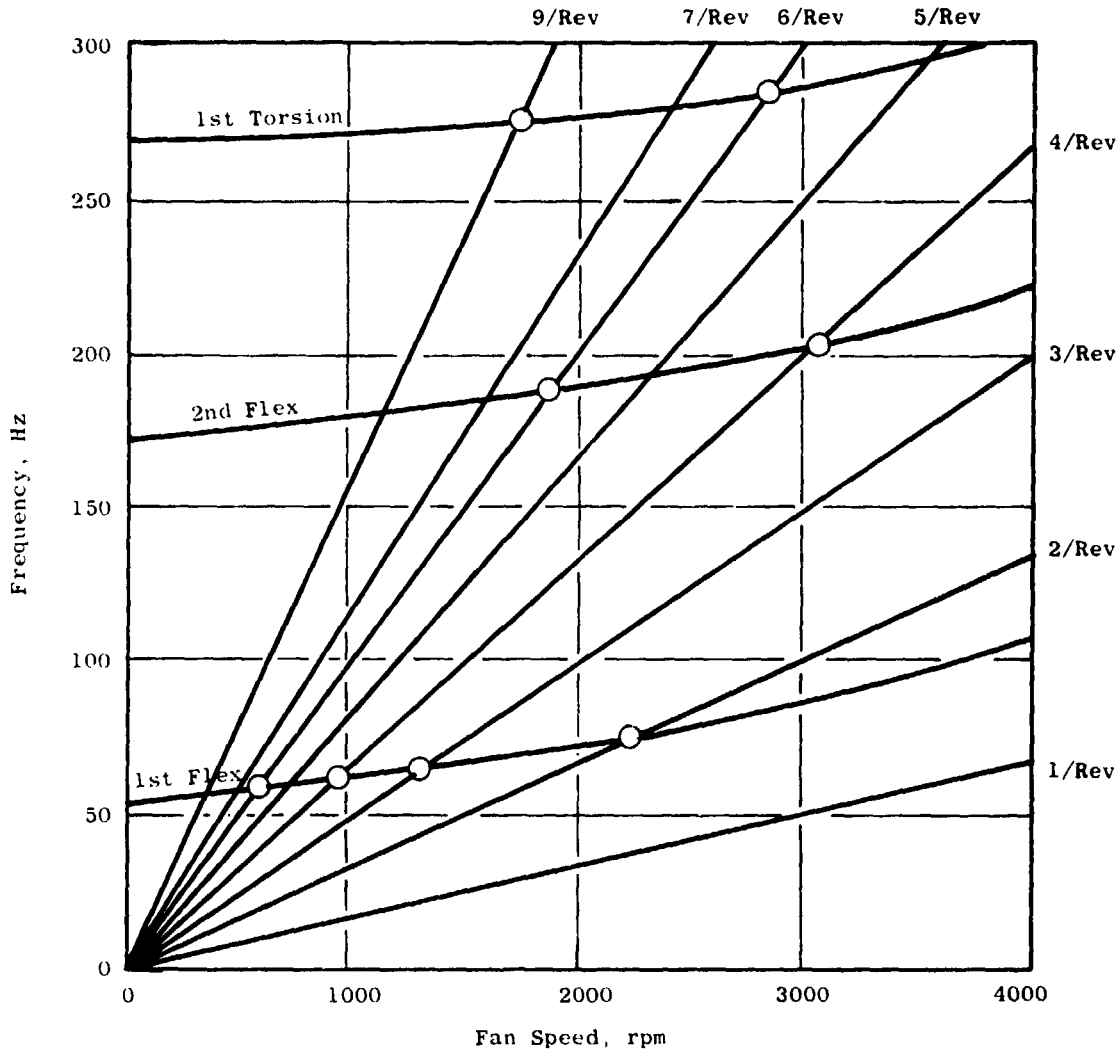
Figure 22. Predicted Campbell Diagram, QCSEE UTW Fan Blade.

Figure 22 shows the predicted Campbell diagram for the blades and the points on the diagram used for determining the dynamic strain distributions. The test consisted of making medium rate accelerations of approximately 2000 rpm/min to 3326 rpm for per-rev conditions of 2/rev, 3/rev, 4/rev, 6/rev and 9/rev. The speed was held at each resonant peak for short periods of time (approximately five seconds) to obtain the frequency content on the tape recorder. The excitation air was adjusted for each condition so that no gage

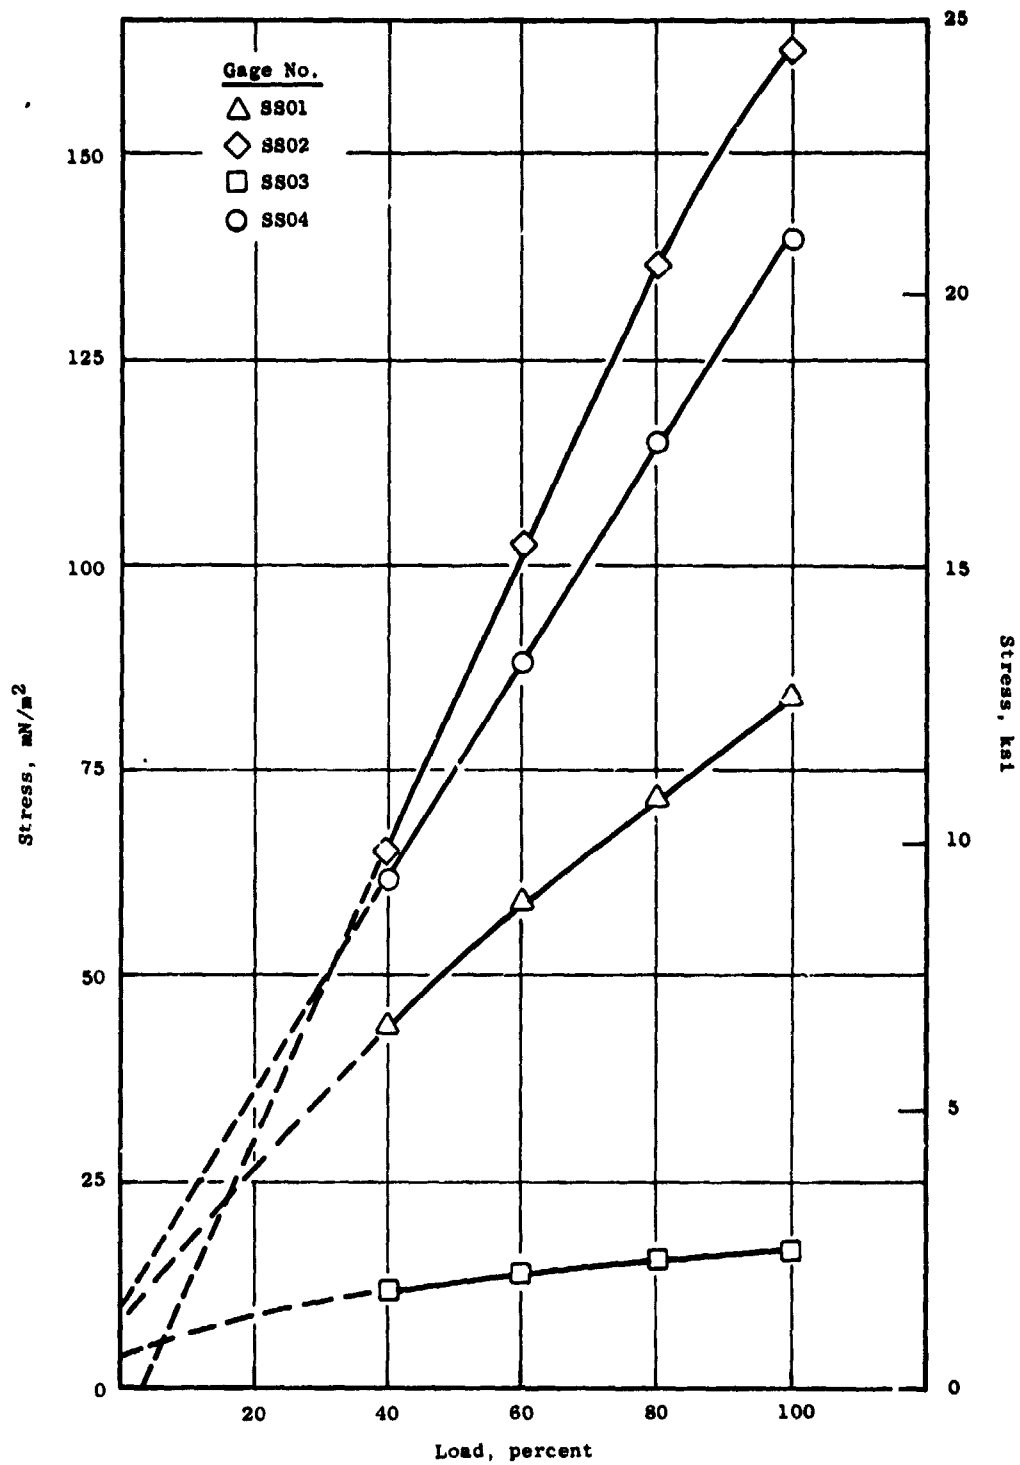
Figure 24. Steady-State Stress Distribution.

Steady state centrifugal and bending stresses were also determined throughout the full speed range using the four steady-state gages. For these runs, no air excitation was used. The rotor speed was increased to a 100% load condition (3326 rpm) in increments of 20%. This loading corresponded to 105% of mechanical design load. These data are summarized in Table VII and plotted in Figure 24, as stress versus percent load. In order to compensate for strain gage output as a result of temperature effect, an apparent strain test was conducted on this blade prior to going into the whirligig. This involved heating the blade in an oven to 393 K (248° F) and recording the strain due to thermal expansion. These data were then factored into the whirligig steady-state strain readings. Blade temperatures were recorded simultaneously with strain gage readings. The data shows that the measured tensile stresses in the root region were 87 to 169 MN/m² (12.6 to 24.5 ksi) with the maximum measured stress appearing near the leading edge on the concave side, adjacent to the outsert. The stress measured in the airfoil leading edge region, concave side, slightly above the platform was 145 MN/m² (21 ksi). These stress levels are consistent with predictions and indicate an acceptable design.

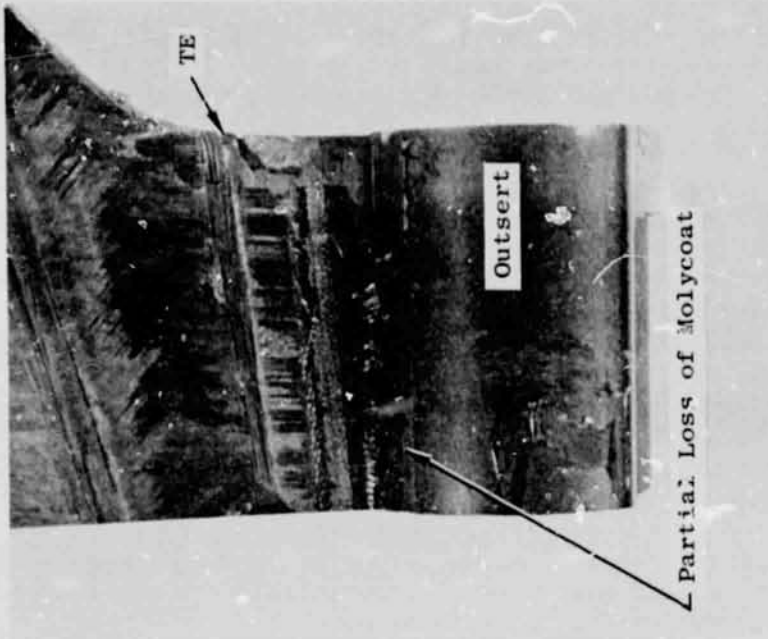
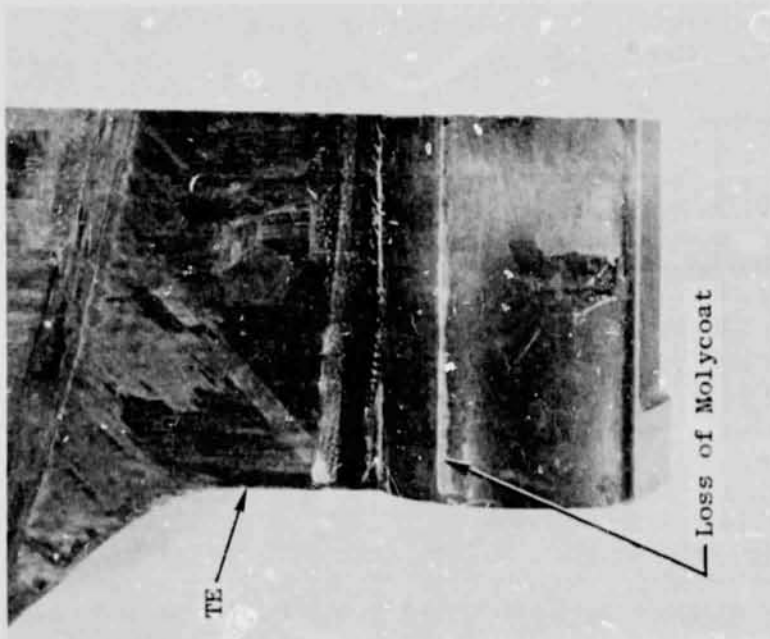
Posttest inspection of the blades consisted of ultrasonic C scanning, die penetrant examination and frequency measurement. Die penetrant inspection of blade Q7 showed signs of a crack in the trailing edge dovetail face. Ultrasonic inspection showed no signs of delamination and frequency measurement showed no loss in frequency. It was concluded that the blade was not structurally damaged. The ultrasonic, die penetrant and frequency inspection of blade Q6 showed no signs of damage and no loss in frequency. The moly-coated aluminum outsert of blade Q6 showed signs of wear and local loss of the molycoat along a chordwise line that coincides with the trunnion interface. This is shown in Figure 25.

Figure 25. Blade Q6 Outsert After Overspeed and LCF Testing, Platform and LE Portion of Blade Root Removed.

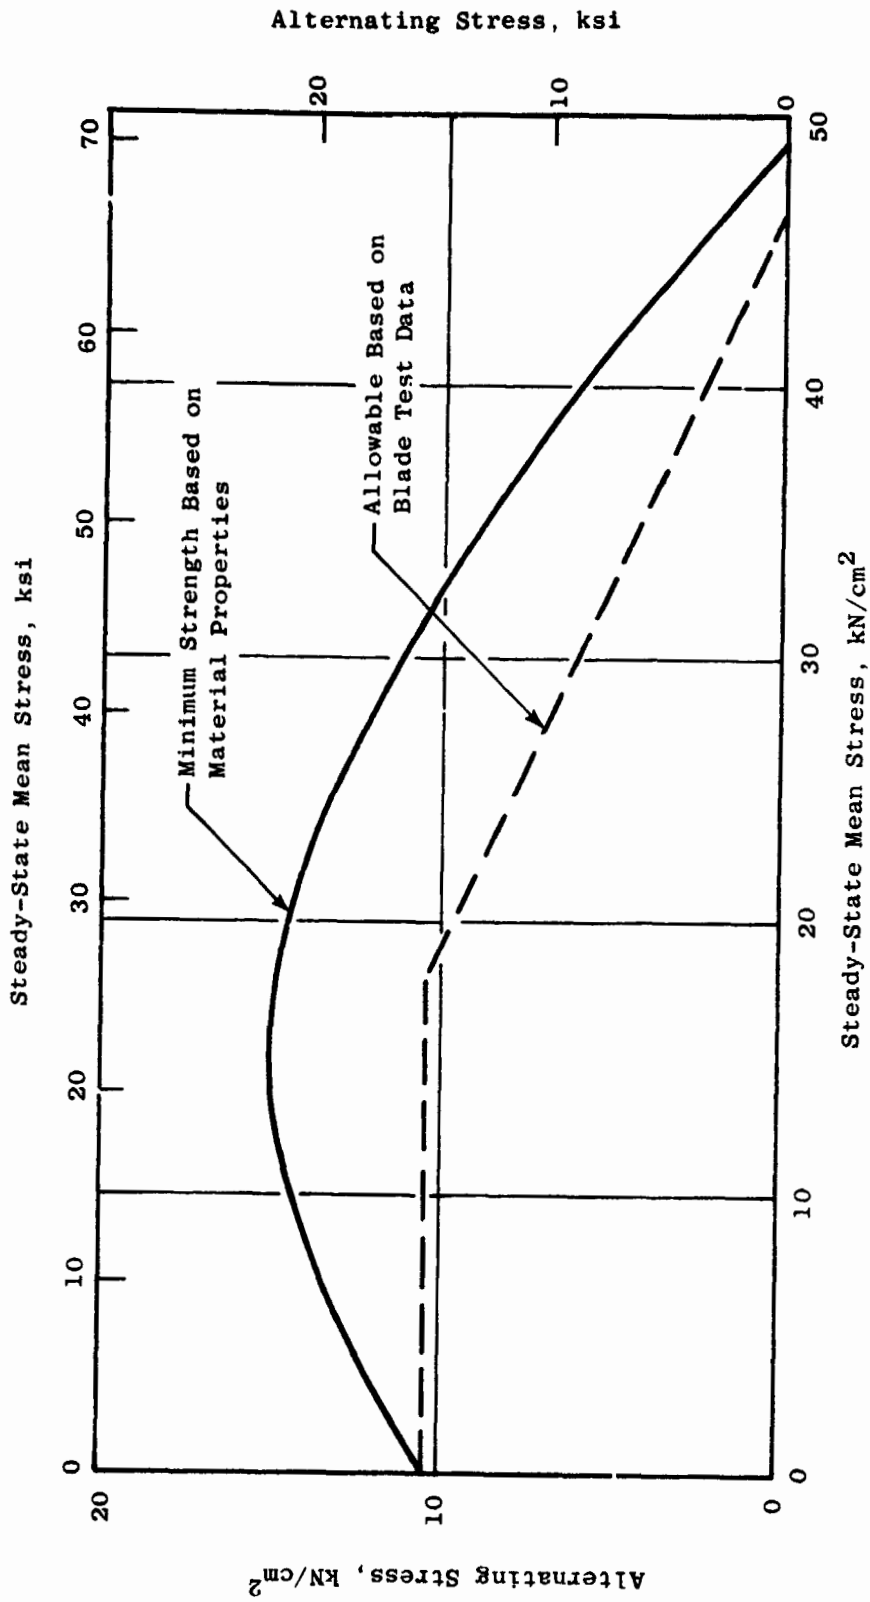
The results of this test and the bench high cycle fatigue tests were used to verify the stress range diagram for the blade, shown in Figure 27. This diagram is in agreement with the predicted stress range diagram shown in Reference 1. The region of the diagram enclosed by dotted lines was investigated by the testing in this program and will be used in establishing engine operating limits.

Figure 27. Allowable Stress Range Diagram - Blade Radial Stress.
