NASA CR135010

# QUIET CLEAN SHORT-HAUL EXPERIMENTAL ENGINE (QCSEE)

## Composite Fan Frame Subsystem Test Report

September 1977

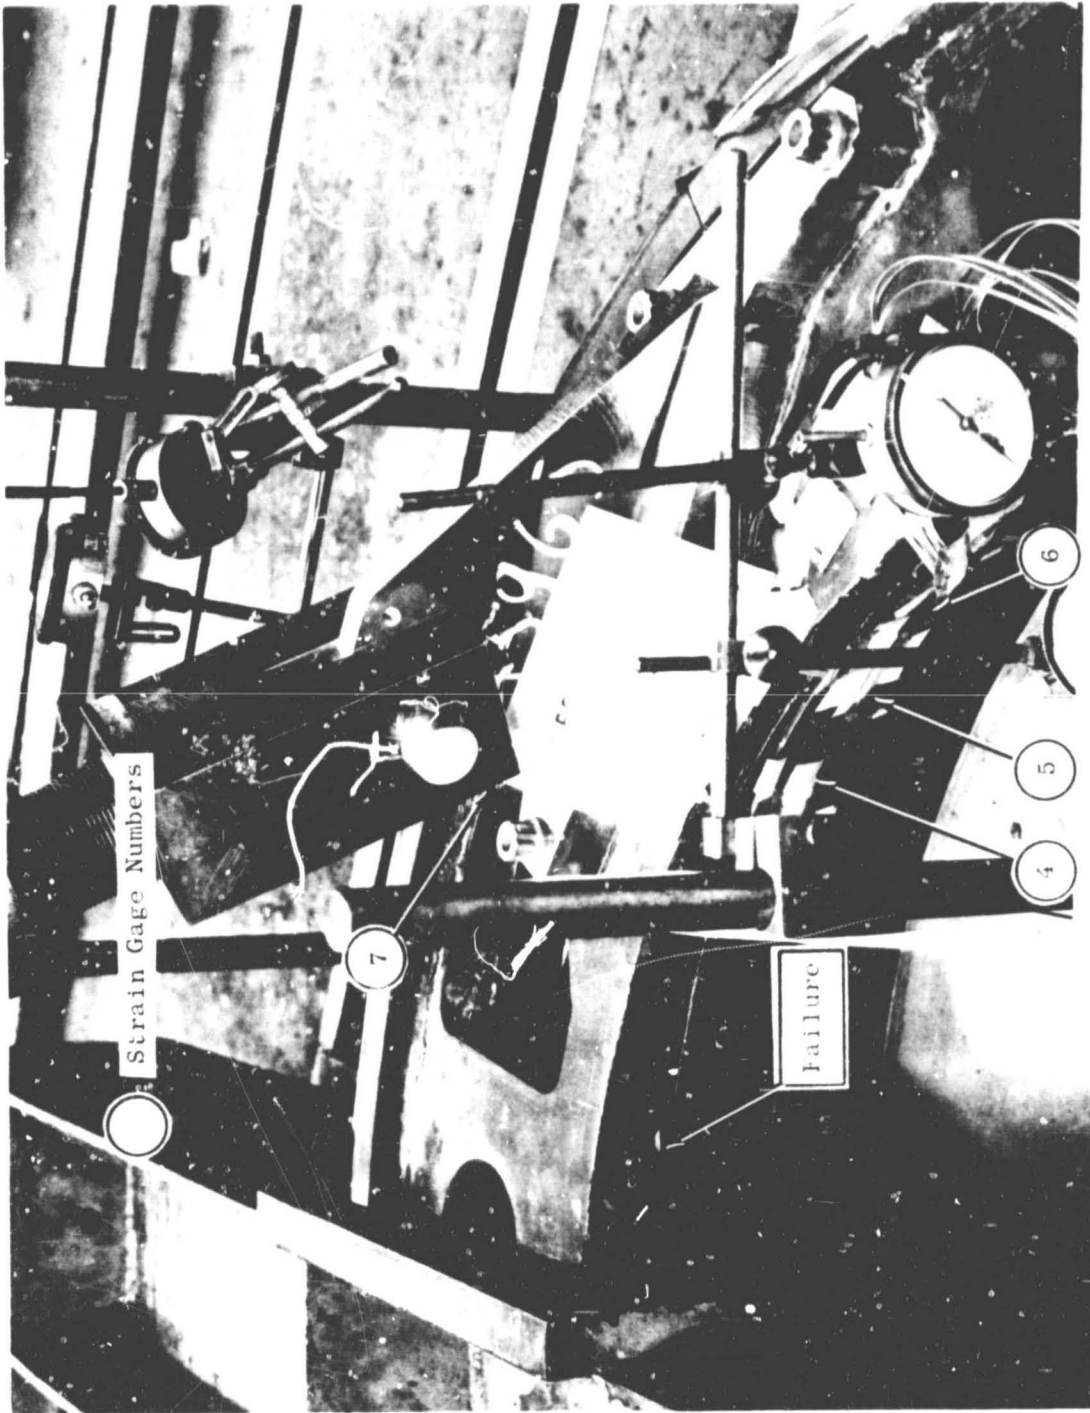
Figure 25. Thrust Mount Test Specimen, After Test.

The test specimen was also instrumented with eight strain gage rosettes as shown in Figures 23 and 25. The critical strains occurred on the lower (radially inward) surface midway between the two wheels (gages 4 and 5), and are shown in Figure 26.

The test was run at room temperature with 13340 N (3000 lb) load increments. Strain and deflection data were recorded at each load increment. Failure occurred at a load of 120,100 N (27,000 lb) and involved interlaminar shear and flatwise tensile failure in the skins and doublers attaching the aft wheel to the mid wheel. The critical loading condition for this area is a 12g forward condition which produces a load of 111,200 N (25,000 lb). A photo of the specimen after test is shown in Figure 25.
