NASA Technical Memorandum 79178

**AN EXPERIMENTAL, LOW-COST, SILICON
SLURRY/ALUMINIDE HIGH-TEMPERATURE
COATING FOR SUPERALLOYS**

**Stanley G. Young and Daniel L. Deadmore
Lewis Research Center
Cleveland, Ohio**

July 1979

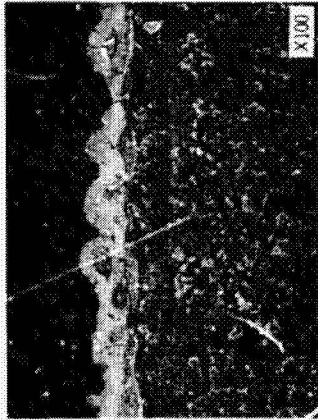
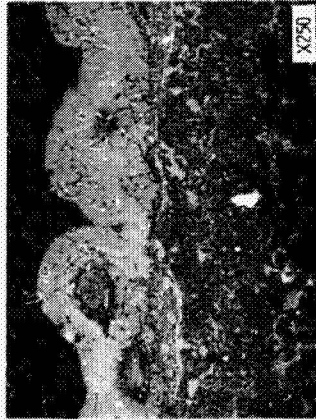
Figure 9. - As-coated Si-Al on alloy VIA.

Test coupons of the as-coated specimens and cross sections of the as-tested specimens were cut and mounted in standard metallographic mounts. Photomicrographs are shown in figures 9 to 12. Figure 9 shows the Si-Al on VIA alloy as coated; figure 10 shows the same alloy and coating after testing in the Mach 1 burner rig for more than 1000 hr at 1093° C. Figure 11 shows the coating on B-1900 alloy, and figure 12 shows the coated B-1900 system after 2000 hr of cyclic testing.

Returning to the as-coated VIA specimen of figure 9, two distinct layers were observed above the VIA substrate. The inner layer is what remains of the original silicon-sprayed layer after the 16-hr pack treatment. This layer appeared as a multiphase, multielement region of small elongated grains. This layer was highest in nickel, then silicon, with widely varying amounts of the other elements. One interesting aspect of this study was that silicon diffusion into the base metal was very slight (much less than expected) but that silicon diffusion outward was significant. The top layer was mostly NiAl, which contained nodules of the silicon-rich phase and, as a result, formed an unusual pebb'y textured surface. These nodules may have been the result of silicon particle agglomeration in the spray process. However, the surface appeared to be covered relatively uniformly with these rounded grains that had an estimated average diameter of about 100 μm . After exposure, this surface tended to become smoother, yet, this pebb'y texture remained long into the tests.
