DEVELOPMENT OF DRIVE MECHANISMS FOR COMMUNICATION SATELLITES

by Arnold C. Schneider and Thomas D. McLay

General Electric Space Division
Valley Forge, Pennsylvania

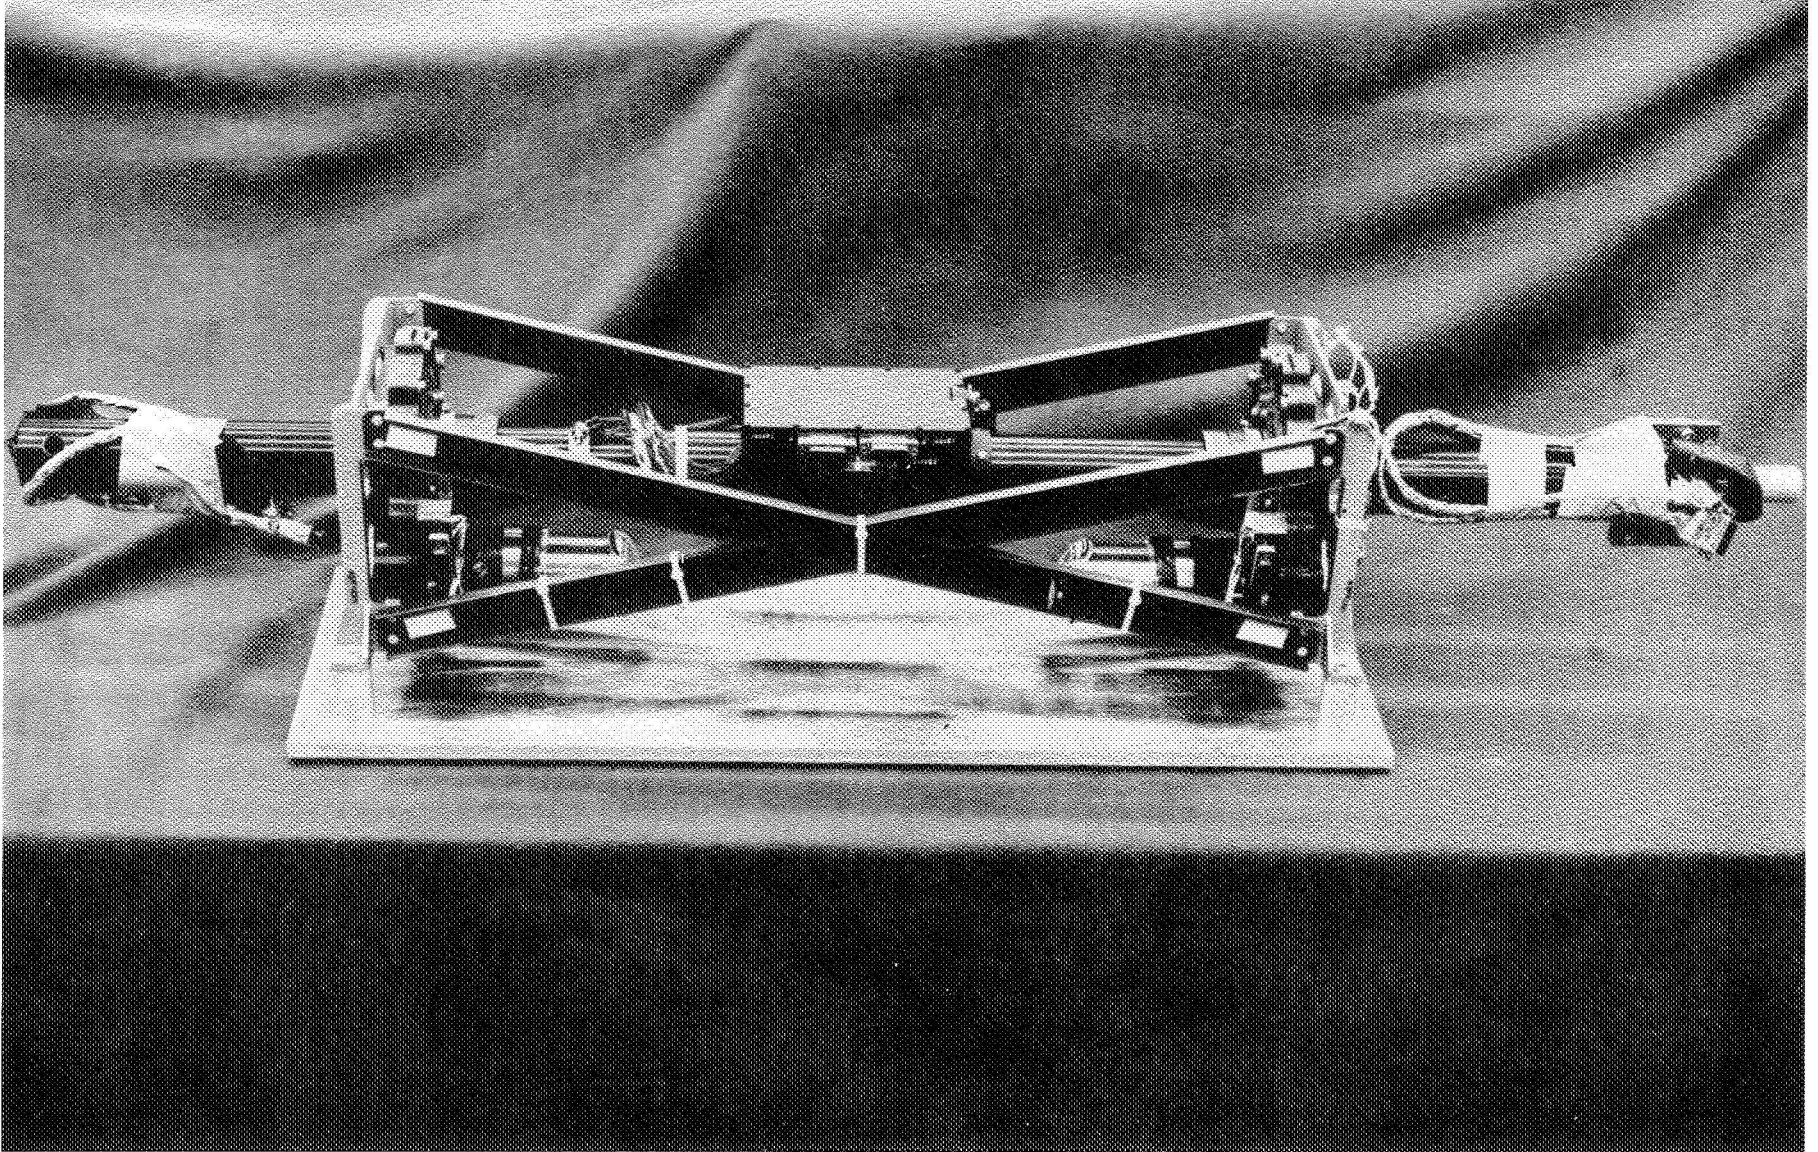
Figure 1. BSE Solar Array Drive

The BSE solar array drive consists of two completely redundant unidirectional drive modules that are interconnected by two, passive, wrap spring clutches (see Figure 1). These clutches permit either drive to be energized with a resultant output torque of 18 Nm (160 Lb.In.) or both to be energized with a torque of 36 Nm (320 Lb.In.). Each drive contains a 1.8 degree step angle, stepper motor, a 100:1 harmonic drive speed reducer, and a 6.05:1 spur gear set. Power is transferred from the rotating solar array panels to the vehicle structure by means of a slip ring assembly consisting of 20 signal rings and four power rings. The slip ring assembly is mounted around the one-piece output shaft that connects the two redundant drives.

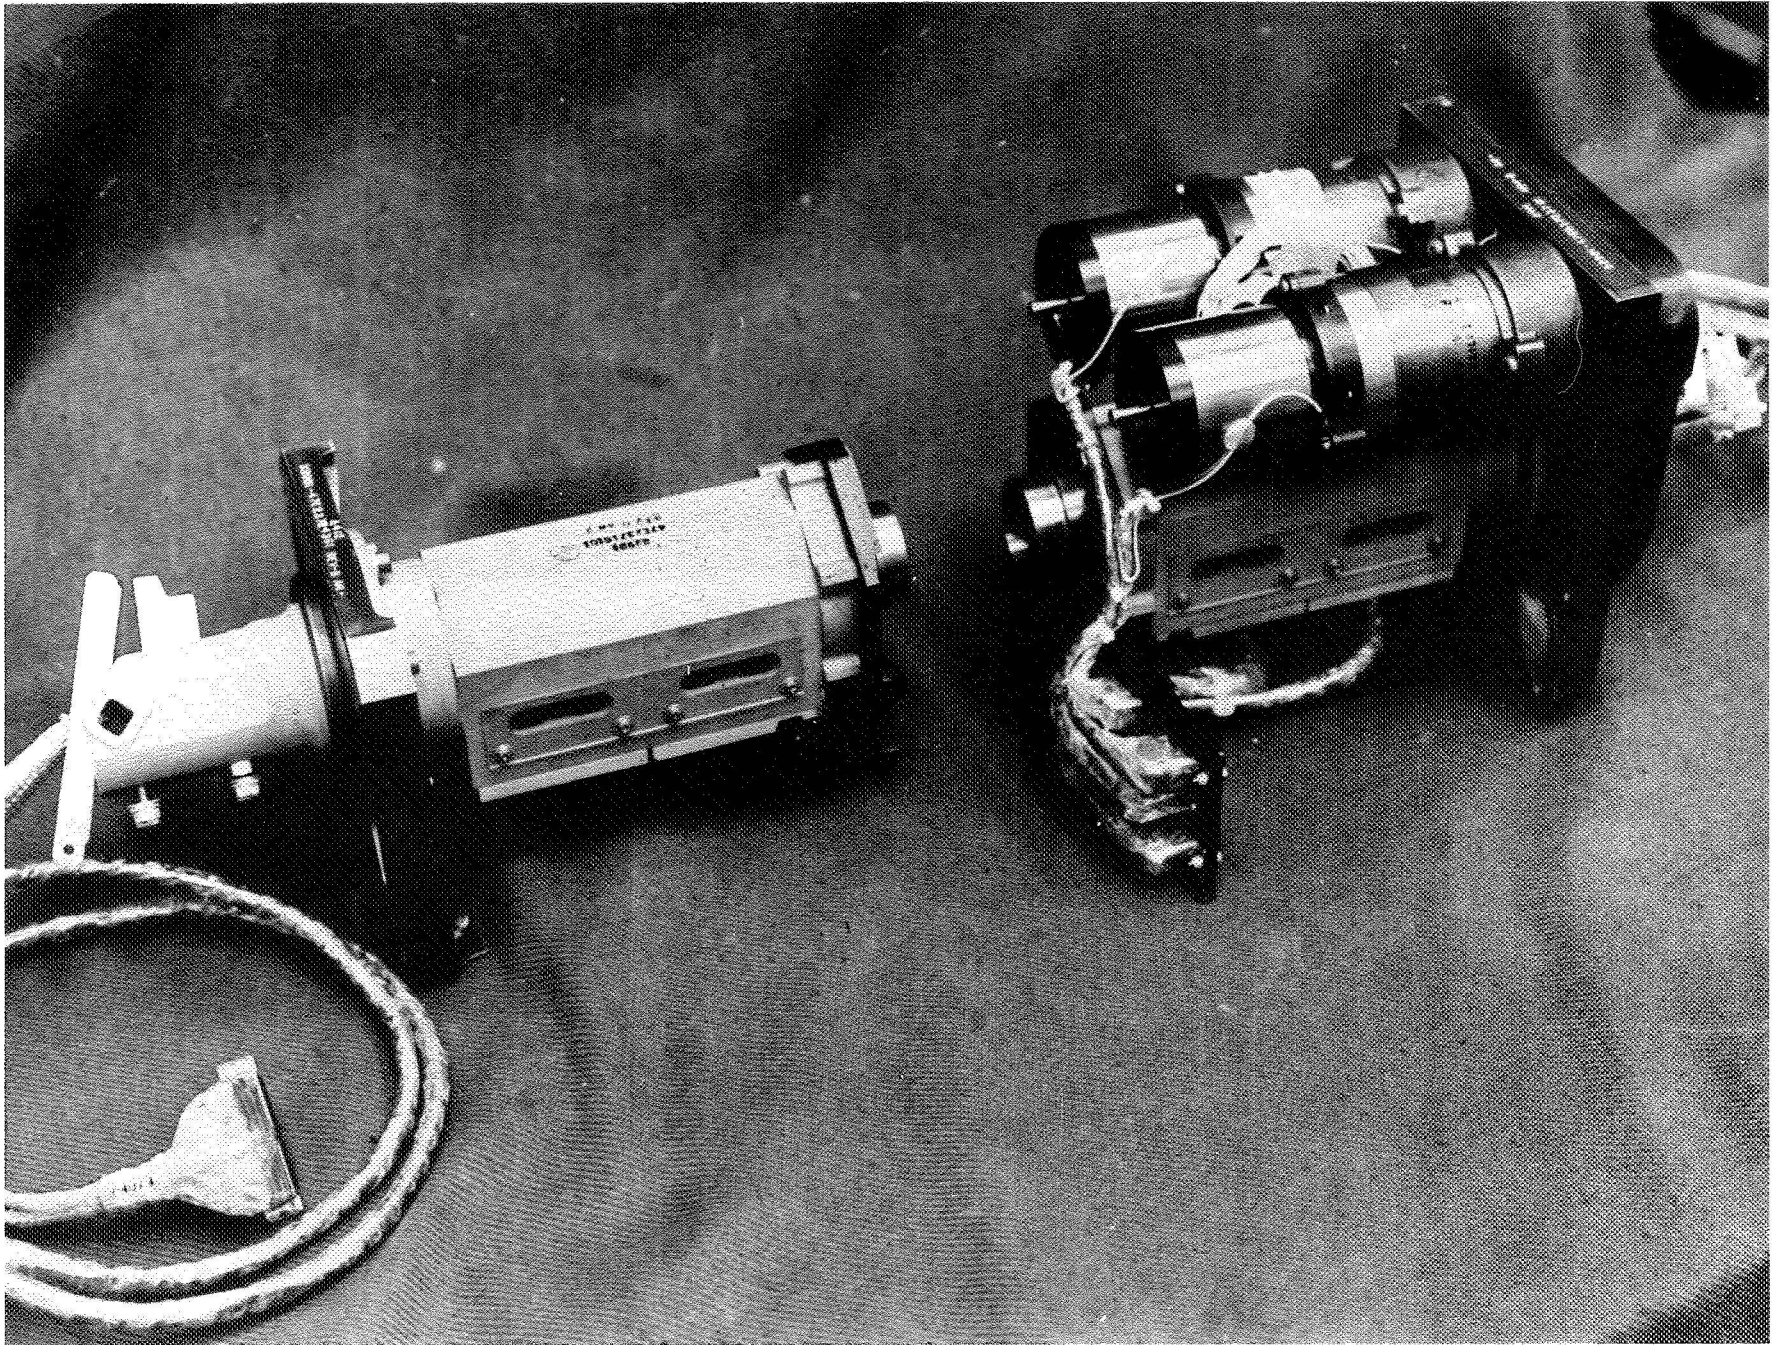
Figure 2. DSCS III Solar Array Drive (Torque Tube not Shown)

The DSCS III solar array drive is a modified version of the BSE drive (see Figure 2). The concept of redundant drive modules is maintained, but the output of the drive modules is a common bull gear rather than the output shaft. The assembly includes two slip ring modules which are integrated into the support housings to reduce weight and to eliminate extra bearings. A separate torque tube connects the driving half of the assembly to the non-driving half.

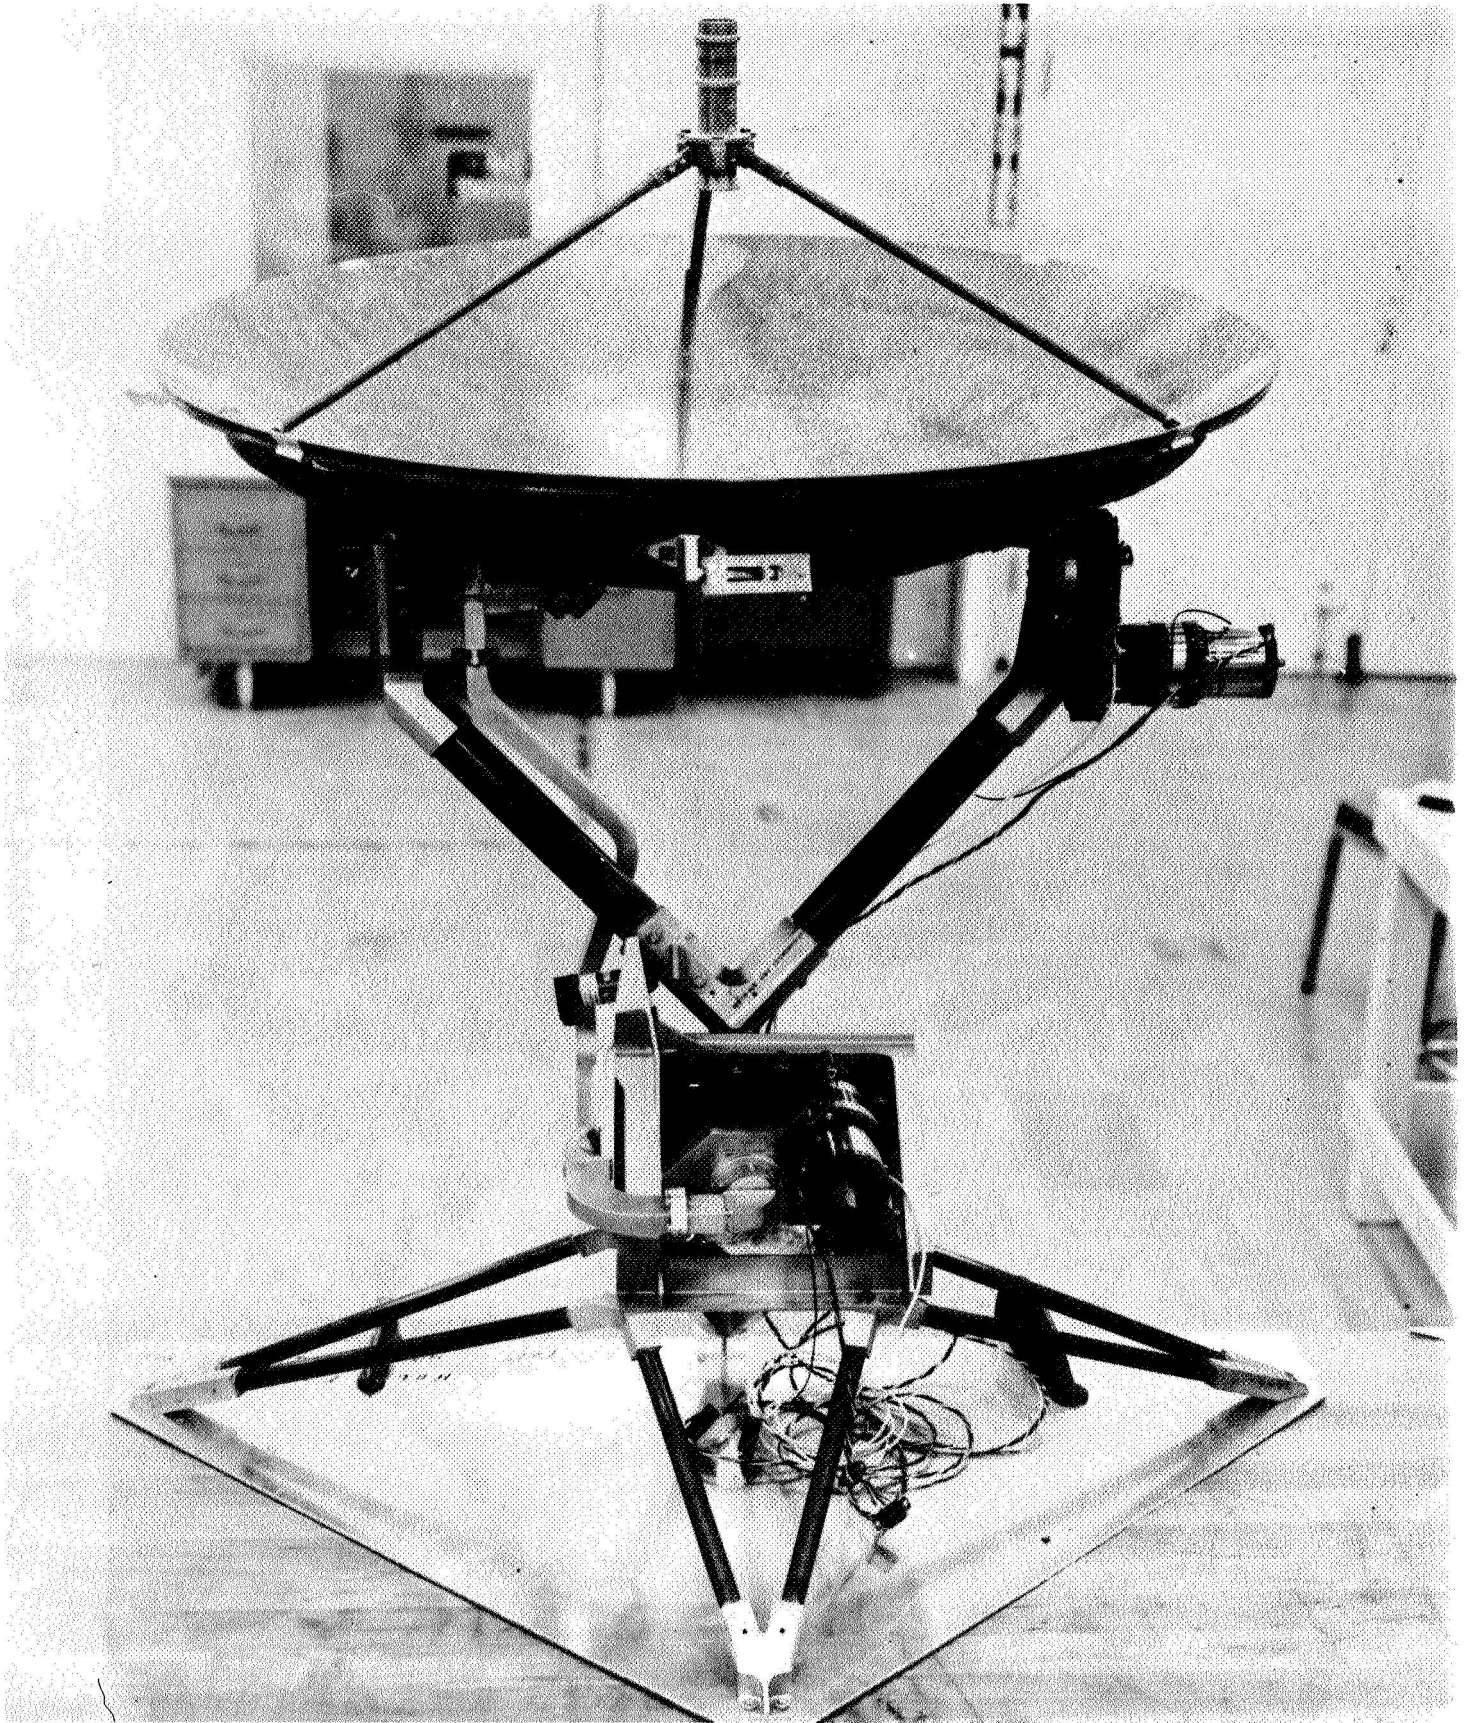
Figure 3. DSCS III Gimballed Antenna

The DSCS III antenna actuators (see Figures 3 and 4) are exact replicas of the BSE drives from stepper motor to pinion gear. The spur gear has been changed to a segment, and the gear ratio has been reduced to minimize weight. A conductive film potentiometer and stops have been added (see Figure 5) to meet design requirements, and the wrap spring clutch has been deleted since the need for redundancy has been eliminated.

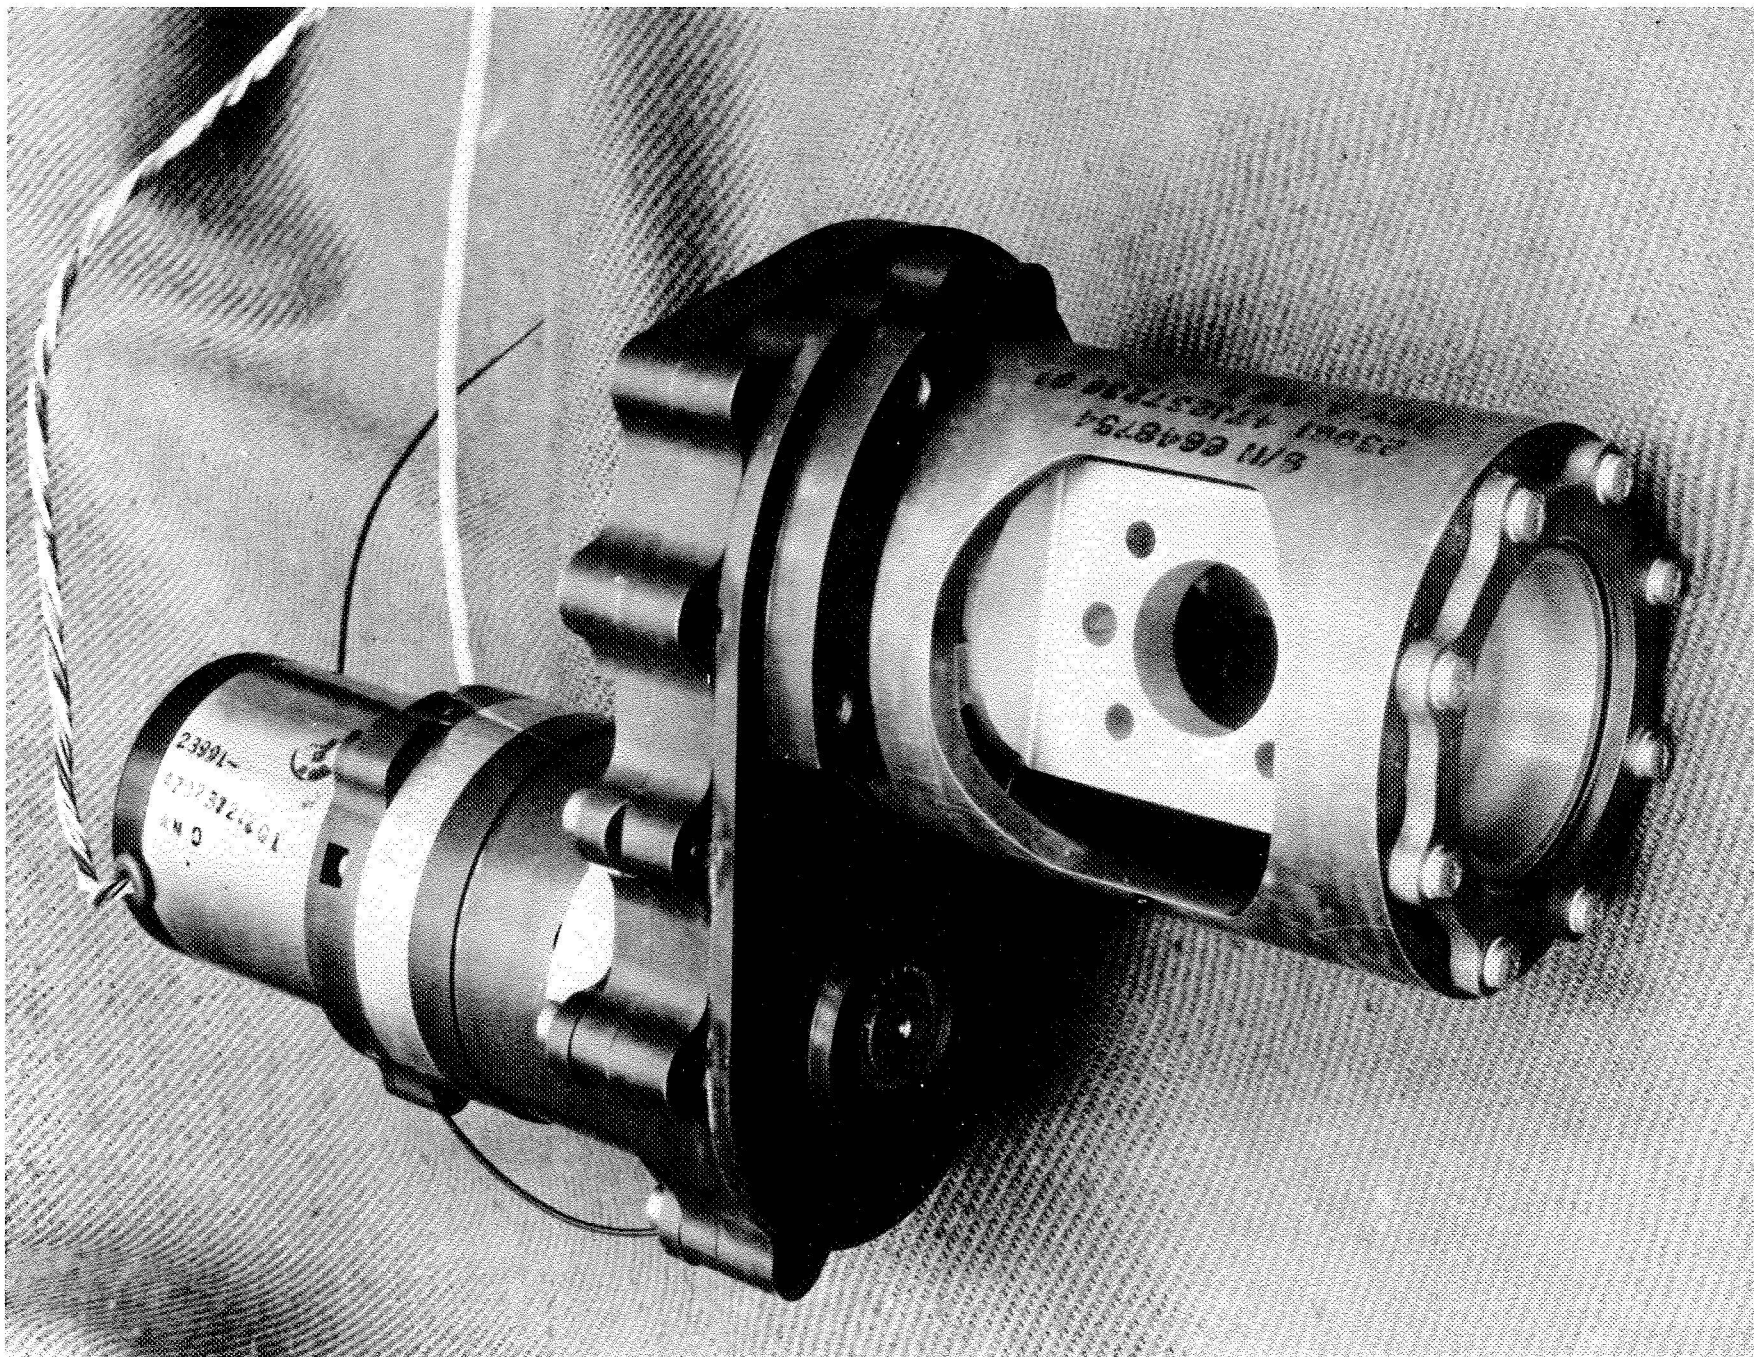
Figure 4. DSCS III Antenna X-Axis Actuator

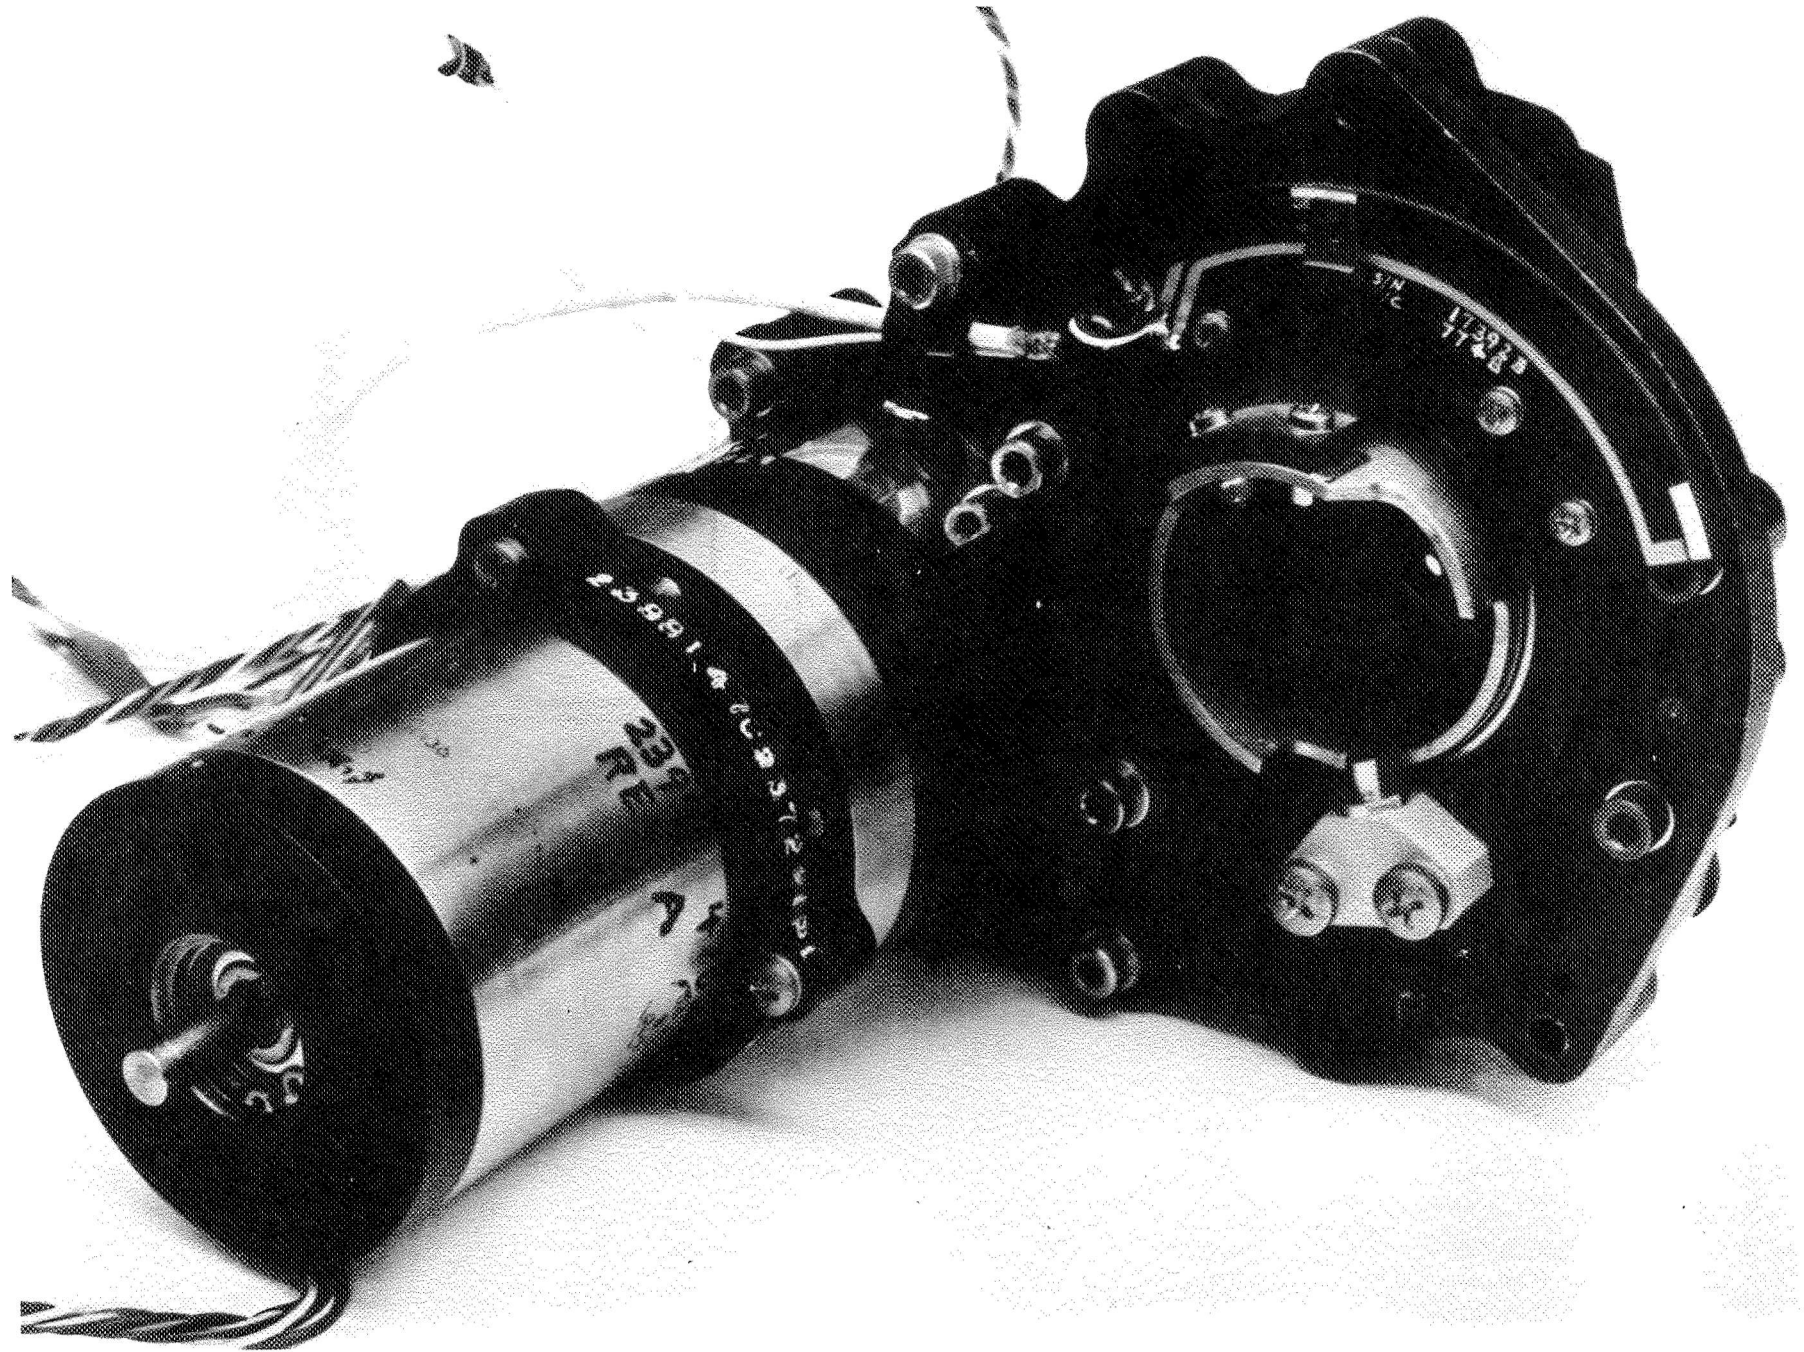
Figure 5. DSCS III Antenna Y-Axis Actuator

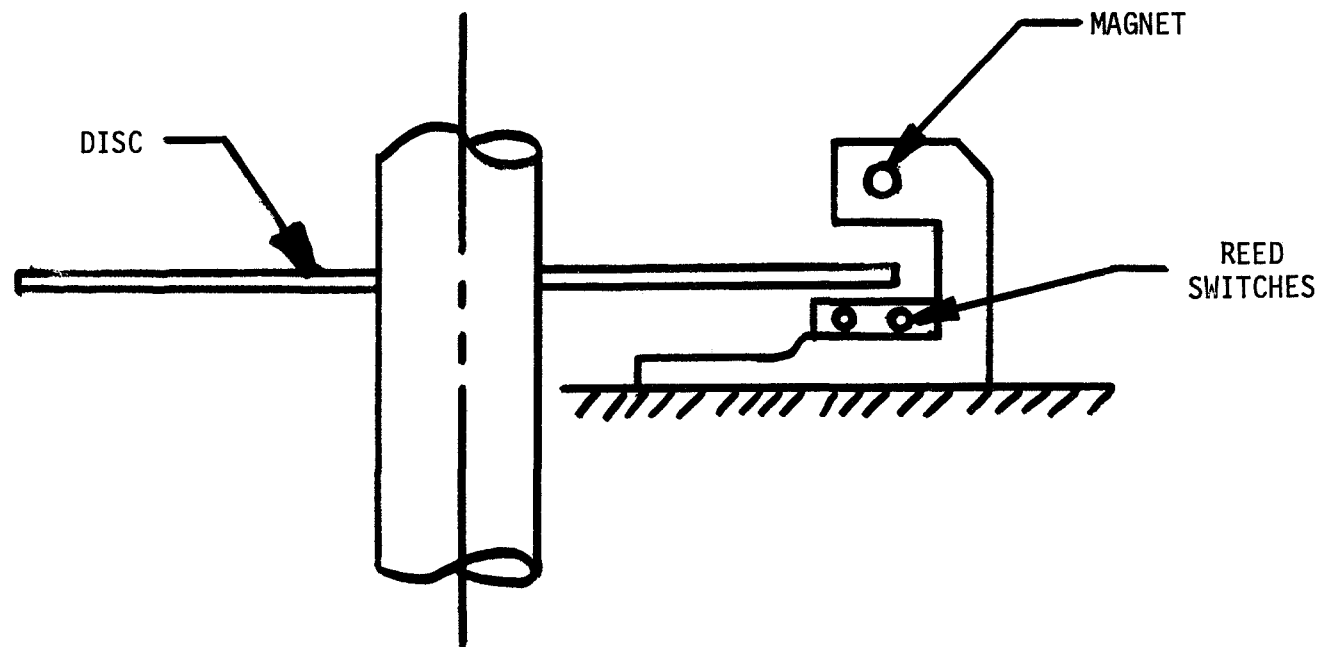
Figure 6. BSE Reed Switch Assembly

Reed switches are used in the BSE solar array drive to generate position inputs to the Attitude Control Subsystem for roll and yaw axis control. Two switches are mounted side by side in each of four position indicator switch assemblies. These assemblies are mounted at 90° spacing around the solar array drive shaft to indicate quadrant position. A bar magnet, which is installed into the position indicator switch assembly, normally keeps the contacts of the two reed switches closed. A disc with a 90° gap is attached to the solar array drive shaft and passes between the magnet and the switches (see Figures 6 and 7). When the 90° sector of the disc passes an assembly, the switches remain closed; but when the solid 270° sector passes an assembly, the magnetic field is interrupted and the switches open. Since the shaft normally rotates at an average speed of one revolution per day, each pair of switches is normally open for six hours per day and closed for 18 hours per day.

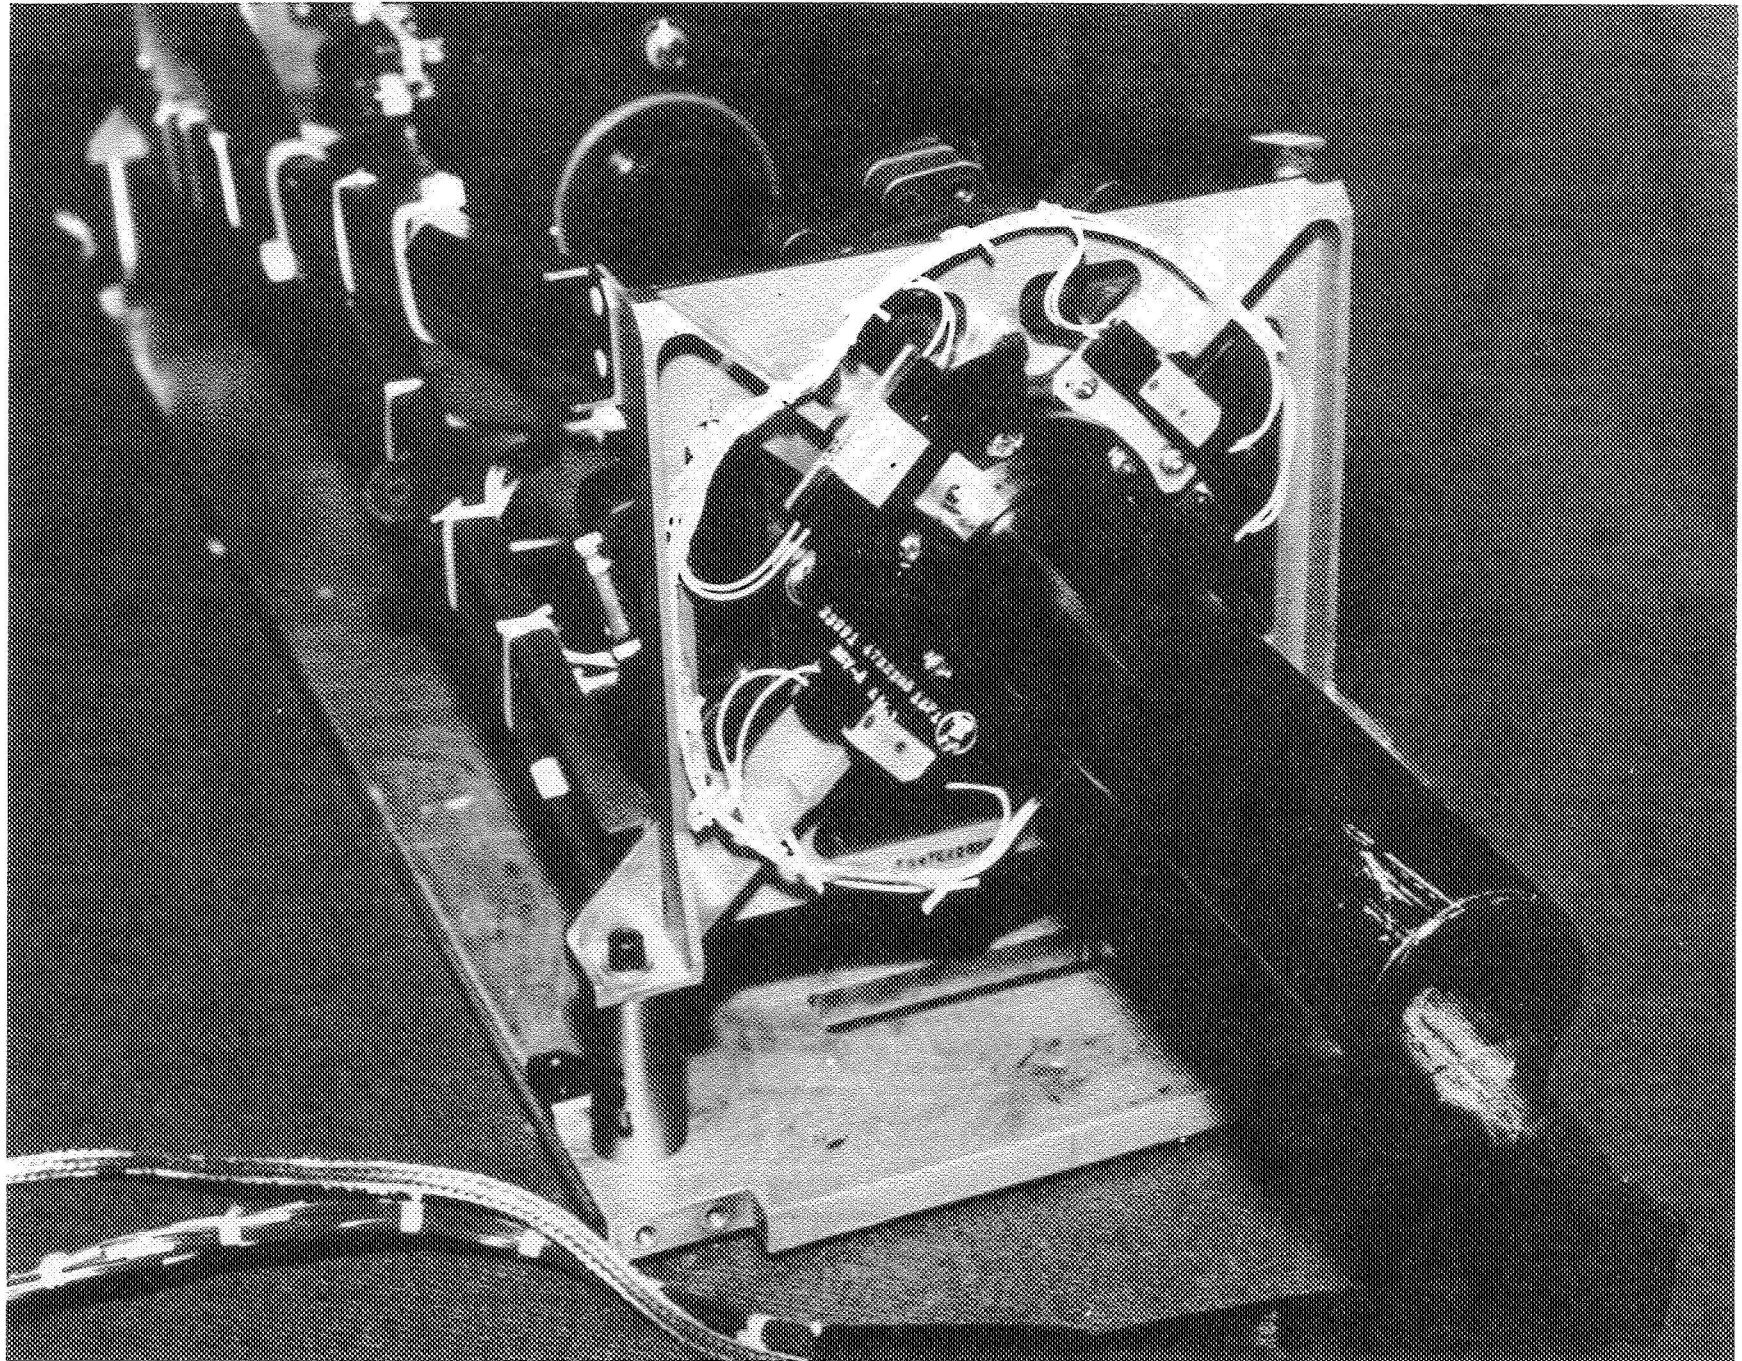
Figure 7. Reed Switches Assembled to BSE Solar Array Drive

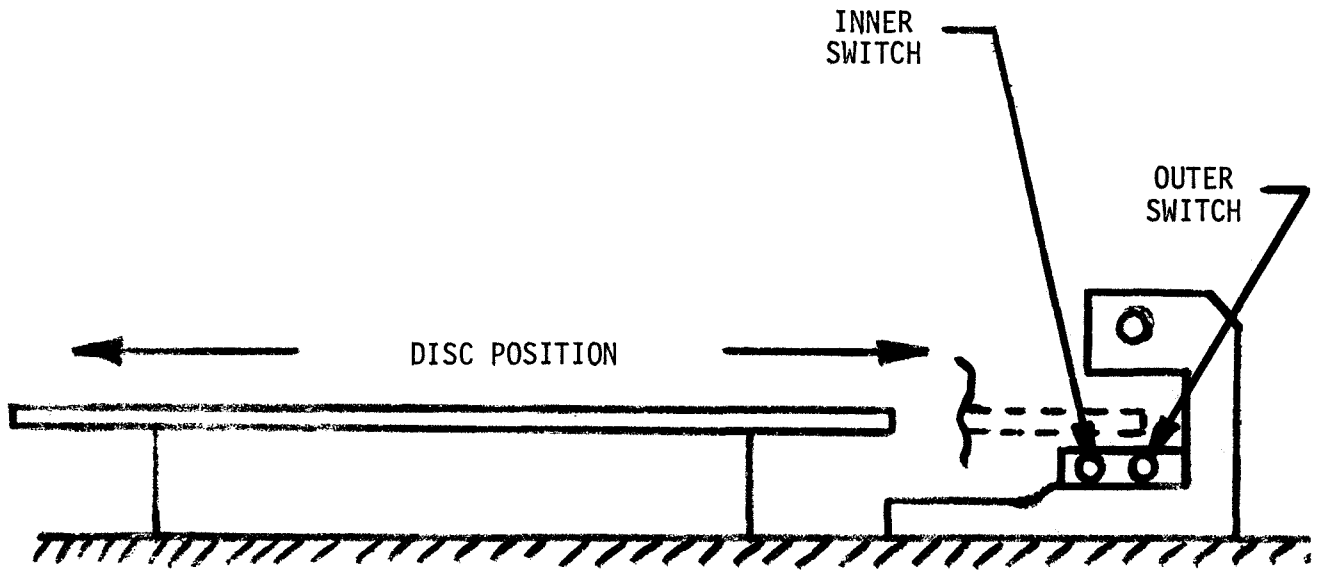
Figure 8. Reed Switch/Disc Test Fixture

In order to investigate Theory 1 above, a test was devised to plot magnetic field at the switch locations versus disc position (see Figures 8 and 9). With switches of differing known pull-in and drop-out values installed in the test fixture, the disc was moved in and out until both inner and outer switches actuated. A number of conclusions were evident from this testing:

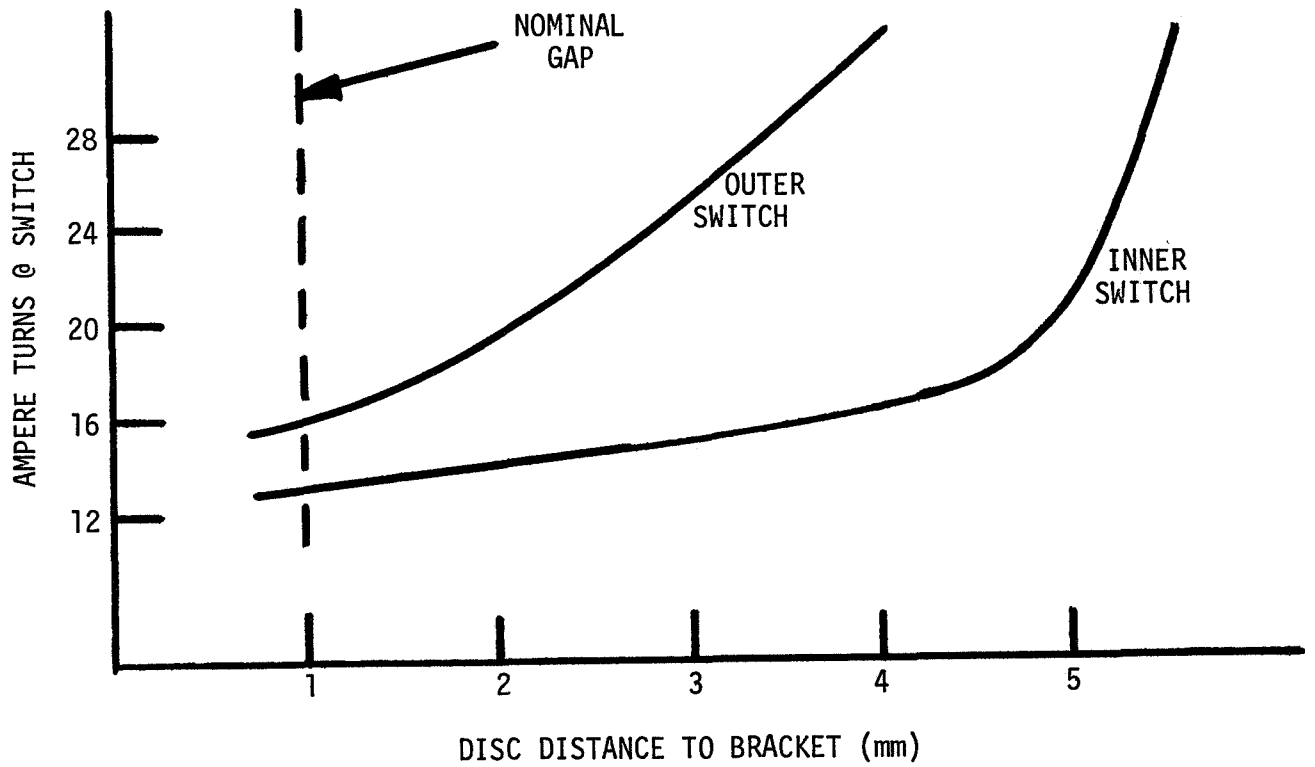
Figure 9. Effect of Disc Position on Magnetic Field

1. With the disc in the switch open position, the magnetic field at the switches is considerable (16 ampere turns vs. 20 ampere turns drop-out).
2. The field strength at the outer switch is always higher than at the inner switch (due to magnetic leakage around the disc).

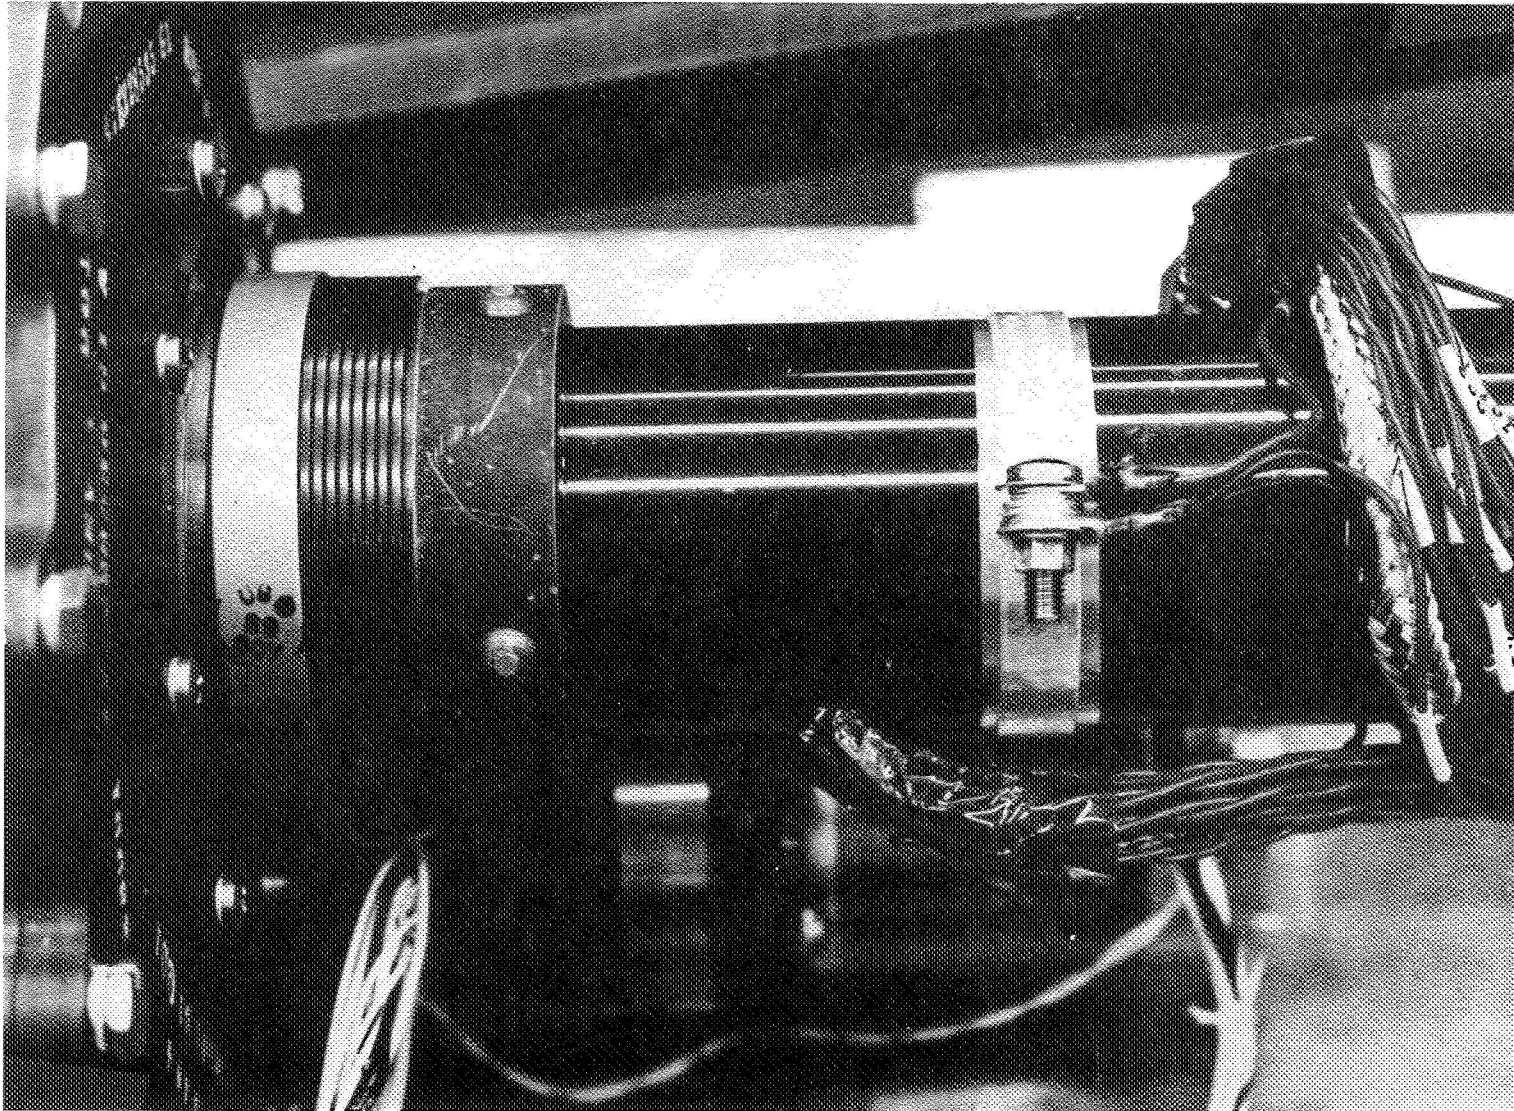
Figure 10. Wrap Spring Portion of BSE Solar Array Drive

Wrap springs are used in the BSE solar array drive to transmit torque from the two redundant drive modules to the common output shaft (see Figure 10). In transmitting this torque, each spring must bridge a gap between the driving hub and the driven shaft. Accurate control of this gap is necessary to prevent the spring from wedging itself into the gap.

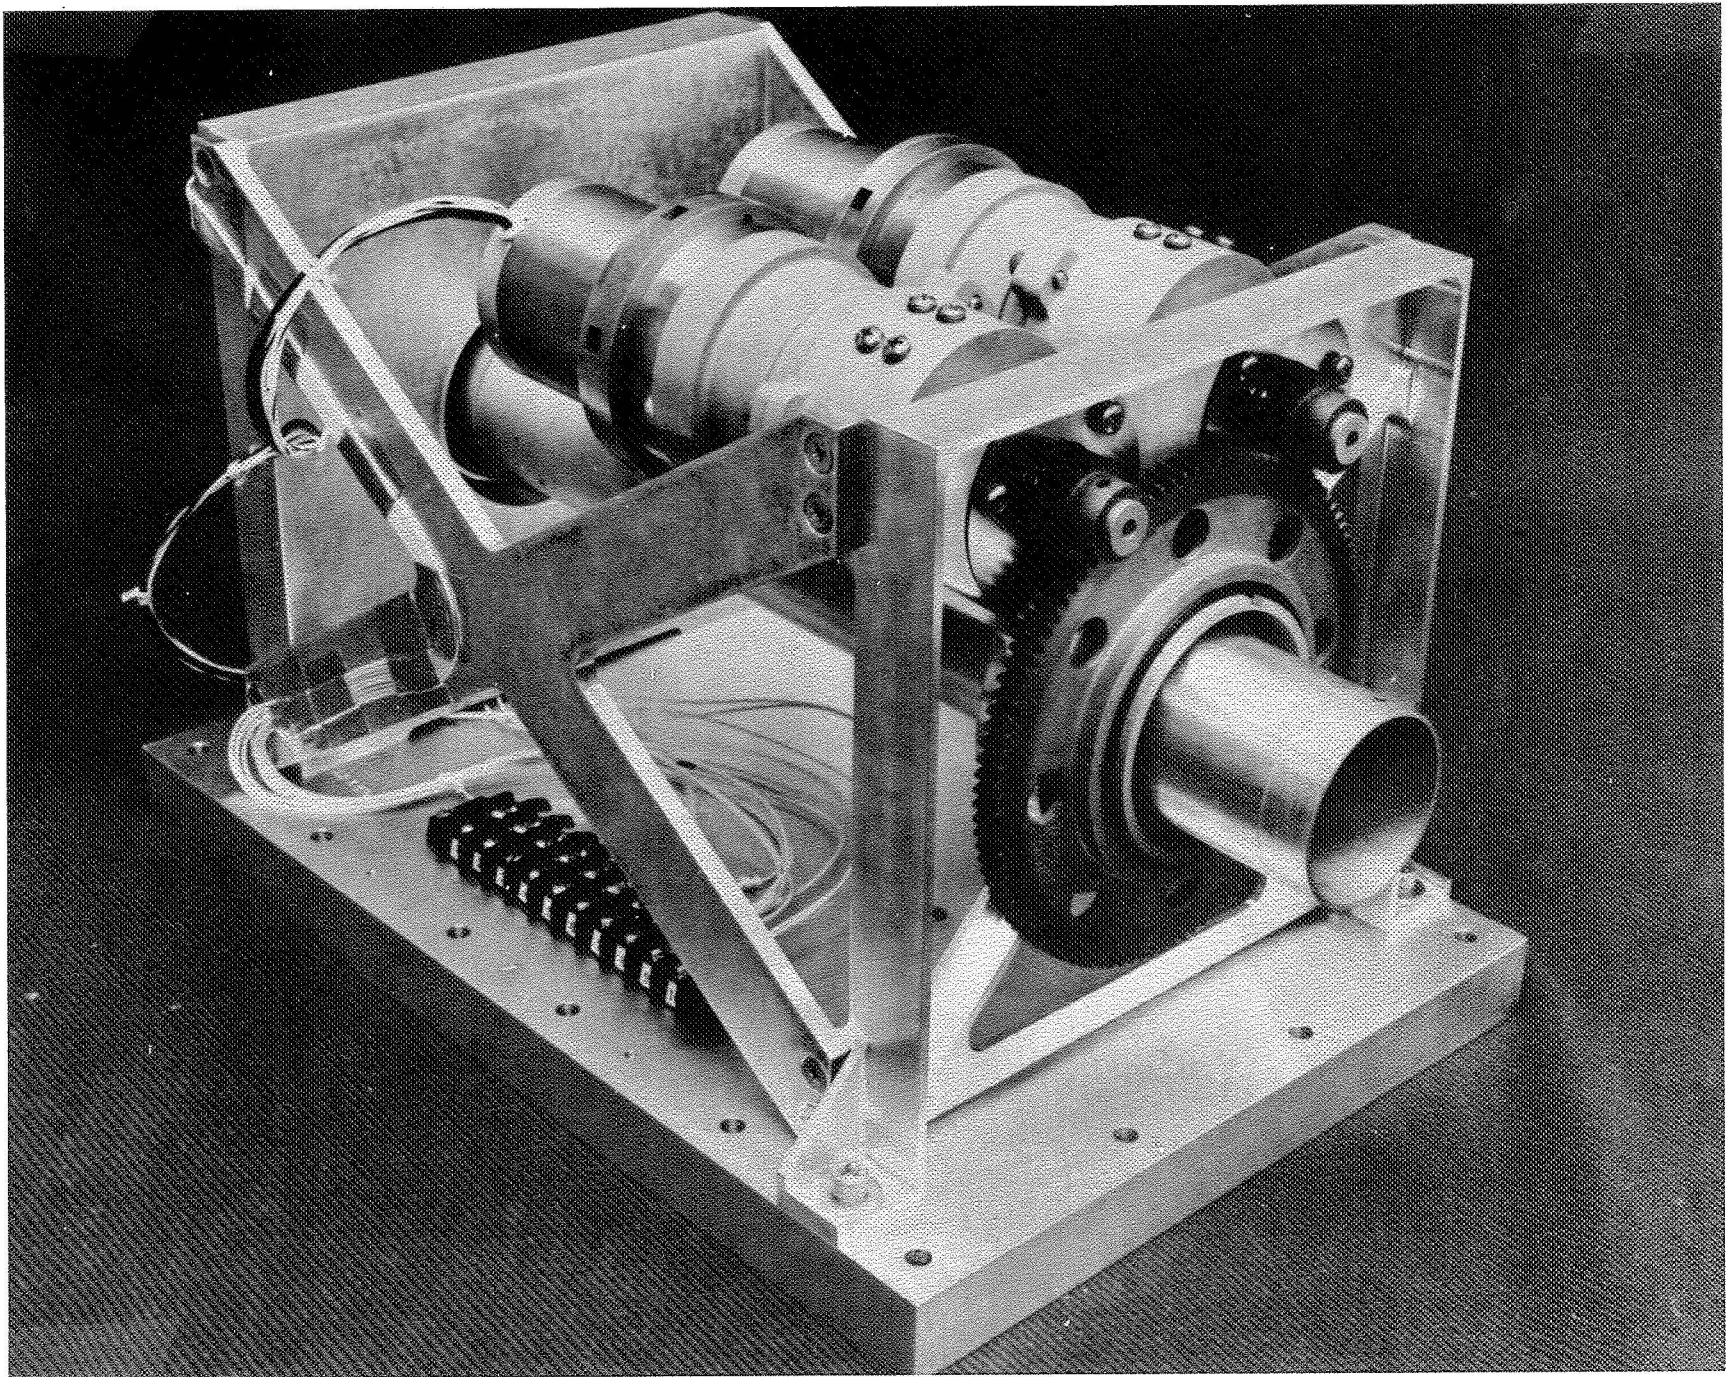
Figure 11. 'DSCS III Solar Array Drive - Engineering Model

An engineering model of the solar array drive was fabricated including all of the critical piece parts (see Figure 11). The assembly was subjected to the full DSCS III qualification test levels for vibration and temperature. At the conclusion of these environmental tests, the assembly was completely disassembled and inspected for damage and/or wear. The inspection did not reveal any out of tolerance conditions.
