HIGH-PERFORMANCE FIBER/ EPOXY COMPOSITE PRESSURE VESSELS

T. T. Chiao, M. A. Hamstad, E. S. Jessop, and R. H. Toland

December 12, 1978

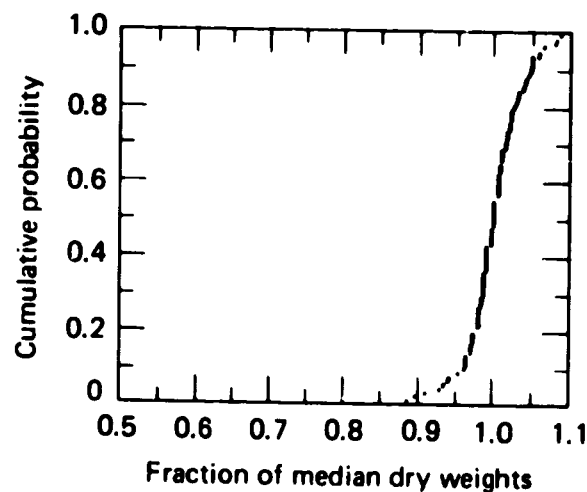
Fig. 1. Denier variation of the Thornel Special graphite fiber: average 641, medium 640, standard deviation 24, CV 3.7%, N 90.

from each spool and checked the weight variation of the fiber strands. Figure 1 is a summary of these data in denier (g/9000 m). The equivalent cross-sectional area of the fiber strands was calculated using the fiber density and the average fiber mass of the three specimens from each spool. The results are shown in Fig. 2. The 3.5% coefficient of variation (CV) is considered small. The average cross-sectional area of $4.022 \times 10^{-4} \text{ cm}^2$ can be used for converting tensile load to fiber stress in most engineering calculations.

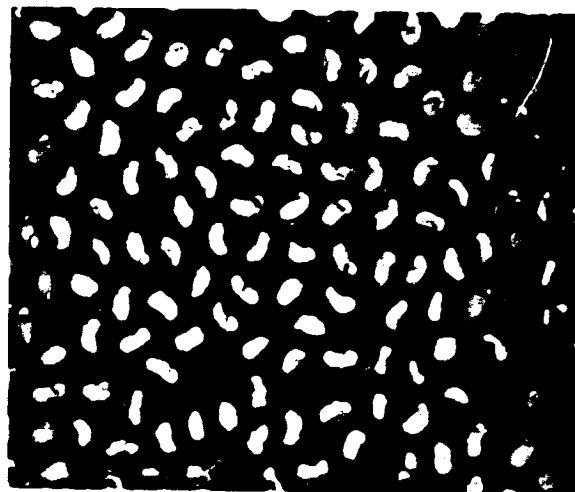
Fig. 3. Photograph of fiber filament shapes.

We used epoxy-impregnated fiber strand specimens to determine the tensile properties of the graphite fiber. Over 5000 composite strands (approximately 180 fiber strands from each spool) were fabricated using a vacuum filament winding process. From a random spool of fiber, we made almost 2000 more composite specimens to study the effect of strain rate and liquid nitrogen temperature on fiber tensile strength. Similar strand specimens also are being used to check the stress-rupture behavior of the fiber composite. The strands were impregnated with the epoxy system described above and cured following the same schedule. We determined the fiber volume content of 10 fiber/epoxy strands selected randomly from each group of 180 specimens. The fiber content of these strands averaged 64.2 vol%, with a CV of 8.7%. The fiber filament shapes are shown in Fig. 3.

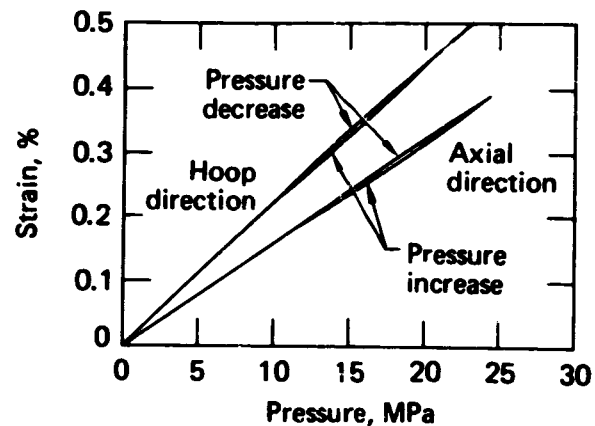
Fig. 16. Typical axial and hoop strains on the outer surface of the fiber/epoxy composite in the cylindrical portion of the vessel during the first load cycle to 50% of the expected burst pressure.

The redesigned liner (used in the third set of vessels) successfully solved the problem of the stress concentration at the ends of the titanium liners. Thus, it was no longer necessary to coat the inner ends of these vessels with epoxy. The redesigned liner was slightly heavier, however, resulting in an increase in total vessel weight of about 5%. During the fatigue tests of the third set of vessels, all failures resulted from cracks in the welds. Figure 16 plots the cyclic strains during the first fatigue cycle for a typical vessel wound over this redesigned liner.

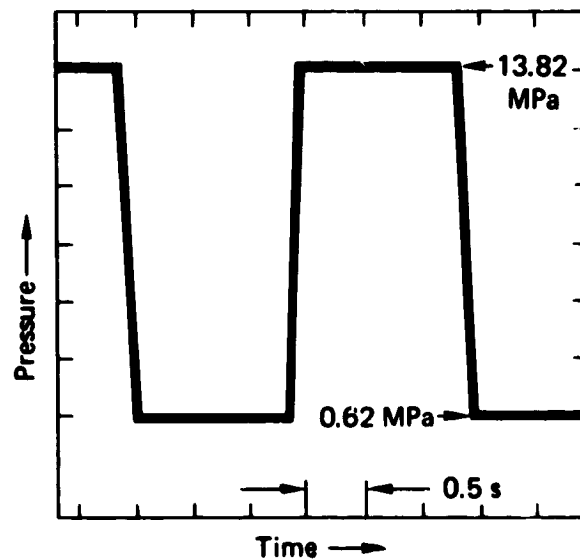
Fig. 31. Actual shape of the nominally rectangular pressure pulse.

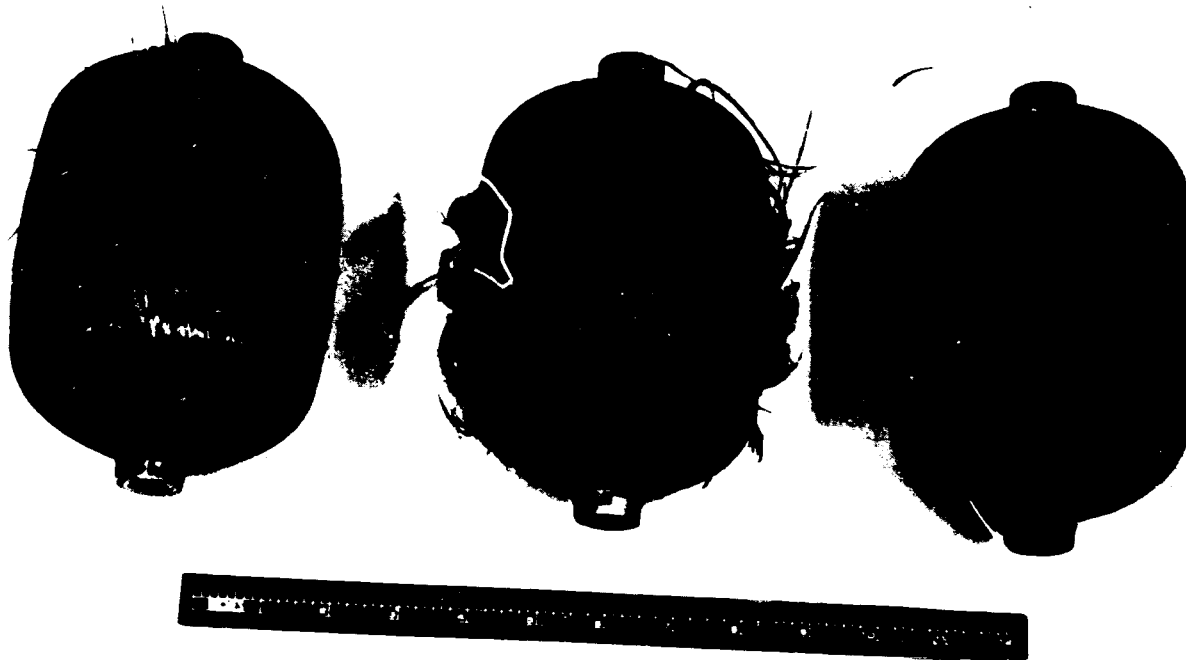
Fig. 32. Photograph of two typical hoop failed vessels (a, b) and a typical unfailed pressure vessel (c).
