ACOUSTIC SENSOR
ENGINEERING EVALUATION TEST REPORT

Prepared By
Lockheed Electronics Company, Inc.
Aerospace Systems Division
Houston, Texas

June 1976

PROJECT SPACE SHUTTLE

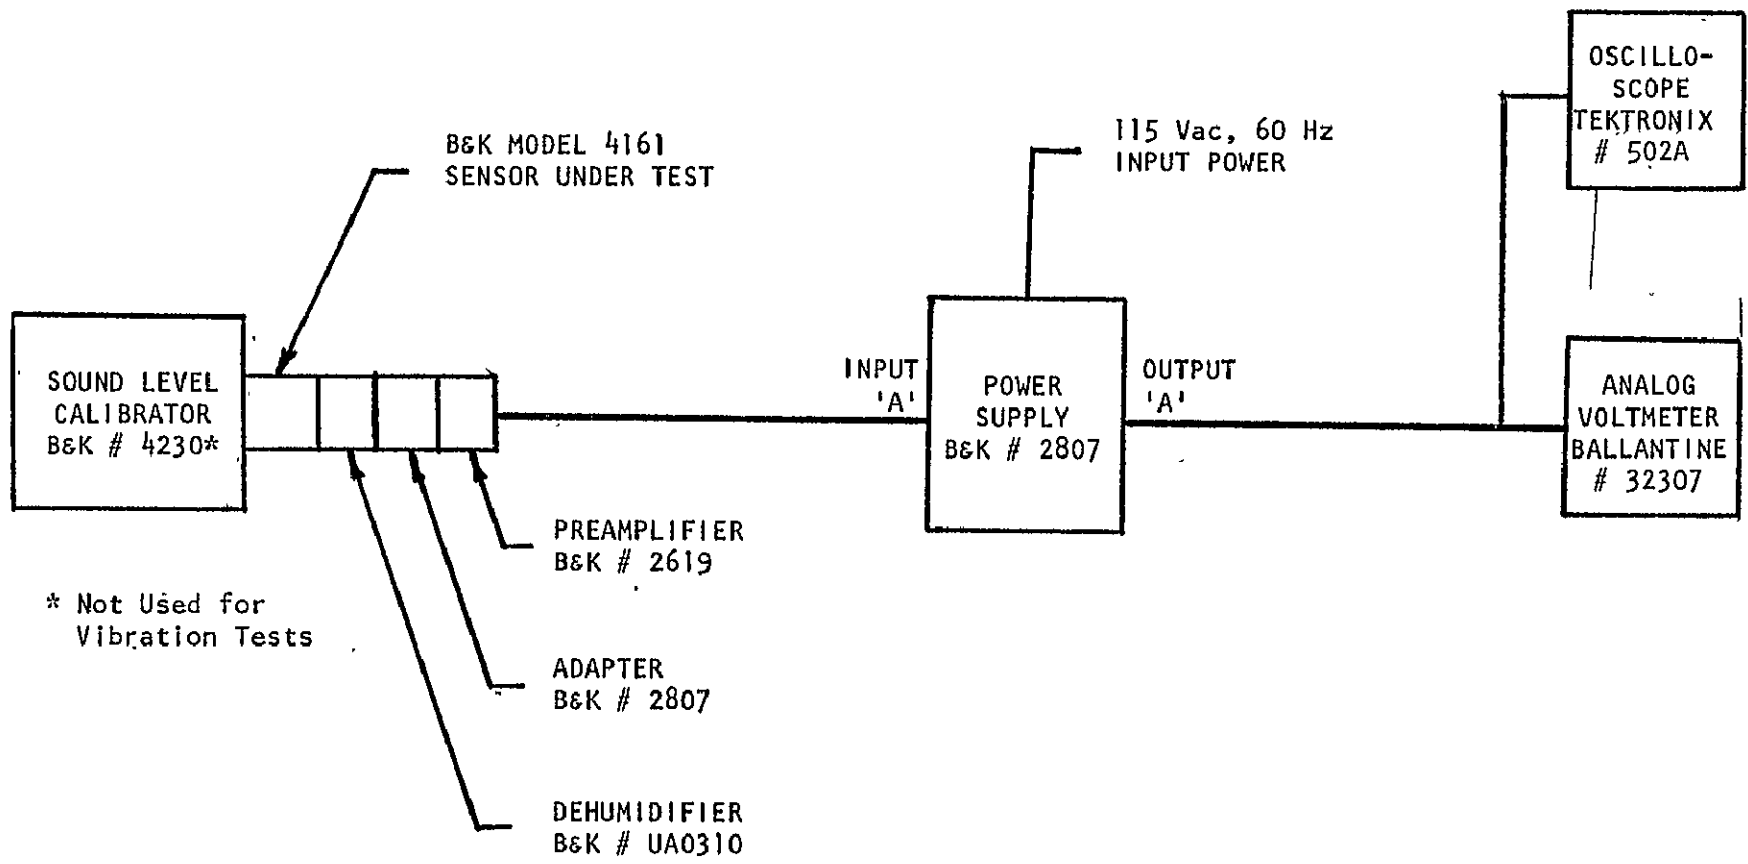
FIGURE 3-1A. - B&K Model 4161 test setup (except frequency response, amplitude, linearity and humidity).

Figures 3-1A and 3-1B show the test setup configuration for the Model 4161 capacitive microphone and the Model 4117 piezoelectric microphone, respectively, used during the baseline calibration, temperature, confidence checking and post-environmental tests. The same figures are applicable to the vibration tests except the sound level calibrator was not utilized.

4.1.2 Calibration - Baseline calibration data consisting of three independent measurements on each of the eight sensors was obtained. The test setup shown in Figure 3-1A was used for the four Model 4161 sensors, and the setup shown in Figure 3-2A was used for the four Model 4117 sensors. A warmup time of 30 minutes was allowed prior to making the measurements.

4.2.3 Vibration Tests - The test configuration was the same as in Figures 3-1A and 3-2A for the B&K Model 4161 and 4117 sensors respectively, except the Sound Level Calibrator was not utilized. Three sensors of each type were exposed individually.

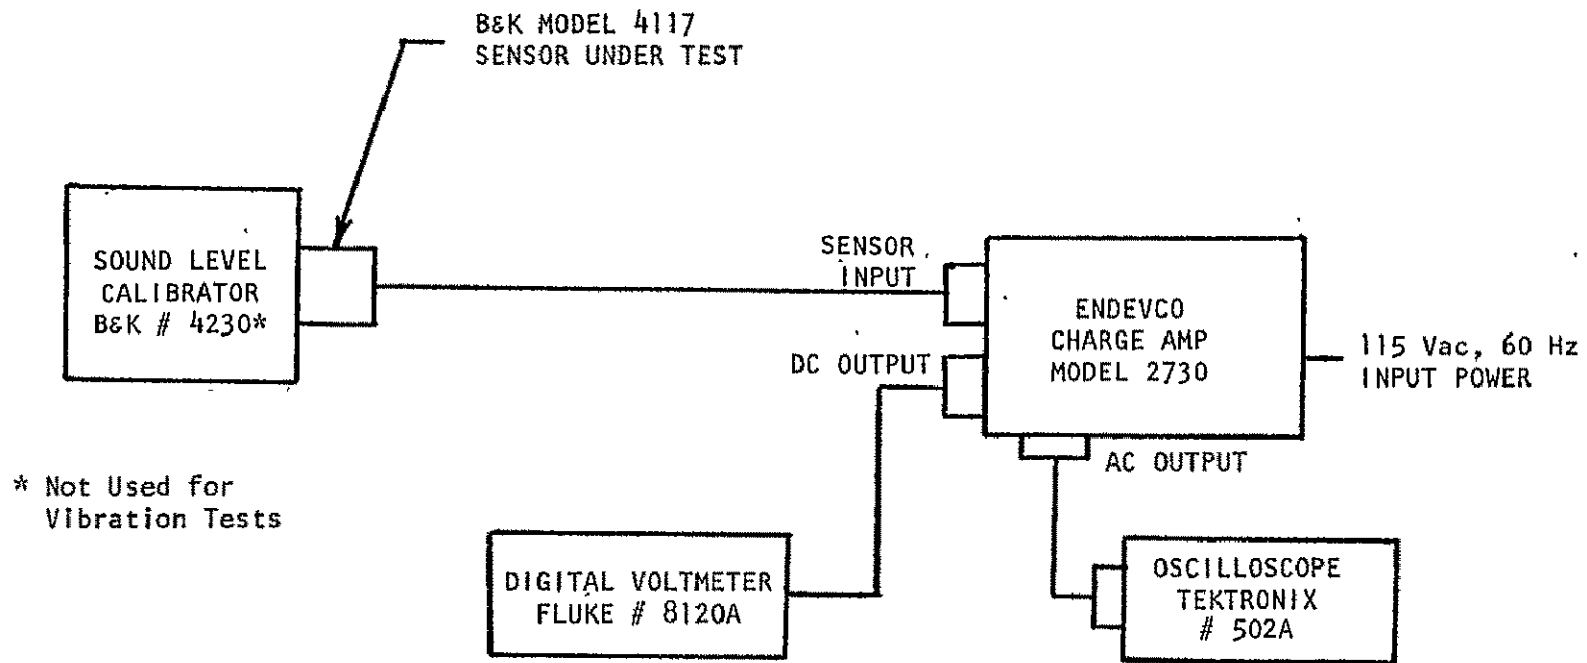
FIGURE 3-2A. - B&K Model 4117 test setup (except frequency response, amplitude, linearity and humidity).

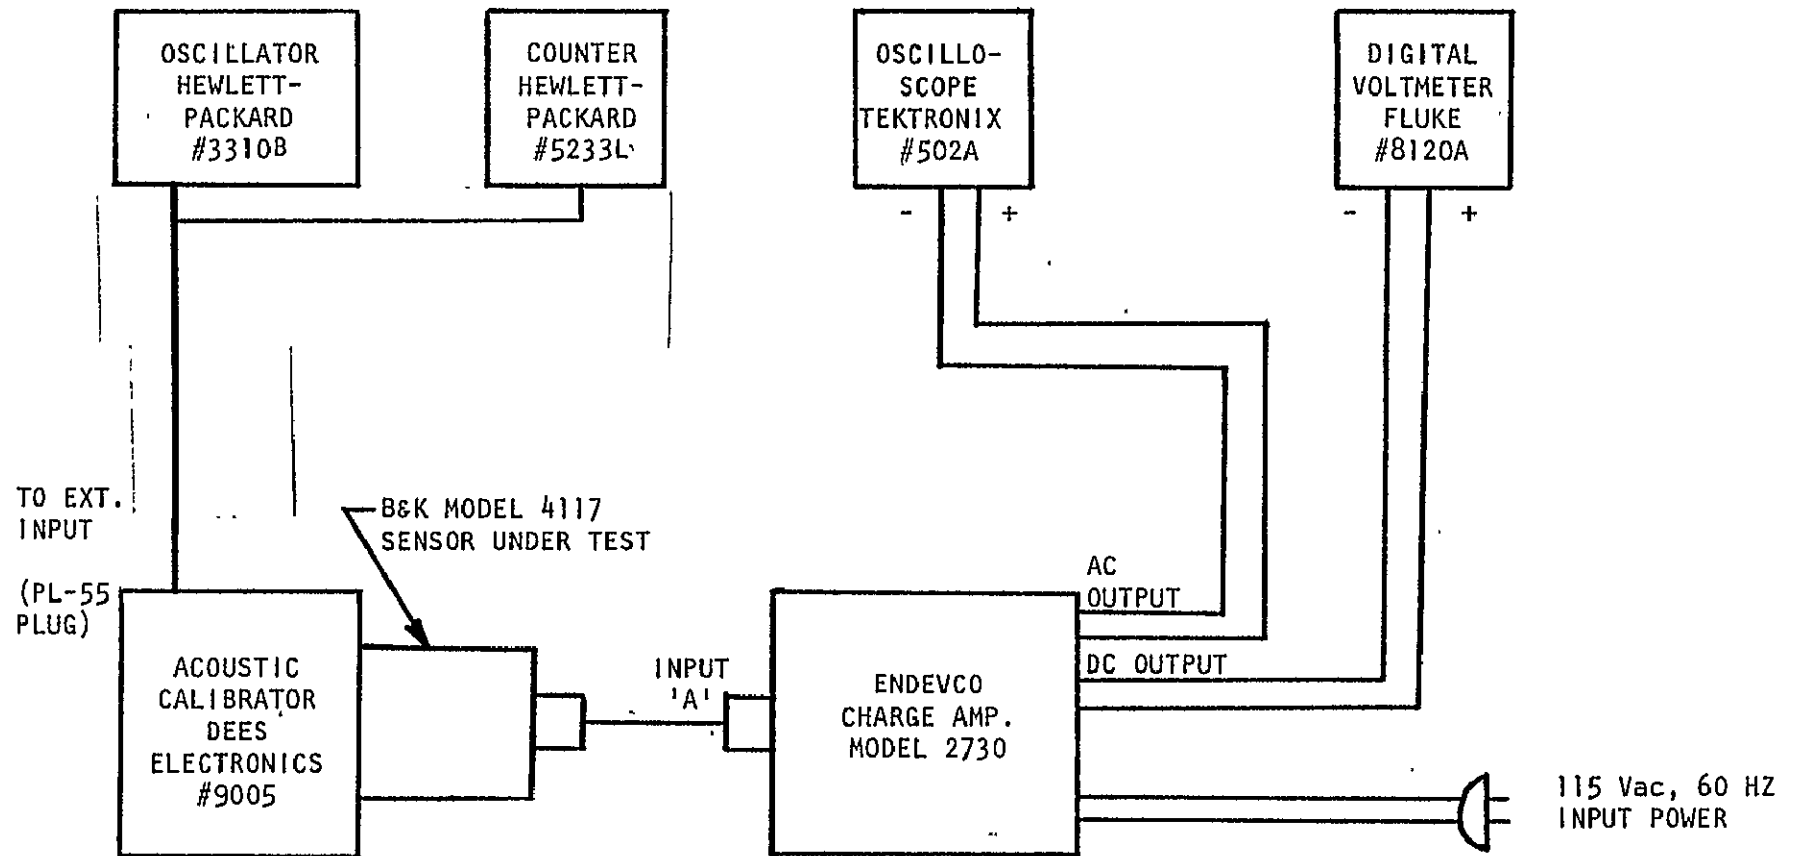
FIGURE 3-2B.-- B&K Model 4117 frequency response and amplitude linearity test setup.

The Amplitude Linearity and Frequency Response tests utilized the same equipment, except an oscillator and the Dees calibrator were substituted for the B&K Calibrator. The setups for these tests are shown in Figures 3-2A and 3-2B for the Model 4161 and 4117 respectively.

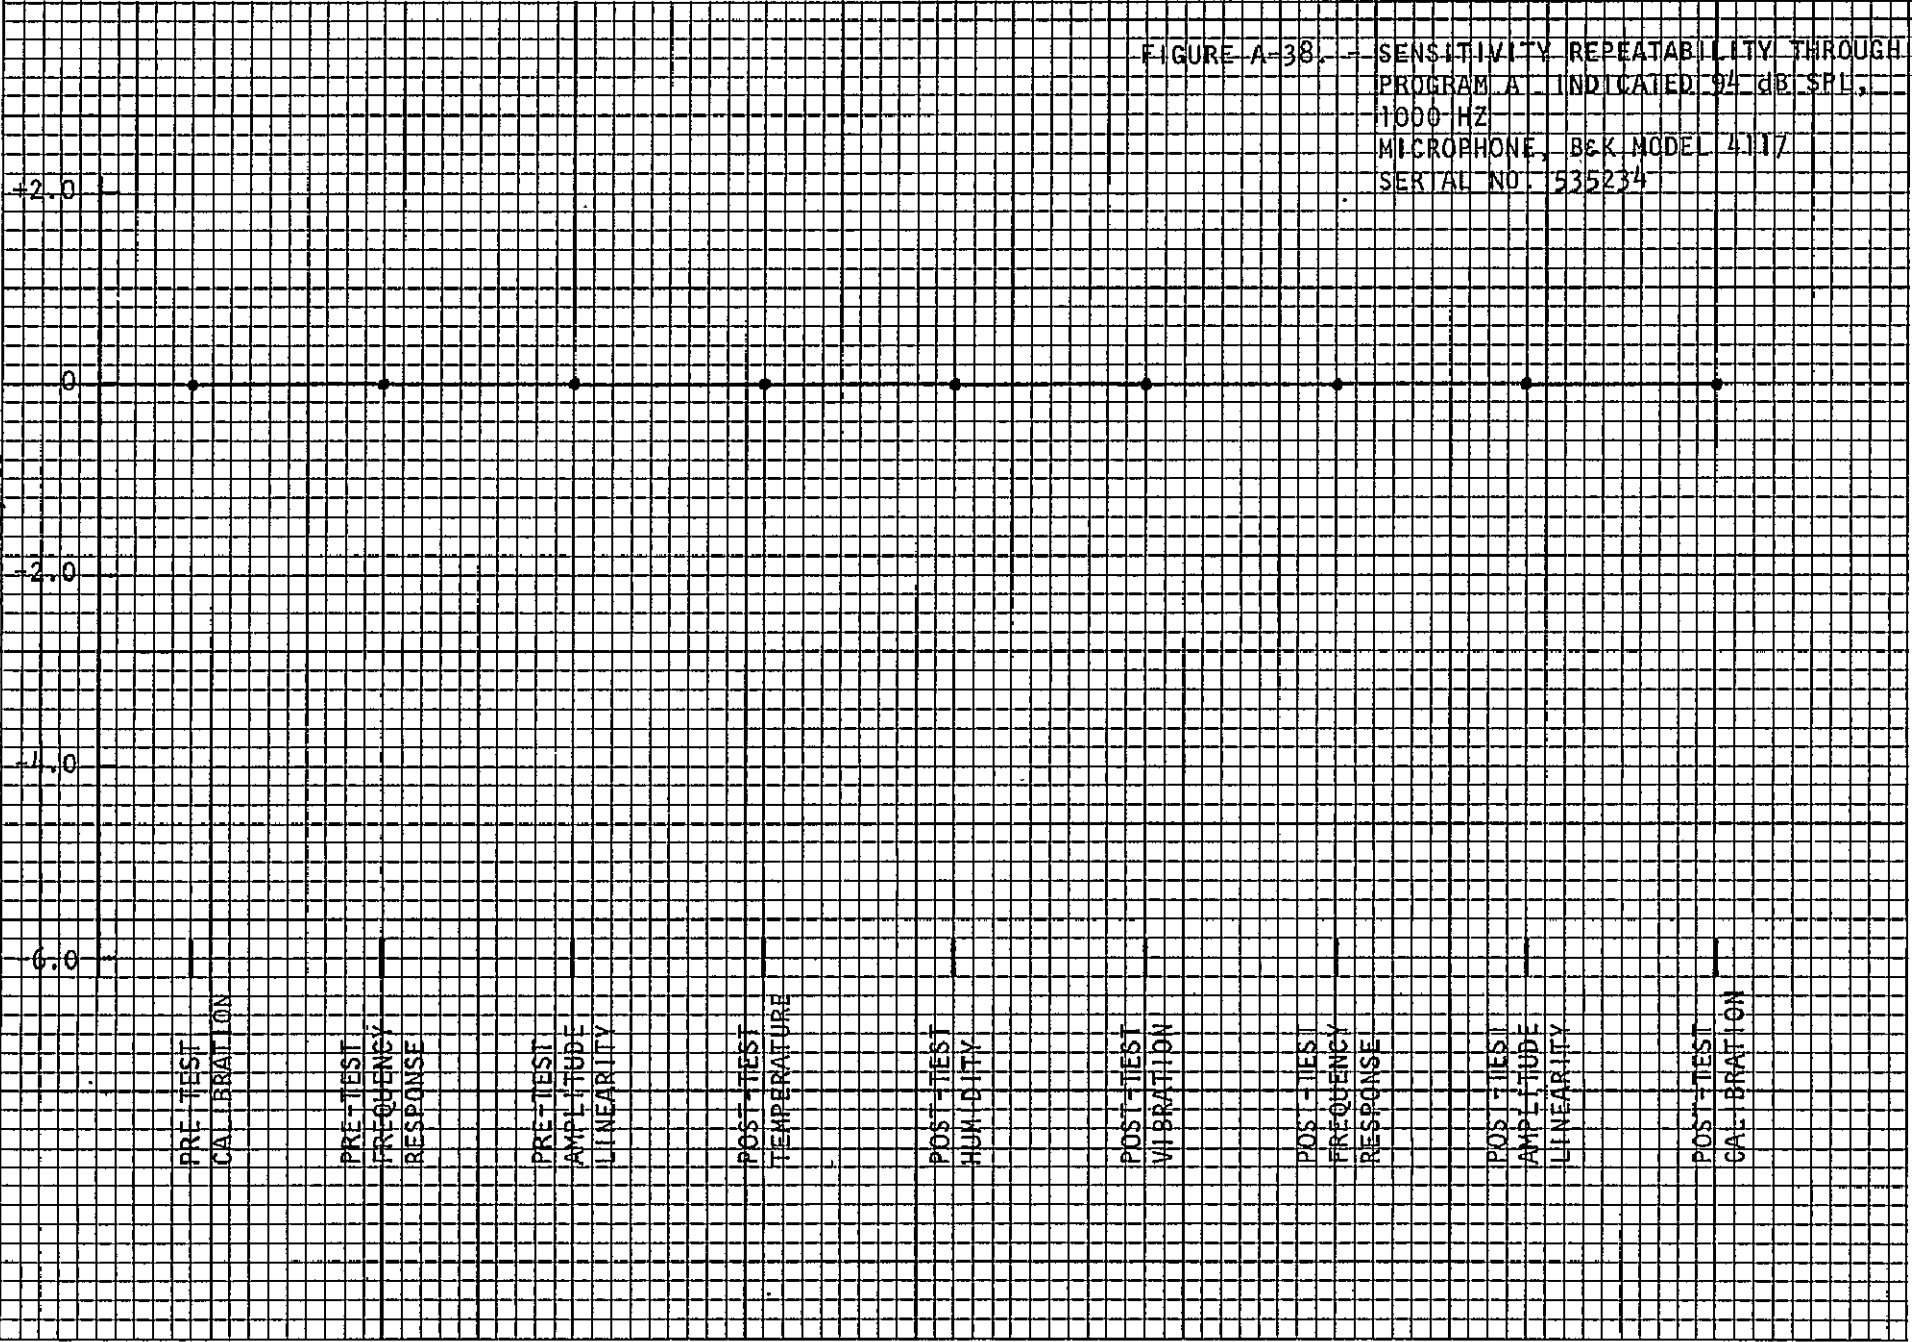
FIGURE A-38. - SENSITIVITY REPEATABILITY THROUGH PROGRAM A INDICATED 94 dB SPL, 1000 HZ MICROPHONE, B&K MODEL 4117 SERIAL NO. 535234

Both the B&K Model 4161 and Model 4117 capacitive microphones are deemed suitable for use on the Shuttle Orbiter vehicle based upon the results of the tests described herein. The Model 4117 is apparently less precise and much more fragile. One Model 4117 test article, serial number 535219, failed following the humidity test. Another unit, serial number 535228, had a substantially degraded output following random vibration exposure. Otherwise the sensitivity repeatability of all the test articles was within 1 dB of the respective initial value throughout the test program. The repeatability of each of the eight test articles is shown in Figures A-31 through A-38 in the attachment to this report.
