## DIODE STEP STRESS TESTING PROGRAM

MSFC/NASA CONTRACT NUMBER  
NAS8-31944

FINAL REPORT  
FOR  
JANTX 1N3016B

FEBRUARY 1979

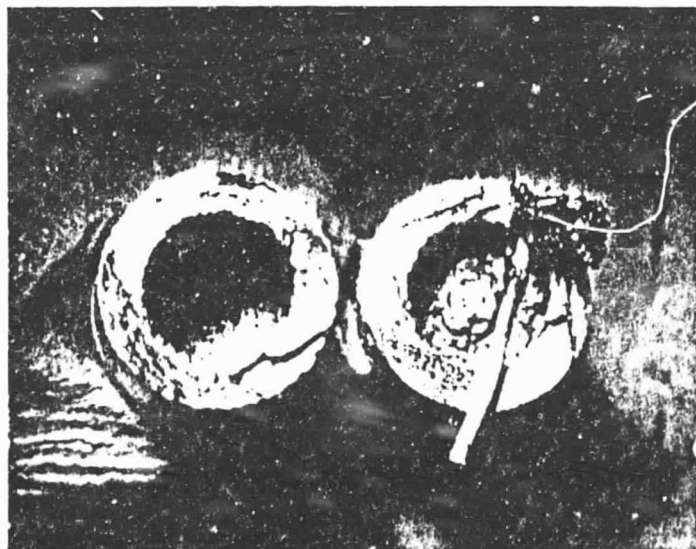
FIGURE B-2

S/N 2271, Typical Siemens Diode, 5X.  
The die has separated from the case and is  
covered with decomposed junction coating.

All six samples failed due to the effects of overheating. Probe testing of the dice after opening the packages showed that all six are shorted. The most probable cause of the shorts is alloying of the molten die metal into the silicon. The most vulnerable feature of these diodes is the low melting point of the internal lead attach bonding material.

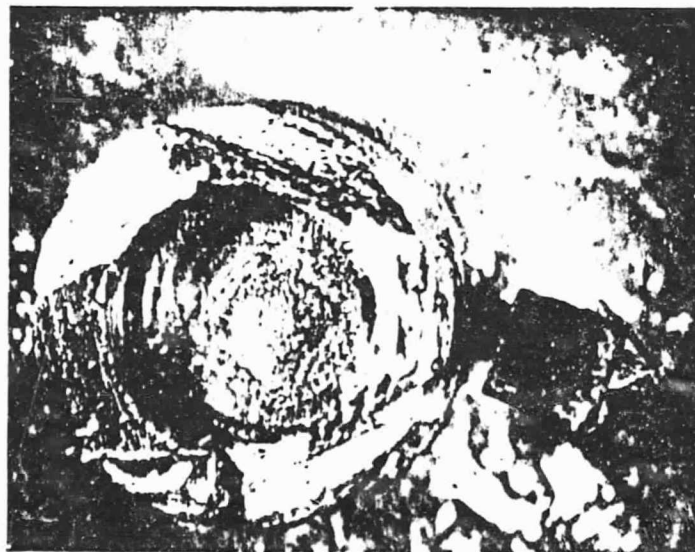
FIGURE C-2

<u>S/N</u>	<u>FAILURE MODE</u>
Motorola:	2236	Lifted internal lead.
	2237	Same as above.
	2248	Lifted die. Die nickel plate separated.
Siemens:	2287	Lifted die.
	2294	Lifted internal lead.
	2301	Lifted internal lead.

S/N 2248, Motorola Device Showing Loss of  
Metallurgic Bond to Cathode, 12X.

Cathode post shown on left; underside  
of die shown on right.

The Siemens silicon dice were undamaged electrically, as demonstrated by internal probing of the devices. Two of the three Motorola dice were also good. This indicates that both might have withstood greater stress than they did if higher melting bonding material was used.
