WEAR OF SEAL MATERIALS USED IN AIRCRAFT PROPULSION SYSTEMS

by Robert C. Bill
Propulsion Laboratory
AVRADCOM Research and Technology Laboratories
and
Lawrence P. Ludwig
Lewis Research Center
Cleveland, Ohio

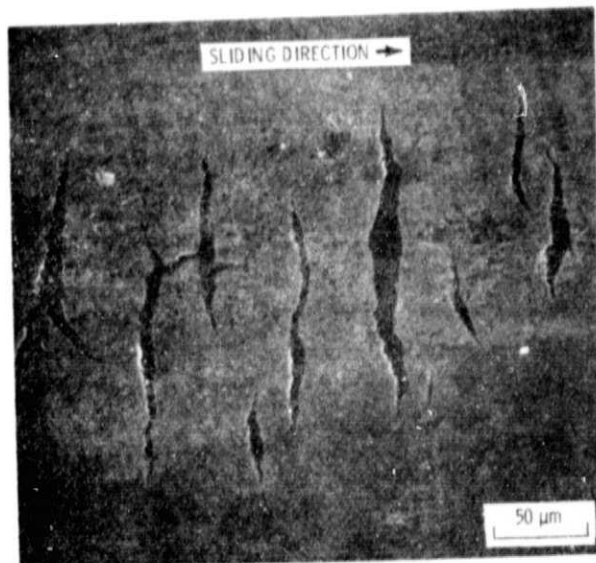
Fig. 9. - Thermal cracking observed on contact surface of 440C face seal seat.

Testing of full seal designs or assemblies is usually conducted on a test rig that closely simulates the intended application in terms of bearing compartment design, sealed lubricant, and lubrication system features. It is intended that the seal should operate much as it would in its final installation. Under normal operating conditions, when full or partial film lubrication is present, wear to the contacting seal components is negligible. However, under severe operating conditions as might occur when the lubricant supply is cut-off for some reason, or when the seal is exposed to a high concentration of abrasive material, or excessive runout and vibration is encountered, the sealing elements can suffer severe distress. Besides wear to the carbon graphite seal elements similar to wear effects described previously, the hard metallic seat often shows evidence of severe distress. It is often observed that severe rubbing conditions promote thermocracking or "heat checking" of hard steel seat components, as shown in Fig. 9 for a 440C seal seat. In (15), a PV type criterion is developed, based on thermal shock resistance of seal materials in which it is envisioned that rub induced heating leads to thermal stresses exceeding the strength of the seal material. The significance of frictional heating on the properties and structure of the 440C material shown in Fig. 9 may be appreciated in the section micrographs of Fig. 10. The thin, light shaded layer adjacent to the rub surface is believed to be a fully martensitic layer, generated by rapid local thermal cycling under rub conditions. Temperatures in this layer must have reached 1400 to 1500° F, followed by cooling to about 500° F within a few seconds. The depth of this layer roughly corresponds to the depth of the cracks shown in Fig. 9. At greater depths beneath the rub surface, a soft darker shaded region is encountered in which lower than bulk hardness are measured. Here, frictional heating promoted further tempering of the hardened 440C structure.

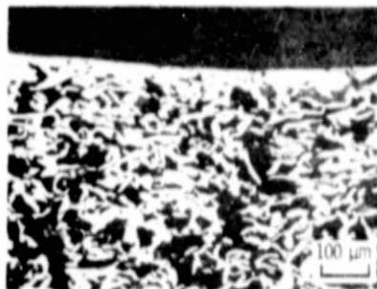
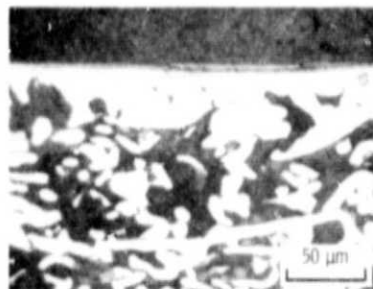
(a) OVERVIEW OF SMEARED RUB SURFACE.

(b) CENTRAL REGION OF (a) SHOWING CRACK AND LAMINAR MORPHOLOGY DETAIL.

(c) SECTION PARALLEL TO SLIDING DIRECTION, THROUGH SMEARED RUB SURFACE.

(d) DETAIL OF (c) SHOWING INCIDENCE OF LAMINAR CRACKS.

Fig. 15. - SEM overview and metallographic section of rub surface on sintered Hastelloy-X fiber-metal seal material after rub interaction with Ti-6Al-4V simulated blade tips.

Low density materials. - For low density gas path seal materials, the intent is that rub interaction be accommodated by removal of discrete particles, thereby minimizing frictional heating effects and wear to the rotating component. Under some rub conditions however, it is observed that the surface of the low density seal material becomes smeared, and in effect the rotating component is in contact with fully dense seal material. Such a smeared rub surface is depicted in Fig. 15. As indicated in Fig. 16, the rate of frictional heat generation at the rub interface increases by two orders of magnitude when smearing occurs (19). Microsections of a Ti-6Al-4V rotating component after such a high energy rub (Fig. 17) show evidence of very rapid oxidation in some cases as indicated by quasi-spherical cavities in the rub surface and intense white sparking during the rub. Also, in other studies it was observed that high energy rubs promoted fine martensitic platelet formation near the rub surface (20).

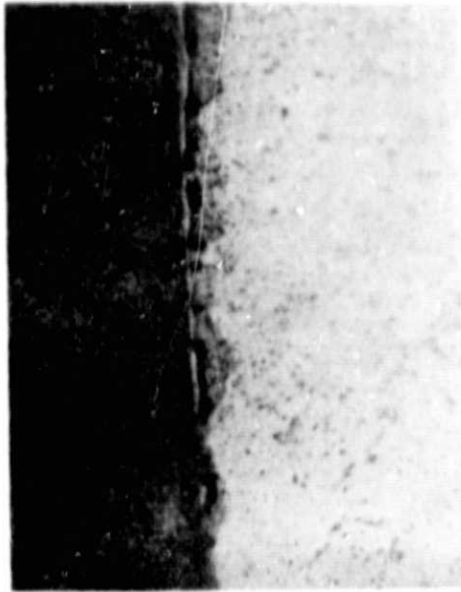
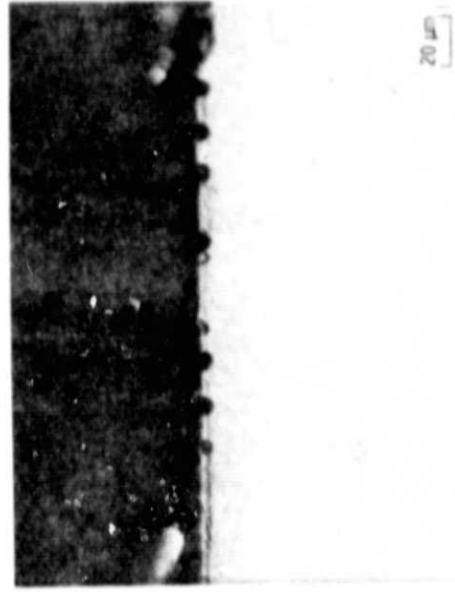
(a) NEAR BLADE-TIP LEADING EDGE.

(b) ABOUT HALFWAY ACROSS BLADE TIP.

Fig. 17. - Section view of Ti-6Al-4V simulated blade tip rub surface.

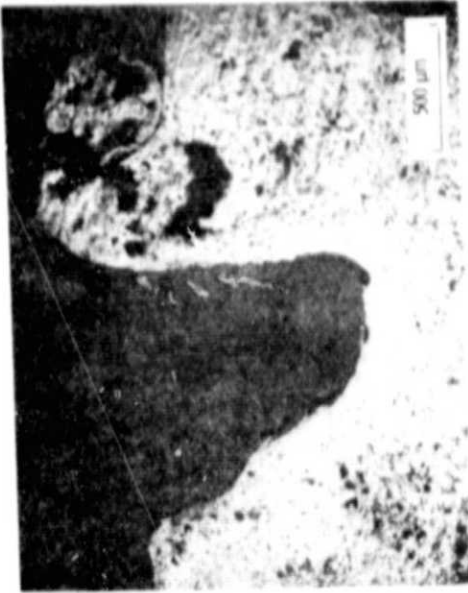
(a) OVERVIEW SHOWING DISPLACED MATERIAL.

(b) DETAIL, BOTTOM OF RUB GROOVE.

Fig. 19. - Microsection of rub groove on plasma-sprayed aluminum gas path seal material after interaction with 17 - 4 PH labyrinth seal knife-edge.

In studying the rub mechanisms associated with fully dense materials (19), it was proposed that the radial or normal load was controlled by plastic indentation considerations. The frictional energy resulting from the rub was then simply the product of this normal load, the coefficient of friction, and the rub velocity. Order of magnitude agreement with knife edge rub data was obtained with this very simple model, and microsections of rub grooves (Fig. 19) are consistent with the plastic indentation model for normal load. Under blade tip rub conditions however, in contrast to knife-edge conditions, the indentation (rub groove) is at least ten times as wide as it is deep, and the rub cannot be entirely accommodated by plastic displacement of material. Some mechanism of micromachining chip or wear particle formation is required. Examples of such particles are to be seen in the rub debris shown in Fig. 20.

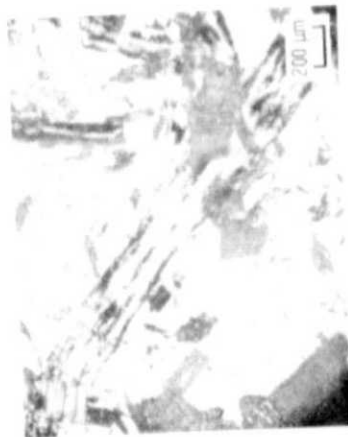
(a) RUB SURFACE ON PLASMA SPRAYED ALUMINUM.

(b) Ti-6Al-4V BLADE-TIP LEADING EDGE SHOWING 20 MICROMETER A MINIMUM TRANSFER.

(c) WEAR DEBRIS IN FORM OF THIN TRANSLUCENT RIBBONS.

Fig. 20. - Plasma-sprayed aluminum rub surface. Ti-6Al-4V blade tip, and wear debris.
