NASA CR- 159442  
AiResearch 31-2936

# MINI-BRU/BIPS FOIL BEARING DEVELOPMENT

by F. X. Dobler and L. G. Miller

AIRESEARCH MANUFACTURING COMPANY OF ARIZONA  
A DIVISION OF THE GARRETT CORPORATION  
Phoenix, Arizona

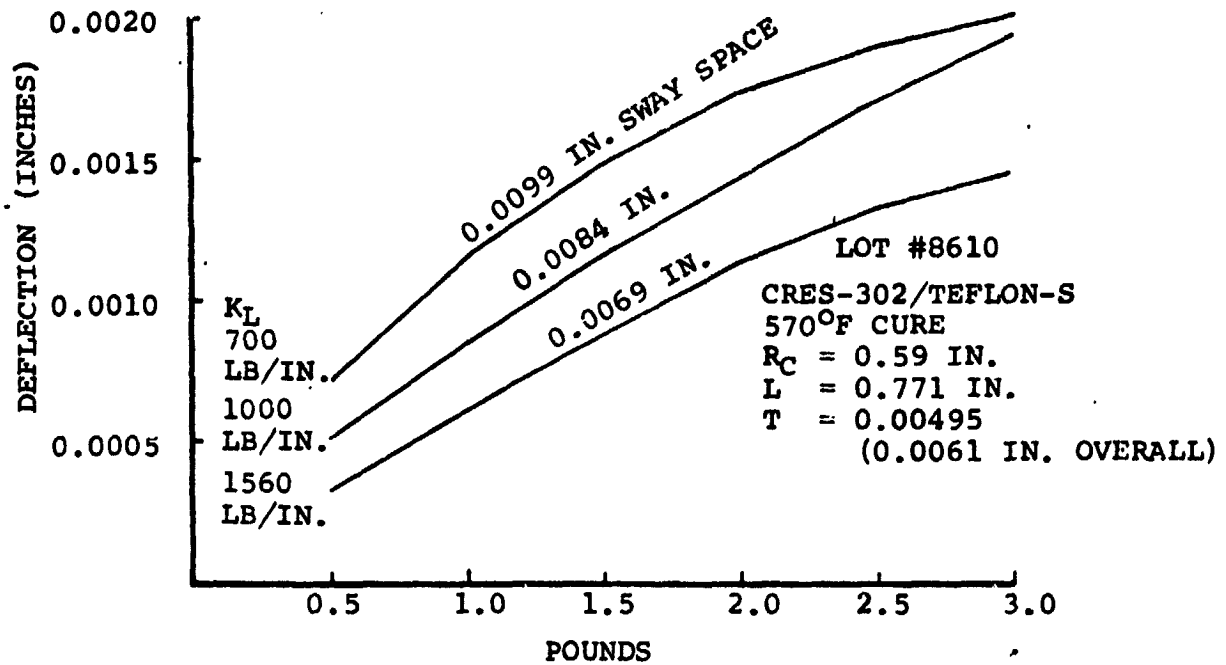
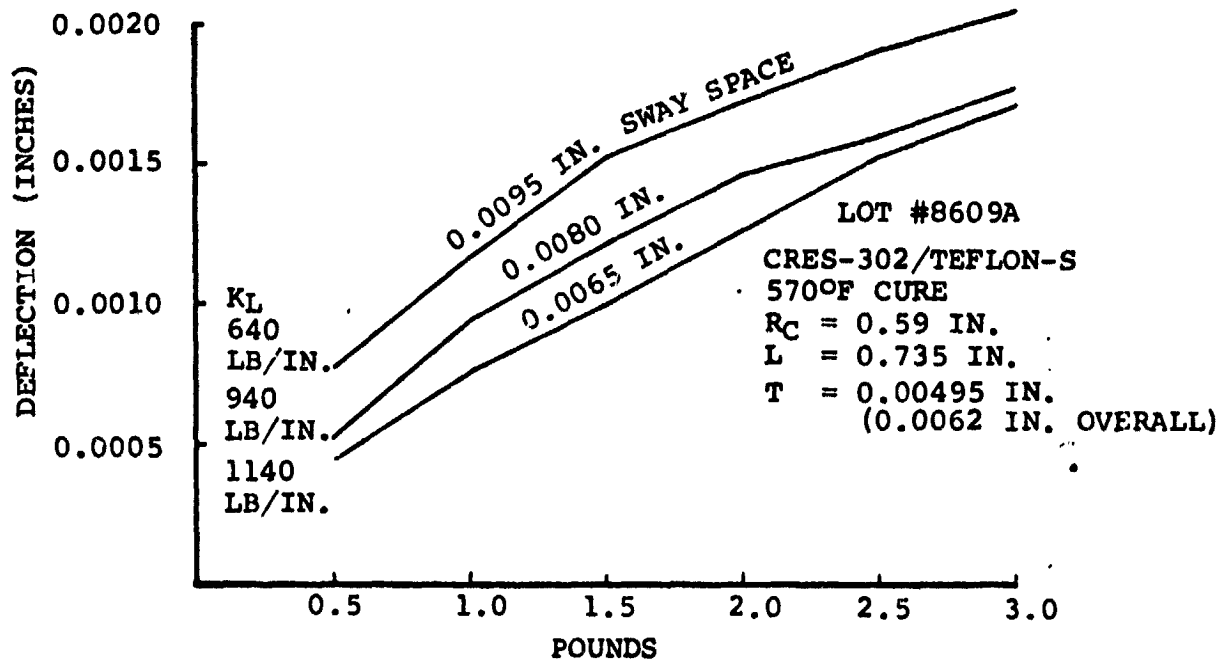
Figure 18. - Spring Rate,  $K_1$ , Versus Sway Space  
(two sets of foil bearings).

Two sets of foils were repeatedly tested, the measurements averaged, and the resulting data plotted. The two sets of foils were similar except for length. Lot No. 8610 was "standard" length; Lot No. 8609A was approximately 0.035 in. shorter in length. As anticipated, stiffness (spring rate) for each set of foils increased as the sway space was decreased. These results, however, did not fully support the contention that reducing the foil length would in all cases reduce the spring rate for a given sway space. For the smallest sway spaces (0.0065 in. and 0.0069 in.), the shorter foils did, indeed, exhibit a lower spring rate for all loads from 0.5 through 3.0 pounds. However, the plots for the other larger sway spaces are inconclusive.

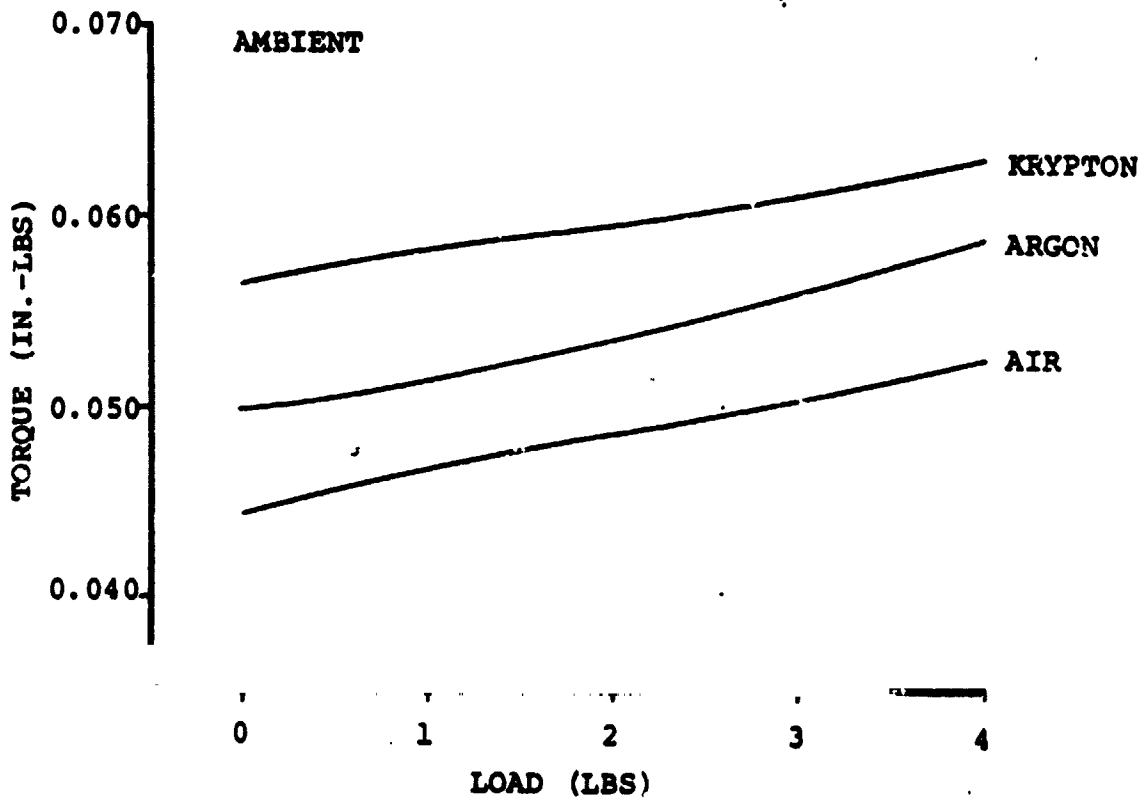
Figure 29. - Torque Versus Load for Three Cases at Ambient Conditions.

8 TEFLON S FOILS, 5.85 MIL THICK,  
0.770" LONG, 0.61" RAD., 1.0702"  
CARRIER, 0.0084" SWAY, 52K RPM

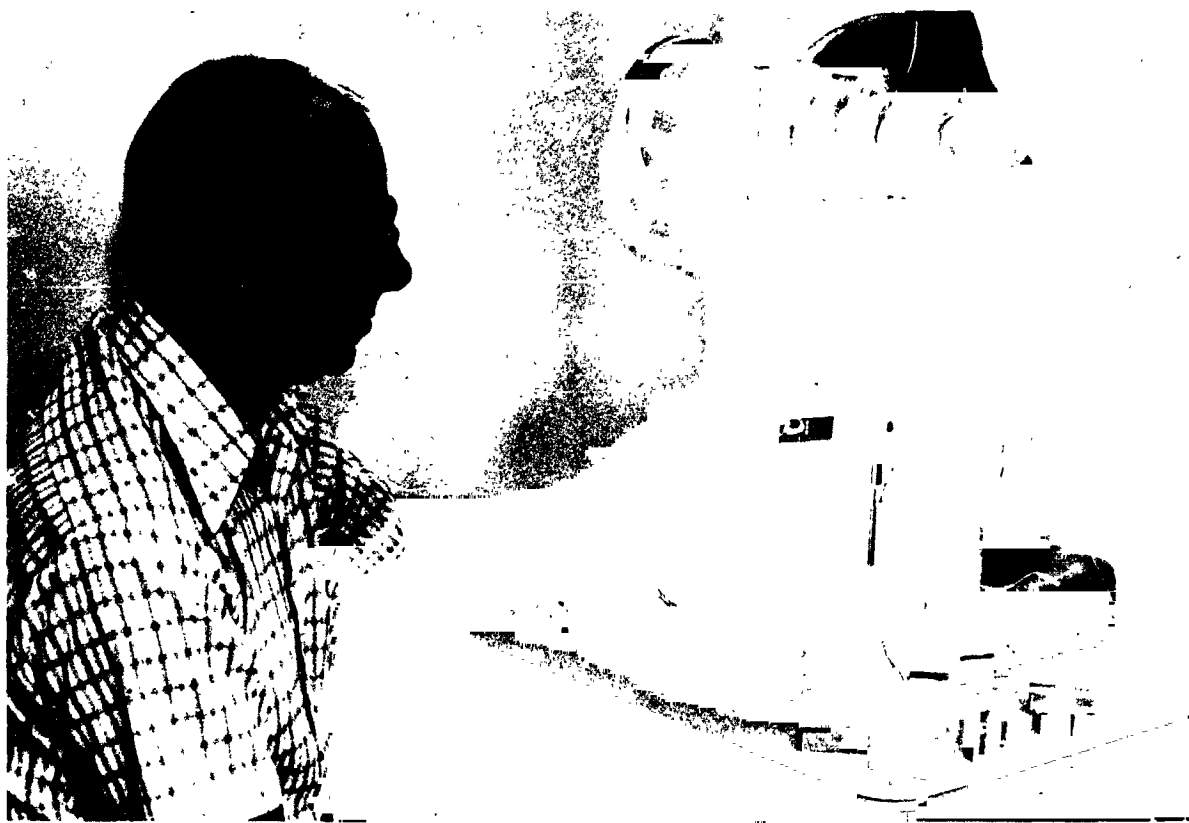
Figure 38. - Foil Bearing Forming Die.

Originally the radius was formed by careful utilization of a three element roller. An attempt was made to develop a forming die which would use fixed geometry dies to make the process absolutely uniform. This die is shown in Figure 38. The foils formed were found to be very uniform but slight variations in material thickness or rate of forming would cause variations in the true radius. A comparison of "rolled" and "formed" foils is shown in Figures 39 and 40. Table XV gives a numerical comparison of key parameters for rolled and formed foils.
