HYDRODYNAMIC AIR LUBRICATED COMPLIANT SURFACE BEARING FOR AN AUTOMOTIVE GAS TURBINE ENGINE II - MATERIALS AND COATINGS

Bharat Bhushan, David Ruscitto, and Stanley Gray
Mechanical Technology Incorporated
Latham, New York 12110

July 1978

Prepared for the
NATIONAL AERONAUTICS AND SPACE ADMINISTRATION
Lewis Research Center
Cleveland, Ohio 44135

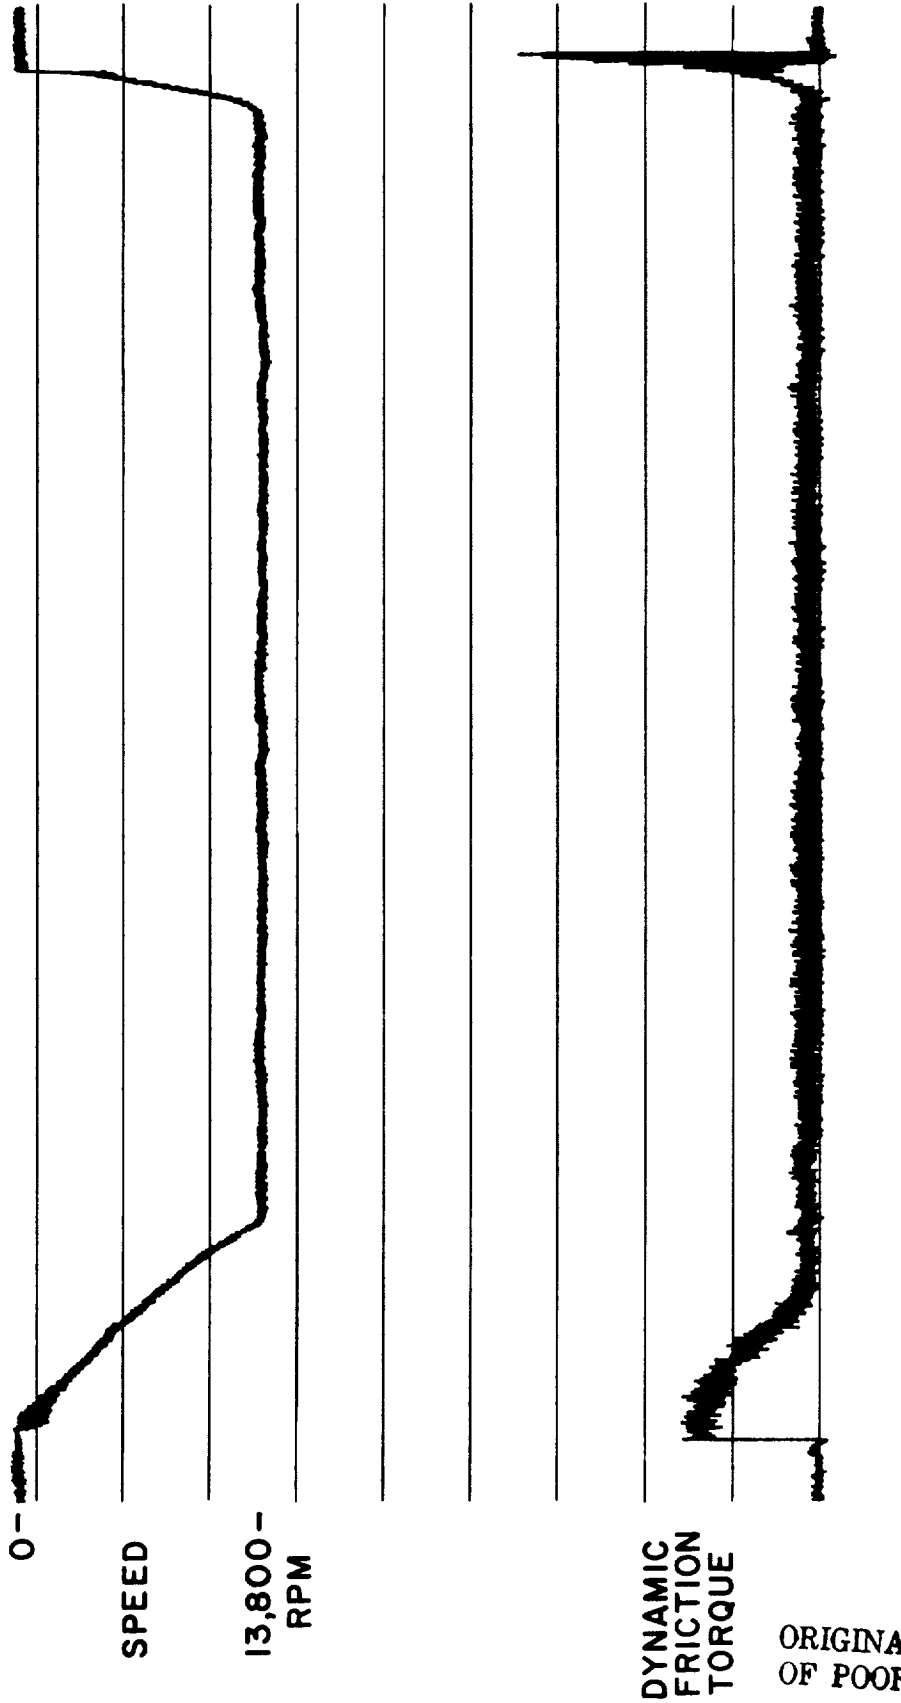
END OF CYCLE, PERIOD
ELAPSED = 16 SEC.

START OF
CYCLE

Fig. V.4 Visicorder Trace of Coating Combination Cr₃C₂ Versus HL-800 After 2000 Start-Stop Cycles

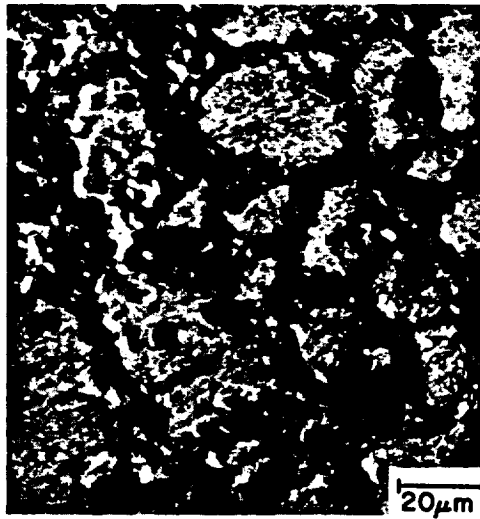
(a) BACK SCATTERED ELECTRON IMAGE

(b) Cr K α X-RAY IMAGE

(c) Ni K α X-RAY IMAGE

Fig. V.14 SEM Micrographs and Diffractographs of Kaman DES Coated Inconel X-750, Heavily Worn Area (Test No. 21)

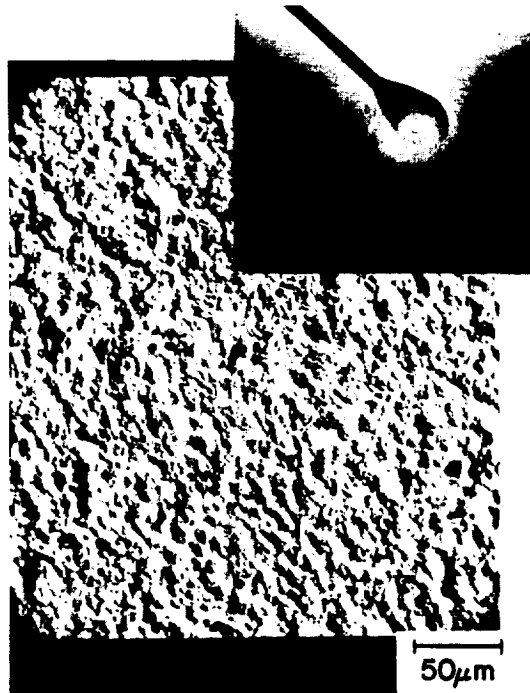
Fig. D.14 Typical SEM Micrograph and Diffractogram of HL-800 on Inconel Base (after oven)

Figure D.14 shows the coating after oven test. Elemental analysis and visual examination of the coating showed the composition of the coating was the same as that of the coating before oven tests except that the graphite content is less. The coating looked intact. CdO particles were not as prominent. They may have reacted with other components in the coating.

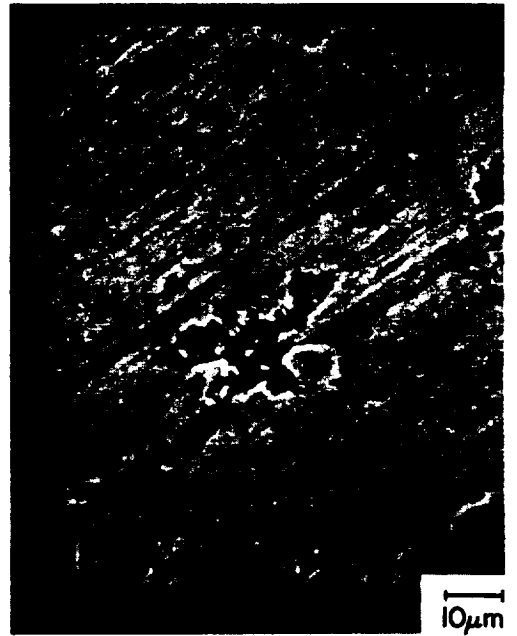
Fig. D.16 Typical SEM Micrographs of Plasma Sprayed Tribaloy 800 on A286 Base (surface ground)
