NASA Technical Memorandum 78738

NINE PERCENT NICKEL STEEL
HEAVY FORGING WELD REPAIR
STUDY

July 1978

Langley Research Center
Hampton, Virginia 23665

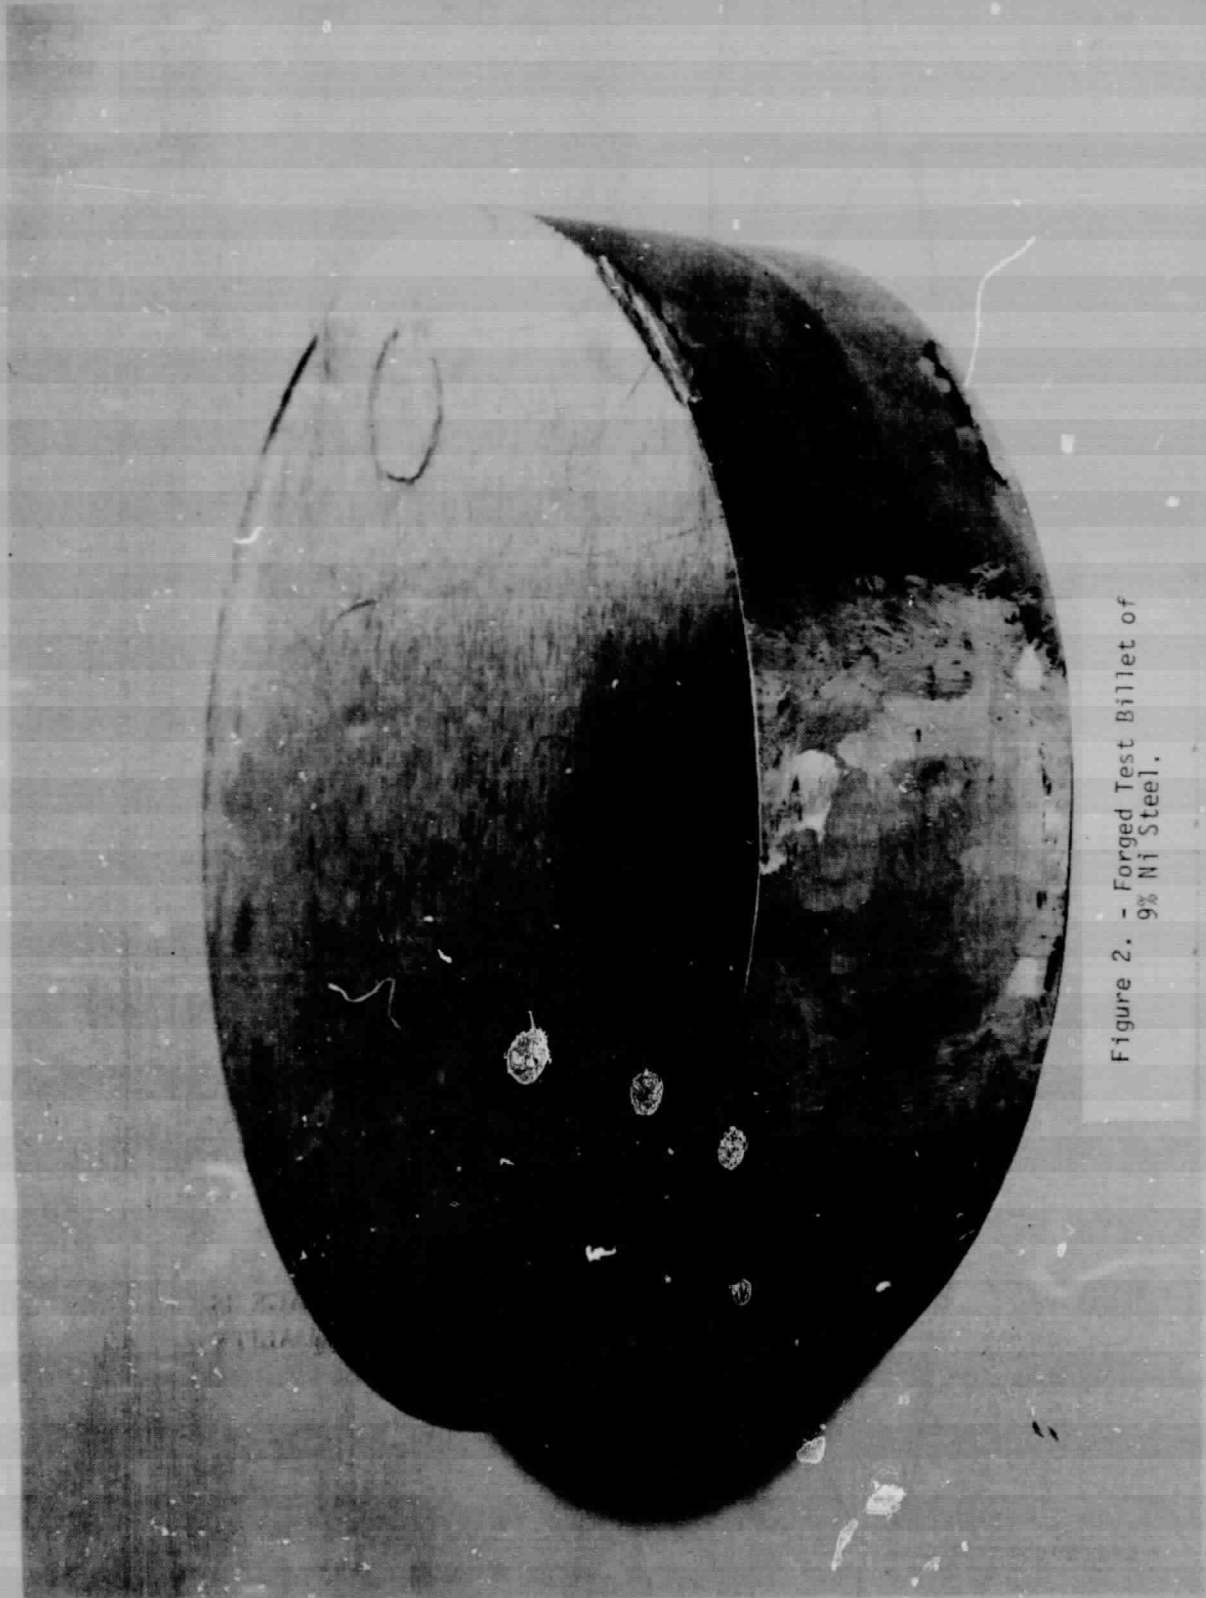
Figure 2. - Forged Test Billet of
9% Ni Steel.

Weld Repair Geometry. - The approach was to utilize existing forging material in 9% Nickel that would have the same chemical composition and heat treatment as the actual Fan Disk part. The test part was a 3 inch thick by 10 inch diameter 9% Nickel forging (disk shape) provided by the Fan Disk supplier (see figure 2). A weld repair geometry was selected for simulating the repair of a penny shape flaw 1" long by 0.5" deep flaw embedded near the mid thickness of the NTF Fan Disk Forging, (see figure 3 for photograph of the weld cavity placed in the forged part).
