NASA Technical Paper 1274

Erosion/Corrosion of Turbine Airfoil Materials in the High- Velocity Effluent of a Pressurized Fluidized Coal Combustor

Glenn R. Zellars, Anne P. Rowe,
and Carl E. Lowell

JULY 1978

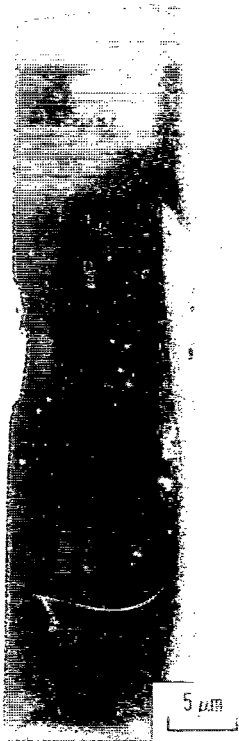
Figure 16. - Knobs on trailing edge of U-700 exposed at 150 meters per second and 800° C for 91 hours.

In the third test, at 150 meters per second and 800^o C for 91 hours, the leading edges were not sharpened as they were at the lower temperature. This was the test condition with the lightest particle loading, an anomalous Δt result for IN-100, and very uneven material removal. All the leading edges and a section of the U-700 trailing edge emerged from the carousel with knobs of the order of 100 micrometers across and 100 micrometers high protruding from the surfaces. Figure 16 shows the U-700 trailing edge knobs in profile, head-on, and at greater magnification. Some leading

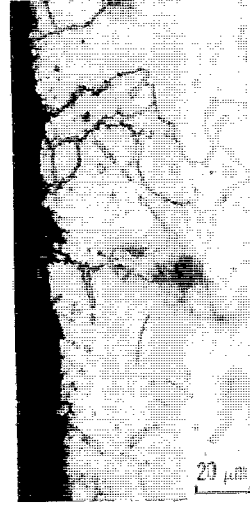
Figure 22. - Right faces of alloys exposed at 270 meters per second and 790° C for 36 hours.

In the final test, at 270 meters per second and 790^o C for 36 hours, the same types of corrosion products were presumably formed as in the third test, but the reaction products were removed more rapidly at the higher velocity. Figure 21 shows one example of nickel-rich oxides underlaid by a chromium-rich region and then a depleted zone containing NiS particles. However, as seen in figure 22, most of the reaction products and depleted zones have been eroded away. Examination of cross sections near the free ends of the specimens instead of at the centers, where the temperature was perhaps lower than at the center but the erosive force was certainly less, revealed both reaction products and depleted zones as shown in figure 23.

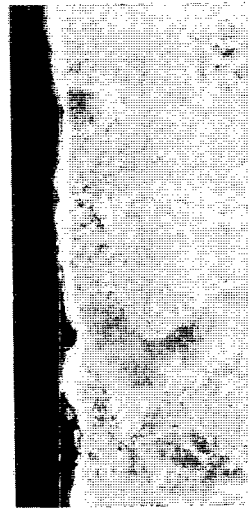
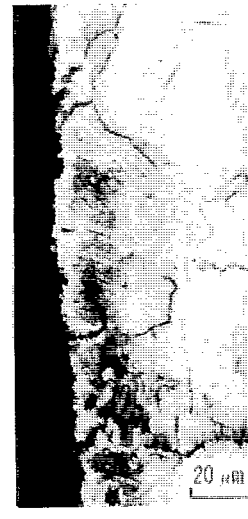
Figure 23. - Right faces near ends of alloys exposed at 270 meters per second and 790° C for 36 hours.
