RESEARCH REPORT CFT RR 78-16	June 22, 1978
FLAW GROWTH OF 7075, 7475, 7050 AND 7049 ALUMINUM ALLOY PLATE IN STRESS CORROSION ENVIRONMENTS (CONTRACT NAS8-30890): 2-YEAR MARINE ATMOSPHERE RESULTS	
R. C. Dorward and K. R. Hasse

FLAW GROWTH OF 7075, 7475, 7050 AND
7049 ALUMINUM ALLOY PLATE IN STRESS
CORROSION ENVIRONMENTS (CONTRACT
NAS8-30890): 2-YEAR MARINE
ATMOSPHERE RESULTS

R. C. Dorward and K. R. Hasse

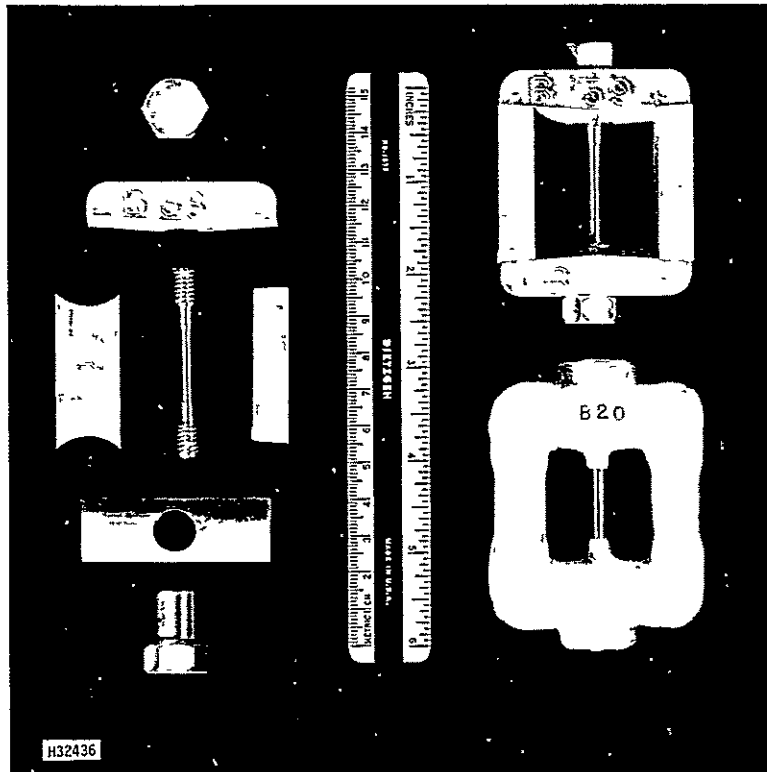
Figure 1. Tensile Round Stress-Corrosion Specimen and Stressing Frame

Left: 3.175-mm-diameter tensile specimen and components of the stressing frame.

Upper Right: Assembled frame with specimen as it appears before stressing.

Lower Right: Stressed specimen and frame coated with 5% polyethylene-paraffin wax (for laboratory tests). Marine atmosphere frames are anodized.

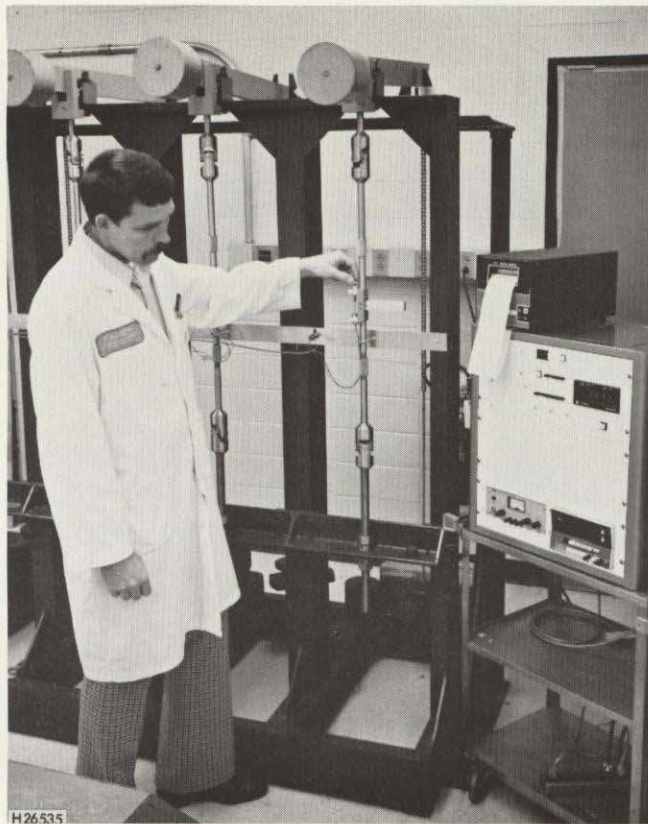
Figure A-1. Direct Load Tests of DCB Specimens

Left: Creep rupture stands are used to apply a constant load to DCB specimens. Power supply and data acquisition system for excitation and recording of output (respectively) from LVDT's are at right in photo.

Right: DCB specimen and the LVDT used to monitor deflection of the specimen are shown in greater detail.

S-L DCB specimens, machined from the 76-mm 7075-T651 and 7075-T7651 plates, had the same dimensions as shown in Figure 2, except that they contained pin-loading holes rather than bolt holes. Fatigue precracks were introduced with an axial fatigue machine and the specimens were then loaded in creep-rupture stands (Figure A-1). Deflections were monitored with linear voltage transducers.

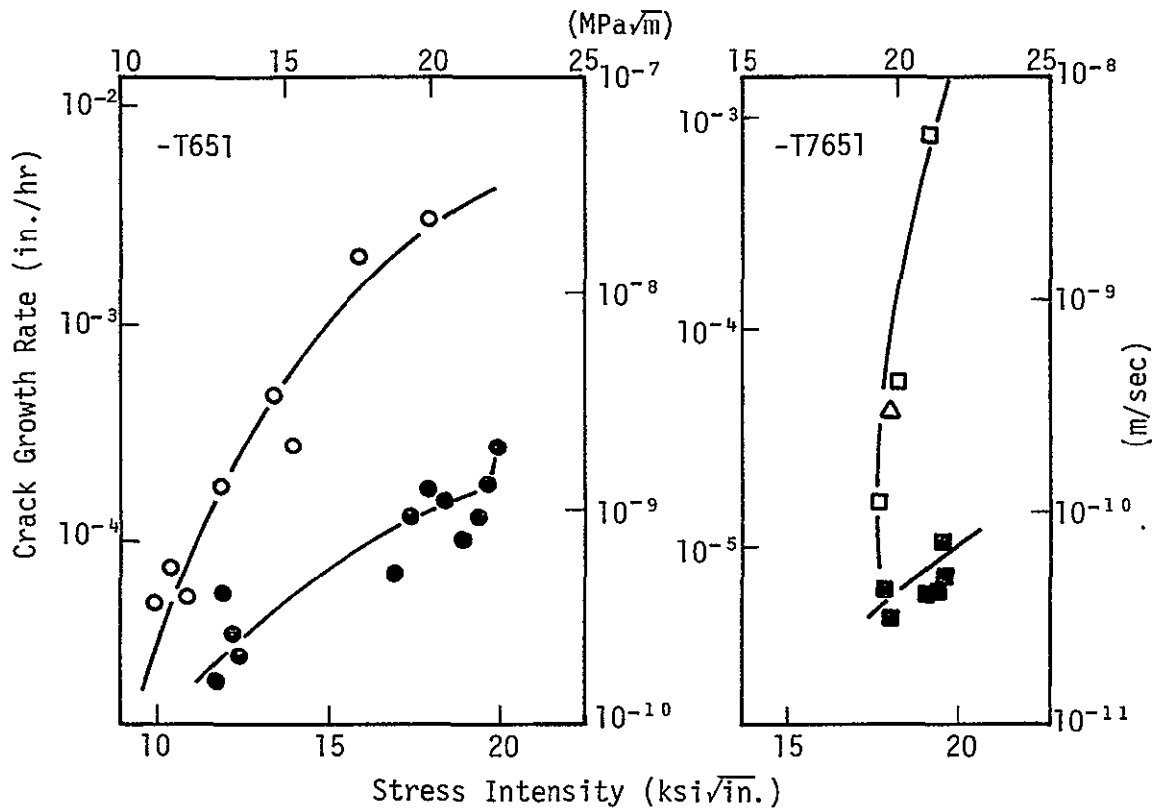
Figure A-3. V-K Plots for 7075-T651 and -T7641 Plate as Determined with S-L DCB Specimens Exposed to Synthetic Seawater

Solid symbols--constant load test; open symbols--constant deflection test. Triangle gives average crack velocity over the entire exposure period based on fracture surface measurement of crack length.

Figures A-3 and A-4 show V-K curves for the artificial seawater environment. The constant-load curves for both materials were substantially displaced from those for the bolt-loaded specimens (lower crack velocity for a given stress intensity). Crack growth in the direct-loaded -T651 temper material was so slow at the initial stress intensity that the load was increased after about 4 months of exposure. The -T7651 temper material never did fracture in the 9-month total exposure period.
