**NASA TECHNICAL  
MEMORANDUM**

**NASA TM-78897**

A COMPARISON OF THE LUBRICATING MECHANISMS OF  
GRAPHITE FLUORIDE AND MOLYBDENUM DISULFIDE FILMS

TECHNICAL PAPER to be presented at the  
Second International Conference on Solid Lubrication  
sponsored by the American Society of Lubrication Engineers  
Denver, Colorado, August 14-18, 1978

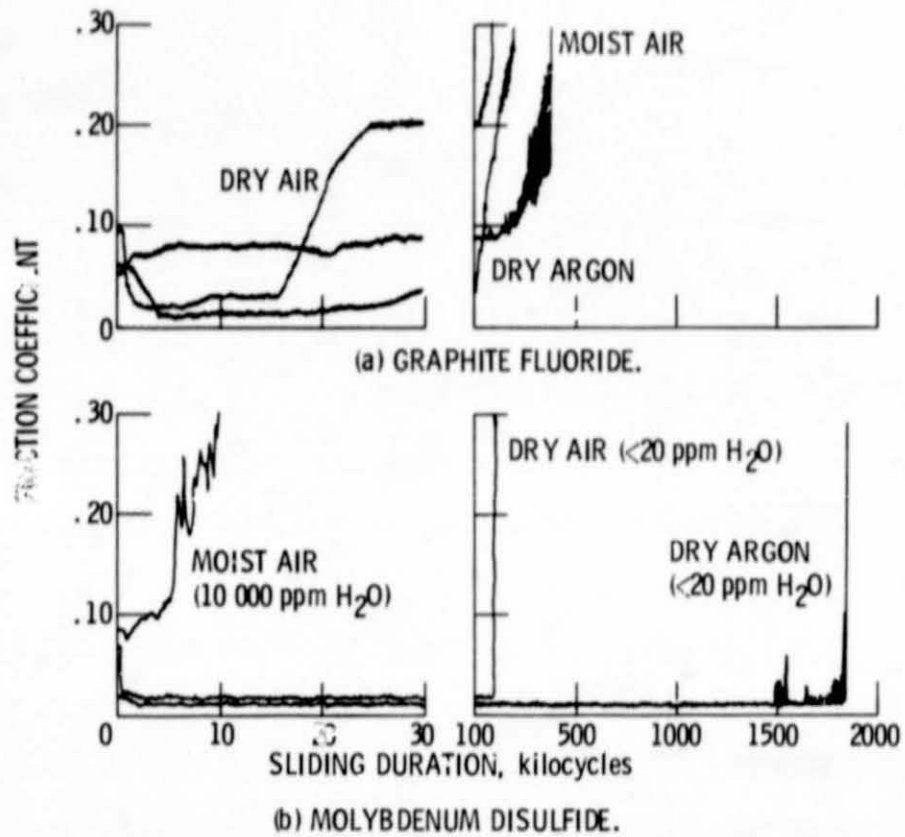
Figure 4. - Friction coefficient as a function of sliding duration for (a) Graphite fluoride films and (b) Molybdenum disulfide films evaluated in three different atmospheres.

Friction traces for 440C HT steel riders sliding on rubbed films of graphite fluoride ( $(\text{CF}_x)_n$ ) and molybdenum disulfide ( $\text{MoS}_2$ ) are shown in Fig. 4. Each film was evaluated at room temperature ( $25^\circ \text{C}$ ) in three different atmospheres; moist air of approximately 50 percent relative humidity (10 000 ppm  $\text{H}_2\text{O}$ ), dry air ( $<20$  ppm  $\text{H}_2\text{O}$ ), and dry argon ( $<20$  ppm  $\text{H}_2\text{O}$ ).

The friction coefficient and wear lives of  $\text{MoS}_2$  films were highly dependent on atmosphere. In dry air and dry argon, the friction coefficients were found to be nearly equal ( $<0.02$ ); however in moist air, the lowest value of friction coefficient obtained was 0.08. Wear life was more highly affected by atmosphere than was the friction coefficient. In moist air, failure occurred after only 10 kilocycles of sliding, while in dry air the wear life was 100 kilocycles and in dry argon it was 1800 kilocycles.

The friction coefficient of  $(\text{CF}_x)_n$  films was found to be very similar to  $\text{MoS}_2$  films, however the variation in wear life (in different atmospheres) was not as great. The longest wear life was obtained in moist air (380 kc) and the shortest in dry air (100 kc), dry argon gave an intermediate wear life of 180 kilocycles. An advantage of  $(\text{CF}_x)_n$  over  $\text{MoS}_2$  is its ability to lubricate for longer periods of time (380 vs. 10 kc) under environmental conditions which one might consider normal (50 percent relative humidity air). Under inert conditions however  $\text{MoS}_2$  was superior to  $(\text{CF}_x)_n$ .

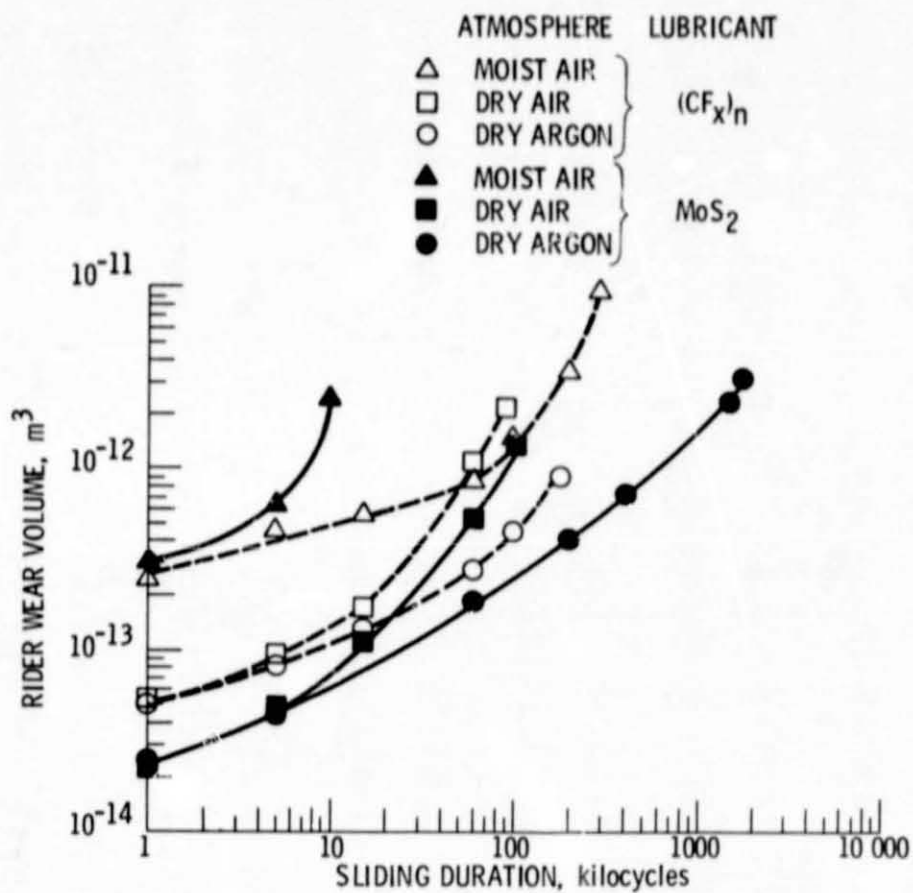
Figure 5. - Effect of atmosphere on rider wear volume as a function of sliding duration for riders which slid on graphite fluoride or molybdenum disulfide films rubbed onto sanded 440C HT steel disks.

Rider wear as a function of sliding duration is shown in Fig. 5 for riders which slid on the  $\text{MoS}_2$  films and  $(\text{CF}_x)_n$  films in the three different atmospheres. In dry air and dry argon less rider wear occurred for the riders which slid on

$\text{MoS}_2$  films than on  $(\text{CF}_x)_n$  films, however in moist air the opposite was true. In general, rider wear did not increase at a constant rate. There appeared to be three regimes to the wear process; the first was an interval of high but gradually decreasing wear rate, the second was an interval of relatively constant wear rate, and the third was an interval of gradually increasing wear rate.

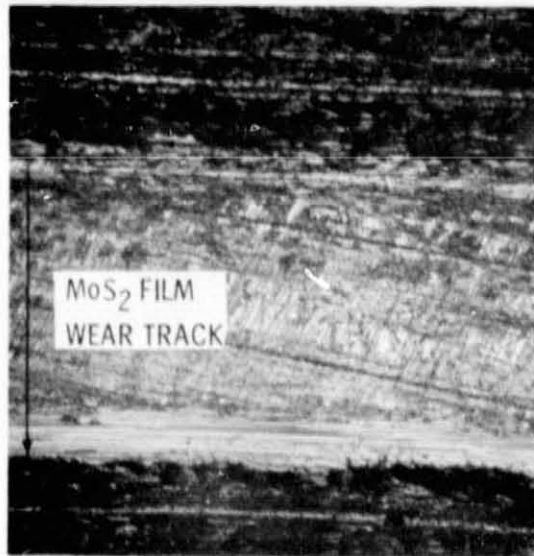
(a) 1 kc OF SLIDING.

Figure 6. - Photomicrograph of rider wear scars and MoS<sub>2</sub> film wear tracks taken after various sliding intervals in a moist air atmosphere (10,000 ppm H<sub>2</sub>O).

The first atmosphere to be discussed is an atmosphere which might be considered a typical condition; that is, an atmosphere of 50 percent relative humidity air at  $25^\circ \text{C}$  (10 000 ppm  $\text{H}_2\text{O}$ ). Figure 6 shows the sliding surfaces after 1, 5, and 10 kilocycles of sliding.

The wear track on the rubbed  $\text{MoS}_2$  films is shown in

Fig. 6(a) and 7(a) after 1 kilocycle of sliding. In the center of the wear track most of the original film has been plowed away and what remained was compacted  $\text{MoS}_2$  in the sanded scratches. The  $\text{MoS}_2$  tended to flow from the scratches in very thin films across the flat metallic plateaus between the scratches.

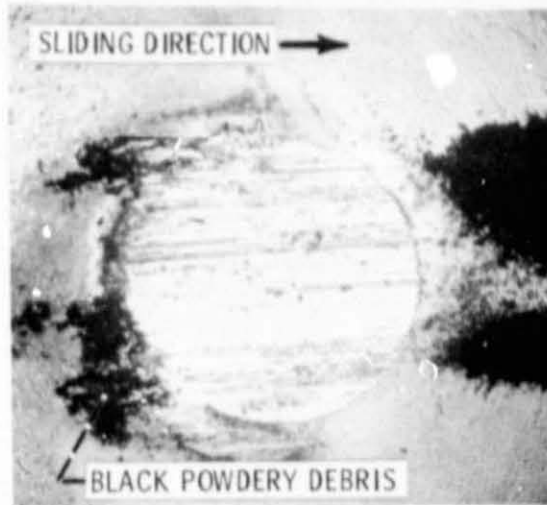
(b) 5 kc OF SLIDING.

Figure 6. - Continued.

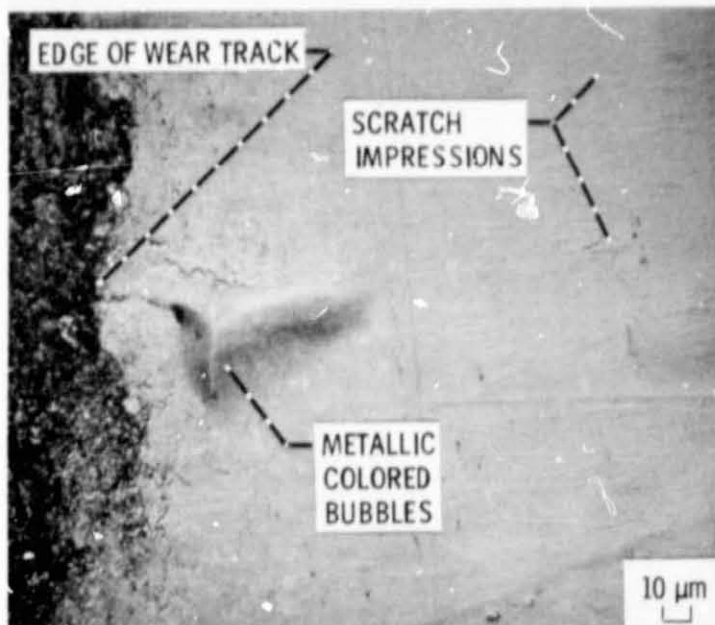
(a) 1 kc OF SLIDING.

(b) 60 kc OF SLIDING.

Figure 10. - High magnification of MoS<sub>2</sub> film wear tracks which were obtained in a dry argon atmosphere (<20ppm H<sub>2</sub>O) after various sliding intervals.

(c) 700 kc OF SLIDING.

(d) 1860 kc OF SLIDING.

Figure 10 gives high magnification photomicrographs of interesting features found on the film wear track after various sliding intervals in dry argon. After 1 kilocycle of sliding (fig. 11(a)), the film on the wear track was smooth and continuous and the metallic substrate could not be seen. A few bubble-like protrusions could be seen after 1 kilocycle of sliding at the outer edges of the wear track (fig. 10(a)), and after longer durations of sliding these bubbles could be found also in the center of the wear track. Figure 10(b) shows one of these bubble areas in which the bubbles have cracked and spalled from the surface. These areas of bubbling, cracking, and spalling were localized and most of the track remained smooth and continuous. Since no change occurred in color (i.e., they remained metallic colored and did not turn black), it is surmised that no transformation of  $\text{MoS}_2$  was occurring.

On continued sliding, the spalled areas tended to be self-healing; nevertheless, after long sliding durations (700 kc) the films started to thin in the center (fig. 10(c)). At failure (1860 kc of sliding), the wear track surface was covered with a coarse, powdery type of material. Thus, as found in moist air and dry air, failure was characterized by the buildup of a coarse, powdery film. In contrast to the air results though, this powdery debris was believed to result from the depletion of  $\text{MoS}_2$  by the radial flow from the contact area rather than by depletion of  $\text{MoS}_2$  by chemical transformation.

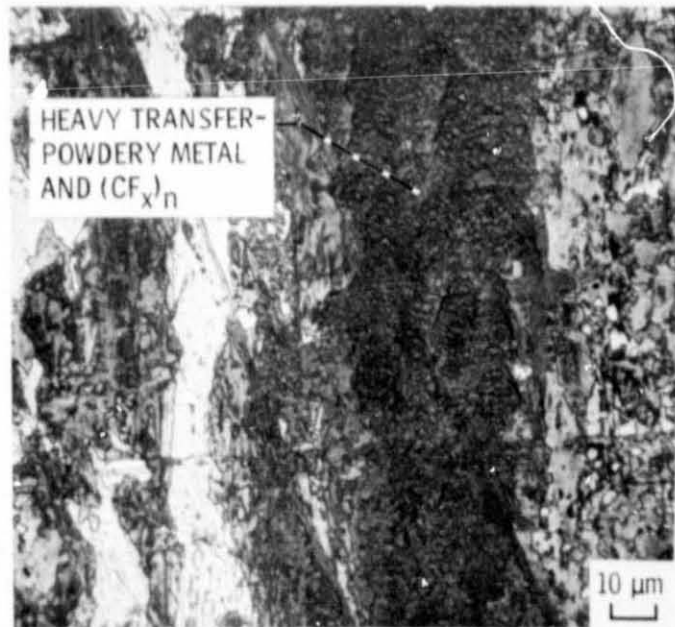
(a) RIDER WEAR SCAR.

Figure 14. - Photomicrographs taken after 308 kilocycles of sliding in a moist air atmosphere (10 000 ppm H<sub>2</sub>O).

(b)  $(\text{CF}_x)_n$  FILM WEAR TRACK

What happened to the surfaces when friction was gradually increasing was quite interesting. Figure 14 shows the surfaces at the time the friction coefficient reached a value of 0.20 (308 kc of sliding). Dark bands of heavy transfer were seen on both the rider wear scar and the film wear track. These bands were found to be a mixture of  $(CF_x)_n$  and fine metallic wear particles. The formation of these bands was

believed to result from the depletion of  $(CF_x)_n$  from localized regions in the film wear track. These regions generate excessive metallic wear particles which mix with  $(CF_x)_n$  present in other regions to produce circumferential bands on the track.

High magnification observation of these bands indicated that even though they contained fine metallic debris, flow still occurred (fig. 14). After 380 kilocycles of sliding, however, the flow properties of the film (both on the rider and the disk wear track) were not nearly as good. Transfer became darker and more powdery. Examination of the wear areas under crossed polarizing filters, showed very few birefringent particles.

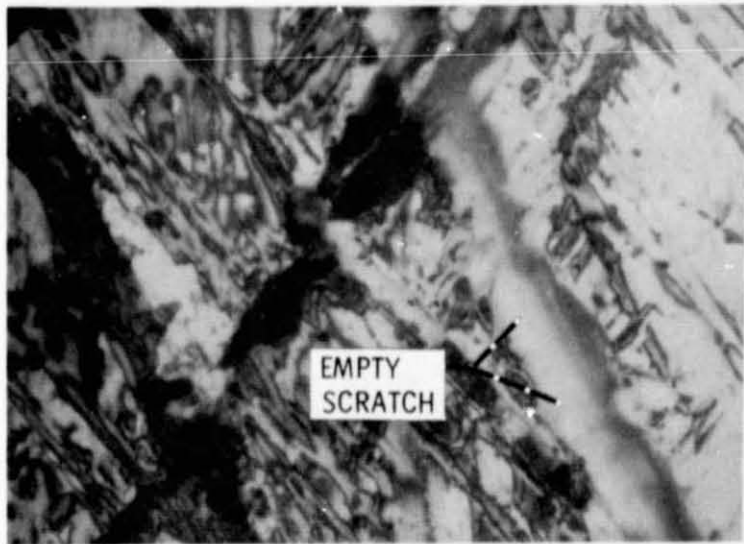
(a) RUN-IN PHASE,  $\mu = 0.10$  (1/4 kc OF SLIDING).

Figure 15. - Photomicrographs of the same area on a graphite fluoride film wear track after various sliding intervals in a dry air atmosphere ( $< 20$  ppm  $H_2O$ ).

(b) LOW FRICTION PHASE,  $\mu = 0.02$  (3 kc OF SLIDING).

(c) HIGH FRICTION PHASE,  $\mu = 0.20$  (24 kc OF SLIDING).

$(CF_x)_n$  films were also evaluated in a dry air atmosphere. In dry air the same three regimes of friction occurred. A run-in phase ( $\mu = 0.10$ ), a low friction phase ( $\mu = 0.02$ ), and a phase of gradually increasing friction. The tests were stopped and the surfaces were observed in each of the three regimes. Figure 16 gives photomicrographs of the same area on the  $(CF_x)_n$  film wear track taken during the (a) "run-in" phase (1/4 kc of sliding), (b) during the low friction phase (3 kc of sliding), and (c) during the high friction phase (24 kc of sliding).

One obvious difference in surface characteristics between moist air and dry air was that in dry air the  $(CF_x)_n$  disengaged from the scratches much more readily than it did in moist air. This disengagement can be seen in Fig. 15(b) and (c), where empty scratches can be seen. Another difference is that during the low friction phase, the  $(CF_x)_n$  in dry air tended to clump together more than it did during the moist air tests (fig. 15(b)). It is possible that disengagement from the scratches was in some way related to the lower friction obtained, but it was also detrimental to wear life due to the fact that it led to a more rapid depletion of  $(CF_x)_n$  from the wear track.

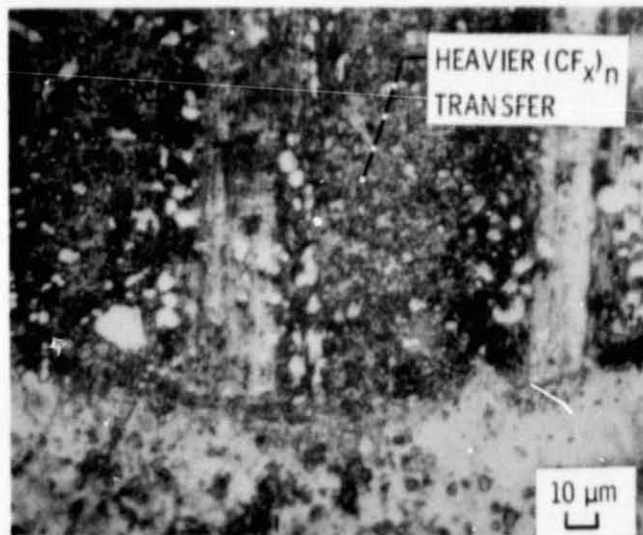
(a) RUN-IN PHASE,  $\mu = 0.10$  (1/4 kc OF SLIDING).

Figure 16. - Photomicrographs of rider wear scars which slid on the graphite fluoride films shown in figure 15.

(b) LOW FRICTION PHASE,  $\mu = 0.02$  (3 kc OF SLIDING).

(c) HIGH FRICTION PHASE,  $\mu = 0.20$  (24 kc OF SLIDING).

Figure 16 shows photomicrographs of the rider transfer films which correspond to the intervals of Fig. 15. Compared to the moist air tests, the rider run in dry air had a thicker transfer film on it. Also there was more transferred  $(CF_x)_n$  material at the sides of the wear scar than found for moist air tests. The difference in transfer may have been a contributing factor to the lower friction attained in dry air.

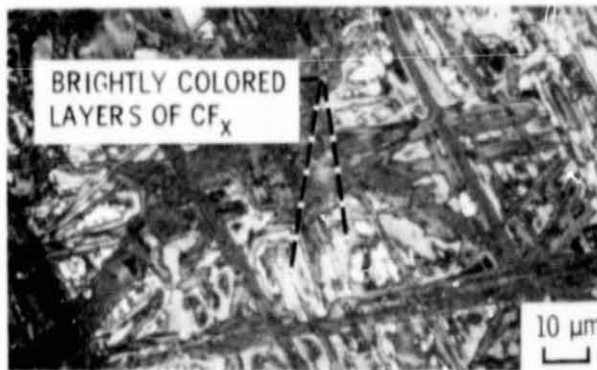
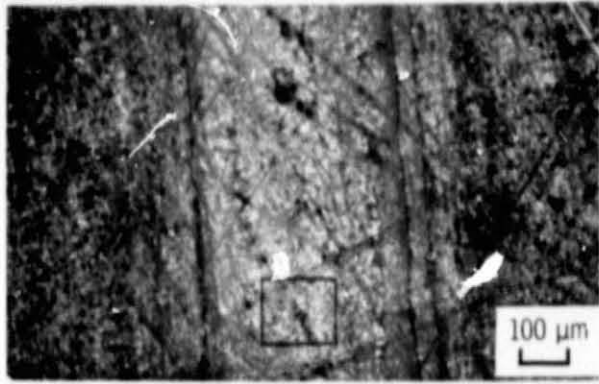
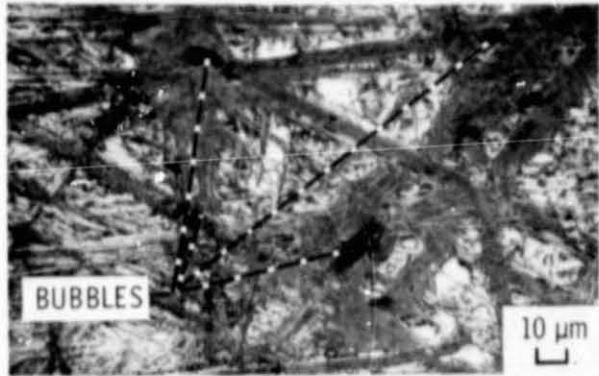
(a) 1kc OF SLIDING.

Figure 17. - Photomicrographs of a graphite fluoride film wear track after various sliding intervals in a dry argon atmosphere ( $< 20$  ppm  $H_2O$ ).

(b) 15 kc OF SLIDING.

(c) 60 kc OF SLIDING.

(d) 180 kc OF SLIDING.

The results from tests which were conducted in a dry argon atmosphere were very similar to those obtained in dry air. Rider wear scars, transfer films, and the  $(CF_x)_n$  film near tracks did not look much different. Figure 17 gives photomicrographs of the film wear track after (a) 1, (b) 15, (c) 60, and (d) 180 kilocycles of sliding. The same general film wear process (as was found in moist air or in dry air) was found to also occur in dry argon, and that was a gradual depletion of the  $(CF_x)_n$  from the contact region.

One difference between the dry air and dry argon tests was that the  $(CF_x)_n$  did not as readily disengage from the scratches, and this most likely was the reason for the longer life in dry argon. Another difference was that heavy bands of transfer did not form on the surface of the rider or the disk wear track when high friction occurred as it did in moist air and in dry air. Some disengagement from the scratches did occur in the form of small bubbles as can be seen in Fig. 17(b).
