**NASA Technical Memorandum 78649**

EFFECTS OF MOISTURE IN INFRARED THERMOGRAPHY OF  
RESIN MATRIX COMPOSITES

January 1978

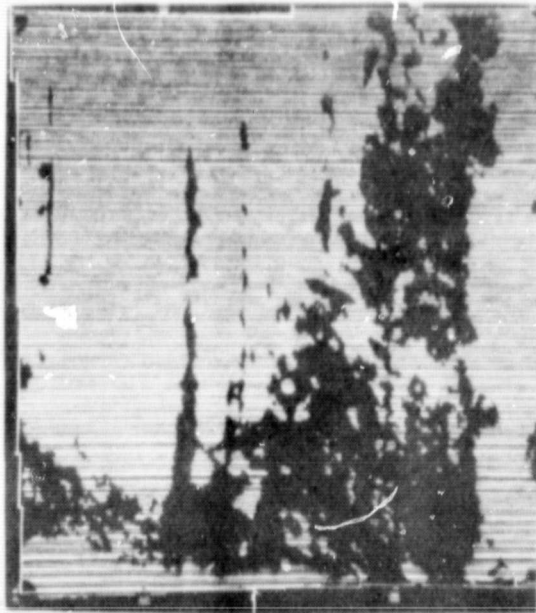
FIGURE 3.- ULTRASONIC SCAN OF THE TEST SPECIMEN. (THIS SPECIMEN HAS BEEN USED IN FIGURES 3, 4, 5, AND 7.)

provide additional information about the matrix thickness uniformity, which cannot be easily obtained by other techniques. Figure 3 shows an ultrasonic transmission C-scan of a typical test sample. It shows a defect area on the right. The defect is prominent in the lower portion and decreases in severity towards the upper portion. Figure 4a is a thermogram of the same specimen, taken from the front face in the dry state. Figure 4b represents the wet thermogram under the same conditions. One can see that there is a definite correlation between figures 3 and 4a. The defect area is quite prominent in figure 4a. However, the prominence of the defect area is considerably reduced in the wet thermogram seen in figure 4b. It thus appears that changes in thermal contrast between the dry and moisture bearing state of the sample can signal the presence of moisture in the specimen. Figures 5a and 5b represent the "dry" and "wet" thermograms of the same specimen, at the same temperature but from the rear face. The sharpness of the thermal contrast seen in figure 4a is missing from figure 5a. Furthermore, the thermograms in figures 5a and 5b are not very different from each other. These differences between figures 4 and 5 are discussed in the following section.

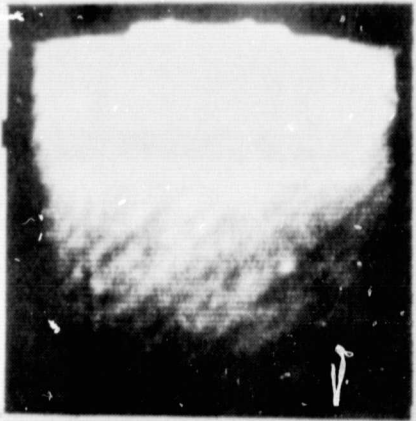
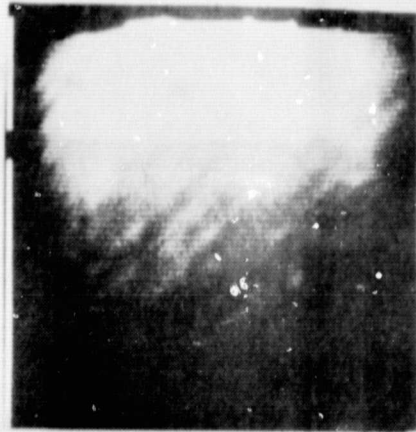
5(A) DRY

5(B) WET

FIGURE 5.- THERMOGRAPH OF DRY AND WET TEST SAMPLE - REAR FACE.

with water, the defect D will trap some water in it and will no longer act as an effective heat shield. Consequently, the presence of water should be signaled by the disappearance of (or reduction in the intensity of) the cold spot present in the thermogram of a defective dry specimen. The change in thermal contrast between the dry and wet state will be more marked when the defect is near the surface studied. This explains the differences between figures 4 and 5. A reflection ultrasonic C-scan (shown in figure 7) confirmed that the defect was nearer the front face than the rear face.
