NASA Technical Paper 1081

Mechanical Behavior and Fracture Characteristics of Off-Axis Fiber Composites I - Experimental Investigation

John H. Sinclair and Christos C. Chamis

DECEMBER 1977

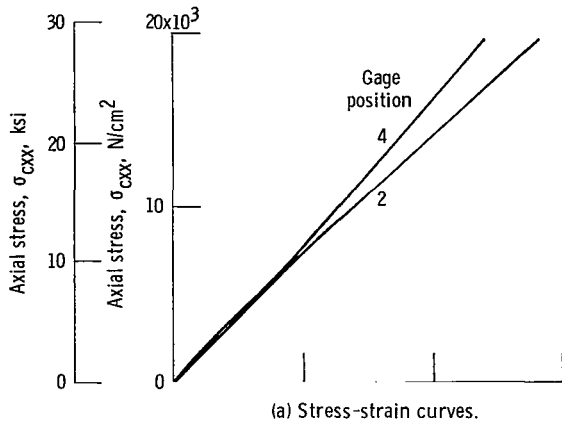
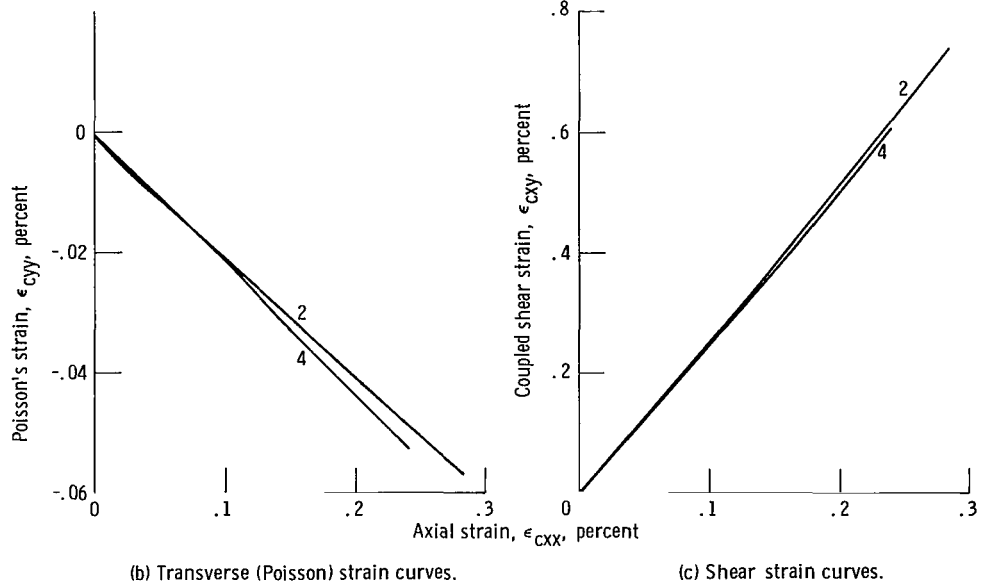
Figure 7. - Computer plotted curves through experimental data for 15° off-axis, Mod I/E fiber-composite, tensile specimen.

Tab-end strains for the specimens tested at 15° , 45° , and 75° off-axis had magnitudes between 0.24 and 0.45 percent and did not vary from midlength strains by more than 18 percent (figs. 7(a), 9(a), and 11(a)), but the transverse specimen (90° off-axis) had a tab end strain of 0.50 percent, which is 139 percent of the midlength strain of 0.36 percent (see fig. 12(a)). The cause for this difference is probably nonuniformities in the laminate due to out-of-plane eccentricities.

The coupled shear strains for this group of specimens lie between 0.08 percent and 0.74 percent. Again, the larger values for a given specimen are found sometimes at the tab end and sometimes at the midlength (parts (c) of figs. 5, 7, 9, and 11).

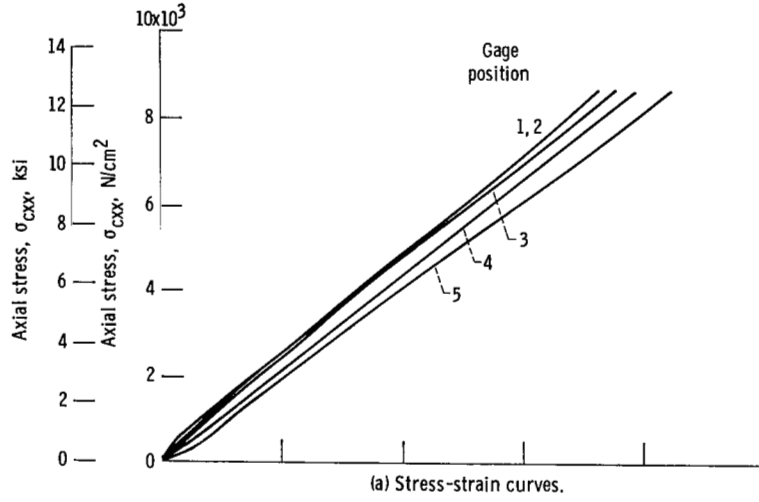
Figure 8. - Computer plotted curves through experimental data for 30° off-axis, Mod I/E fiber-composite, tensile specimen.

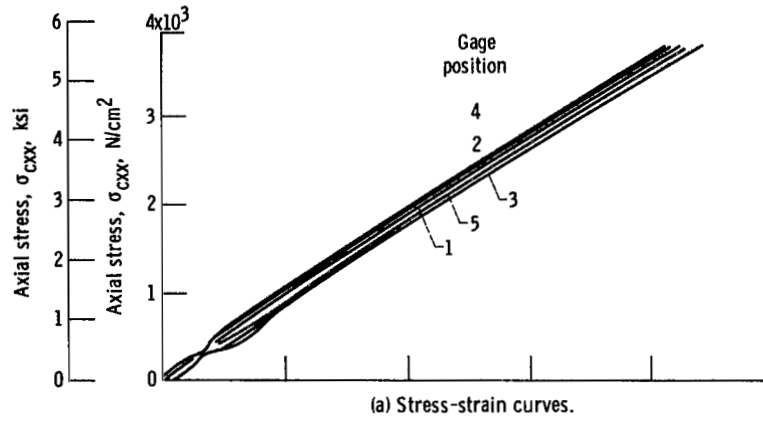
Figure 10. - Computer plotted curves through experimental data for 60° off-axis, Mod I/E fiber-composite, tensile specimen.

The fracture strains measured at the five gage sites for the 60° off-axis specimen ranged from approximately 0.41 percent to 0.44 percent (fig. 10(a)).

Figure 6(b) shows Poisson's strains as a function of axial strains for the 10° off-axis specimen. They range between 0.45 and 0.085 percent. At any level of axial strain $\epsilon_{c_{xx}}$, it can be seen that the Poisson's strains $\epsilon_{c_{yy}}$ are larger at the specimen edges than at the center. Note that the difference is magnified because of the large scale on the ordinate. This is true both near the tabs and at the specimen midlength. The cause for this behavior is probably due to coupling between normal, shear strains, and transverse strain in the presence of the possible out-of-plane twisting mentioned previously. The Poisson's strains at fracture for the gage sites on the 30° off-axis specimen lie between approximately 0.062 and 0.089 percent (fig. 8(b)) and those for the 60° off-axis specimen range from about 0.03 to 0.04 percent (fig. 10(b)).

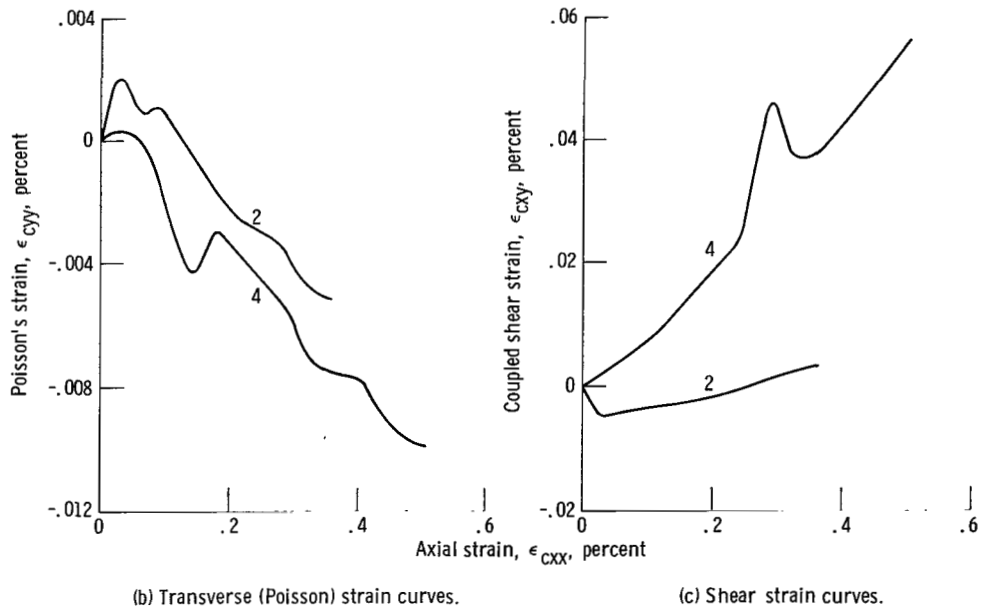
Figure 12. - Computer plotted curves through experimental data for transverse (90°) fiber-composite tensile specimen (Mod-I/E).

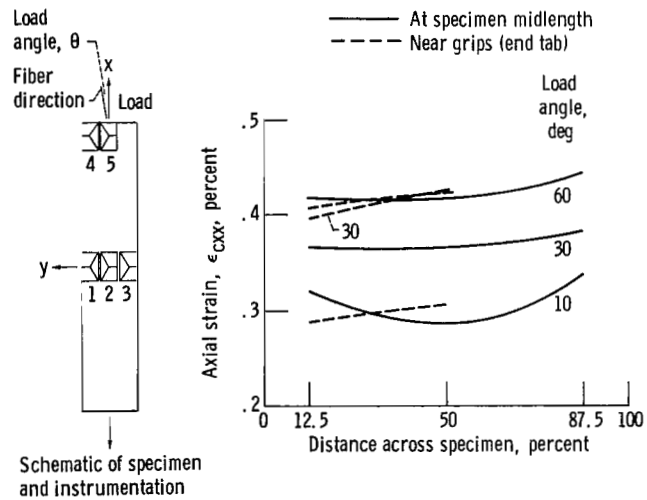
Measured axial strains at fracture

Figure 13. - Axial strain variation at fracture across specimens of Mod I/E composite loaded at various angles from fiber direction.

Axial strains at fracture are shown in figure 13 for specimens tested at load angles of 10° , 30° , and 60° from the fiber direction (five gage specimens). These data points, taken directly from the measured stress-strain data, are accompanied by a schematic of the specimens and plots of strain against gage location.

For the 10° off-axis specimen the experimentally measured fracture strains are higher at the specimen edges than at the center (0.320 percent and 0.336 percent compared with 0.287 percent) for the gages located at the midlength. Near the tensile grips, however, the strain was higher halfway across the specimen (0.305 percent) than near the edge (0.288 percent). It is suspected that these differences are due primarily to the restraining effects of the grips. The important point to observe is that the difference between the axial strains at the edges (at the specimen midlength) is less than 5 percent. At the tab end the strains are very close to those measured at midlength. The 0.288 percent at the specimen edge and 0.305 percent halfway across the specimen lie within the strain range measured at the midlength of the specimen.

For the 30° off-axis specimen the fracture strain at midlength measured 0.365 percent at one specimen edge, 0.365 at the center, and 0.380 at the other edge. Near the grips, however, the strains were 0.395 percent at the specimen edge and 0.424 percent halfway across the specimen (fig. 13). As mentioned previously, the difference is suspected to be due to possible out-of-plane eccentricities.

The 60° off-axis specimen shows a narrow range of strains measured at the five gage sites. At the specimen midlength edges, the experimentally measured fracture strains are 0.417 and 0.440 percent, while halfway across the specimen the fracture strain is 0.414 percent. Near the grip the fracture strain was 0.406 percent at the specimen edge and 0.421 percent halfway across the specimen. As with the 10° off-axis specimen, the fracture strains at midlength are higher at the specimen edges than the halfway across the specimen, while near the grips the strain halfway across the specimen exceeds that near the specimen edge. Strain variation among the five gages on the 60° off-axis specimen is less than that observed for the 10° off-axis specimen (see fig. 13).

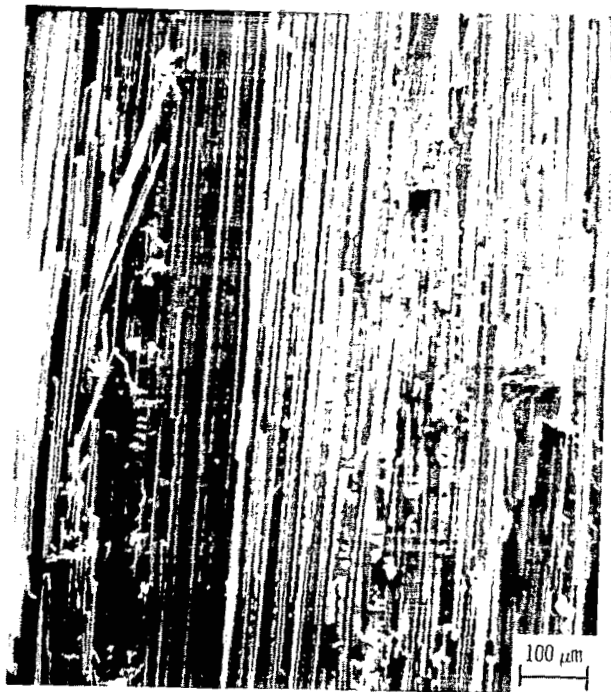
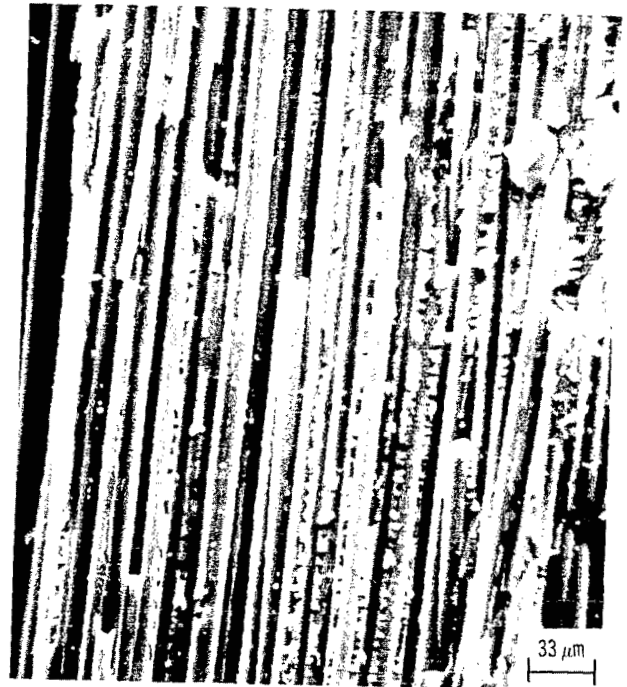
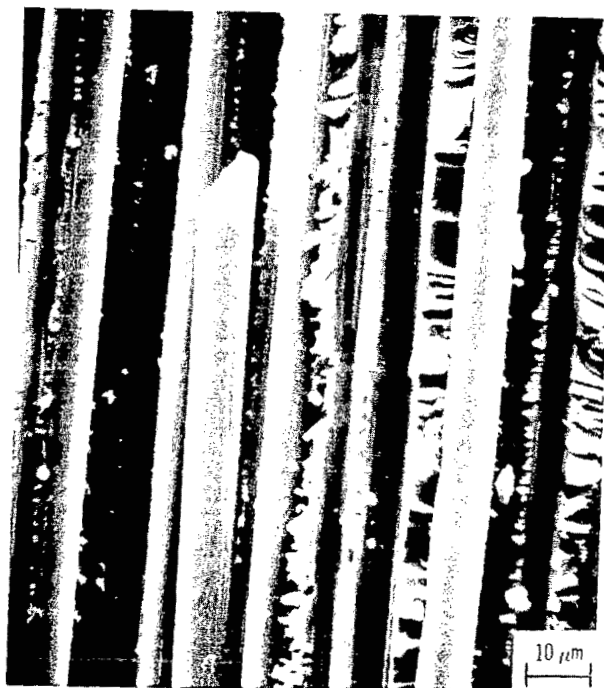
Figure 20. - Scanning electron photomicrographs of fractured surface of Mod I/E composite tested at 30° to fiber direction.

The fracture surfaces of the 15° and 30° off-axis tensile specimens (figs. 19 and 20) reveal similar features to those of the 10° off-axis tensile specimen. These surfaces, too, indicate that fracture was induced mainly by intralaminar shear stress.

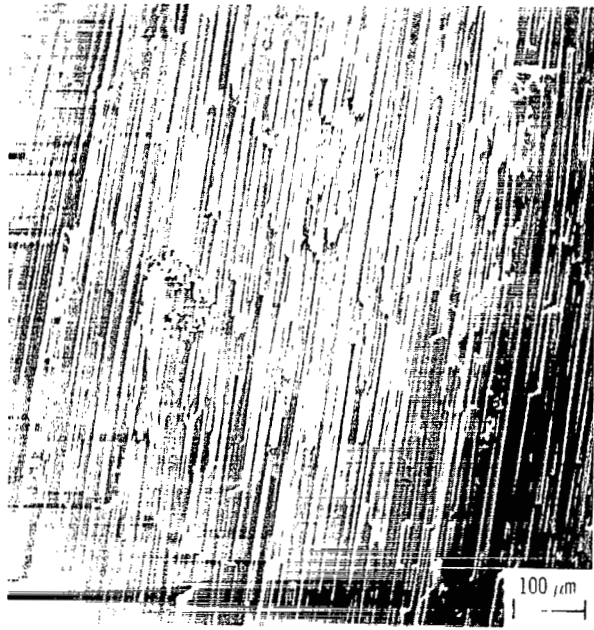
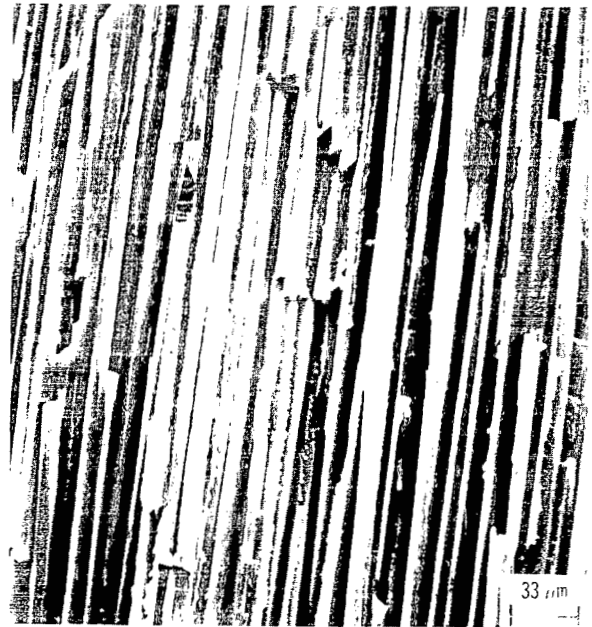
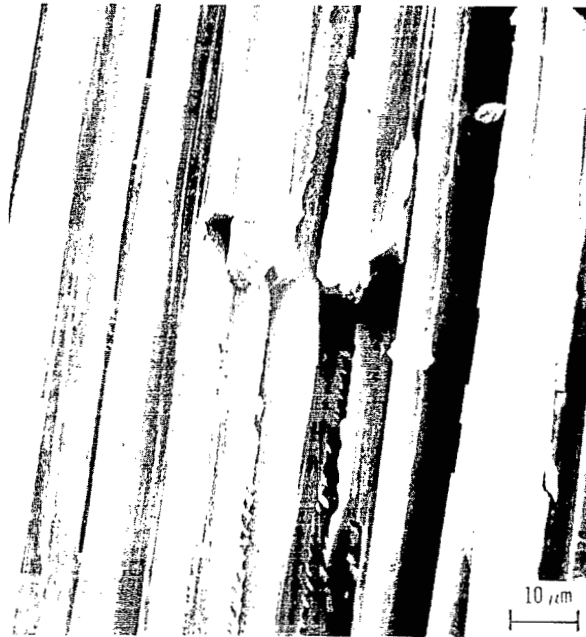
Figure 23. - Scanning electron photomicrographs of fractured surface of Mod I/E composite tested at 75° to fiber direction.

The fracture surfaces of the 60° off-axis tensile specimen (fig. 22) and the 75° specimen (fig. 23) reveal mainly matrix cleavage and some fiber surface free of matrix residue; both of these features indicate that fracture was induced by transverse tensile stress.
