CHARACTERIZATION, SHAPING, AND
JOINING OF SiC/SUPERALLOY SHEET
FOR EXHAUST SYSTEM COMPONENTS

July 20, 1977
Final Report

NASA CR-135301
Contract NAS-19735

Westinghouse R&D Center
1310 Beulah Road
Pittsburgh, Pennsylvania 15235

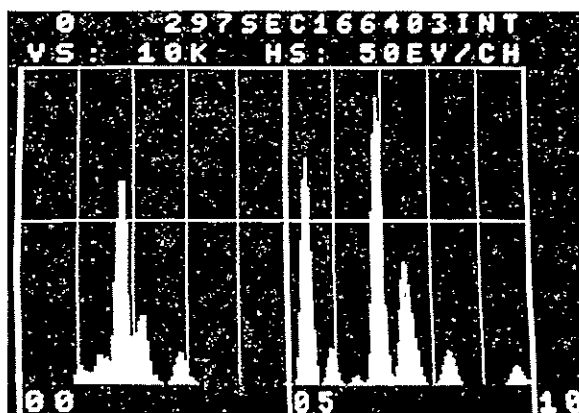
Fig. 17a. HA-188/HfC/SiC diffusion couple after 200 hr at 1093°C (2000°F). Microstructural and EDX analysis of selected areas.

Fig. 17b. EDX analysis of selected areas of HA-188/HFC/SiC diffusion couple after 200 h at 1093°C (2000°F).

the initial coating and the matrix and two zones between the matrix and SiC are noted in Fig. 17. This couple demonstrates the inadequacy of HA-188 as a matrix candidate with HfC barriers.
