DEVELOPMENT OF LOW COST,
HIGH RELIABILITY SEALING TECHNIQUES
FOR HYBRID MICROCIRCUIT PACKAGES

PHASE II
FINAL REPORT

Contract NAS8-31992

Prepared by:
K. L. Perkins
J. J. Licari

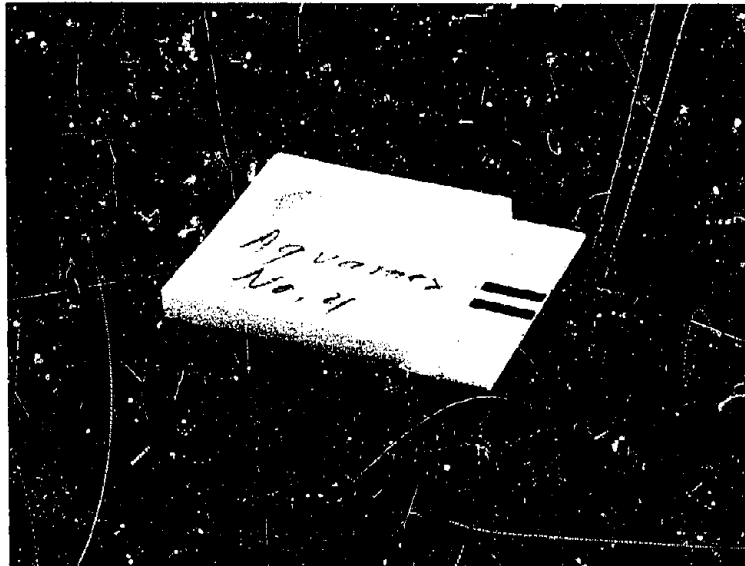
Figure 27. Adhesive-Sealed Ceramic Package
for Moisture Permeation Testing
