NASA TM 73715

**FERROGRAPHIC ANALYSIS OF WEAR DEBRIS GENERATED
IN ACCELERATED ROLLING ELEMENT FATIGUE TESTS**

by William R. Jones, Jr. and Richard J. Parker
Lewis Research Center
Cleveland, Ohio 44135

**TECHNICAL PAPER to be presented at the
Joint Lubrication Conference
cosponsored by the American Society of Lubrication Engineers
and the American Society of Mechanical Engineers
Kansas City, Missouri, October 3-5, 1977**

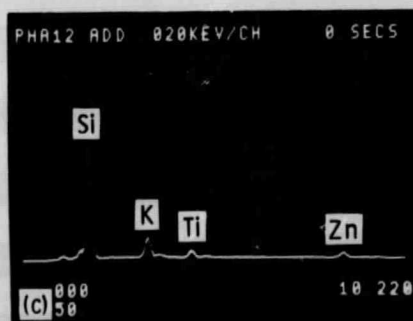
Figure 5. - (a) Electron micrograph of wear debris from test F-7 (98 hours), (b) energy dispersive x-ray analysis (EDAX) of particle A, (c) background EDAX of ferrogram.

Oil samples from almost any source contain some normal rubbing wear particles. This particle type normally represents a benign form of wear and most samples in this study contained at least a few such particles. These particles consist of small ($<5 \mu\text{m}$ in major dimension and $<1 \mu\text{m}$ thick) asymmetrical metallic flakes. When many of these particles are present in a sample, they will appear as strings on the Ferrograms due to alignment by the magnetic field. An electron micrograph of such a string of normal rubbing wear particles appears in figure 5(a). These particles were in the oil sampled at the conclusion of the 98 hour test, F-7. Energy-dispersive

X-ray analysis (EDAX) of the particle labelled A in figure 5(a) is shown in figure 5(b). The analysis indicates that the particle is from the bearing steel test specimens. Figure 5(c) contains the background EDAX analysis for the Ferrogram slide. In addition, most Ferrograms were gold-plated prior to analysis.

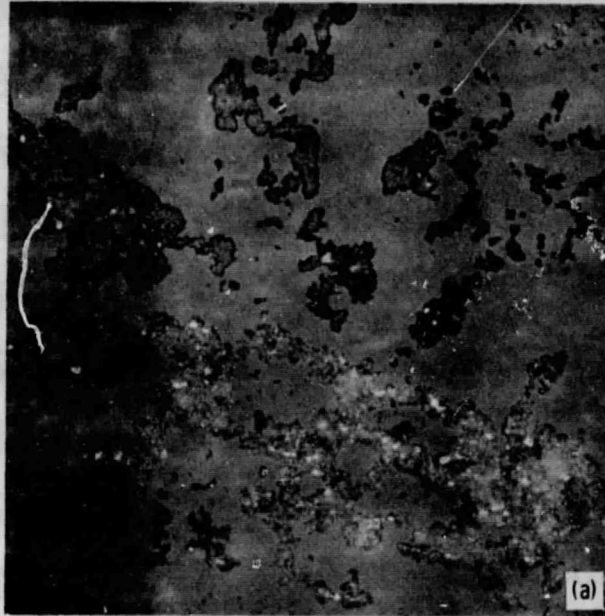
Figure 7. - Friction polymer deposit from test S-4 (27 hours). (a) Reflected light, (b) Reflected polarized light with crossed analyzer.

Actually two types of the friction polymer deposit were observed. These are illustrated in figure 7. The first type is an amorphous appearing deposit that is transparent when viewed with transmitted light and appears dark in reflected white light. This type was not observable when reflected polarized light was used with a crossed analyzer. The second type appears to be crystalline in nature. When viewed with reflected white light it appears light blue and is translucent to transmitted light. Under reflected polarized light viewed with a crossed analyzer, it appears white.
