NASA CR-145148

VIKING 75 PROJECT

VIKING LANDER SYSTEM
PRIMARY MISSION PERFORMANCE
REPORT

MARTIN MARIETTA CORPORATION

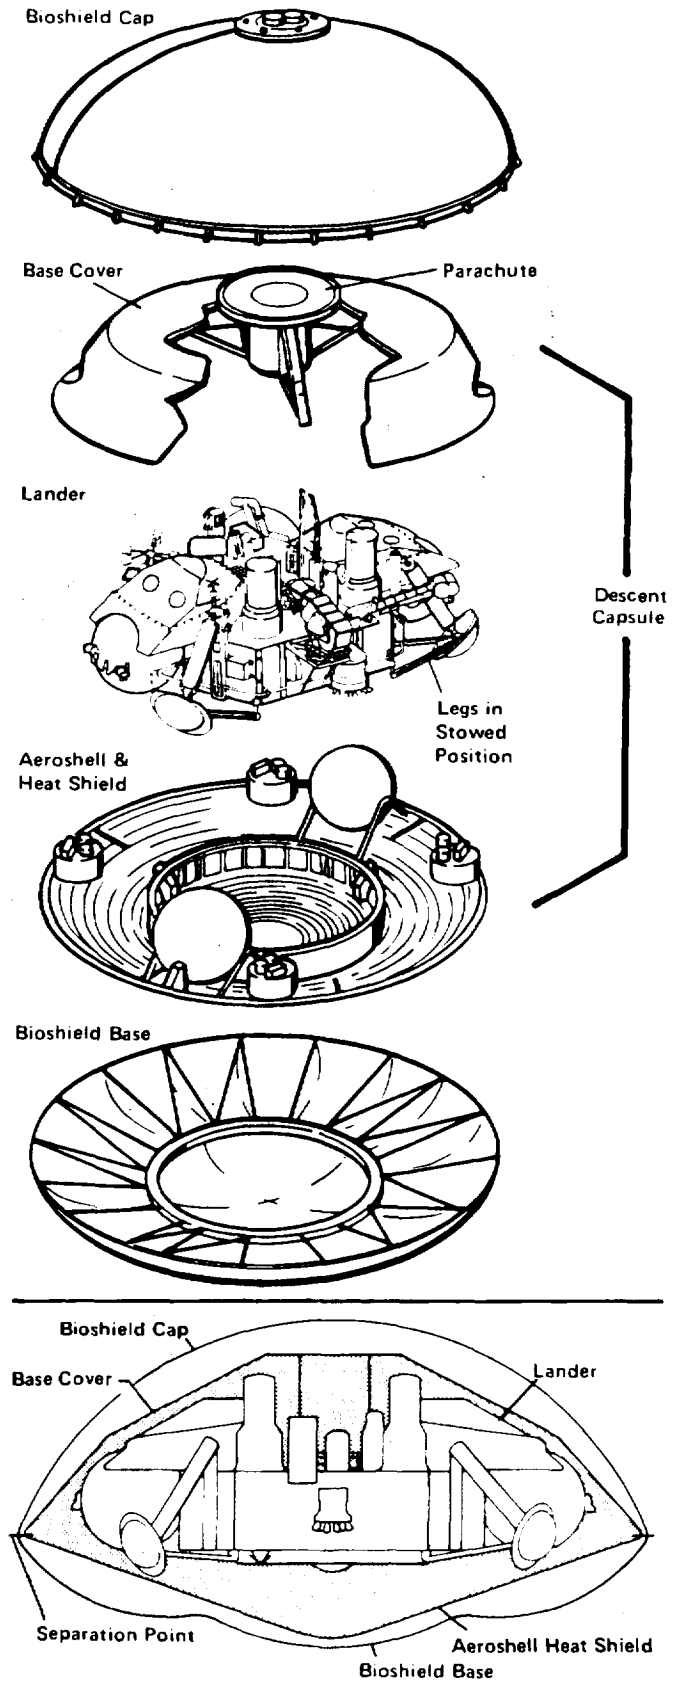
Figure I-3 Viking Lander Capsule

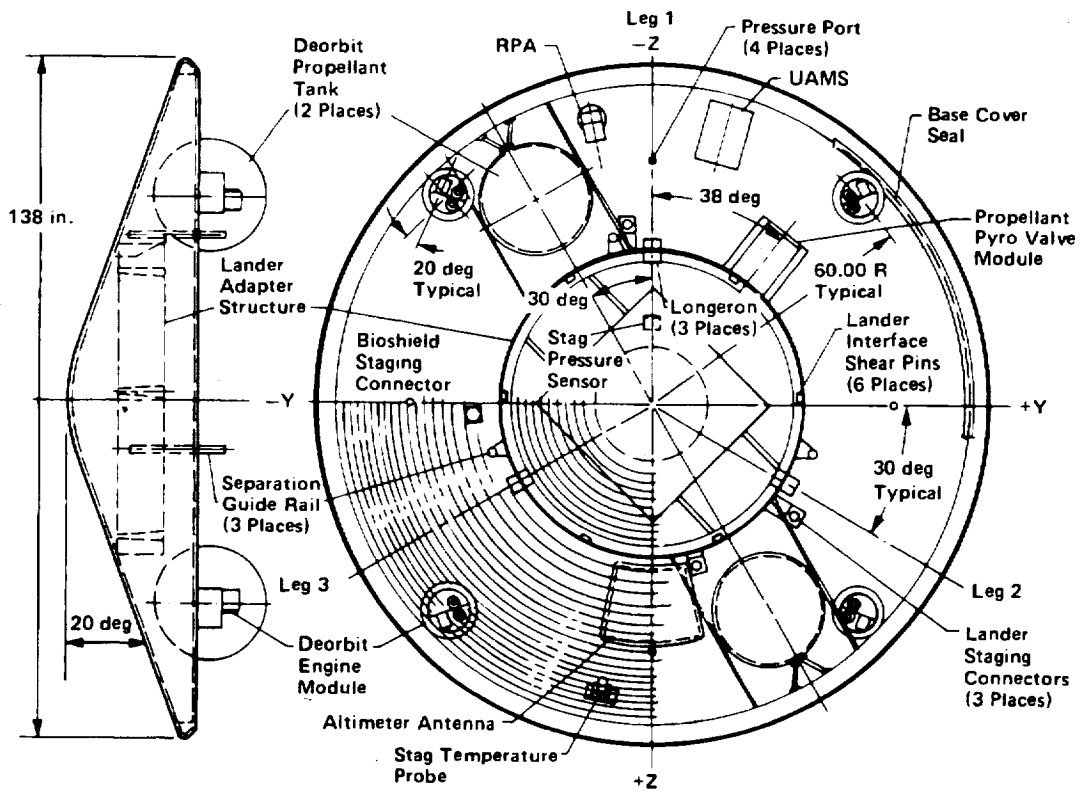
Figure I-4 Lander Aeroshell

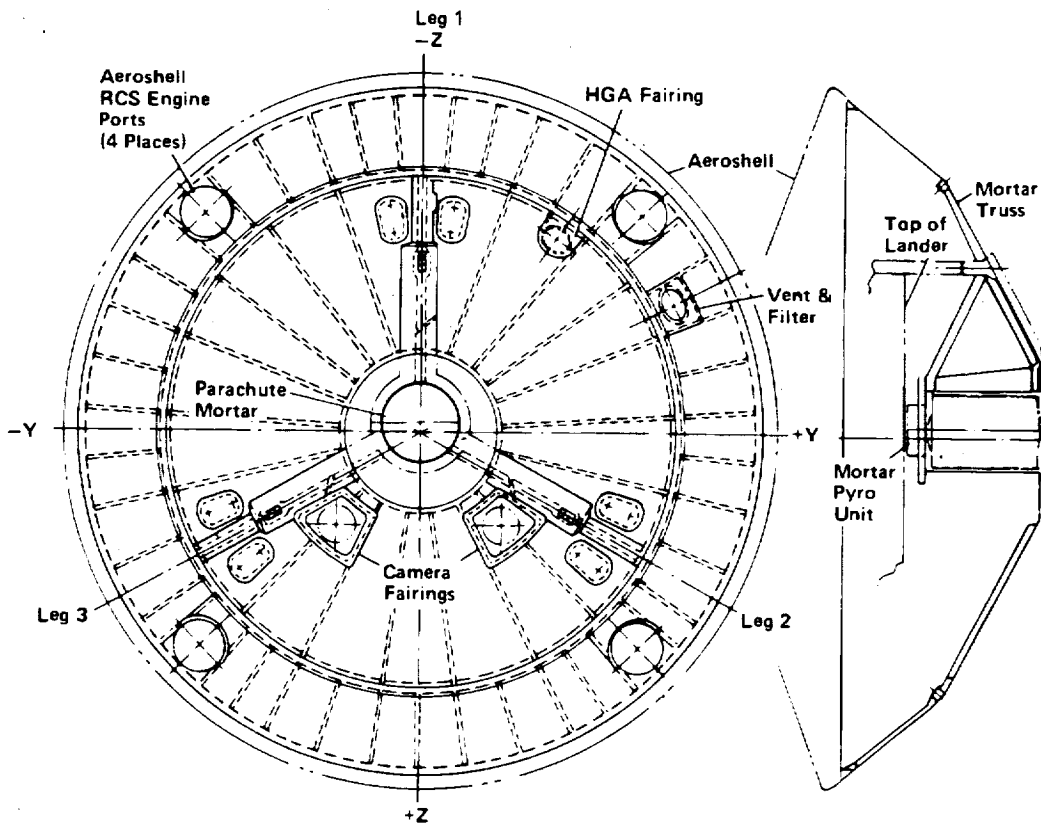
Figure I-5 Lander Base Cover and Mortar Truss

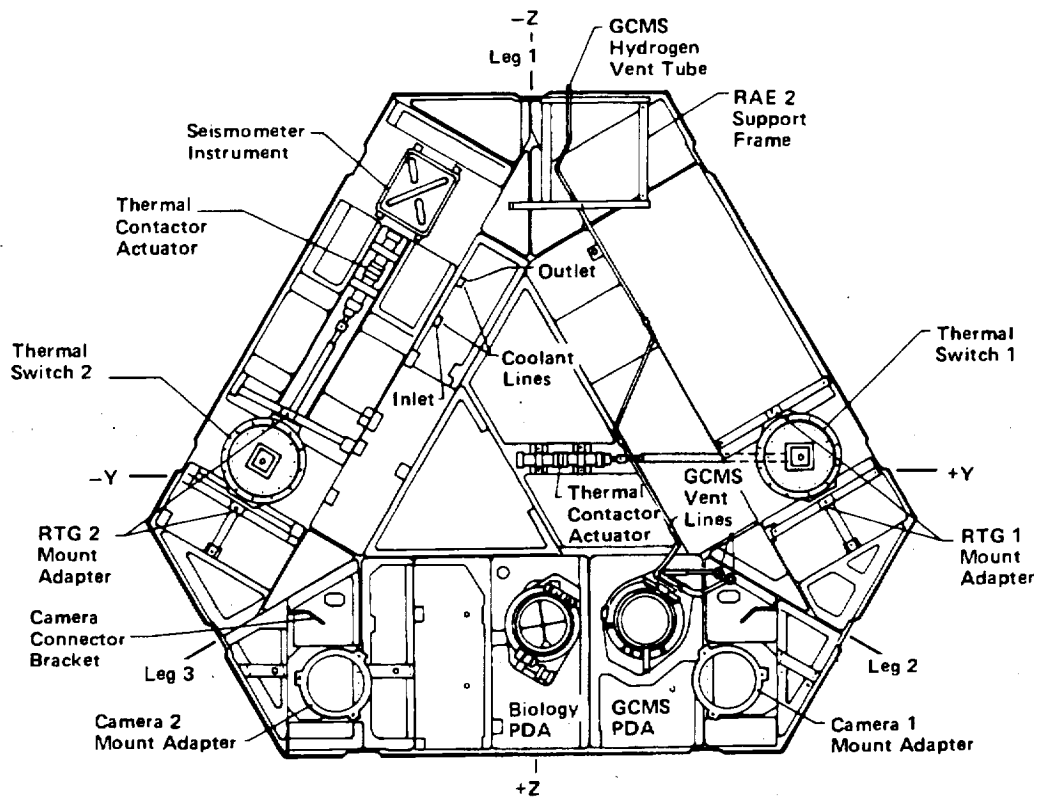
Figure I-6 Lander Body Equipment Plate, Top View

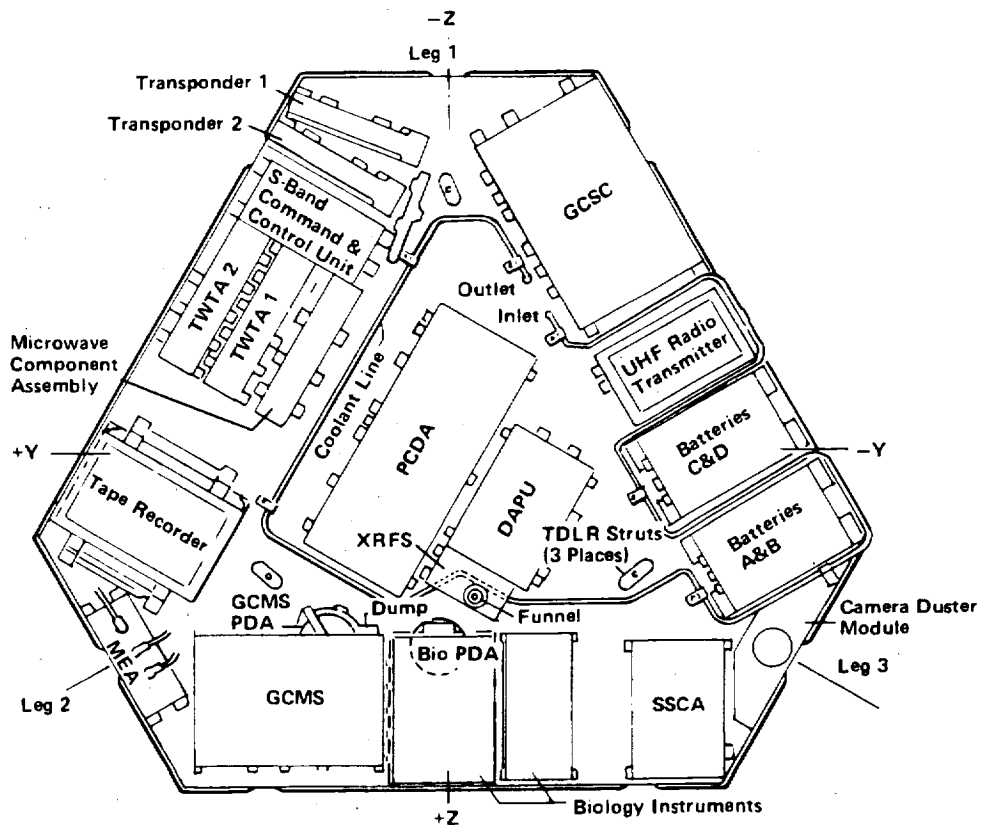
Figure I-7 Lander Body Equipment Plate, Bottom View

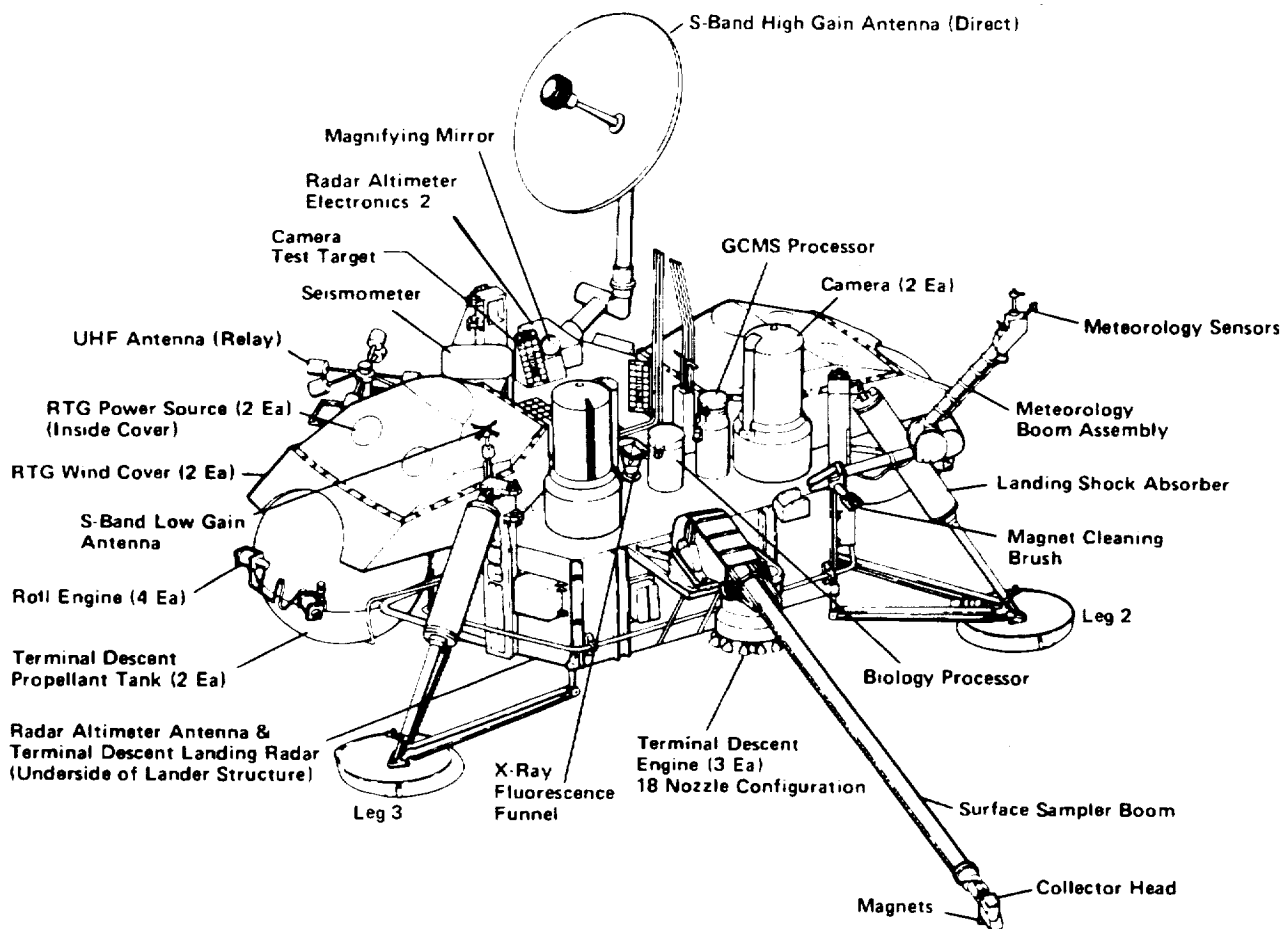
Figure 1-8 Landed Configuration

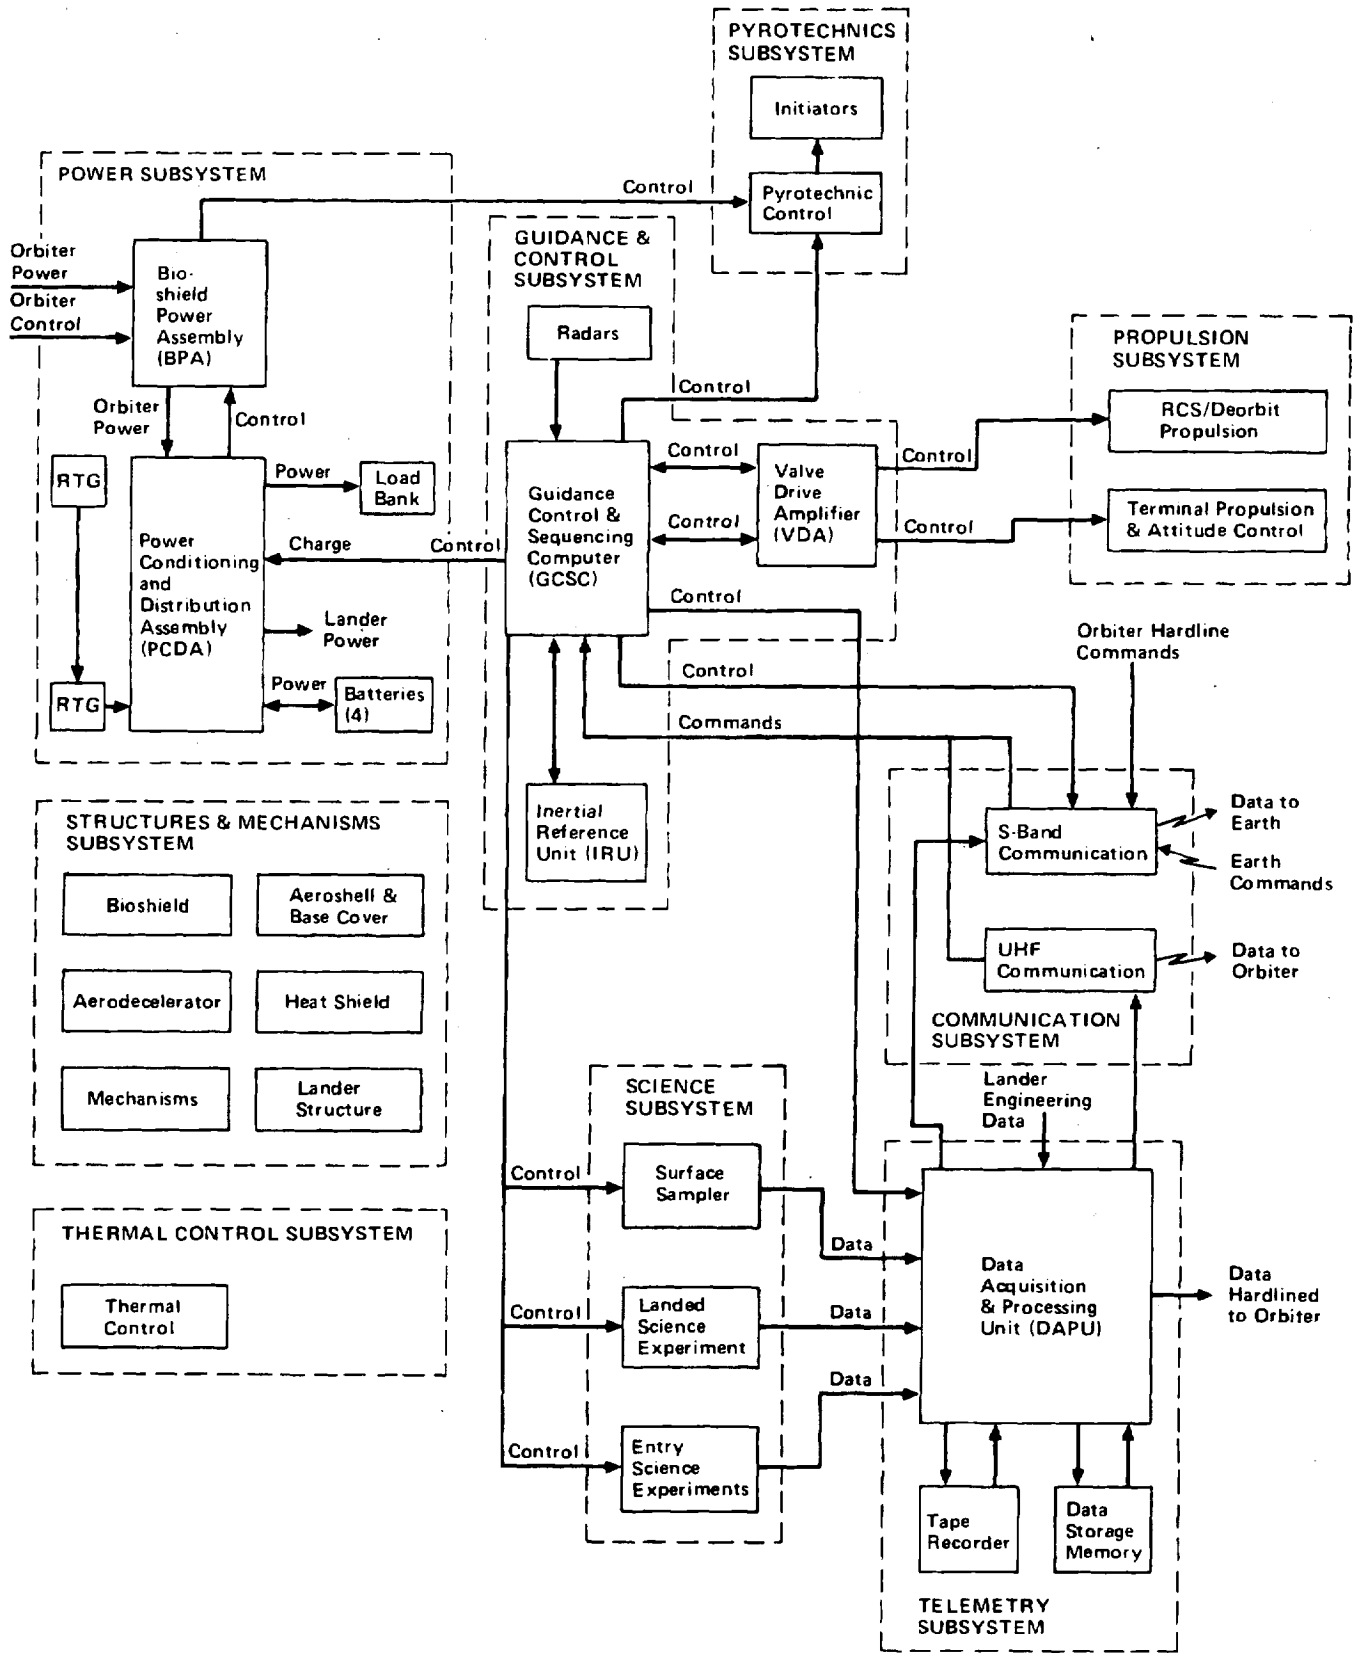
Figure I-9 Lander Functional Block Diagram

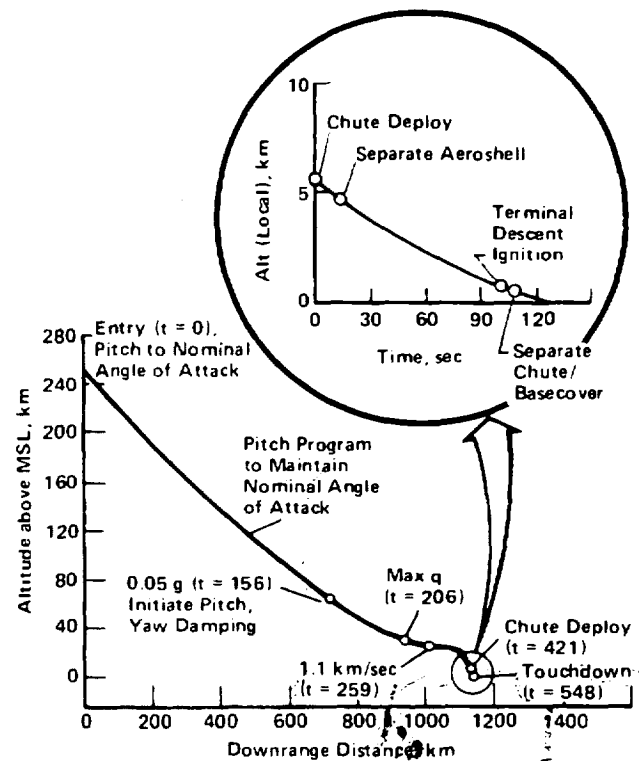
Figure II-2 Lander Entry Sequence

After deorbit burn, the Landers were reoriented for RPA operation and deorbit coast began. During this period, RPA and engineering data were relayed to the Orbiter for about 70 sec every 6.5 min. The deorbit coast phase continued for approximately 2.5 hr on each Lander. All operations were nominal except for the attitude rates that exceeded those predicted; however these higher rates caused no problems.

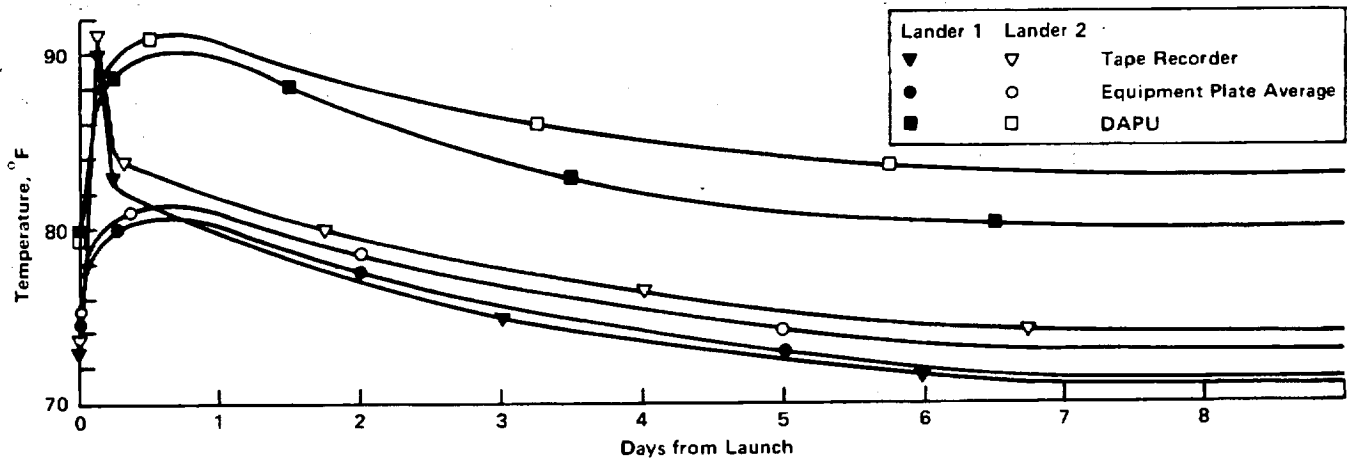
Figure III-2 Lander Launch Transient Internal Temperatures

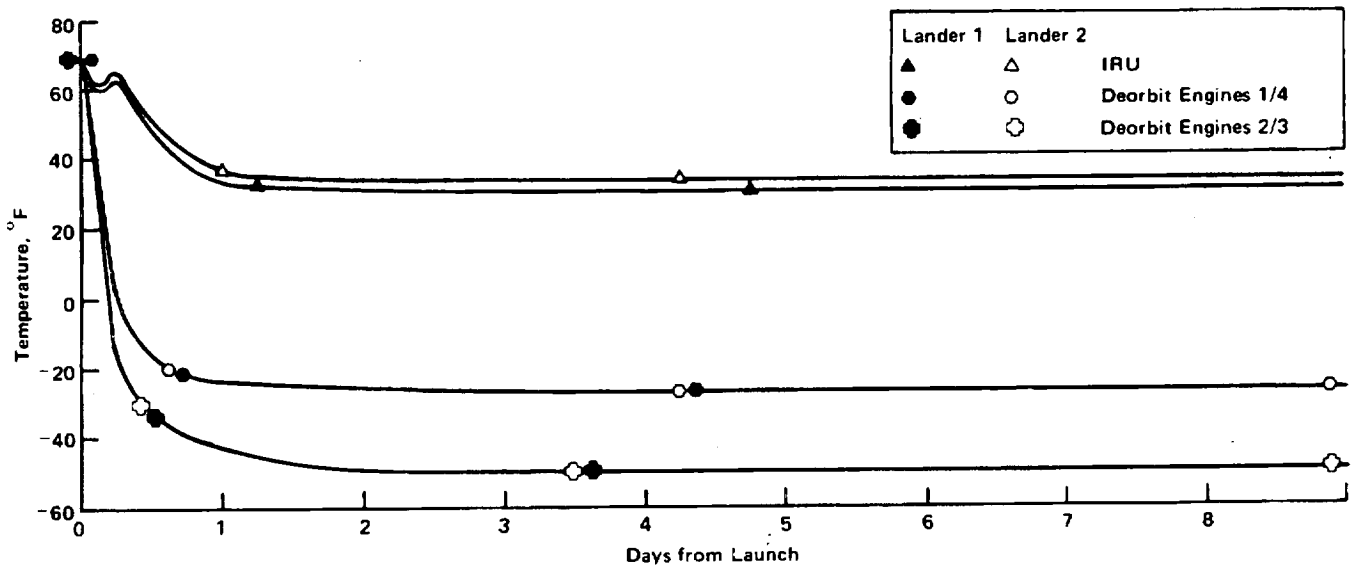
Figure III-3 Lander Launch Transient External Temperatures

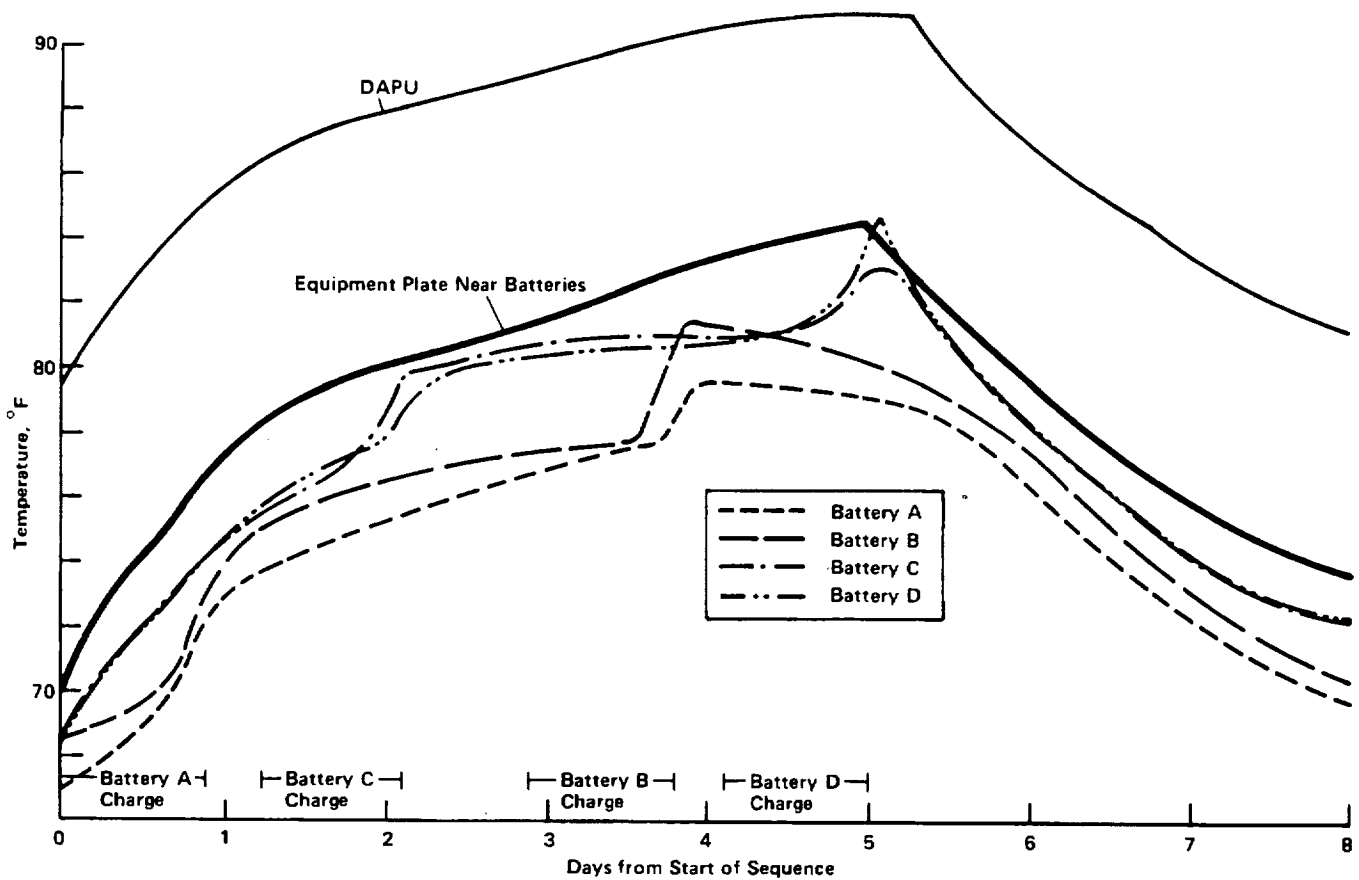
Figure III-4 Typical Lander Internal Temperatures for Battery Charging

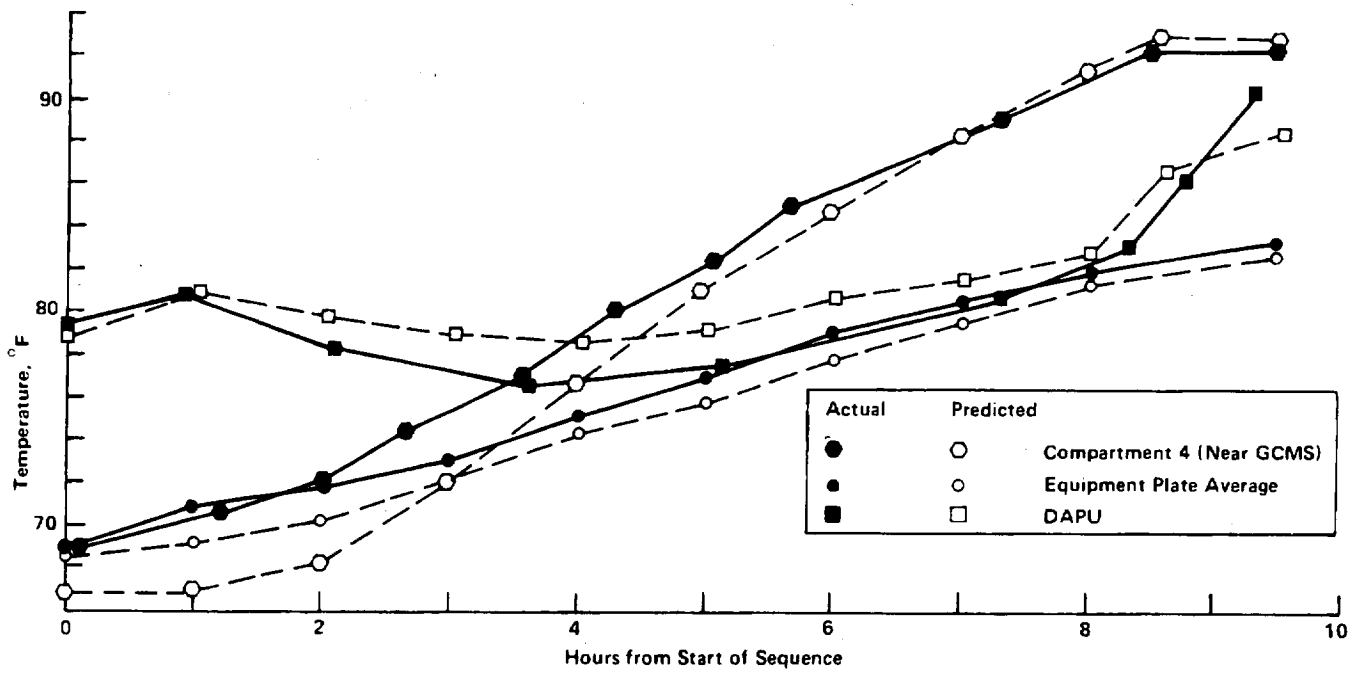
Figure III-5 Typical Lander Internal Temperatures for GCMS Bakeout

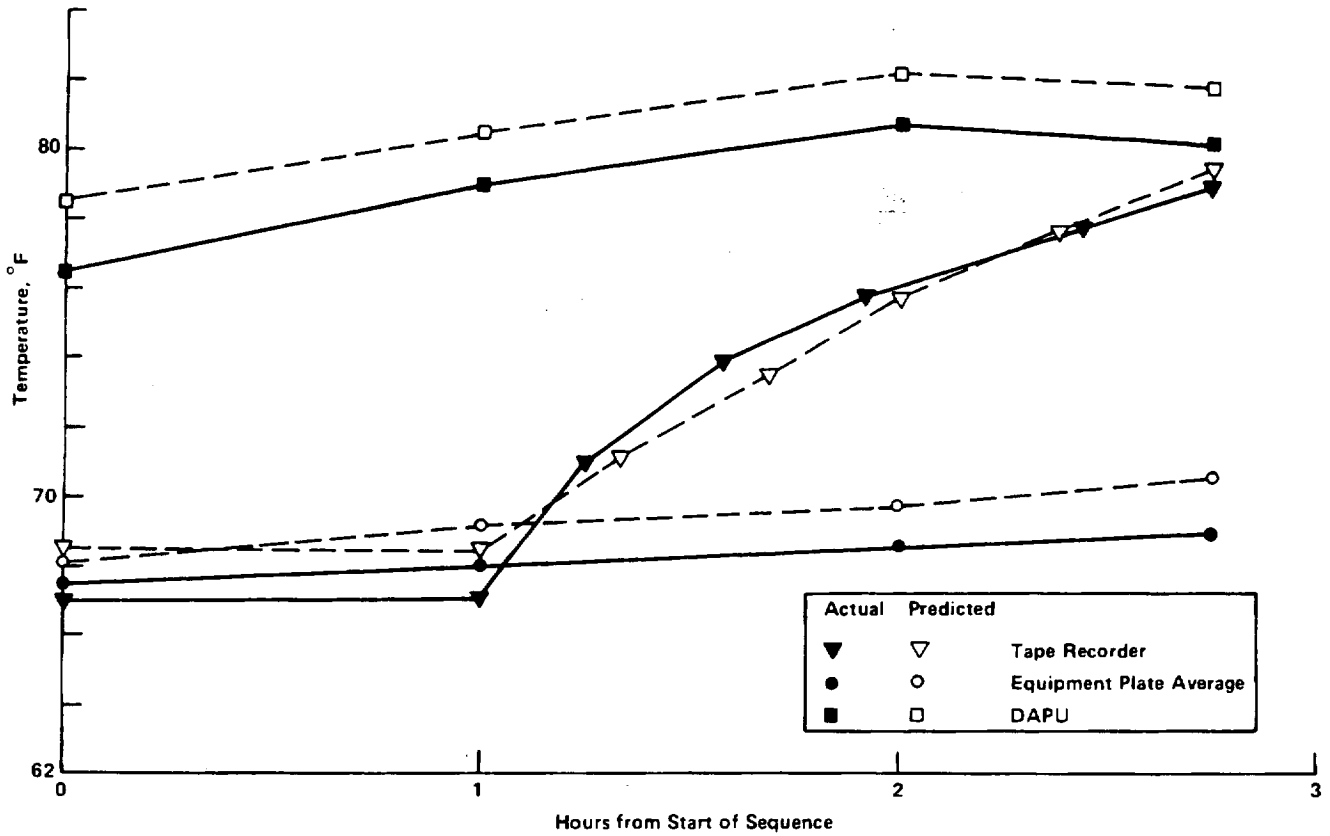
Figure III-6 Typical Lander Internal Temperatures for Tape Recorder Maintenance

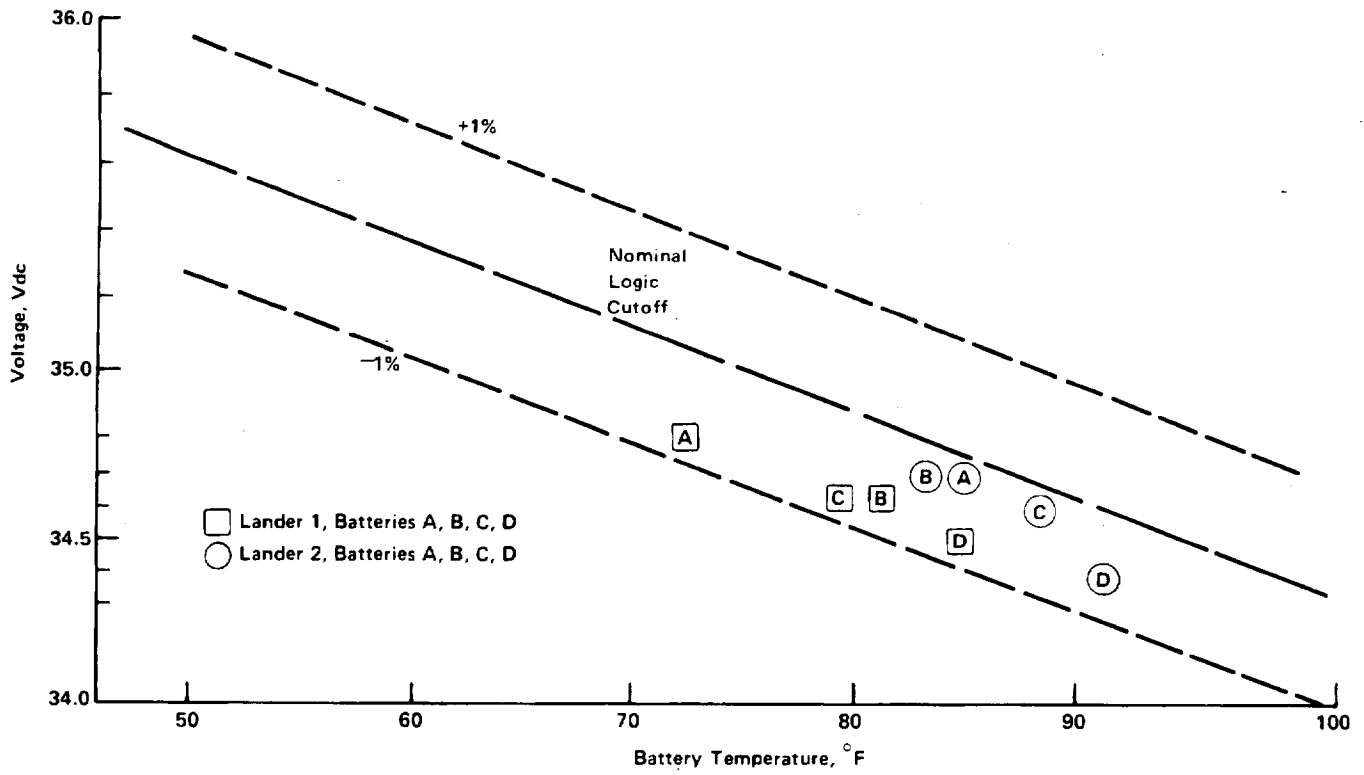
Figure III-7 Battery Charge Cutoff Logic

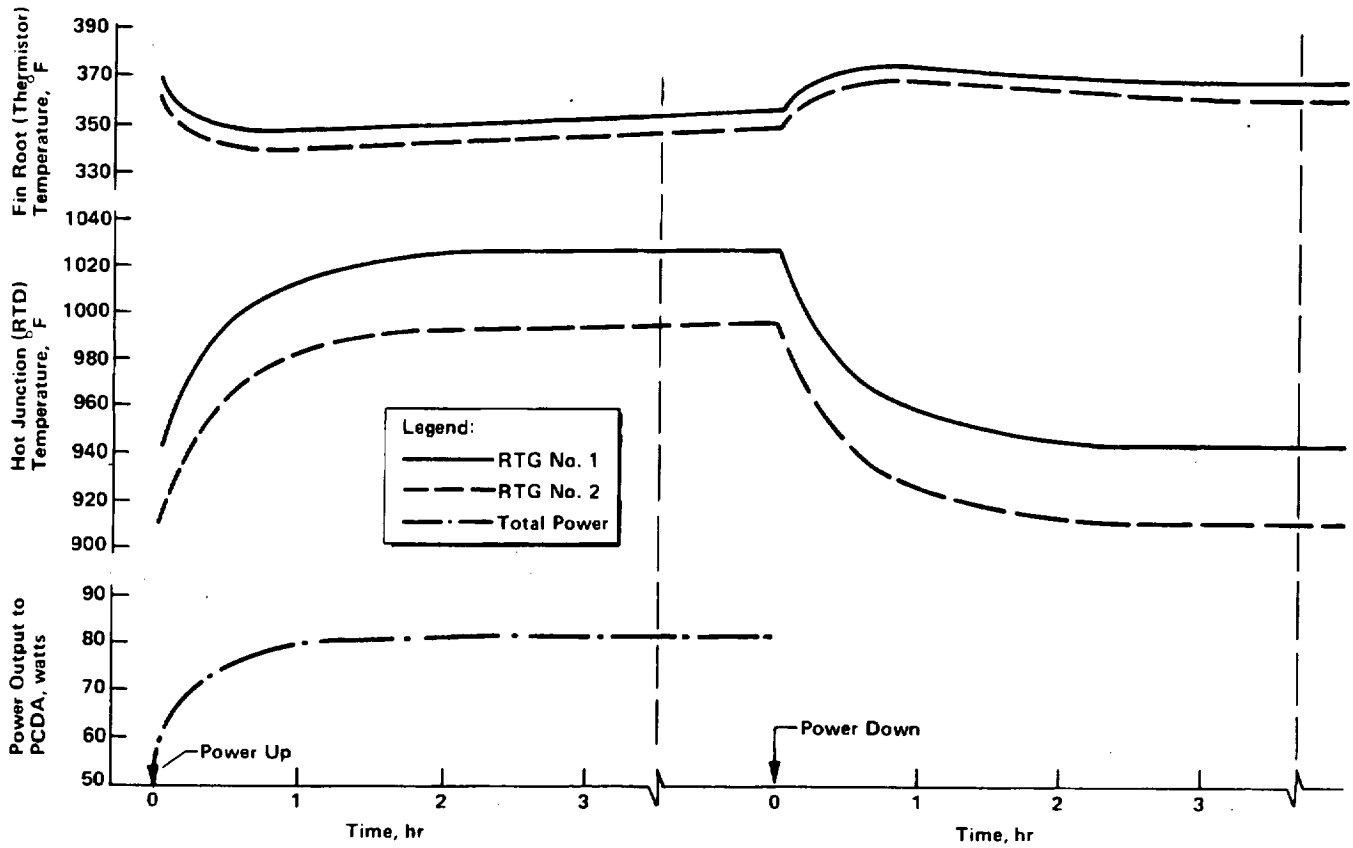
Figure III-8 Lander 1 RTG Transient Data for Cruise Checkout

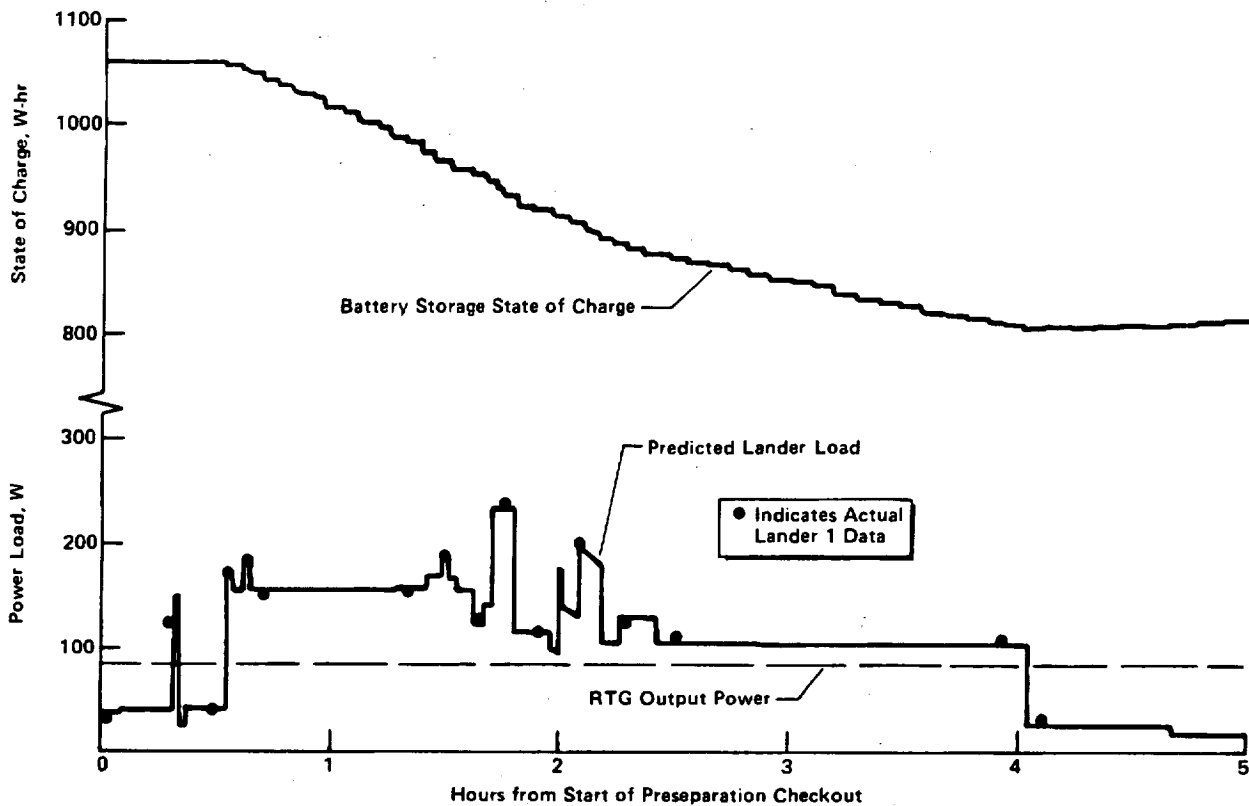
Figure IV-4 Lander Loads during Preseparation Checkout

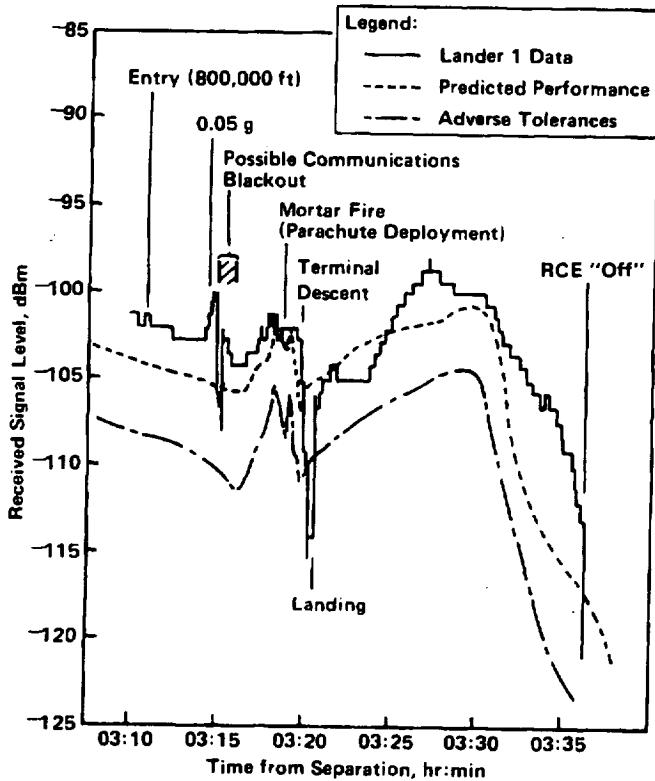
Figure V-2 Lander 1 Relay Link Performance from Entry through Landing

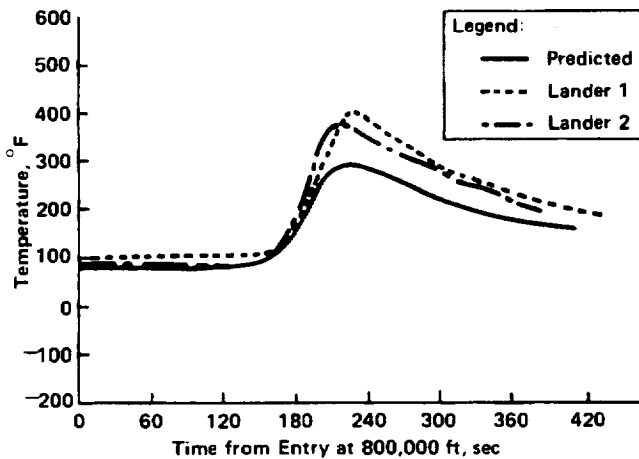
Figure V-5 Base Cover Inner Ring Entry Temperatures

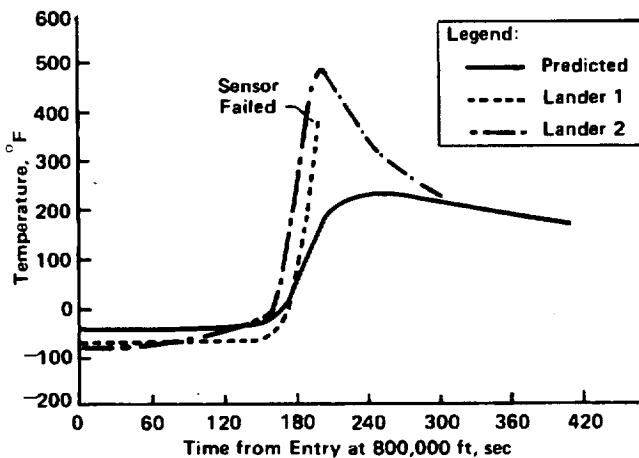
Figure V-6 Base Cover Outer Ring Entry Temperatures

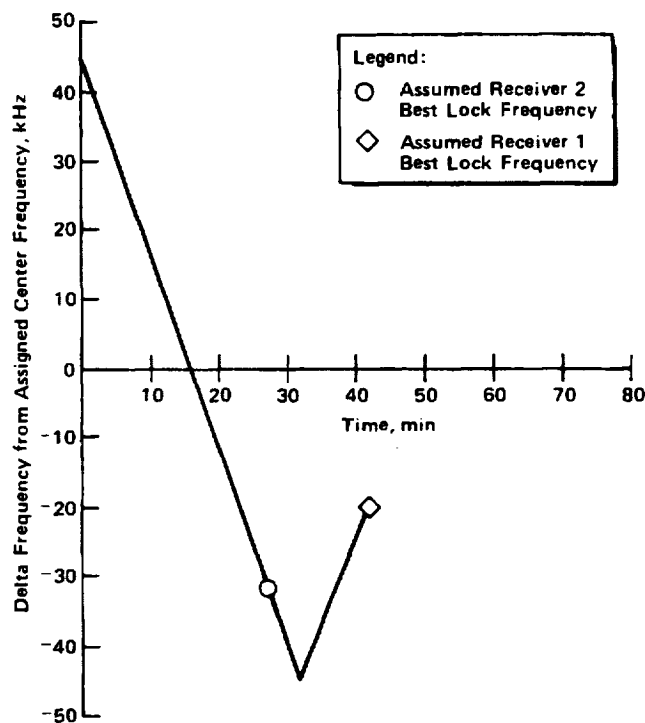
Figure VI-5 Typical S-Band Receiver Acquisition Sweep

The DCS sequence implemented for the first several landed sols is illustrated in Figure VI-4. An approximately 50-minute uplink frequency acquisition sweep, illustrated in Figure VI-5 was performed to acquire the Lander command receivers.

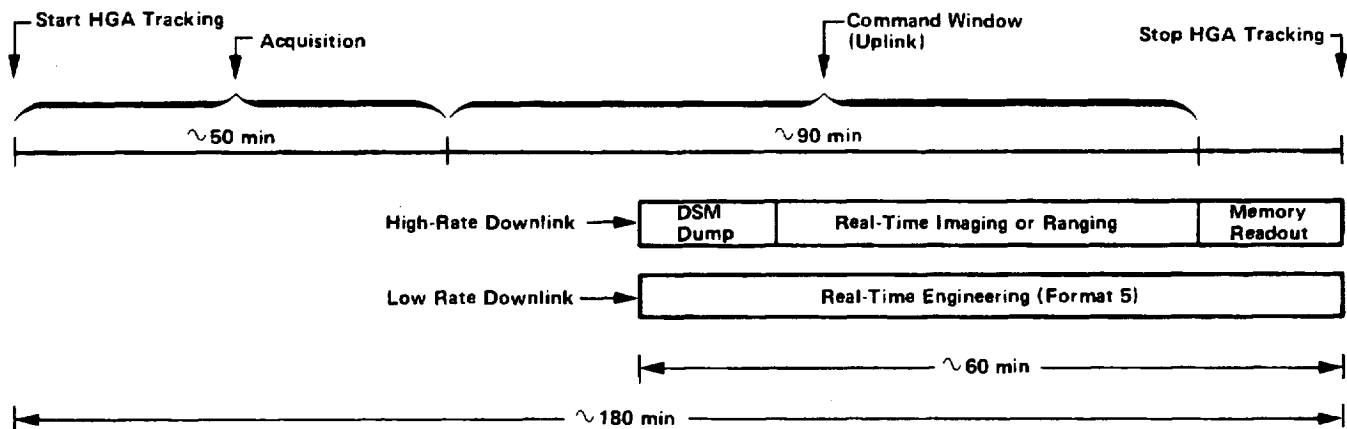
Figure VI-4 Typical Direct Link Sequence

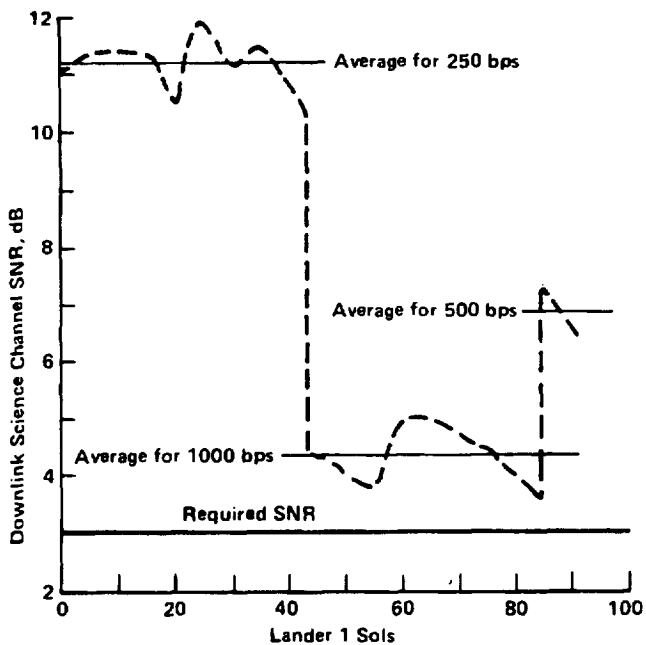
Figure VI-6 Lander 1 Downlink Science Channel Signal-to-Noise Ratio

Other than the above described anomalies, the DCSs of both Landers performed exceptionally well during the entire primary missions. The Lander 1 downlink performance was sufficiently above the predicted nominal level to allow a data rate increase from 250 bps to 1000 bps for sols 44 through 84. This rate was later reduced to 500 bps to offset solar corona degradation of the downlink. Similarly, the Lander 2 data rate was increased to 500 bps on sol 63. Both Landers supported 500 bps links until the Landers were reconfigured for the solar conjunction radio science experiments. A typical example of the downlink signal-to-noise-ratio (SNR) and bit-error-rate (BER) performance for the Landers is illustrated in Figure VI-6. Typical command performance for the Landers is illustrated in Figure VI-7.

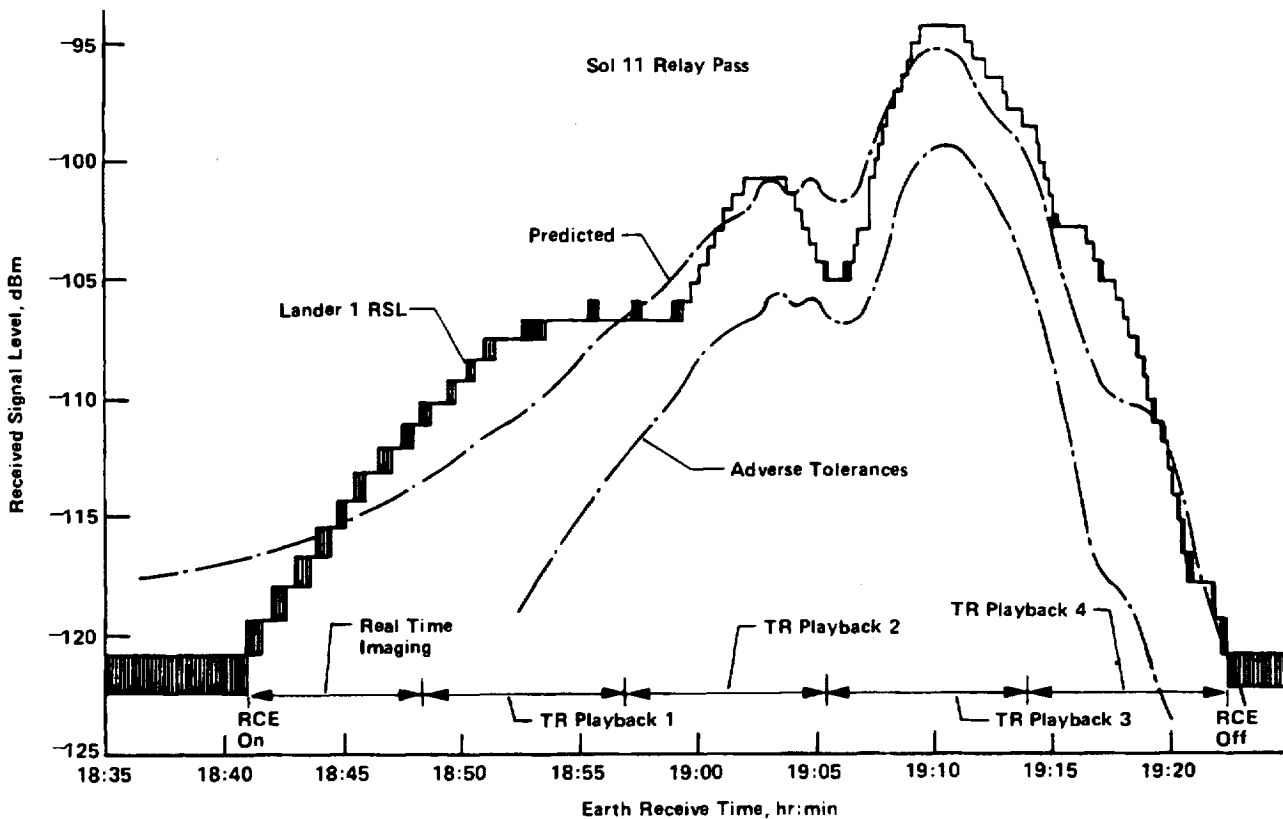
Figure VI-8 Typical Lander 1/Orbiter 1 Relay Link

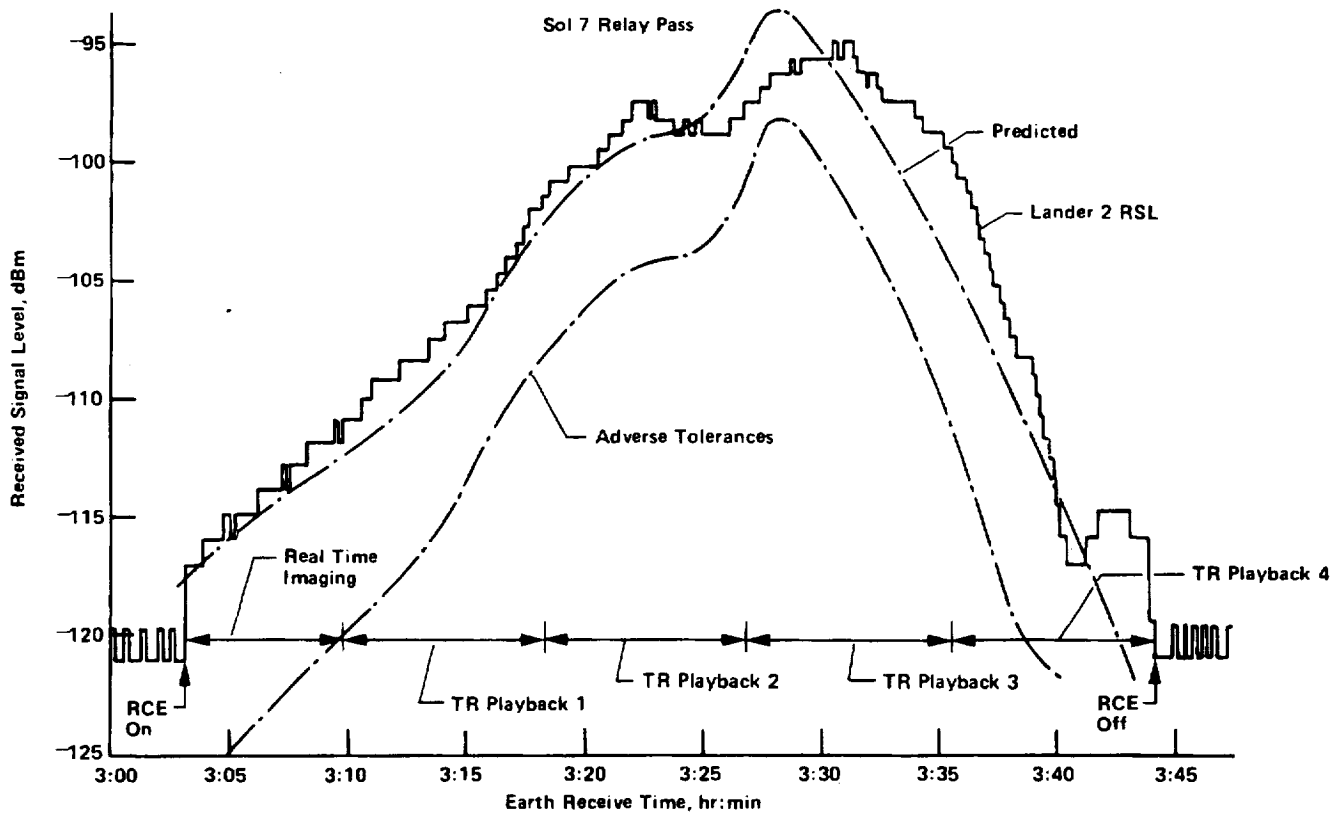
Figure VI-9 Typical Lander 2/Orbiter 2 Relay Link

Nominal hardware and link performance was also observed for the Orbiter 2/Lander 2 relay passes. This resulted in the return of over three times the required volume of scientific and engineering data from the surface of Mars. Typical performance for the Orbiter 2/Lander 2 relay links is shown in Figure VI-9. By sol 21 of the Lander 2 mission, Orbiter 1 was moved into position to support the Lander 2 relay links. This maneuver was in the mission plan to allow Orbiter 2 to leave its station over Lander 2 to conduct further scientific exploration of the planet. Test relay links from Lander 2 to Orbiter 1 were conducted on sols 21, 23, and 25, in addition to the planned Orbiter 2/Lander 2 links. Orbiter 1 took over sole support of the Lander 2 relay link on sol 27 and continued in this capacity for the remainder of Lander 2's primary mission. An interesting feature of the Orbiter 1/Lander 2 relay passes is that the relay link was initiated when the Orbiter was very close to the Lander horizon. The maximum elevation angle achieved by the Orbiter was approximately 25 deg. All previous relay links were initiated at approximately 5 deg elevation with the Orbiter passing nearly overhead of the Lander. The observed performance for a typical Orbiter 1/Lander 2 relay pass is shown in Figure VI-10. The larger differences between the observed and predicted performance shown in the figure are believed to be the result of surface reflections, surface ground plane effects, and the inherent error in the scale-model Lander antenna radiation pattern data at extreme aspect angles used for the performance predictions.

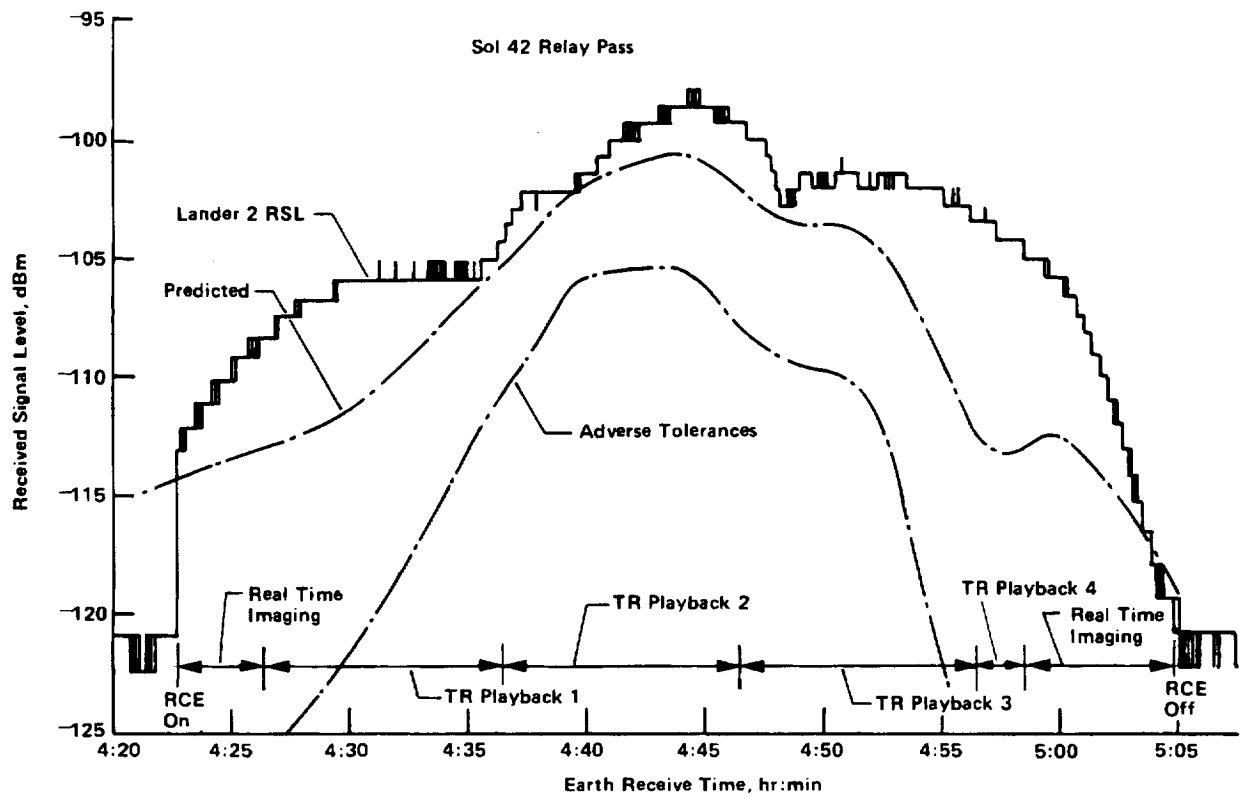
Figure VI-10 Typical Lander 2/Orbiter 1 Relay Link
