NASA CR-145148

VIKING 75 PROJECT

VIKING LANDER SYSTEM
PRIMARY MISSION PERFORMANCE
REPORT

MARTIN MARIETTA CORPORATION

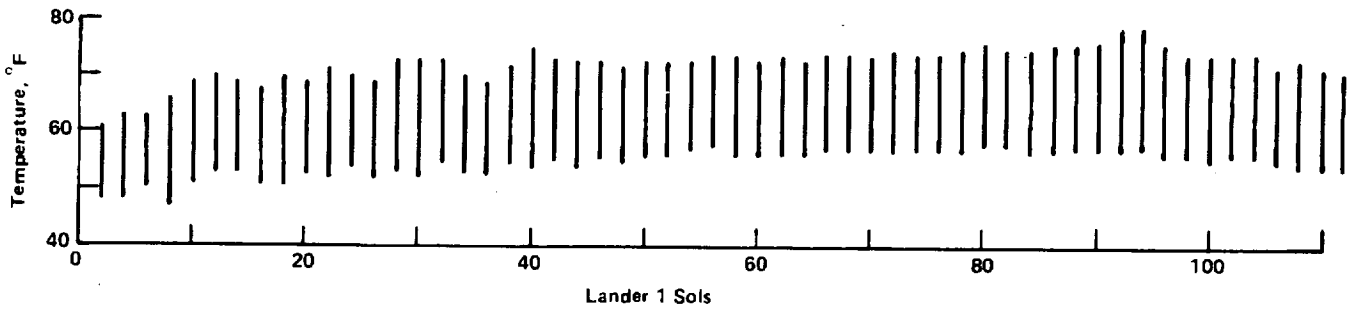
Figure VI-12 Lander 1 Primary Mission Internal Temperature Ranges

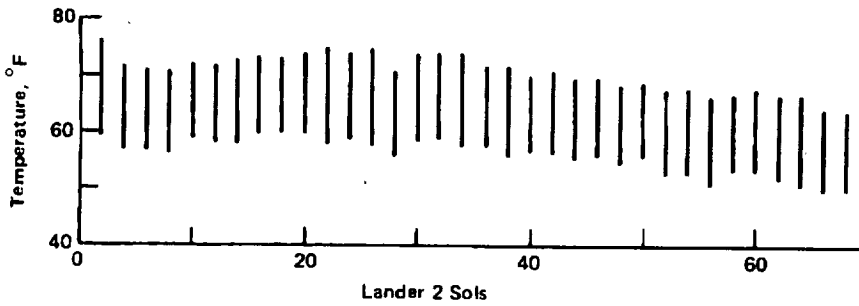
Figure VI-13 Lander 2 Primary Mission Internal Temperature Ranges

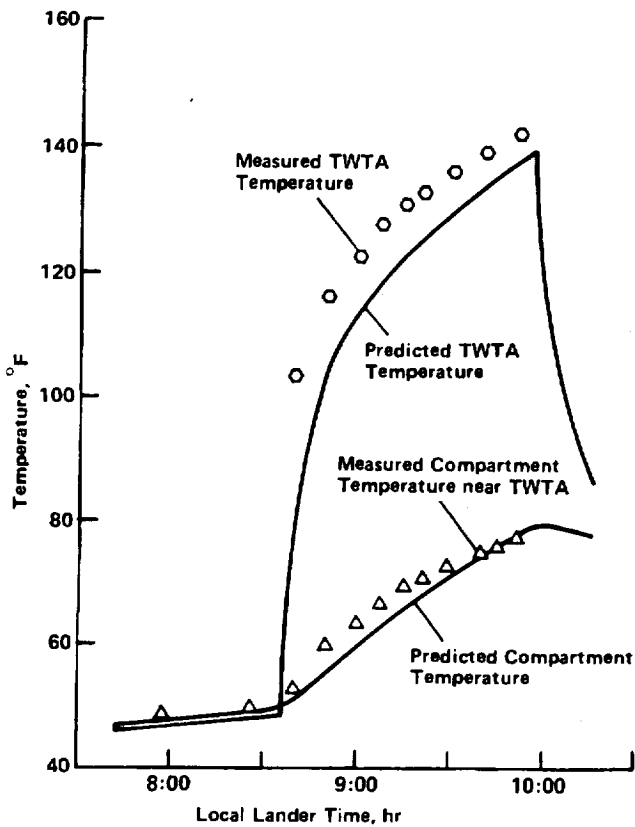
Figure VI-14 Landed TWTA Temperatures

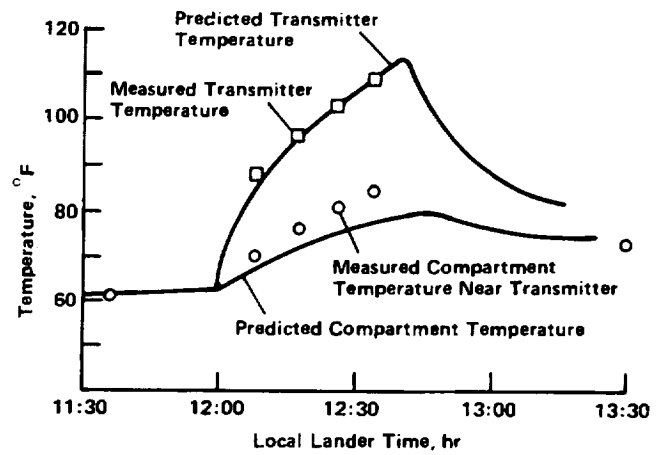
Figure VI-15 Landed UHF Transmitter Temperatures

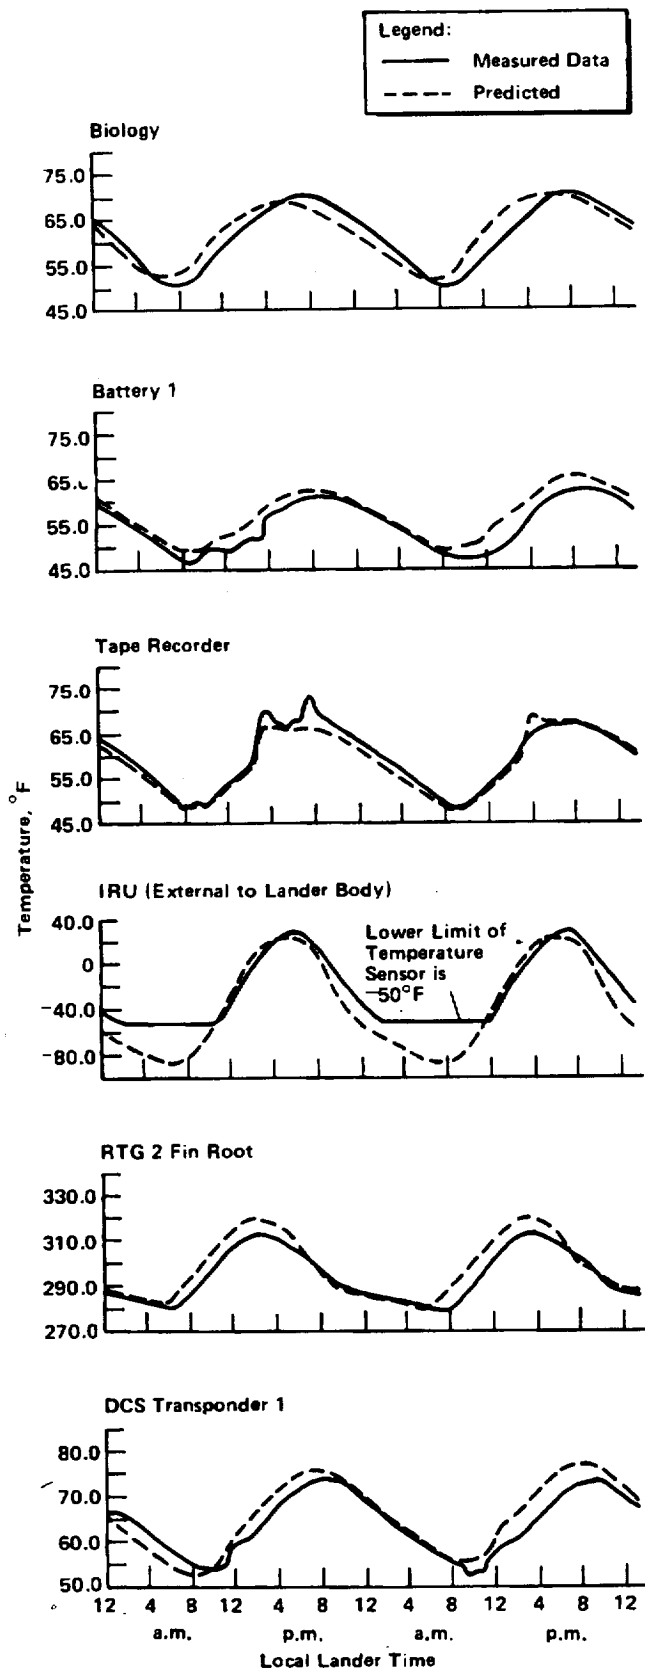
Figure VI-16 Typical Landed Temperature Profiles

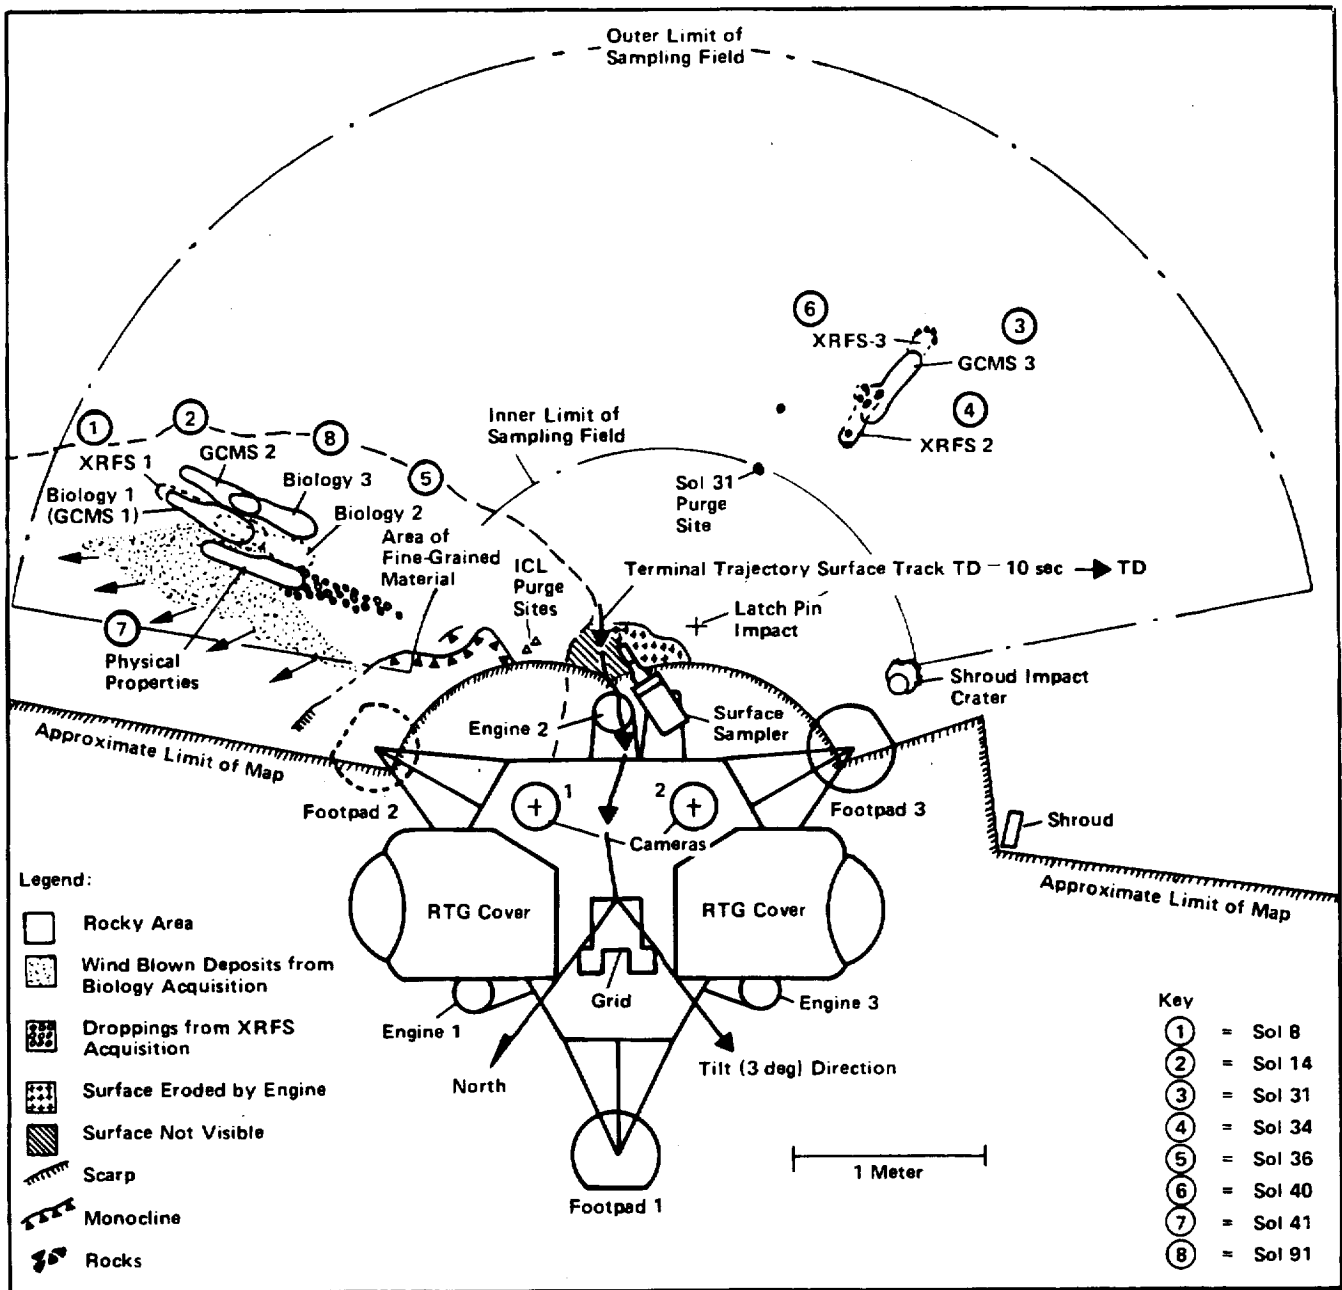
Figure VI-17 Schematic of Lander 1 Sampling Area Summarizing Nominal Mission Surface Sampler Activities
