NASA TM X- 73912

NASA DIAGONAL-BRAKED TEST VEHICLE EVALUATION OF TRACTION
CHARACTERISTICS OF GROOVED AND UNGROOVED RUNWAY SURFACES
AT MIAMI INTERNATIONAL AIRPORT, MIAMI, FLORIDA
MAY 8-9, 1973

Walter B. Horne

Langley Research Center
Hampton, Virginia 23665

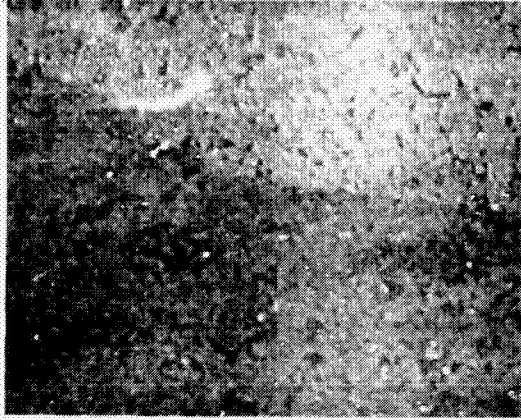
FIGURE 3.- PHOTOGRAPH OF PAVEMENT SURFACE IN RUNWAY TEST ZONE. (MARCH 14-15 TESTS)

A) RUNWAY 9R/27L ZONE A.

B) RUNWAY 9R/27L ZONE B.

C) RUNWAY 9R/27L ZONE C.

D) RUNWAY 9R/27L ZONE D.

E) RUNWAY 9R/27L ZONE E (OVERRUN).

F) RUNWAY 9L/27R ZONE A.

4.2 A measurement of the surface texture depth was made for each of the runway test zones evaluated during the March DBV tests. This was accomplished by means of the NASA grease test which entailed spreading a known volume of grease between parallel tapes spaced 4 inches apart on the test zone surface. The length of the surface between the tapes required for the grease to fill all the asperities, divided into the known volume of grease used, yielded the average texture depth of the pavement surface. The results of these measurements are shown in table I.

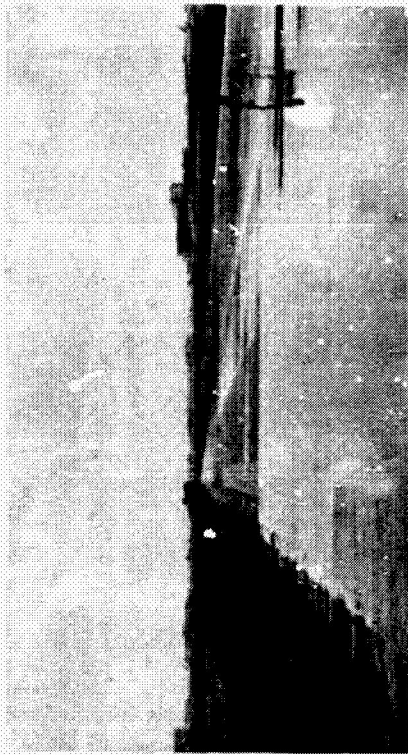
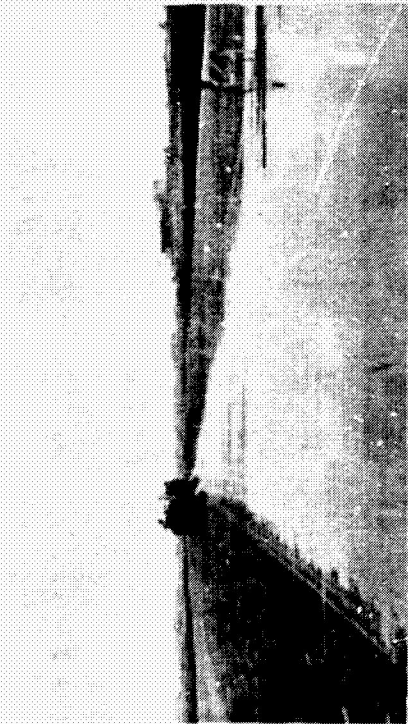
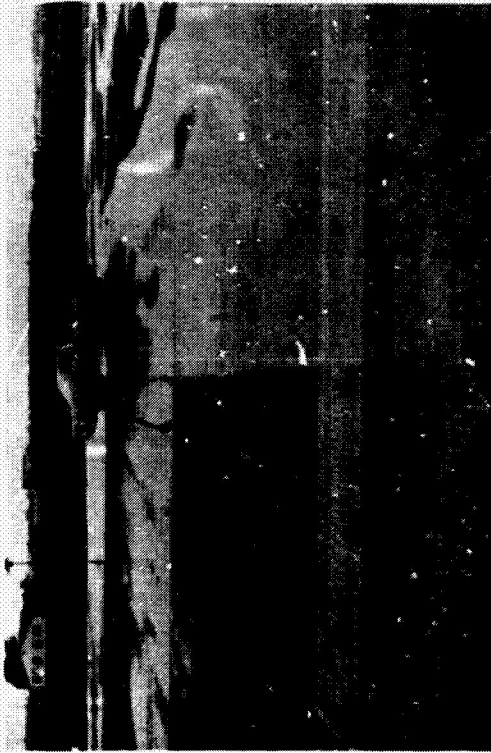
FIGURE 6 . - COMPARISON OF WATER DRAINAGE FROM GROOVED AND UNGROOVED SURFACES OF RUNWAY 9L-27R, ZONE B. MIAMI INTERNATIONAL AIRPORT, MAY 9, 1973.

A) WATER TRUCKS WETTING RUNWAY BEFORE DBV RUN.

B) PHOTOGRAPH TAKEN PARALLEL TO RUNWAY CENTER-LINE.

B) AFTER DBV RUN. PHOTOGRAPH TAKEN NORMAL TO RUNWAY CENTER-LINE.

5.1.3 A large effect of surface winds on ungrooved pavement drainage was also noted in the May 9 tests on Runway 9L/27R, zone B. In these tests, multiple water trucks were used to wet the upwind side of the runway in the presence of a quartering wind (10 knots/165 degrees). This cross wind was strong enough to prevent water drainage against the wind down the cross slope of the runway, and the water depths in the wetted ungrooved test zone remained constant from approximately 0.05 to 0.06 inches during the DBV test period (4 to 5 minutes) after wetting.

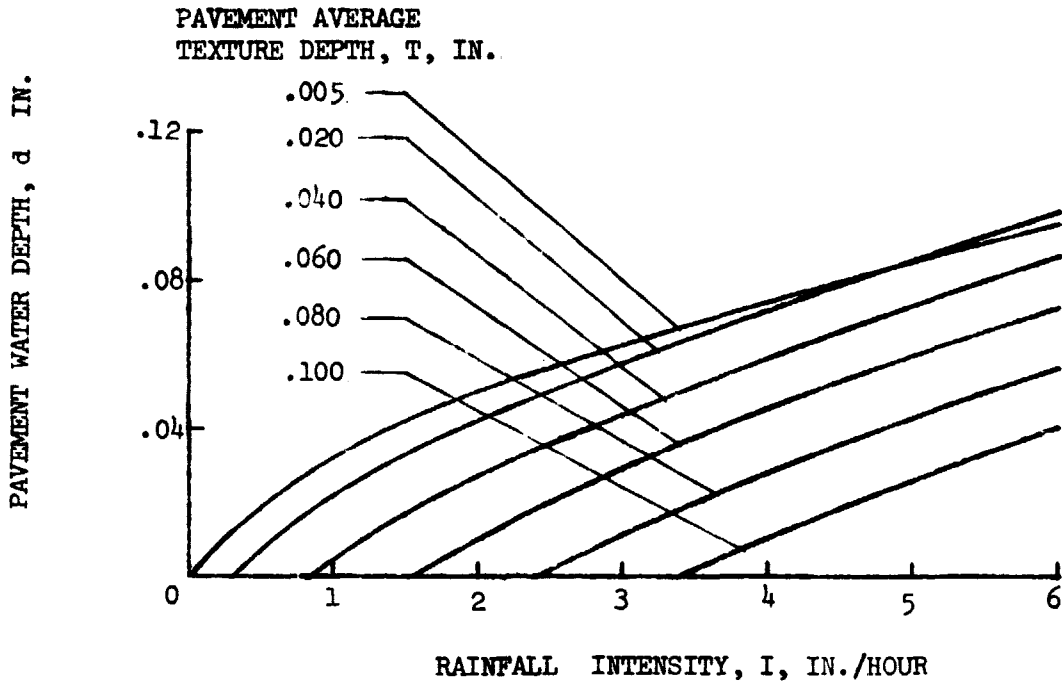
FIGURE 8.- CALCULATED EFFECTS OF PAVEMENT AVERAGE TEXTURE DEPTH AND RAINFALL INTENSITY ON WATER DEPTHS DEVELOPED ON PAVEMENTS DURING RAINSTORMS IN STILL AIR. PAVEMENT CROSS SLOPE, (S), $\frac{1}{100}$. DRAINAGE PATH LENGTH, (L), 10 feet.

A) CALCULATED EFFECTS OF RAINFALL INTENSITY AND PAVEMENT AVERAGE TEXTURE DEPTH ON PAVEMENT WATER DEPTH IN STILL AIR.

B) CALCULATED INCREASE IN PAVEMENT AVERAGE TEXTURE DEPTH FROM RUNWAY GROOVES.

5.2 Grooved Pavement Drainage.- Grooving pavements increases the average texture depth of the surface as shown in figure 8(b). If the ungrooved texture depth of the pavement is known, then the grooved texture depth of the pavement may be estimated from the equation (derived in figure 8(b)).

Using the TTI water depth equation (equation 1), still air water depths were calculated for a cross slope 1/100 (Miami runway design), drainage path length = 10 feet, pavement texture depths ranging from .005 to .100 inches, and for rainfall intensities ranging from 0-6 inches/hour. These results are plotted in figure 8(a). Figure 8(a) may be used with figure 8(b) to demonstrate the improved water drainage resulting from pavement grooving. For example, these plots indicate that standing water will develop on a ungrooved pavement having a average texture depth = 0.02 in. when the rainfall intensity reaches 0.32 inches/hour. Grooving this pavement to a 1 1/2 x 1/4 x 1/4-inch groove configuration increases this pavement's average texture depth to 0.0545 inches, and standing water develops at a rainfall intensity of approximately 1 inch/hour, thus showing a considerable improvement in pavement drainage from grooving.

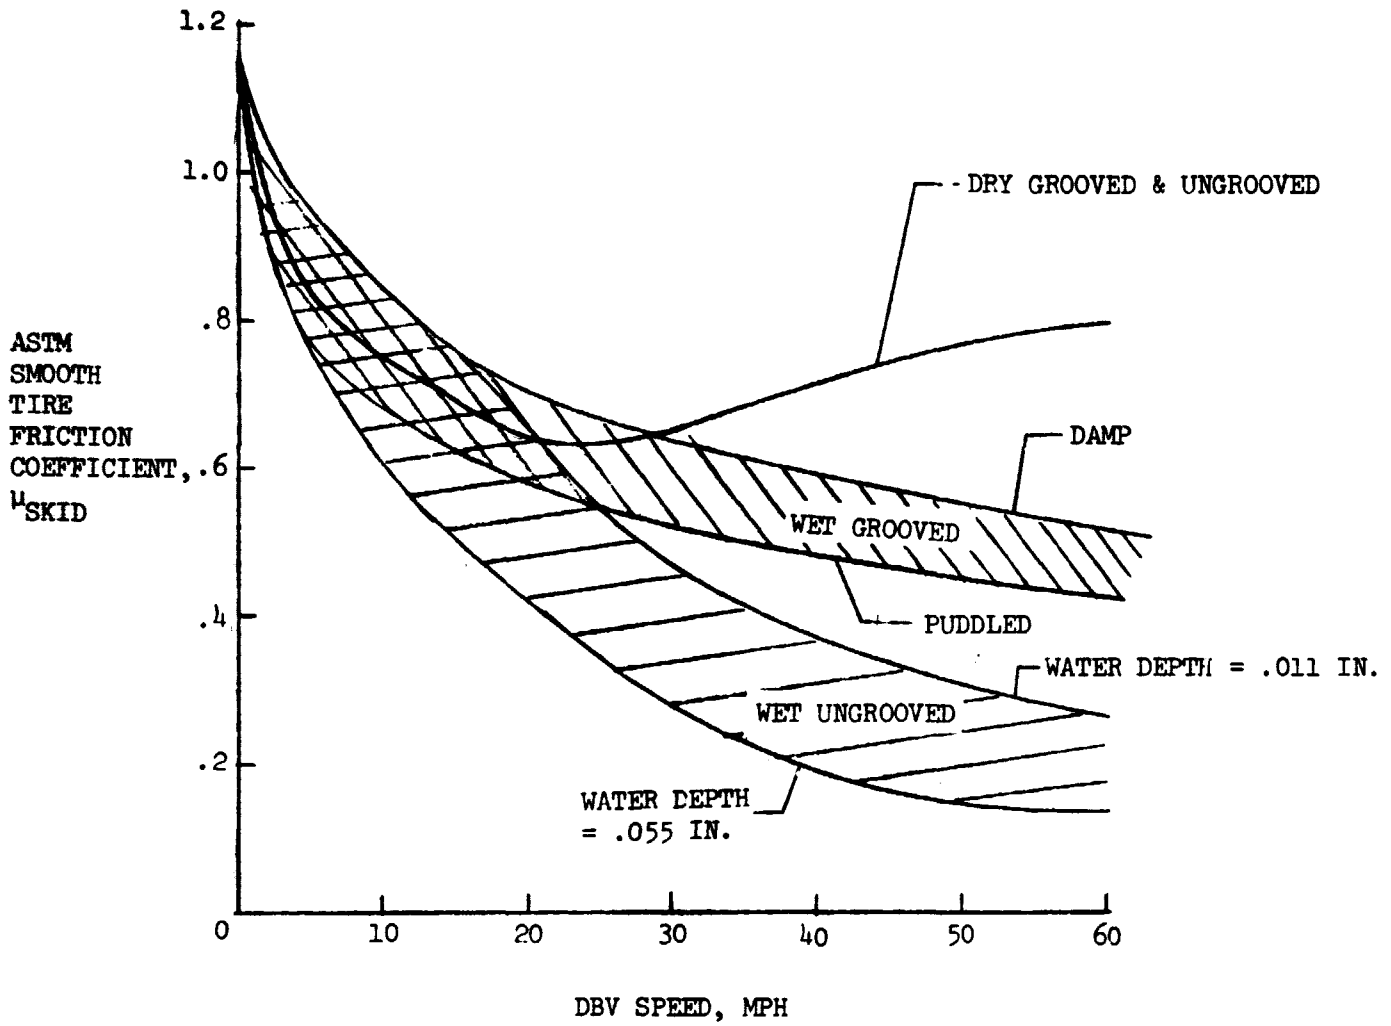
FIGURE 16.- SKID RESISTANCE OF MIA RUNWAY 9L/27R ZONE B (CLEAN ASPHALT) BEFORE AND AFTER GROOVING UNDER DRY AND WET CONDITIONS.

5.5 Skid resistance-Runway 9L/27R.- The clean ungrooved asphalt surface of Runway 9L/27R (zone B) had an average texture depth of 0.017 inches (see table I) from the NASA grease test. This surface is comparable in texture depth to surface four of the TTI drainage study (reference 1) described in table VII. This relatively low value of average texture depth indicates that the zone B pavement surface has a small macrotexture and possible poor tire/pavement drainage under standing water conditions. This point of view is supported by the μ_{skid} data obtained on this surface shown in figure 16. These data indicate that the ungrooved pavement skid resistance decreases with increasing water depth and speed. Aircraft and ground vehicles operating on this surface at high speeds will therefore encounter dynamic hydroplaning when standing water develops on this surface during rainstorms. Grooving this
