APPLICATIONS OF REMOTE SENSING  
TO ESTUARINE MANAGEMENT

ANNUAL REPORT NUMBER 5

John C. Munday, Jr.  
Principal Investigator

Virginia Institute of Marine Science  
Gloucester Point, Virginia 23062

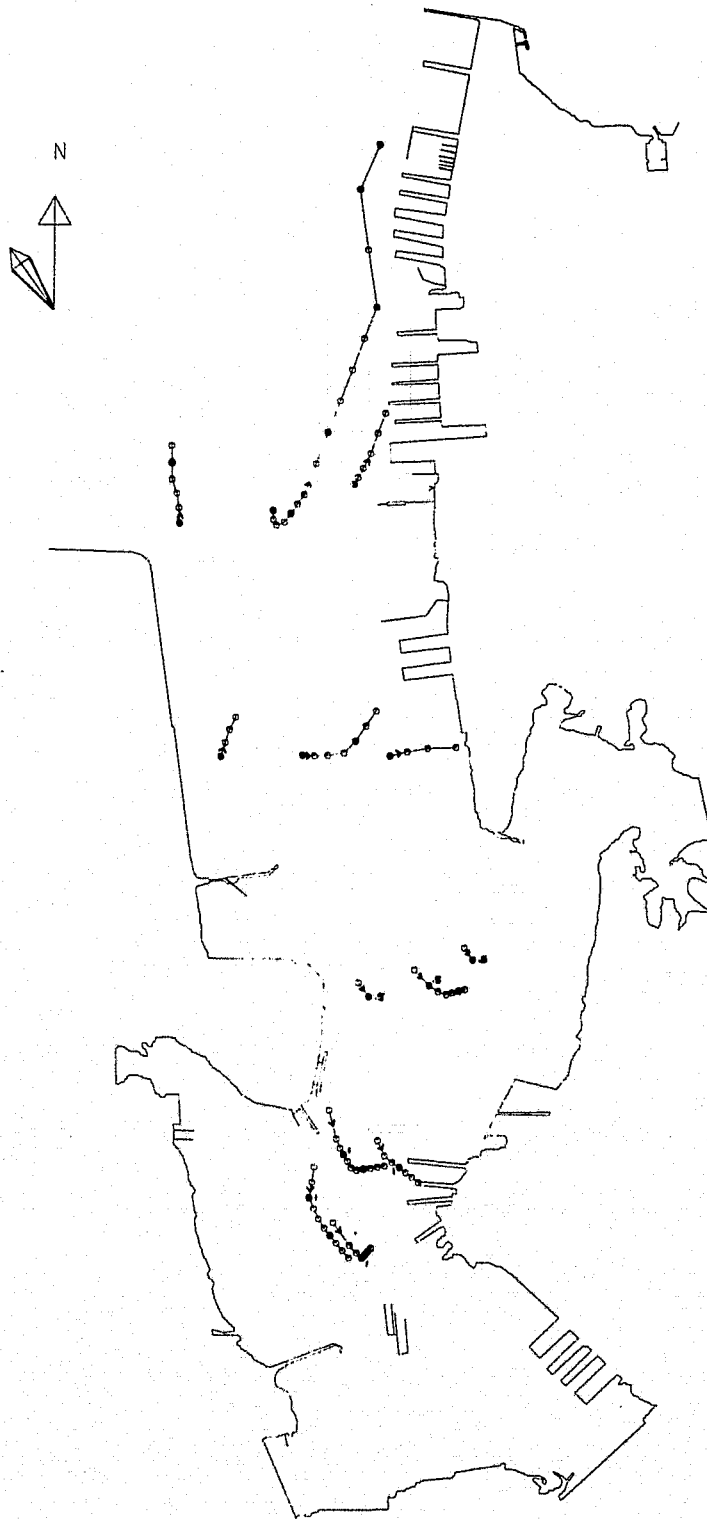
FIGURE 2. Elizabeth River surface circulation.  
February 7, 1977.  
Ebb tide, wind NW 10-19 knots.

Wind direction and speed are vector averaged at three hour intervals from observations at the Norfolk Weather Bureau, and the resultant vector input to the computer program. Although winds in the local study area may be different, it is assumed that the wind driven component of surface circulation will be similar under similar wind conditions at any standard location. Also wind information is available from the Weather Service on a 24-hour basis, enhancing the real time utility of the map products. The computer program plots a scaled wind arrow with length proportional to one of three wind speed classes (0-9, 10-19, 20-29 knots) and direction pointing with the wind, and a north arrow on each Lagrangian map. An example of one of the maps is included as Figure 2. Drifter tracks are depicted by solid lines, overlain with circles to represent pseudo drifter position every 15 minutes from the interpolation routine. A special symbol near the beginning of each track is used to reference the data to predicted high or low tide at a standard tide station. Each fourth circle thereafter is blackened to highlight hourly intervals. Changes in the spacing of successive symbols can be directly interpreted as changes in tidal current speed.

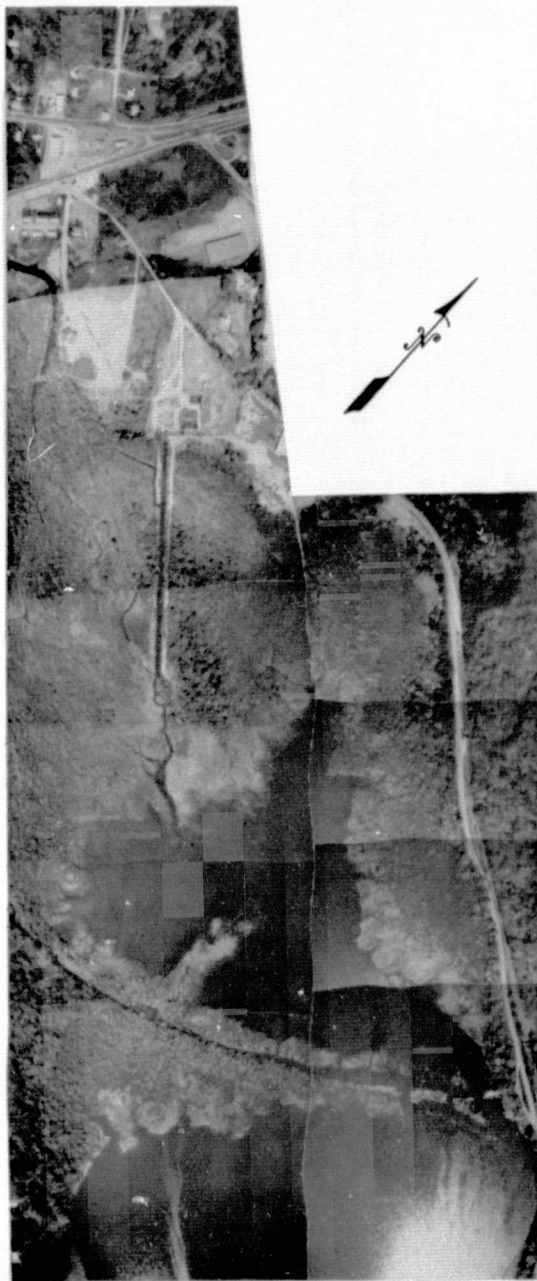
FIGURE 4. Quantico Creek and freshwater marsh, 1976.

The photomosaic with superimposed engineering plans was used by VIMS and FWS in a joint analysis of the project. Recommendations for environmentally acceptable flood control measures were prepared. FWS has stated that the remote sensing allowed a "rapid determination of the extent of work necessary to accomplish the project purpose and the environmental features which would be altered or destroyed by various project alternatives." The major recommendation regarding the project, based largely on remote sensing in conjunction with field investigation, was that "the channelization as proposed extend no further downstream than 1,420 feet from the outfall of the sewage treatment plant" (see Oland, 1976 in Appendix; see also other letters in Appendix). This recommendation was made specifically to protect the freshwater marsh of 0.708 km<sup>2</sup>.

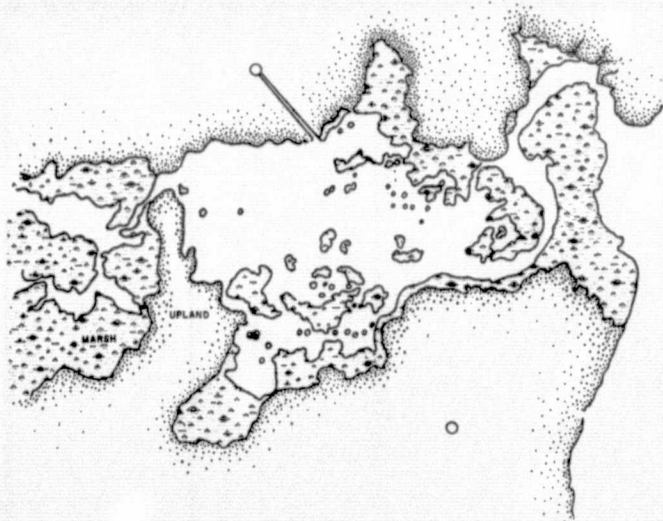
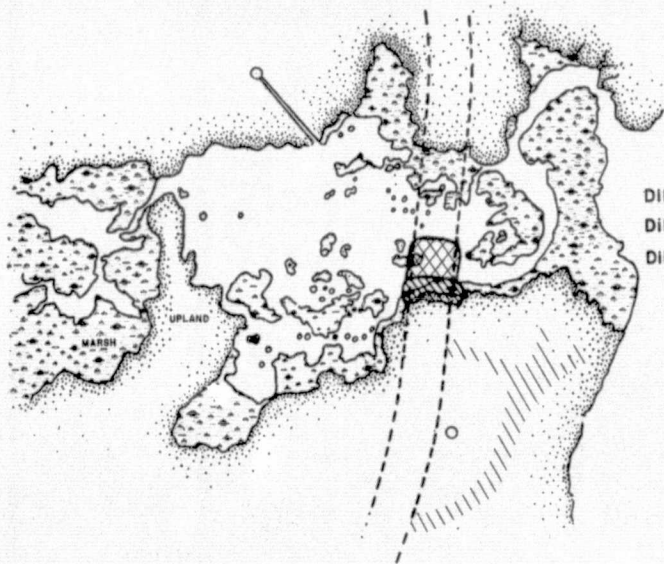
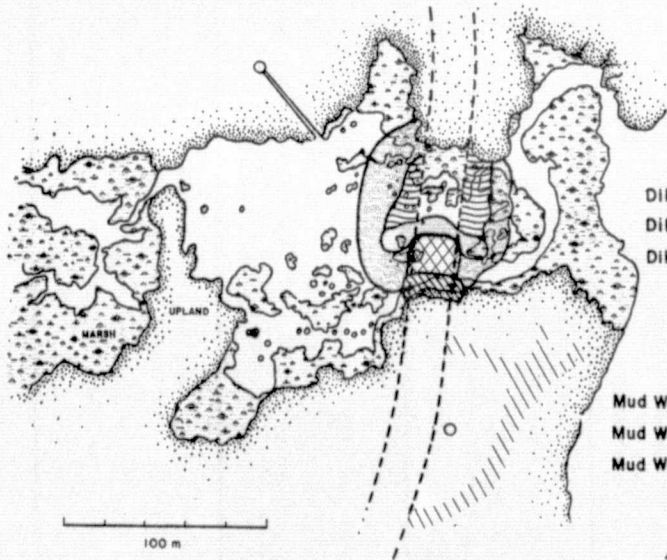
FIGURE 5. Papermill Creek mud wave development caused by highway/dyke construction.

from 250 m<sup>2</sup> on August 11, to 945 m<sup>2</sup> by August 27, to the present 3,140 m<sup>2</sup> as of March 8, 1977. The mud wave has caused the loss of marsh, and altered species composition in its vicinity. Mapping during the summer of 1977 will give the first quantitative indication of species change both in the vicinity of the mud wave and further up the creek. Careful attention will be paid to detect further spreading of the mud wave, and its possible effect on tidal flooding.

After three years in the planning and construction phase, the highway was opened to traffic in June, 1977. Most of the summer of 1976 was spent fabricating the concrete culvert. By August 11, 1976 the culvert was completed and the movement of dirt was begun to form an elevated dyke over the marsh/creek. The weight of the dyke material on the soft creek bottom displaced a large amount of mud from beneath the dyke in the form of a wave. Figure 5 graphically illustrates the growth of the mud wave

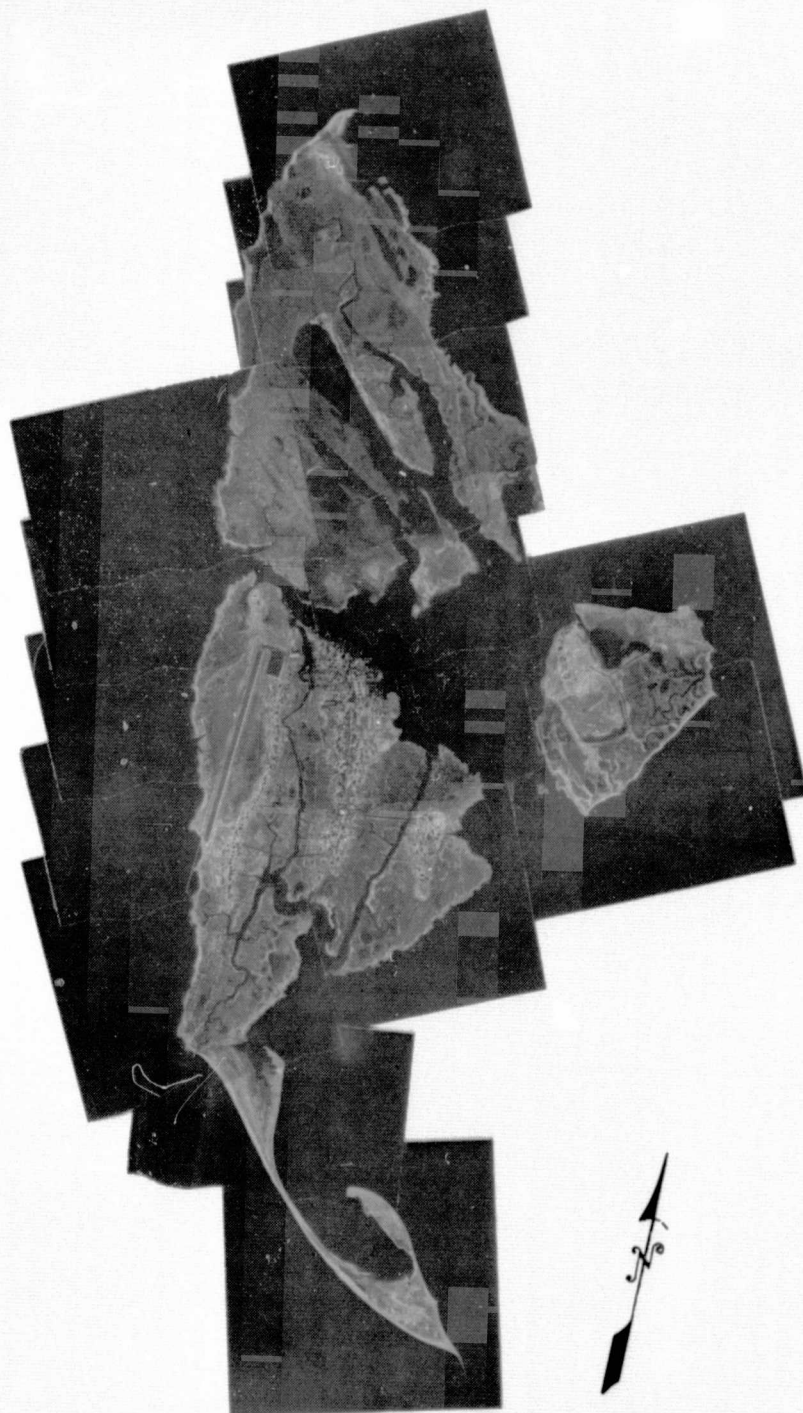
FIGURE 6. Tangier Island panchromatic infrared mosaic at high tide, 1976.
