NASA CR-152532

SNOWPACK GROUND TRUTH

DONNER PASS SITE
SODA SPRINGS, CALIFORNIA

February 1977
Mission Report--January 18, 1977, Mission

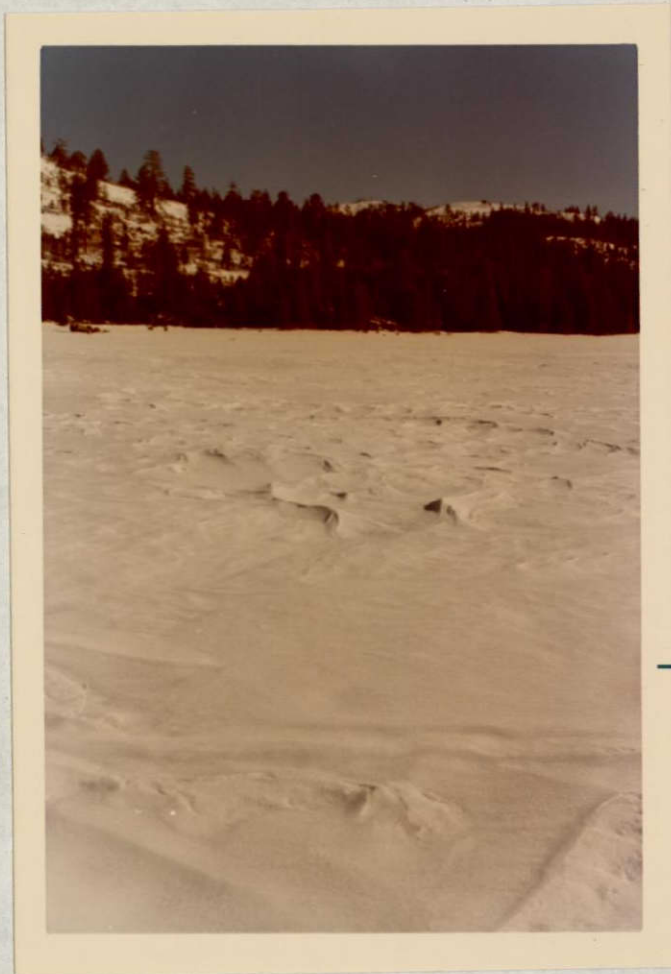
Figure 3 shows the rather typical surface roughness along the flight line.

Fig. 3. Typical snowpack roughness (note short distance variations).

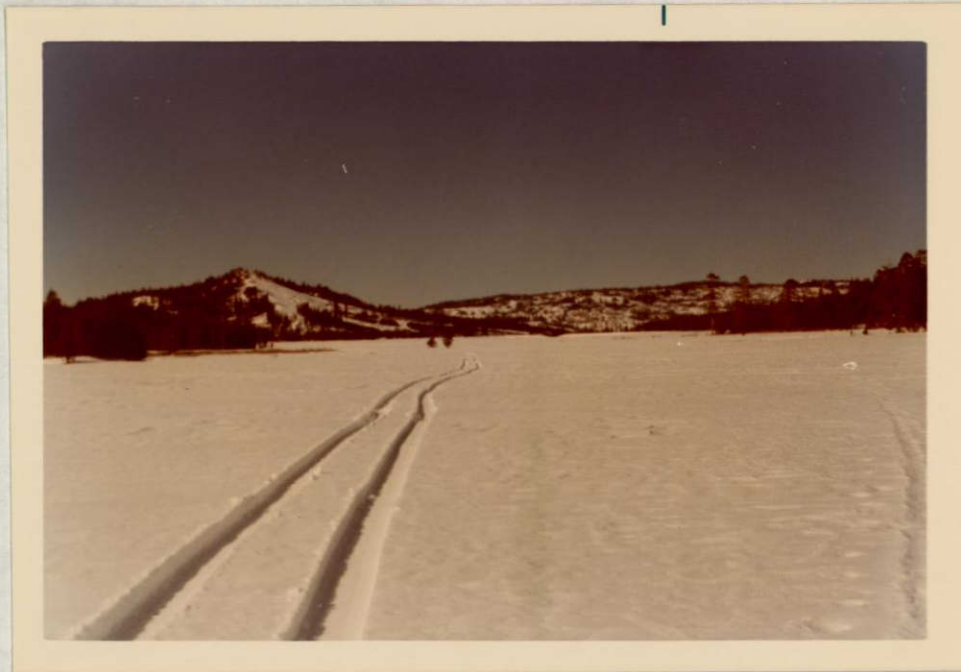
Figure 4 is a view looking back towards the starting point near the upstream toe of the dam. The flight line is just to the north of the two small trees. The tracks in the snow were made by the over-snow vehicle used in obtaining the ground truth. This vehicle was of great assistance on this particular snowpack condition.

Fig. 4. Scene looking west along flight line.
