NASA CR-2824

## SUMMARY REPORT OF EVALUATION OF COATED COLUMBIUM ALLOY HEAT SHIELDS FOR SPACE SHUTTLE THERMAL PROTECTION SYSTEM APPLICATION

*Prepared by*  
CONVAIR DIVISION OF GENERAL DYNAMICS  
San Diego, Calif. 92123  
*for Langley Research Center*

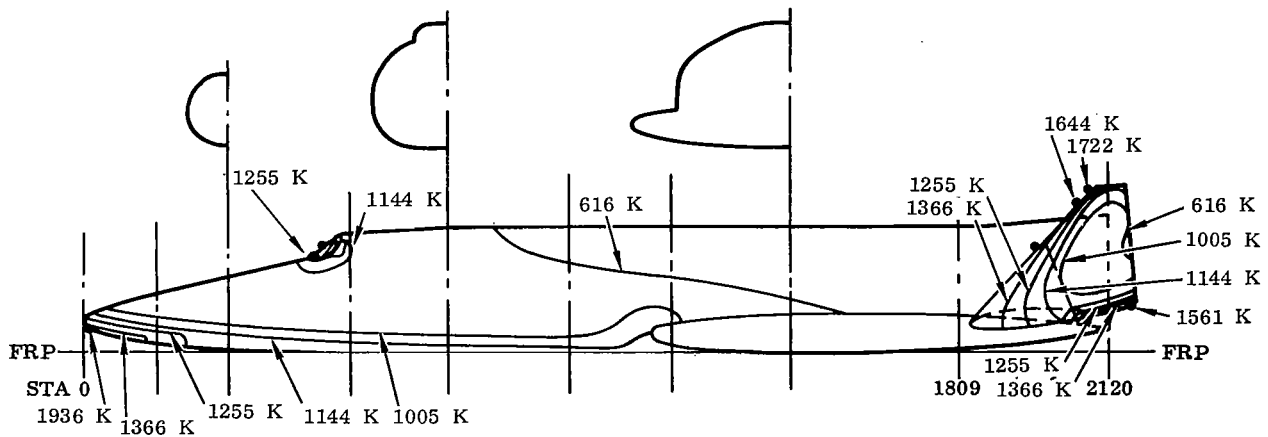
Figure 2. Predicted Orbiter Maximum Surface Temperatures

The focus vehicle selected for this investigation was a Rockwell International high cross-range orbiter launched on a Convair recoverable booster. Figure 2 illustrates predicted maximum surface temperatures for the selected orbiter. As shown, only the extreme nose tip and wing and tail leading edge temperatures exceed 1590 K (2400° F). A region of severe heating (see fig. 3) was selected as the area of investigation in all subsequent work. The maximum temperatures in this region vary from 1590 K (2400° F) at the forward edge to 1370 K (2000° F) at the aft edge. The environmental parameters were based on the most severe case, at the forward edge of the region.

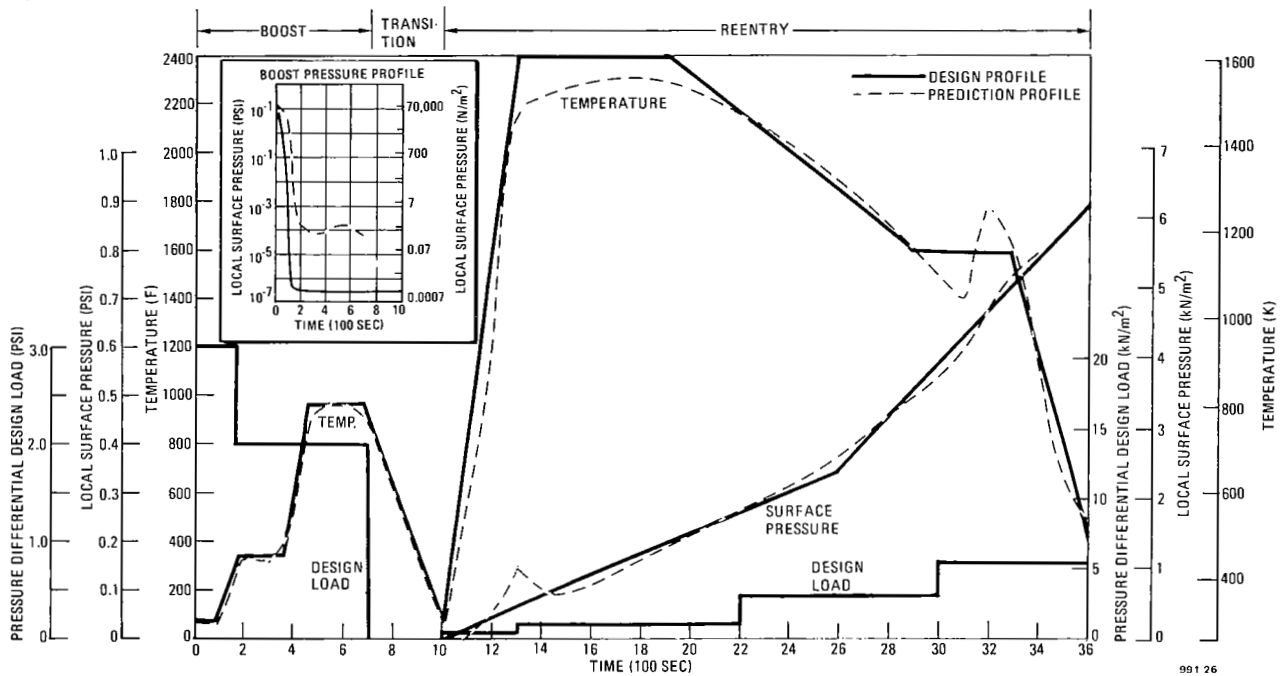
Figure 4. Design and Test Profile

The various flight conditions were combined into the design profile shown in figure 4. The critical loading occurred during launch at  $t=170$  seconds when the pressure differential load was  $20.7 \text{ kN/m}^2$  (3.0 psi) and the temperature was  $445 \text{ K}$  ( $340^\circ \text{F}$ ). As the temperature increased to  $790 \text{ K}$  ( $960^\circ \text{F}$ ) during staging, the pressure differential decreased to  $14.1 \text{ kN/m}^2$  (2.0 psi). During reentry the design load was step functioned from  $1.03 \text{ kN/m}^2$  (0.15 psi) during the maximum heat shield surface temperature of  $1590 \text{ K}$  ( $2400^\circ \text{F}$ ), to  $3.10 \text{ kN/m}^2$  (0.45 psi), and finally to  $5.86 \text{ kN/m}^2$  (0.85 psi) during the final stages of entry when a 2.5g maneuver would be performed. The maximum panel temperature after 2500 seconds of reentry would be below  $480 \text{ K}$  ( $400^\circ \text{F}$ ).

The trade study was based on heat shields of the general size 30.5 by 40.6 cm (12 by 16 inches) and the design profile shown in figure 4. In the structural analyses, the panels were considered to have simply supported edge conditions with joints that permit free thermal expansion. Five configurations had ribs or corrugations (in the direction of flow) that behave essentially as simply supported beams under normal pressure loading. The remaining two configurations were treated as plates. The short span, 30.5 cm (12 inches), minimum gages, and stiffener spacing, in general, dictated the section geometry. The analysis was composed of:

the pressure loading capability of the test system. From figure 4 it can be seen that the maximum required test pressure during boost was  $21 \text{ kN/m}^2$  (3.0 psi), and  $1.0 \text{ kN/m}^2$  (0.15 psi) during high temperature reentry. Pressurization tests indicated that for a pressure of  $7.45 \text{ kN/m}^2$  (1.08 psi),  $0.10 \text{ m}^3/\text{sec}$  ( $220 \text{ ft}^3/\text{min}$ ) of air was required. Thus for  $21 \text{ kN/m}^2$  (3.0 psi) an intolerably high flow rate was indicated. Pressure testing was performed that isolated the specimen and the facility and that showed that 56% of the apparent leaks were around the specimen holding fixture and through the test specimen. The balance of the losses were through the top enclosure around the quartz cooling tube penetrations and the quartz tube penetrations into the hot gas plenum.

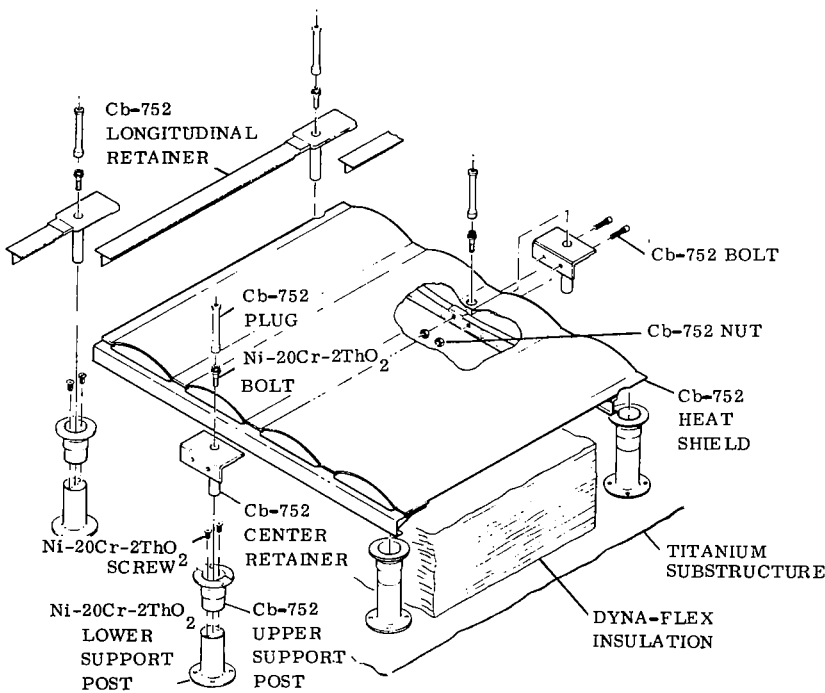
Figure 5. Open-Corrugated TPS Exploded Assembly

The panel employs transverse beams for stability with transverse panel expansion being accommodated by the corrugation deflection. Except for the aft center panel support post that is bolted permanently to the transverse beam, the tubular support posts and access are as previously described. However, note the material differences of the lower support posts and the insulation. These changes were made between Phase II when the open-corrugation TPS was conceptually evaluated and Phase III when the final tee-stiffened TPS configuration shown in figure 1 was selected.

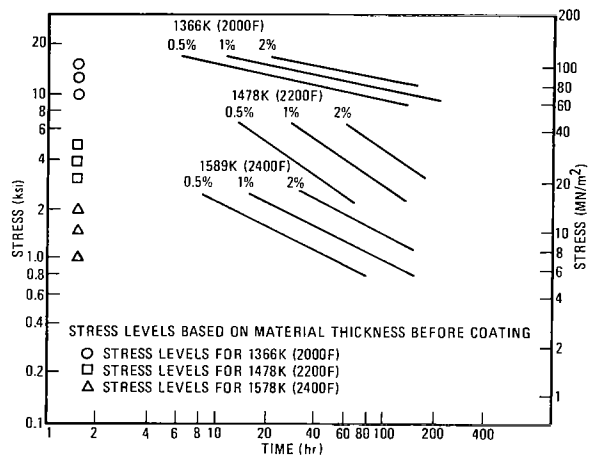
Figure 8. Creep Properties of Cb-752/R-512E at 1370 K (2000° F), 1480 K (2200° F) and 1590 K (2400° F)

The target was to provide stress levels covering the range of 10 to 100 hours for 1% creep. The stress levels were calculated on the basis of the original metal thickness prior to coating. Composite creep curves for 0.5%, 1%, and 2% creep are presented in figure 8.

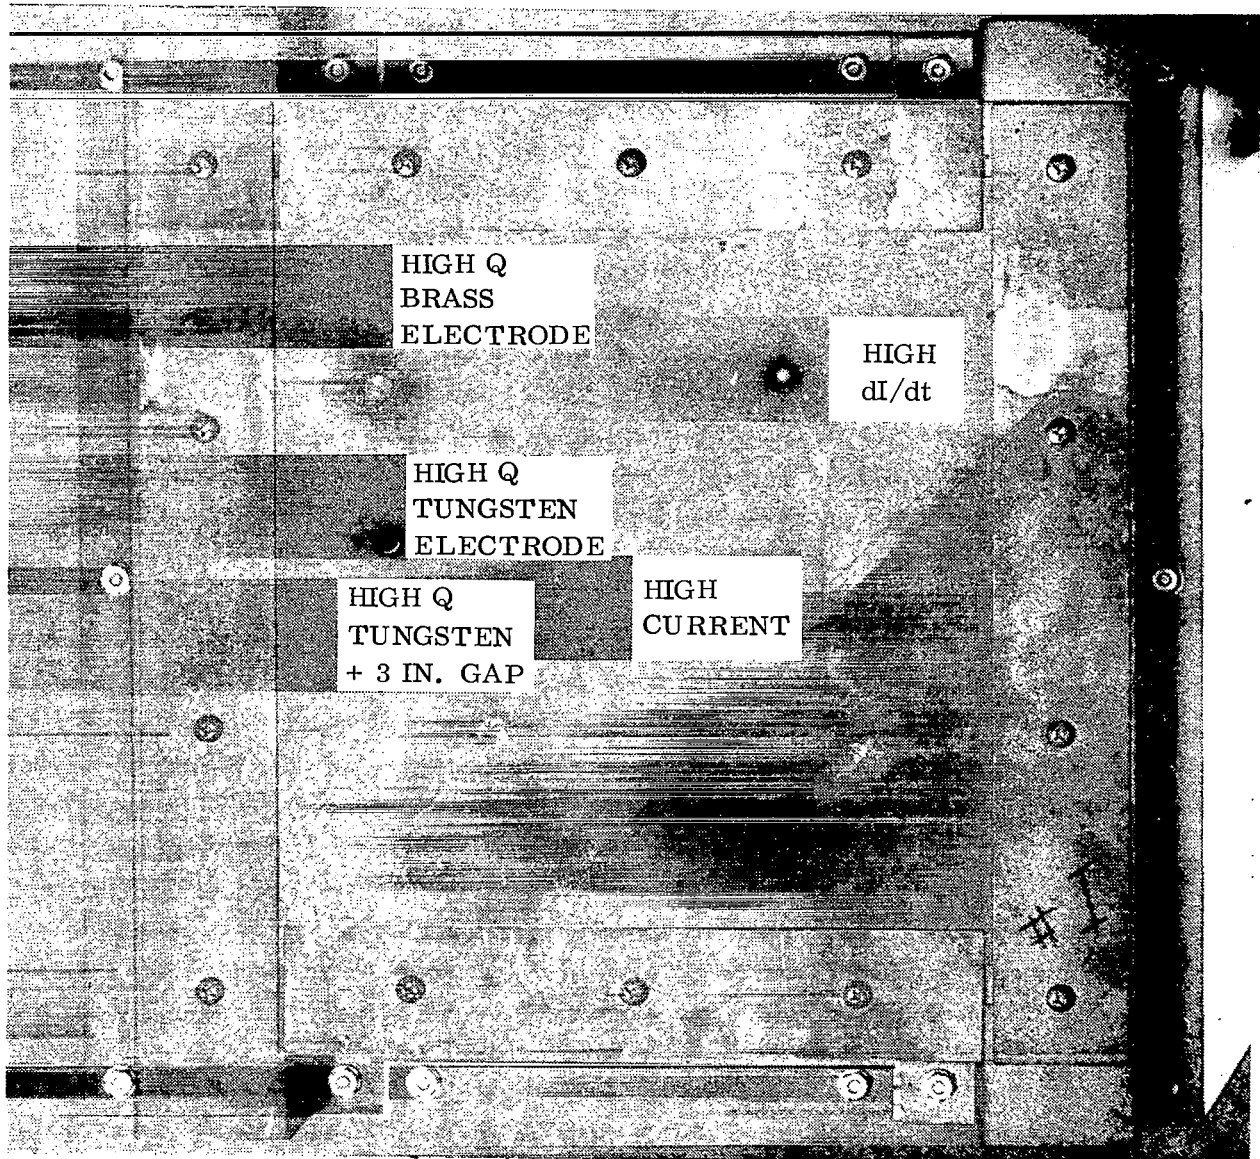
Figure 10. As-Coated Cb-752 Test Specimen After Lightning Strike Test Sequence

The maximum current strike, typical of a cloud-to-ground bolt, ruptured the panels causing the material to rip. Rips of approximately 2.50 to 5.25 inches (6.35 to 13.34 cm) along with inward bending of the ripped areas occurred. A panel damaged in such a manner would be unsatisfactory for reentry due to ingestion of the air stream. It would therefore, require repair or replacement prior to atmospheric entry. However, since the strike condition was an example of an on-the-pad mode, it is unlikely that the vehicle would be launched with a noticeably damaged heat shield.

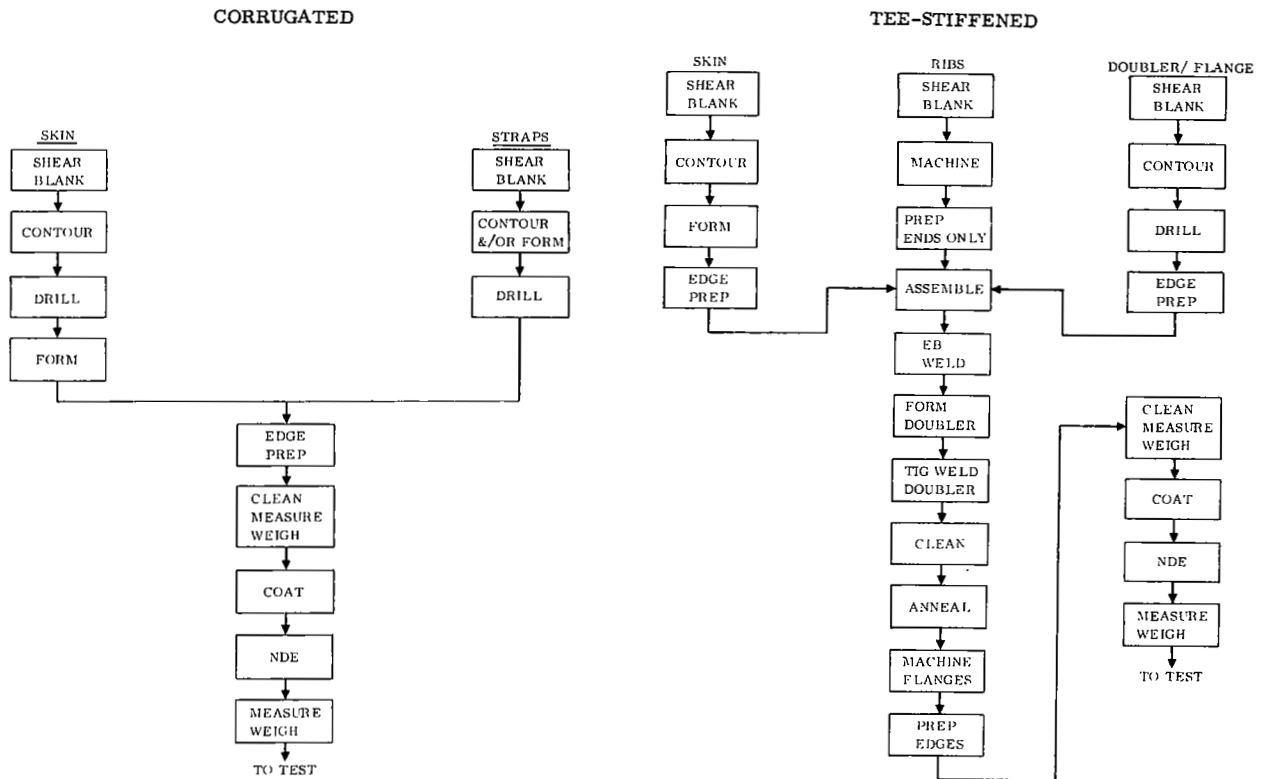
Figure 13. Fabrication Sequence for Subsize TPS Panels

employed normal sheet metal fabrication. Only the edge and corner preparation and the use of electron beam welding differentiates this structure from other common sheet metal structures. The requirements for edge and corner preparation for coating were the same as for the corrugated panel. The edge preparation noted in figure 13 was sequenced to be done when the operation could be most readily performed during assembly (i. e., in detail or at some stage of assembly).

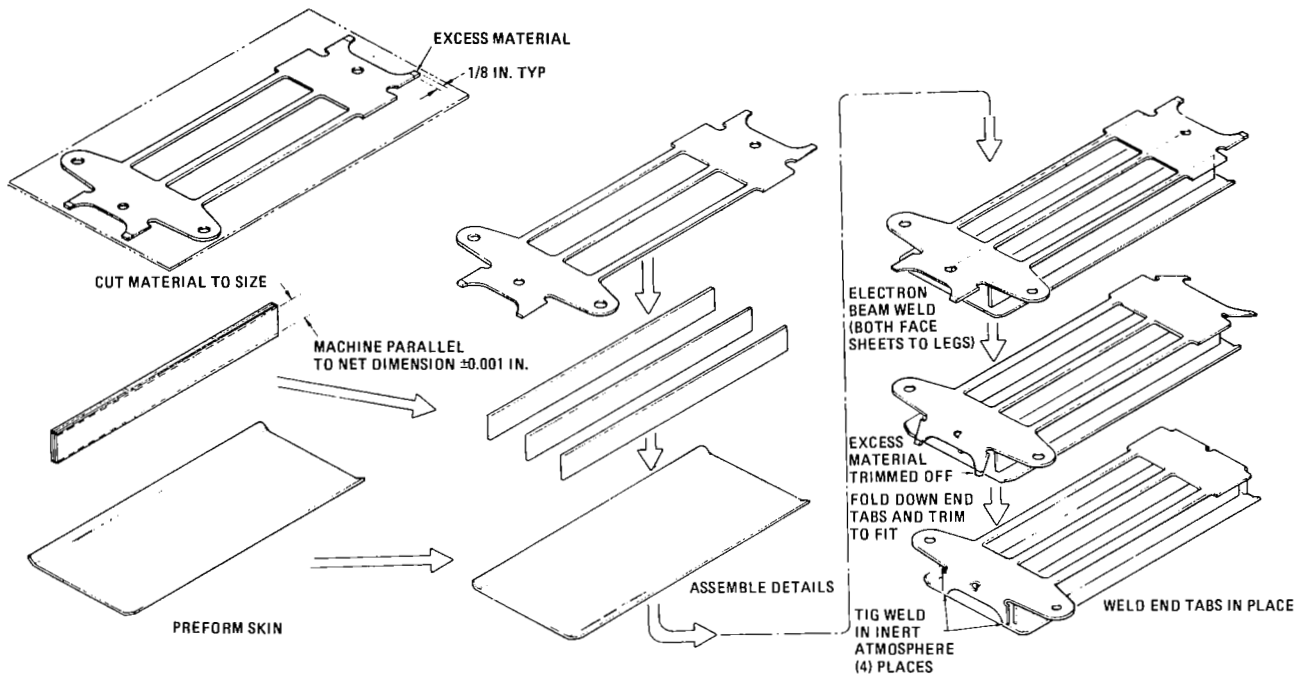
Figure 14. Subsize Tee-Stiffened Panel Fabrication Sequence

Figure 14 graphically portrays the assembly, welding, and final forming operations for the tee-stiffened panel. It can be seen that the primary electron beam welding was done with the doublers in a flat and unformed position. This permitted access to the interior of the panel from either end for removal of internal weld tooling, for the inspection of the penetration side of the welds, and/or for the repair of the welds. After completion of the electron beam welding, the doublers were formed down, creating the panel end angles that were then tungsten inert gas (TIG) welded to the ends of the skin.

The tooling philosophy for electron beam welding of the tee-stiffened panels was 100% solid, hard tooling (aluminum and chrome-plated copper). This required that all elements of the panel be assembled and located in the tooling before electron beam welds were made and all welds be accomplished without removing the panel from the tooling. Upon completion of the welds, the tooling was removed permitting inspection of both sides of all welds. When rewelding or repair welding was necessary, the tooling was reassembled on the part before welding. A limited number of interior repair welds were made without the aid of internal tooling. The TIG welds were performed without

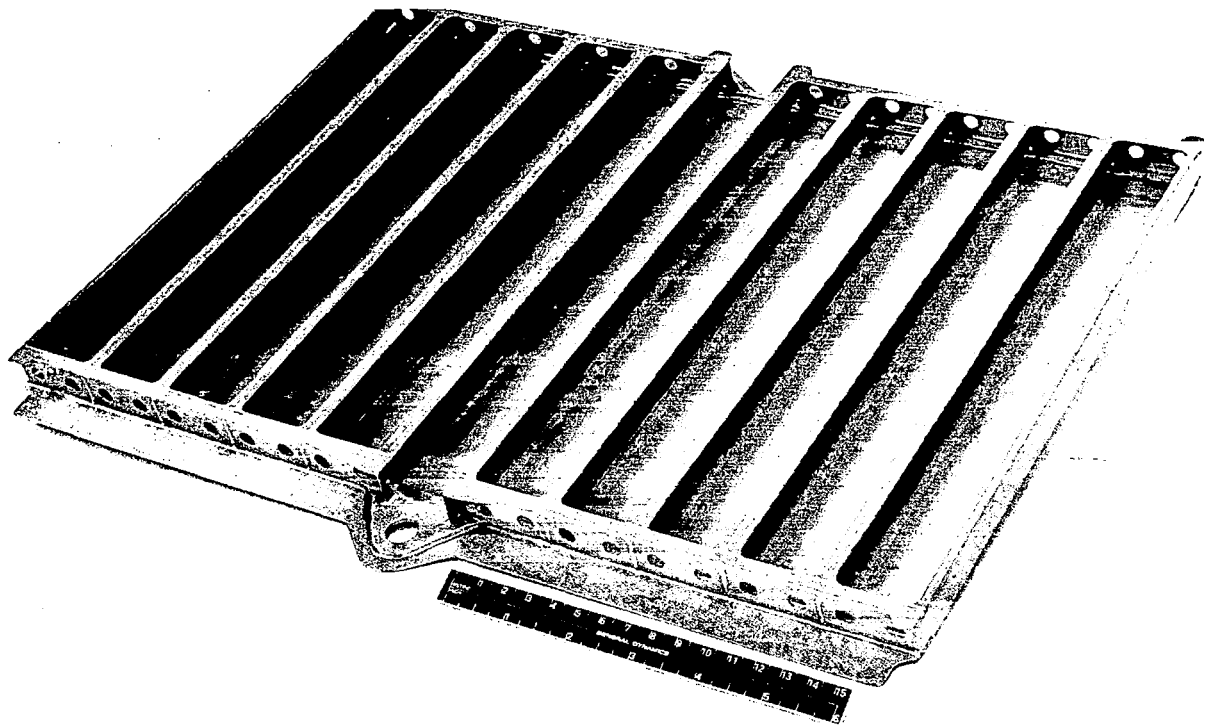
Figure 18. Interior View of Electron Beam Welded Tee-Stiffened Cb-752 Heat Shield (Photo 12-8326)

Figure 18 shows a completed tee-stiffened heat shield panel ready for test. These panels were completely assembled by electron beam welding, each panel containing over 30 feet of weld applied without any straightening or intermediate heat treating of the parts. The panels were first welded into a subassembly composed of the skin, flange skin, and ribs, which was subsequently machined to receive the end closure beams for welding.

The electron beam welding used on the tee-stiffened panels involved three types of weld joints: (1) burn-through tee-welds between ribs and skins and flanges, (2) step-butt welds between skins and flange skins and closure beams, and (3) burn-down tee-welds between rib tangs and beam webs. All webs required 100% joint fusion with full penetration and fillet formation. Welds were made using chrome-plated copper and aluminum hard tooling. Hard chromium was applied to copper tooling to prevent copper contamination of the columbium during welding and assembly operations. As further

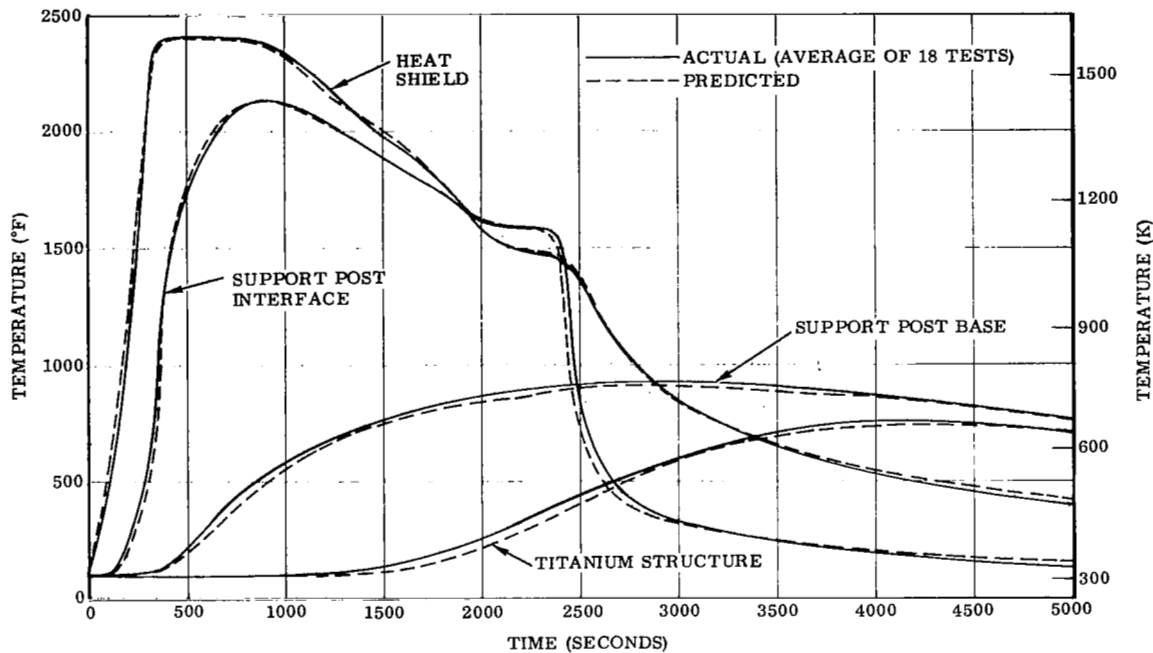
Figure 20. Hot Gas Flow Test Composite Temperature Distribution - Open Corrugation TPS

A composite temperature distribution is shown in figure 20, which illustrates the degree of predicted accuracy when compared with the recorded data. Similar accuracy was achieved for the tee-stiffened TPS specimen.

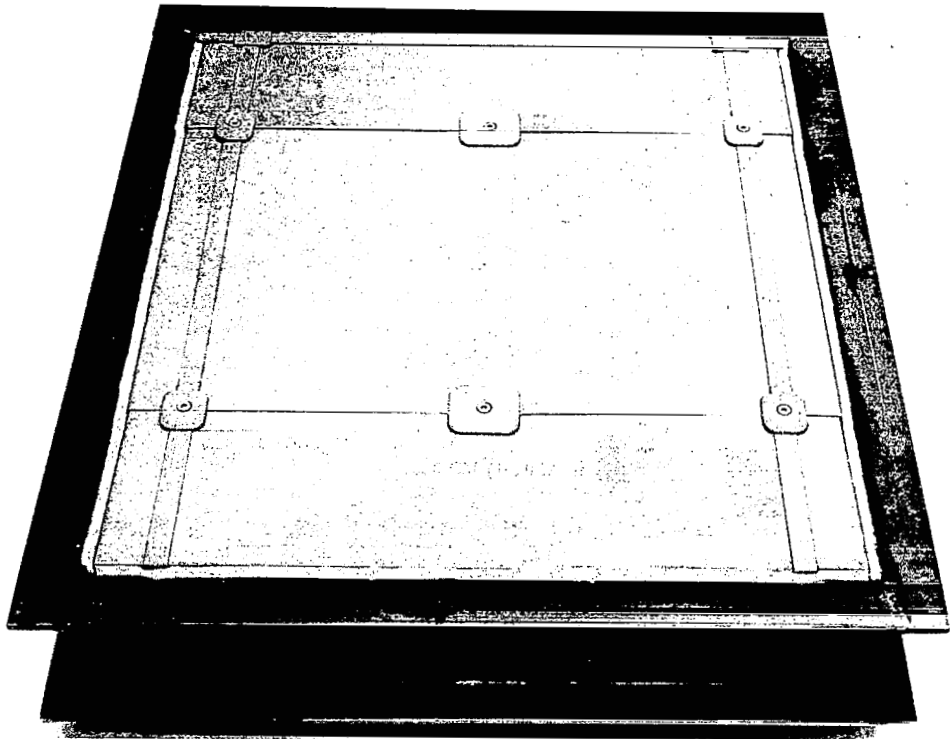
Figure 21. Unexposed Tee-Stiffened TPS Specimen – End View (Photo 13-0328)

Tee-stiffened TPS. - The tee-stiffened TPS specimen (fig. 21) was also subjected to 20 thermal flow cycles. The maximum heating rate was  $680 \text{ kW/m}^2$  ( $60 \text{ Btu/ft}^2 \text{ sec}$ ) and the total mass flow rate was  $0.118 \text{ kg}$  ( $0.259 \text{ lb}$ ) per second. The static pressure and the Mach number were  $170 \text{ N/m}^2$  ( $0.025 \text{ psig}$ ) and  $0.8$  respectively. No anomalies were experienced during this test series. The specimen was removed and partially disassembled after cycle 10 as previously described. Disassembled components are shown in figure 22.

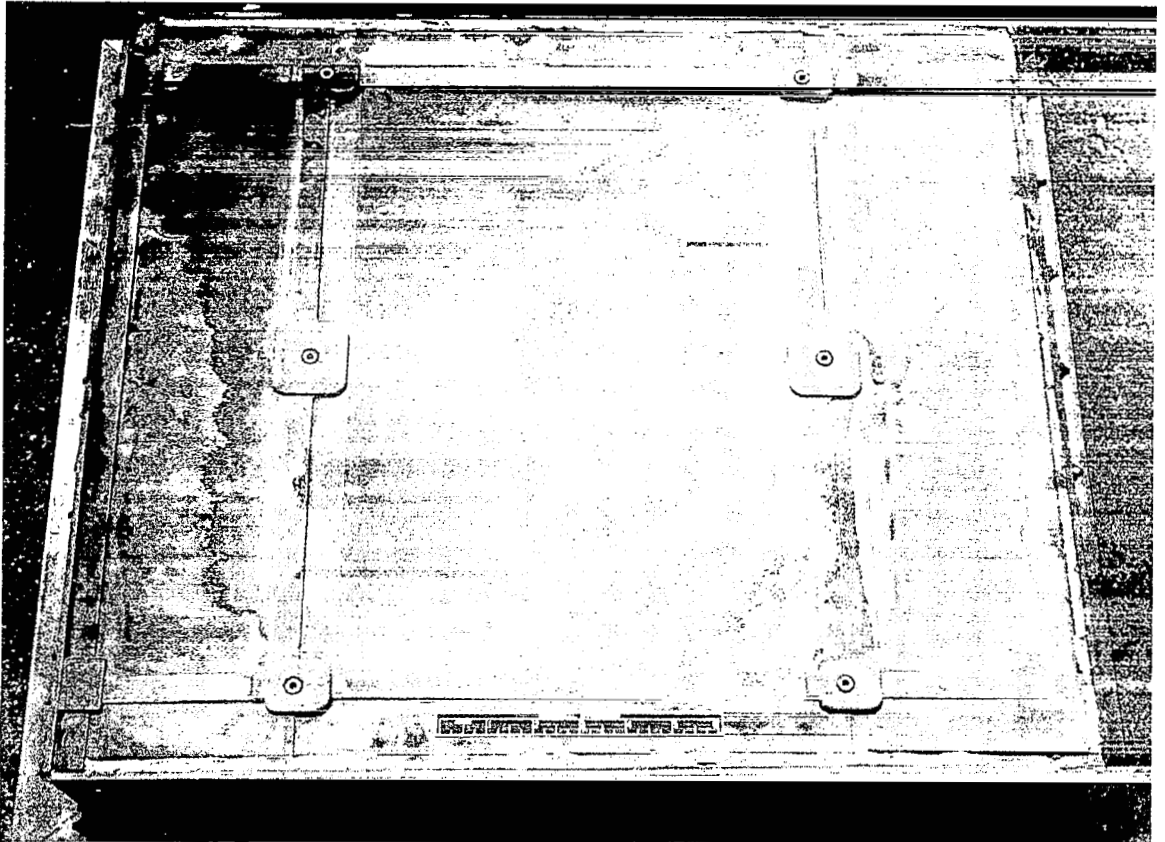
Figure 23. Tee-Stiffened TPS Specimen after 50 Radiant Heat/  
Pressure/Load Cycles – Side View (Photo 13-2766)

The specimen is shown in figure 23 after 50 thermal cycles. Again, the varied surface patterns can be seen in the post test photographs. No sites of substrate oxidation,

impending coating failure, or structural deterioration were found. Following the 50 thermal cycle exposure the specimen was exposed to 75 simulated boost acoustic cycles.

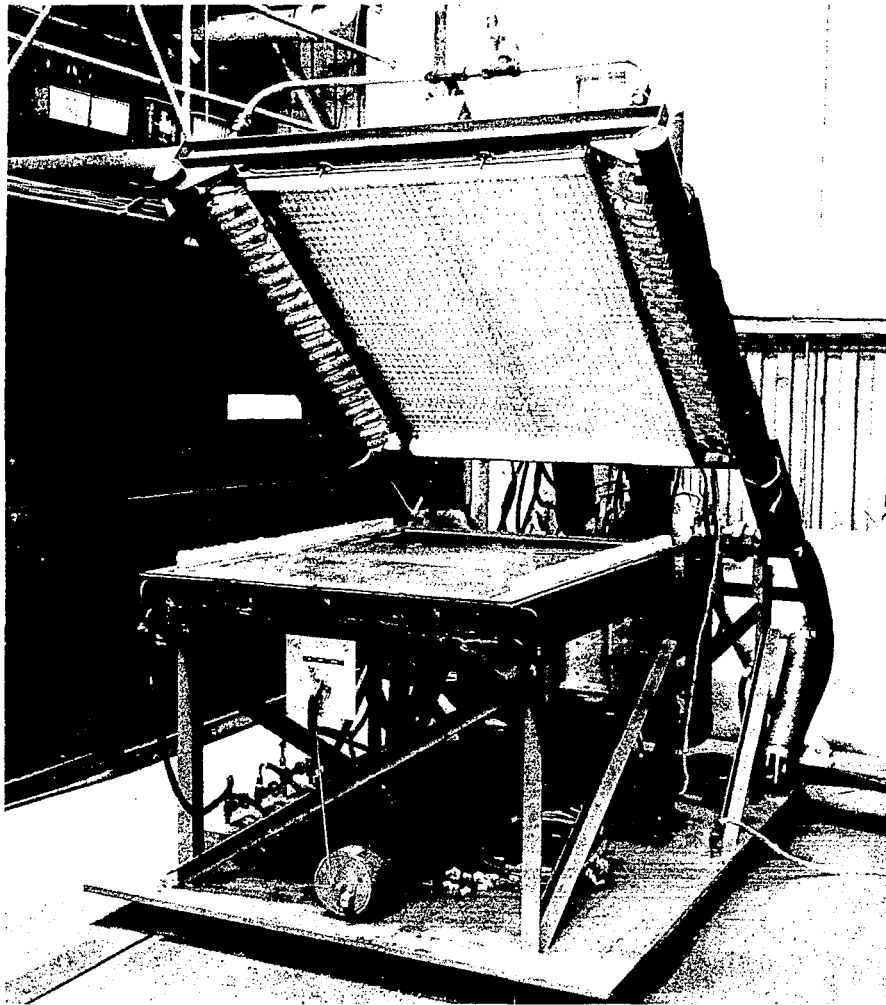
Figure 26. Facility for Thermal, Load, and Environmental Testing of Multi-Panel TPS (Photo 135429)

This facility consisted of two box-like, stainless steel enclosures: the bottom enclosure that mounted the test specimen and temperature sensing instruments, and the top enclosures that mounted the power distribution system, the heat lamps, the cooling air distribution system, the pressurization gas and oxygen partial pressure manifolding, and the hot air plenum and exhaust ducting. The top enclosure was insulated with approximately 5 cm (2 inches) of fused silica foam insulation (Glasrock) that was mechanically mounted. An oxygen partial pressure sensor line was also mounted in the top enclosure. The two enclosures were hinged to open in a clam-shell fashion exposing the skin surfaces of the test specimen. Opening was accomplished by two hydraulic cylinders operated from an air-hydraulic accumulator. The two surfaces closed and sealed against a silicone rubber gasket, permitting pressurization of the cavity over the specimen.

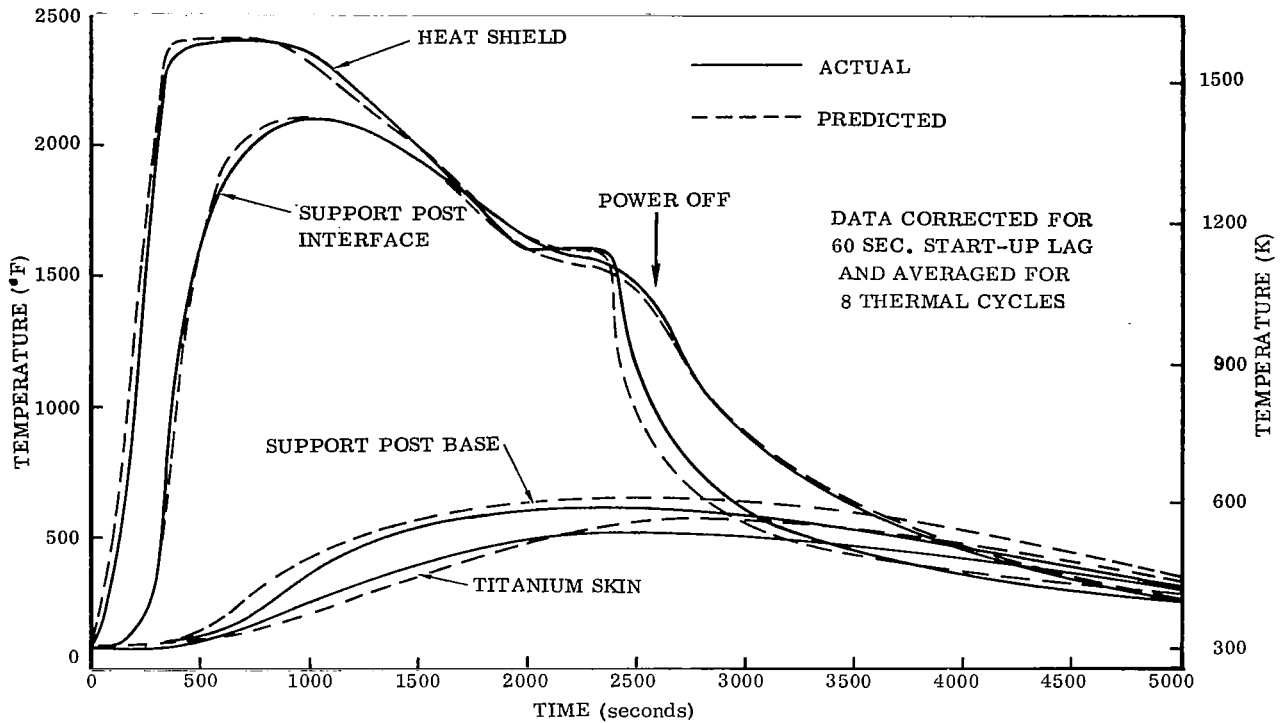
Figure 30. Radiant Heat Test Composite Temperature Distribution

Data plots of the average temperature history for four critical locations are shown in figure 30. The average maximum temperature at the center of the heat shield surface as recorded on the interior side was 1593 K (2408° F) compared to a programmed and predicted 1590 K (2400° F). The data closely followed the predicted curve until the final cool-down period after 2400 seconds from start of reentry. At this point the cool-down rate was slower than anticipated. This deviation was probably due to the heat stored in the Glasrock insulation above the lamps.

The bi-metallic support post interface maximum temperature was 1419 K (2095° F) compared to a predicted level of 1422 K (2100° F). This data set exhibited excellent correlation over the entire recorded range with slight deviations occurring during the heat-up and during the simulated reentry maneuver (2000 to 2400 seconds following start of reentry).

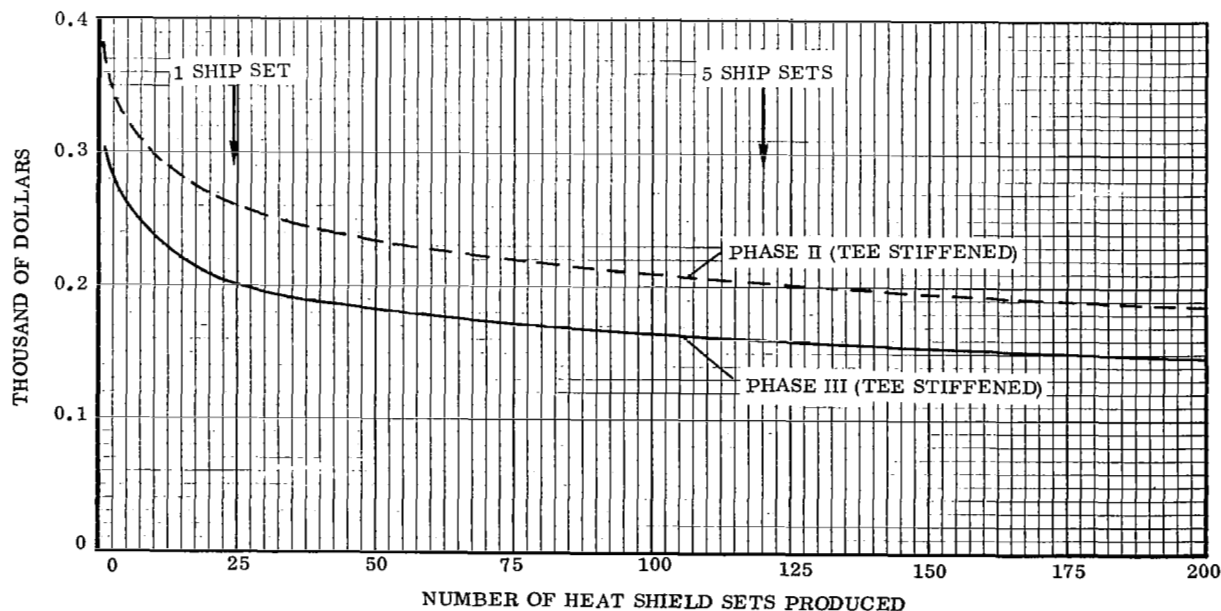
Figure 33. Tee-Stiffened TPS Cumulative Average Cost

heat shield units would be required per vehicle; the current actual costs were baseline; there would be no reduction in per pound material cost; and there would be approximately an 89% composite learning factor (ref.11) applied to all fabrication parameters. This composite was based on the assumptions that learning factors were 100% for material; 90% for machining, joining, and coating; and 85% for forming and finishing. The cumulative average cost for n units is shown in figure 33. In addition to the Phase III components cost projections, those generated during Phase II are also shown for comparison. The variation in the curves is due to the initial cost since the same learning curve factors at an 89% slope were applied.
