NASA TM X-73605

**THERMODYNAMIC DATA REPORT FOR THE
TITAN/CENTAUR TC-5 EXTENDED MISSION**

by Raymond F. Lacovic
Lewis Research Center
Cleveland, Ohio 44135
January 1977

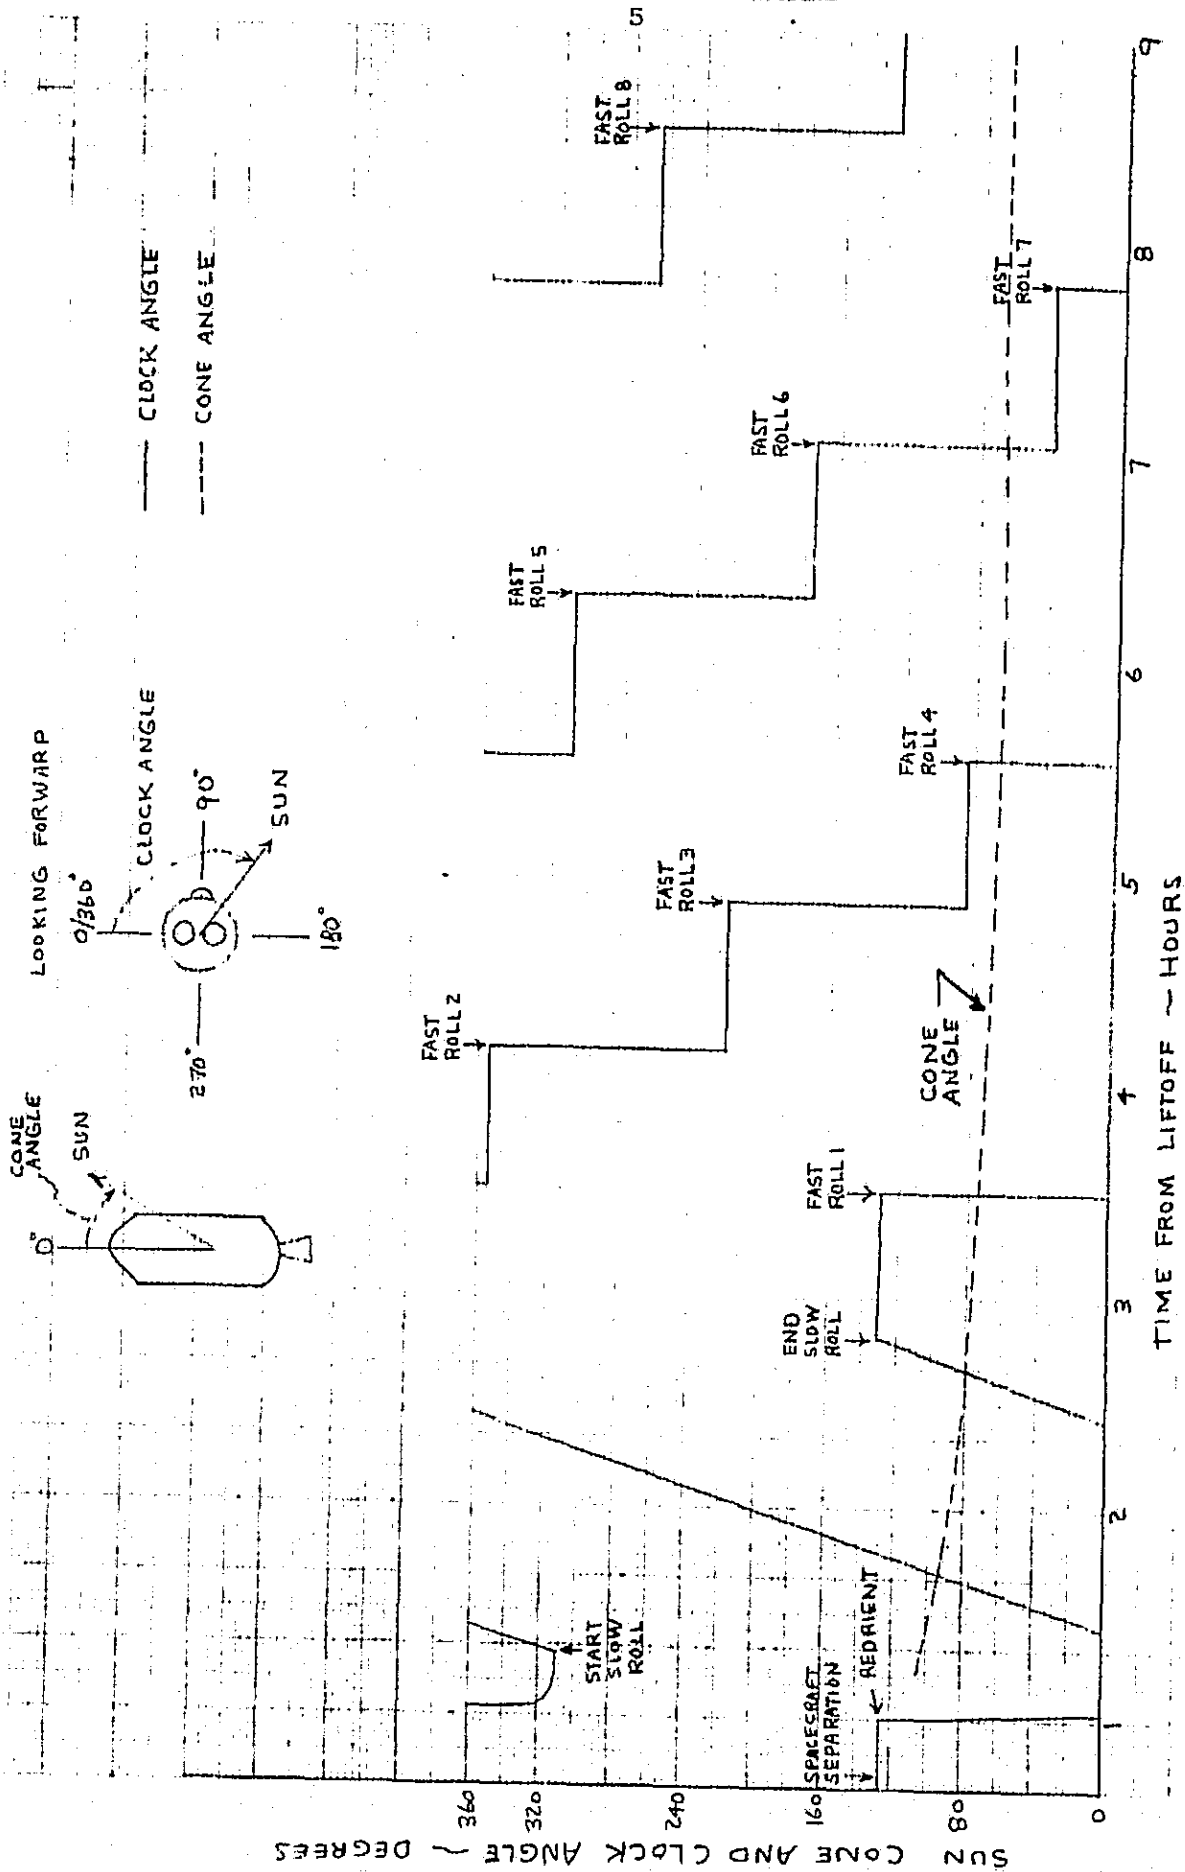
FIGURE 1 EXTENDED MISSION VEHICLE - SUN CLOCK AND CONE ANGLE HISTORY.

The sequencing of these thermal roll maneuvers, together with the resulting solar clock and cone angles, is shown in figure 1. The angles shown are approximate since wide control limits ($\pm 10^{\circ}$) were used throughout most of the mission. The vehicle-sun clock angle changed continuously during the mission as the various thermal rolls were performed. The vehicle-sun cone angle remained relatively constant at about 75° to provide continuous vehicle broadside heating. This cone angle resulted in a near maximum heating environment for the LH_2 tank and forward components and a slightly less than nominal heating environment for the aft bulkhead components. The vehicle was far enough away from the Earth that the thermal and albedo radiation from the Earth were negligible.

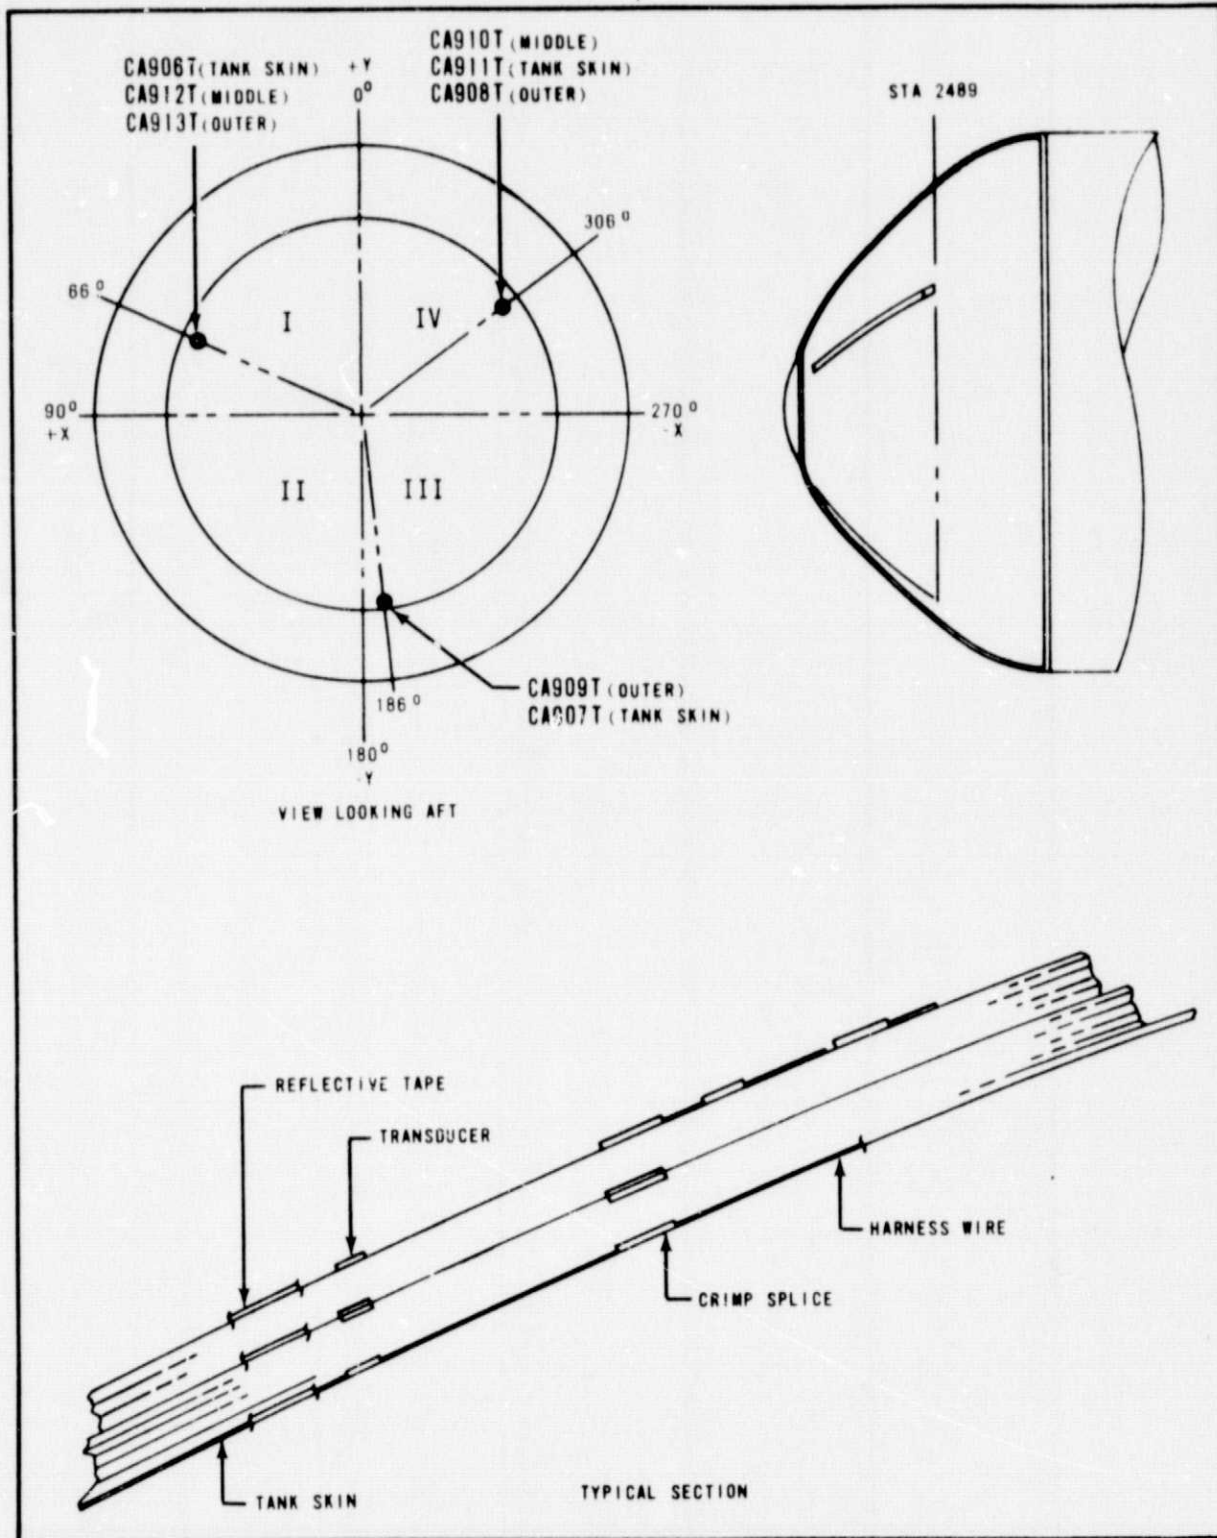
Figure 2A CENTAUR Forward Bulkhead Temperatures

* SEE FIGURE 2A FOR INSTRUMENTATION LOCATIONS

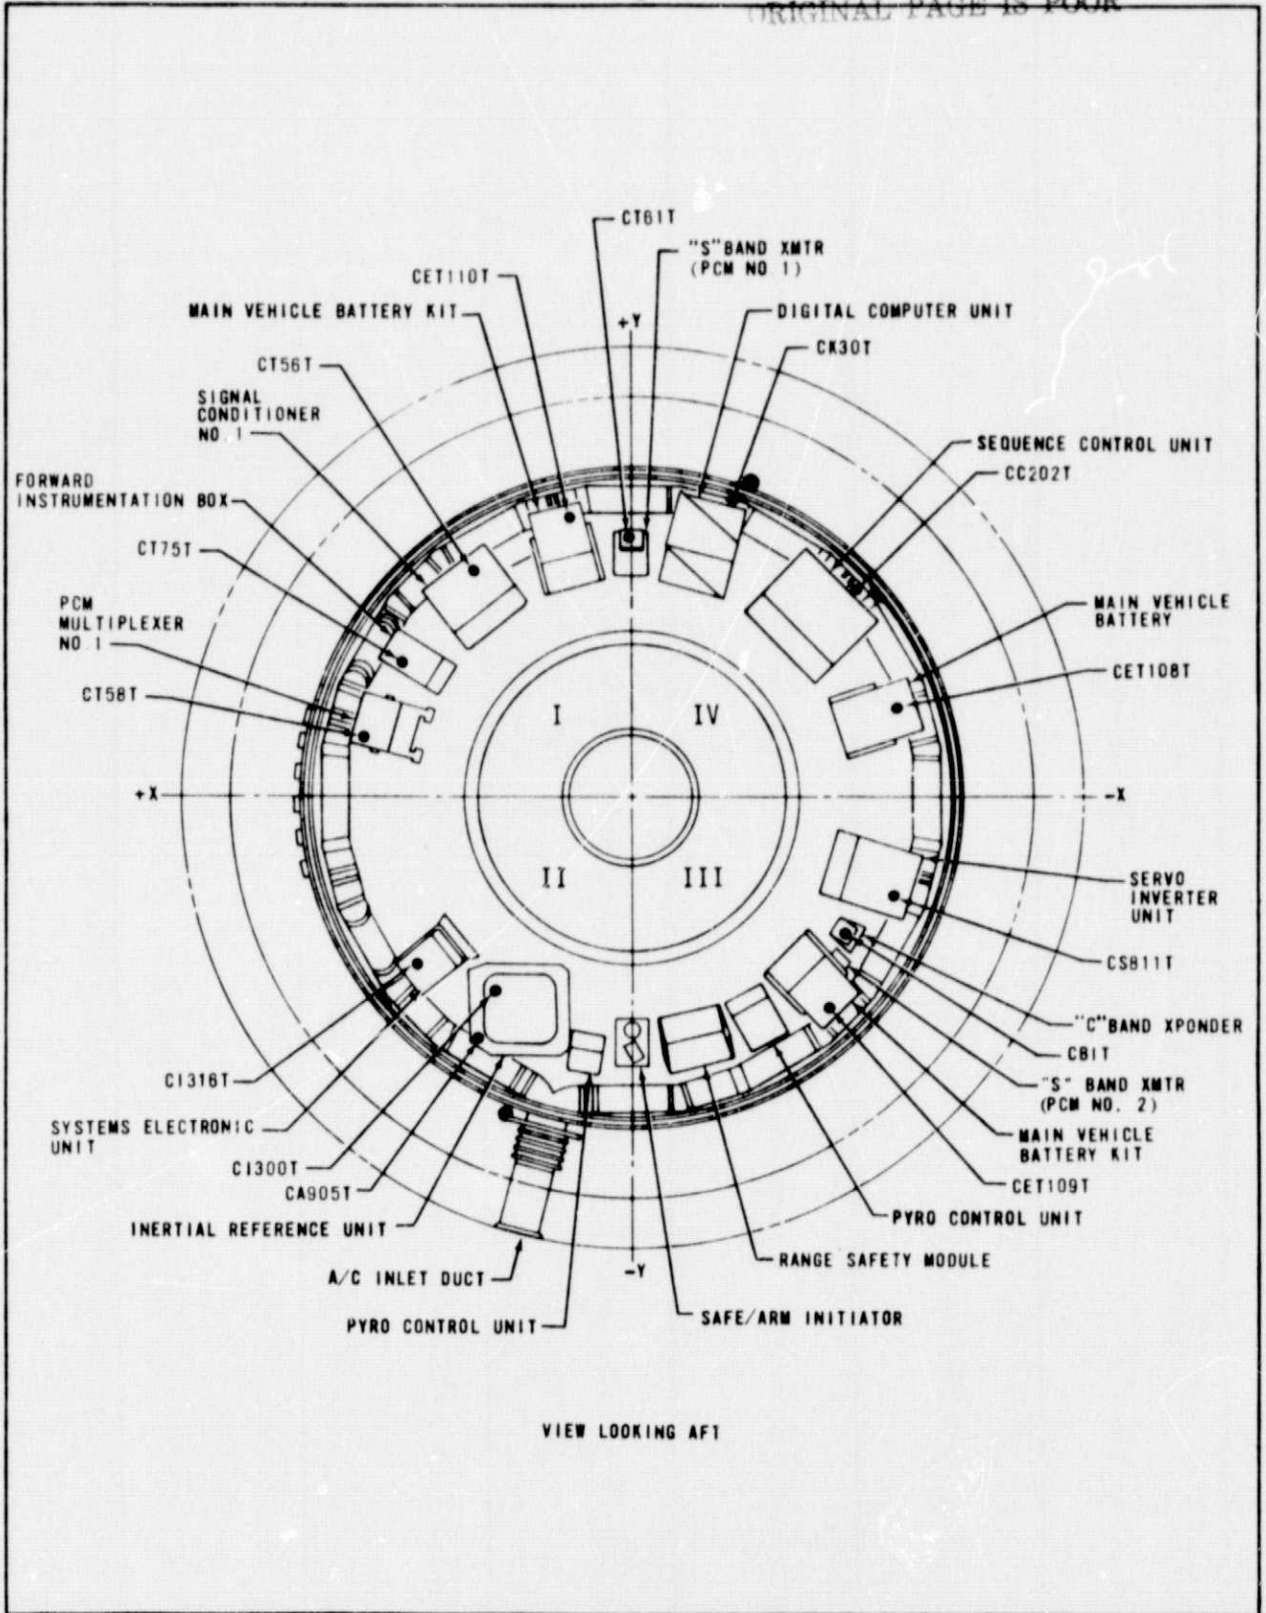
Figure 2B CENTAUR Forward Equipment Module

*Refer to figure 2B for instrumentation locations

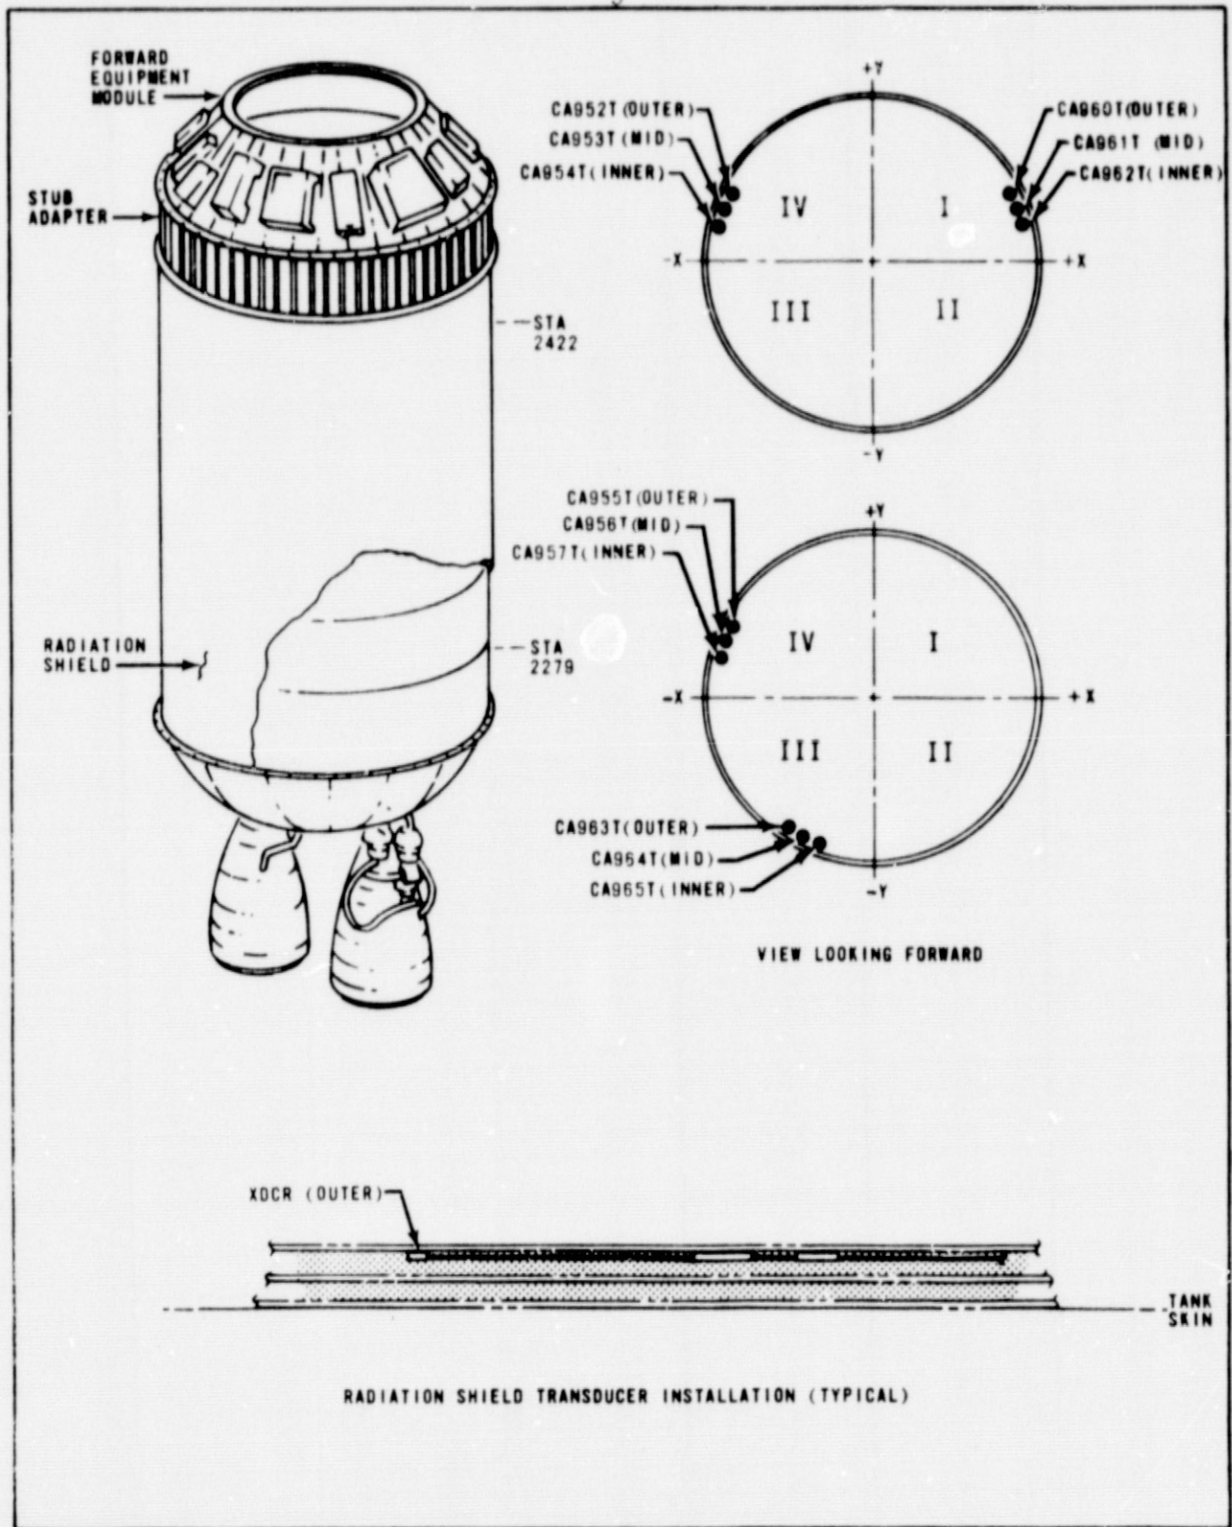
Figure 2C CENTAUR Tank Radiation Shield Temperature

The Centaur stub adapter is a skin and stringer structural section that mates to the forward end of the tank as shown in figure 2C. For long space coast missions the adapter is constructed of titanium in order to reduce the heat conduction to the forward end of the LH₂ tank. The thermal conductivity of the titanium is about 1/25th that of the thermal conductivity of the standard aluminum stub adapter used for short duration missions. The outside of the stub adapter is also covered by a 0.020-inch fiberglass - .002-inch aluminum foil radiation shield composite to reduce the environmental heating to the adapter.

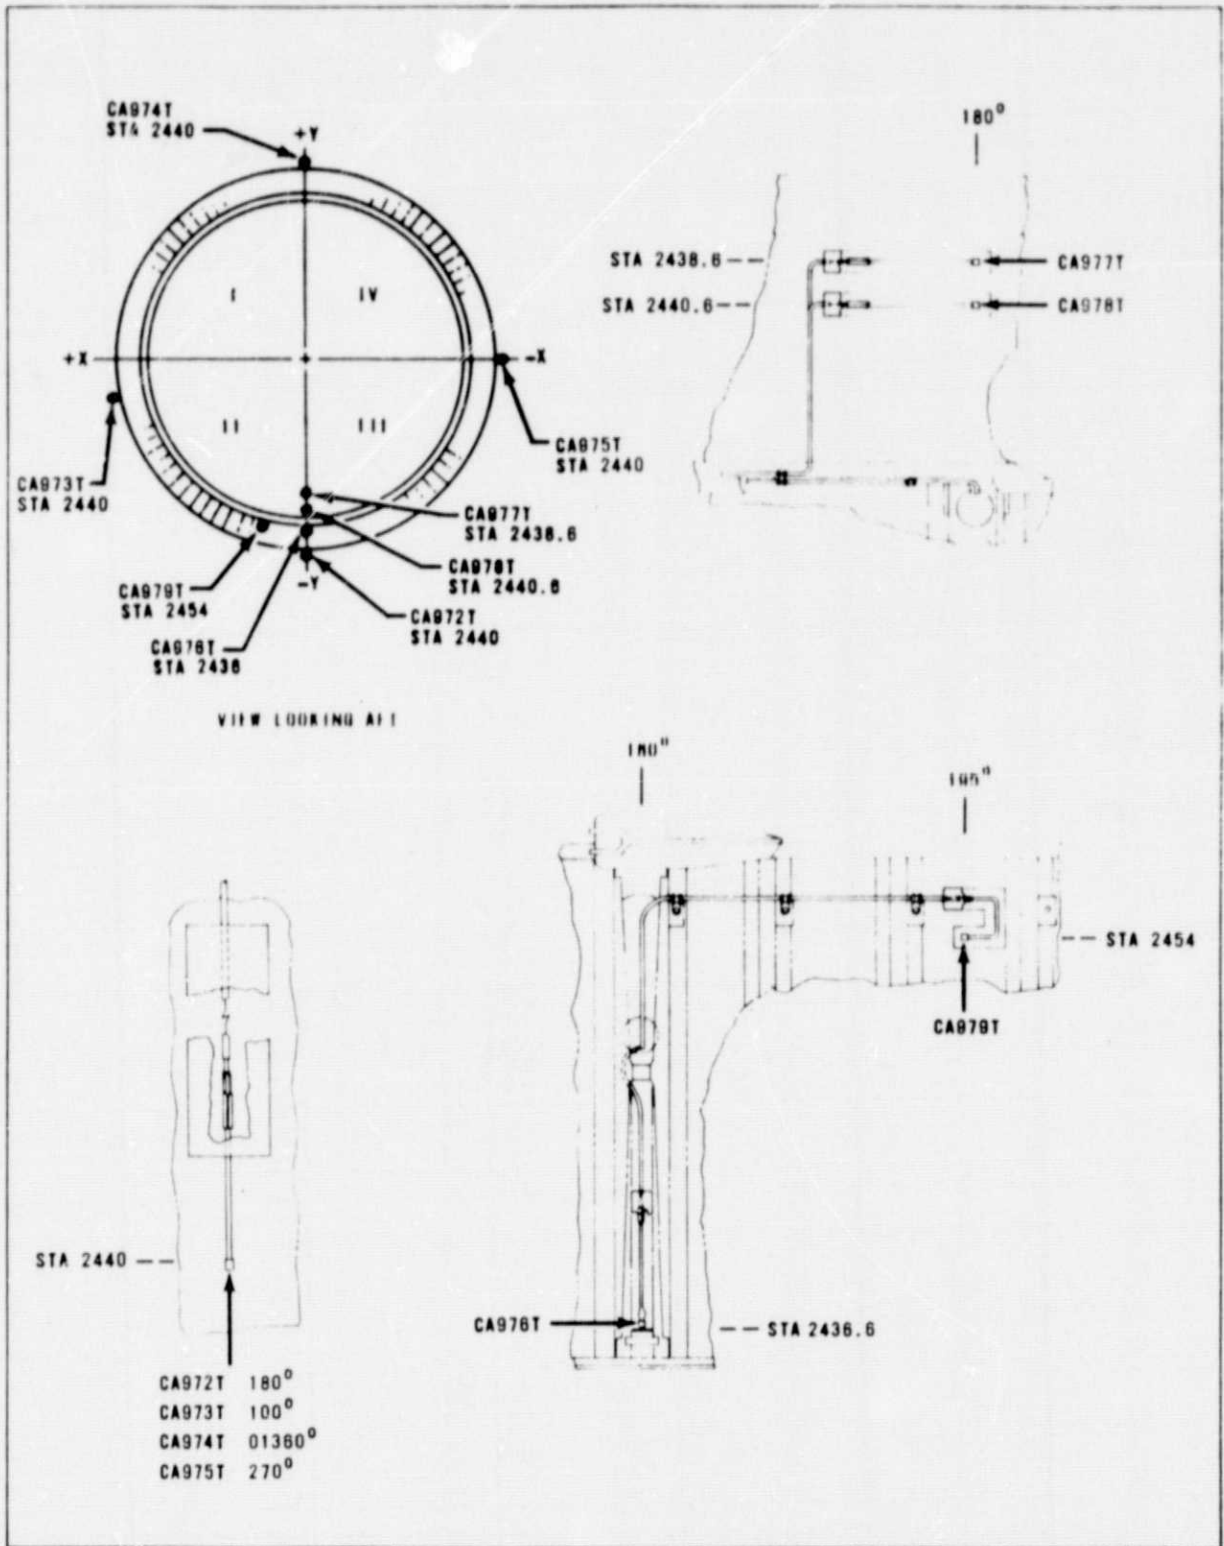
Figure 2D CENTAUR Stub Adapter Skin and Radiation Shield Temperatures

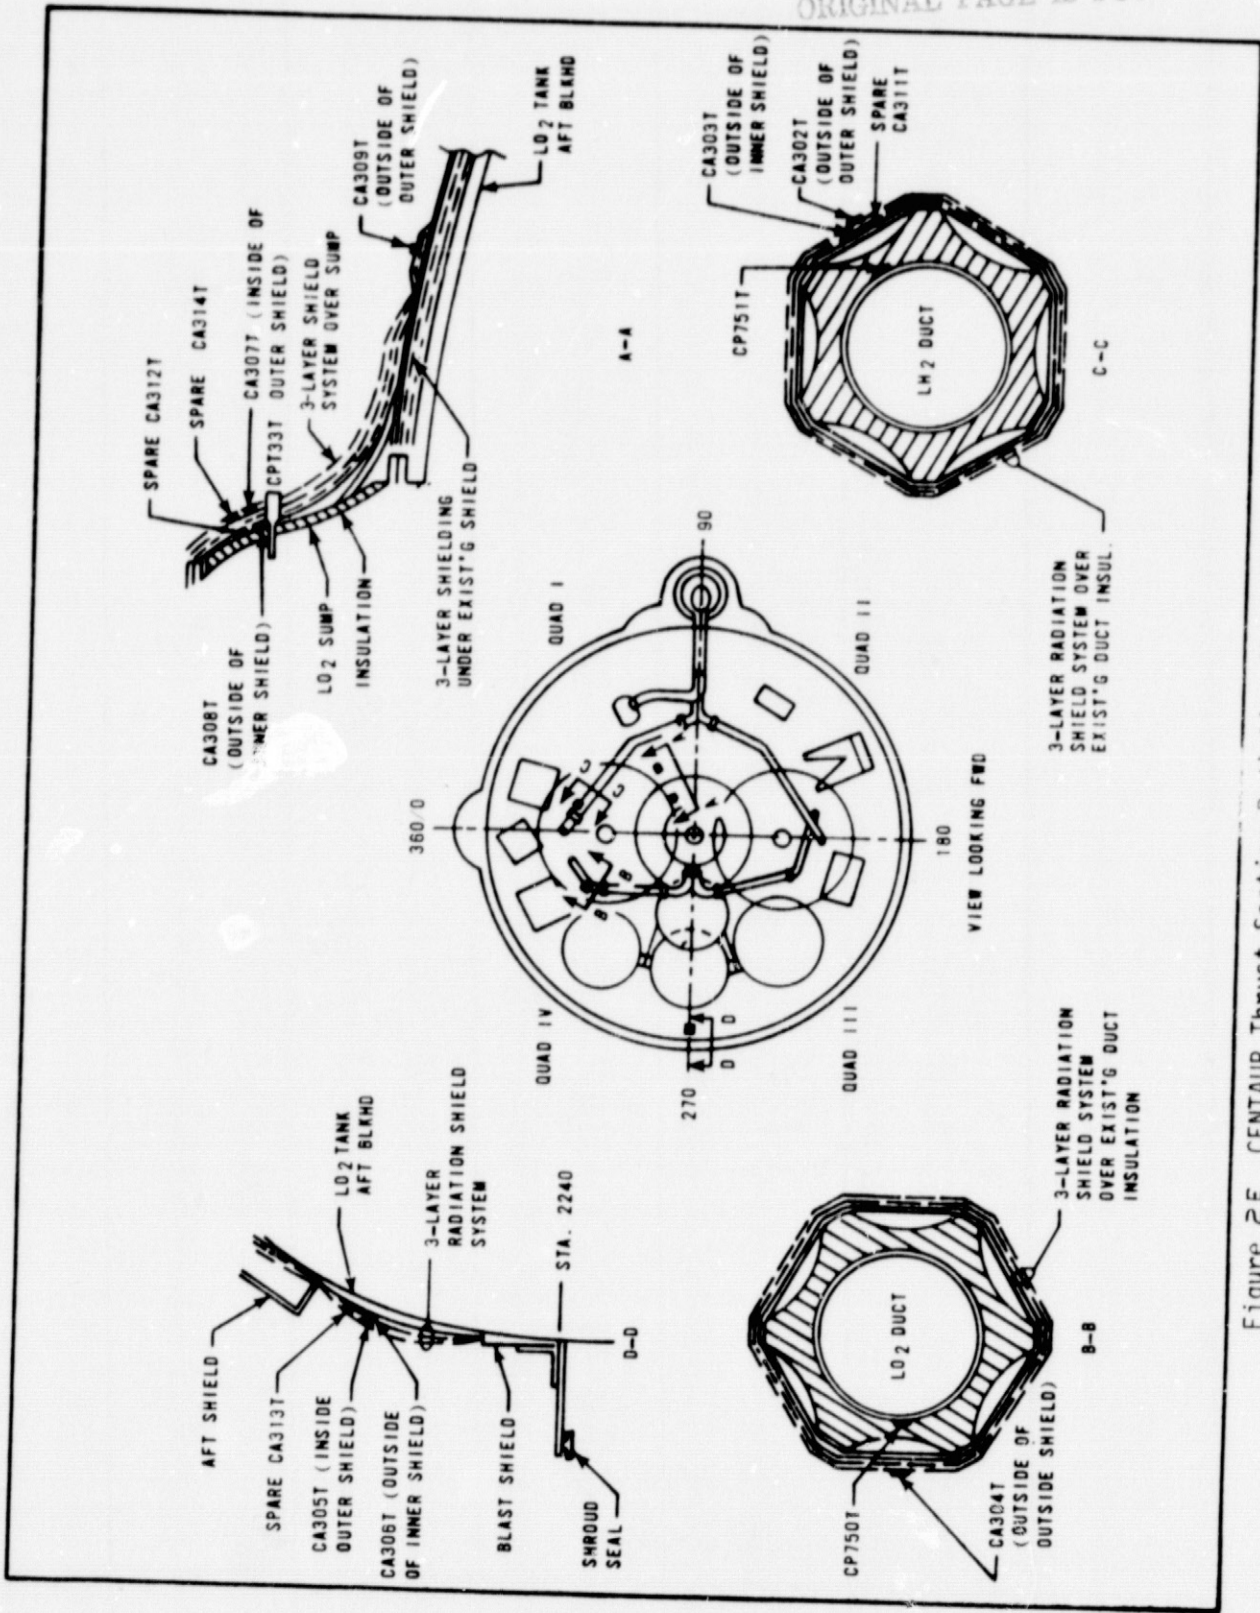
Figure 2E CENTAUR Thrust Section Radiation Shield Temperatures

The propellant duct insulation configuration is shown in figure 2E. For the extended mission, the standard foam insulation of the LH₂ and the LO₂ propellant ducts was covered with three layer radiation shielding with dacron net separators in order to limit the duct temperature increases during the 5-1/4-hour coast.

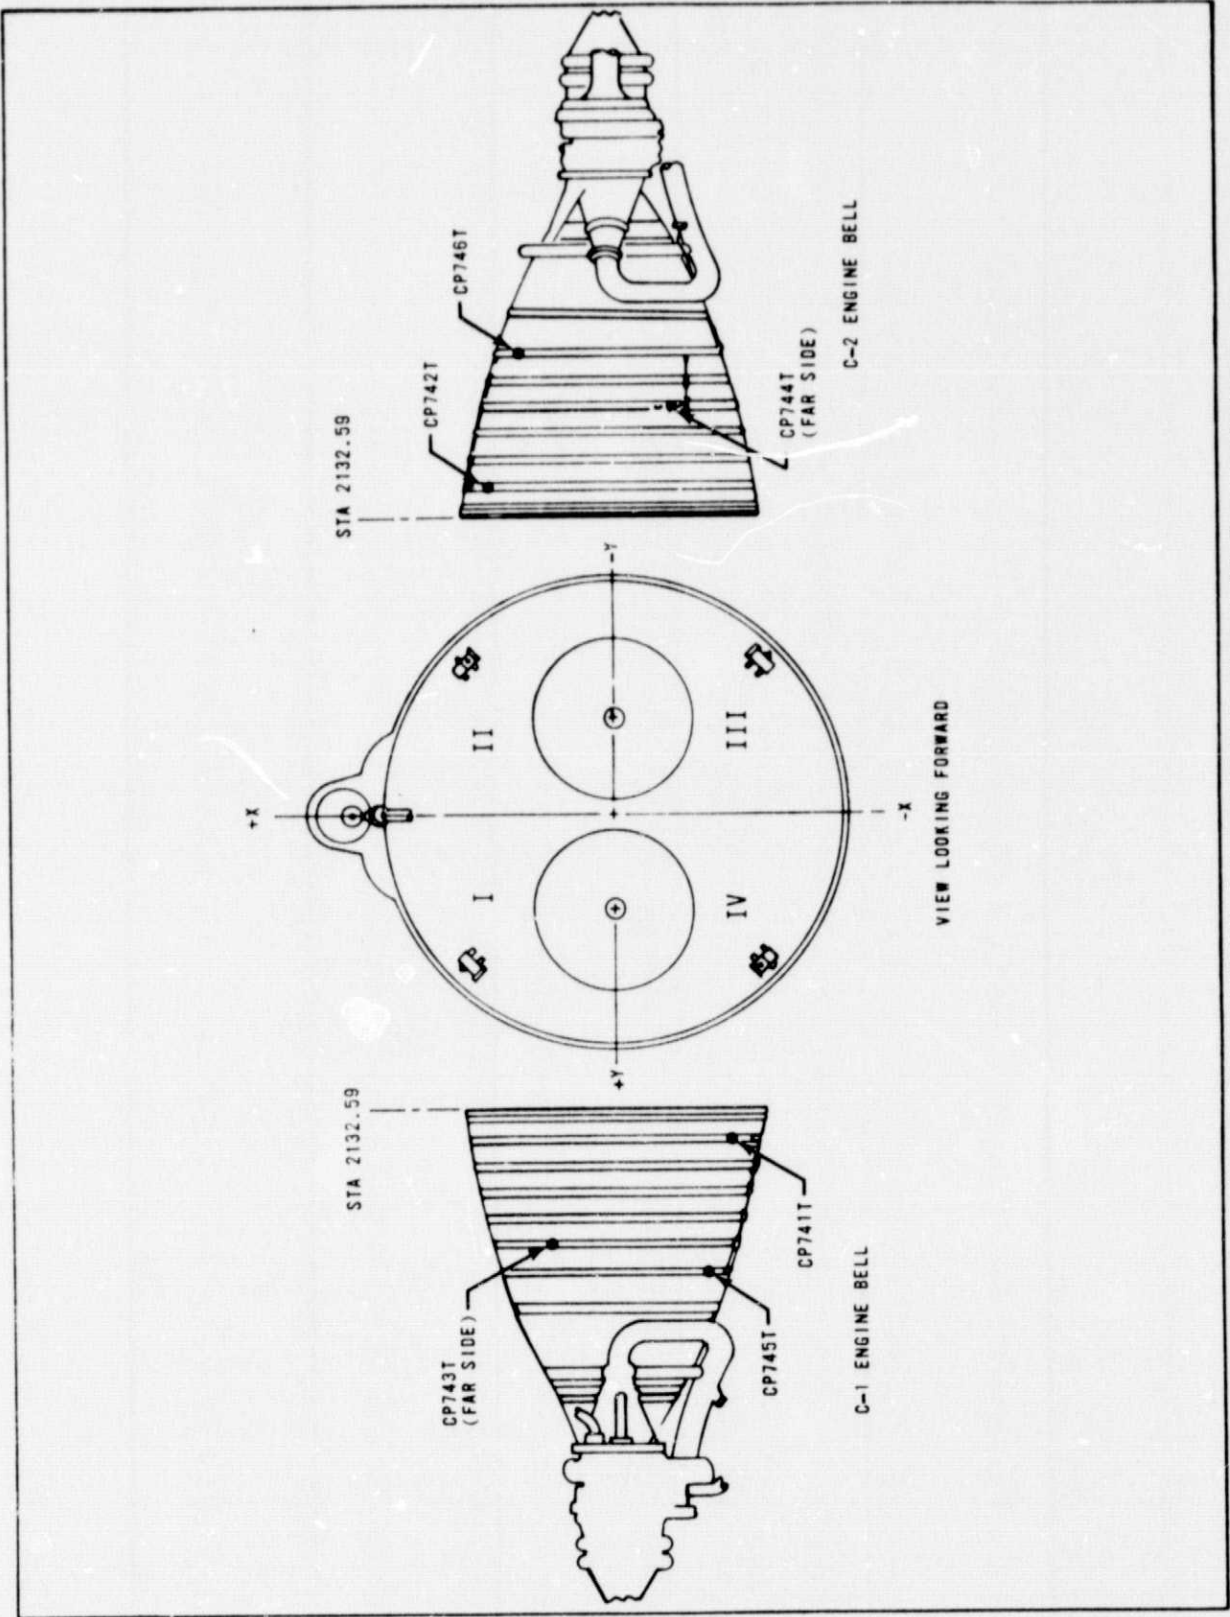
Figure 2F CENTAUR C-1 and C-2 Engine Bell Temperature

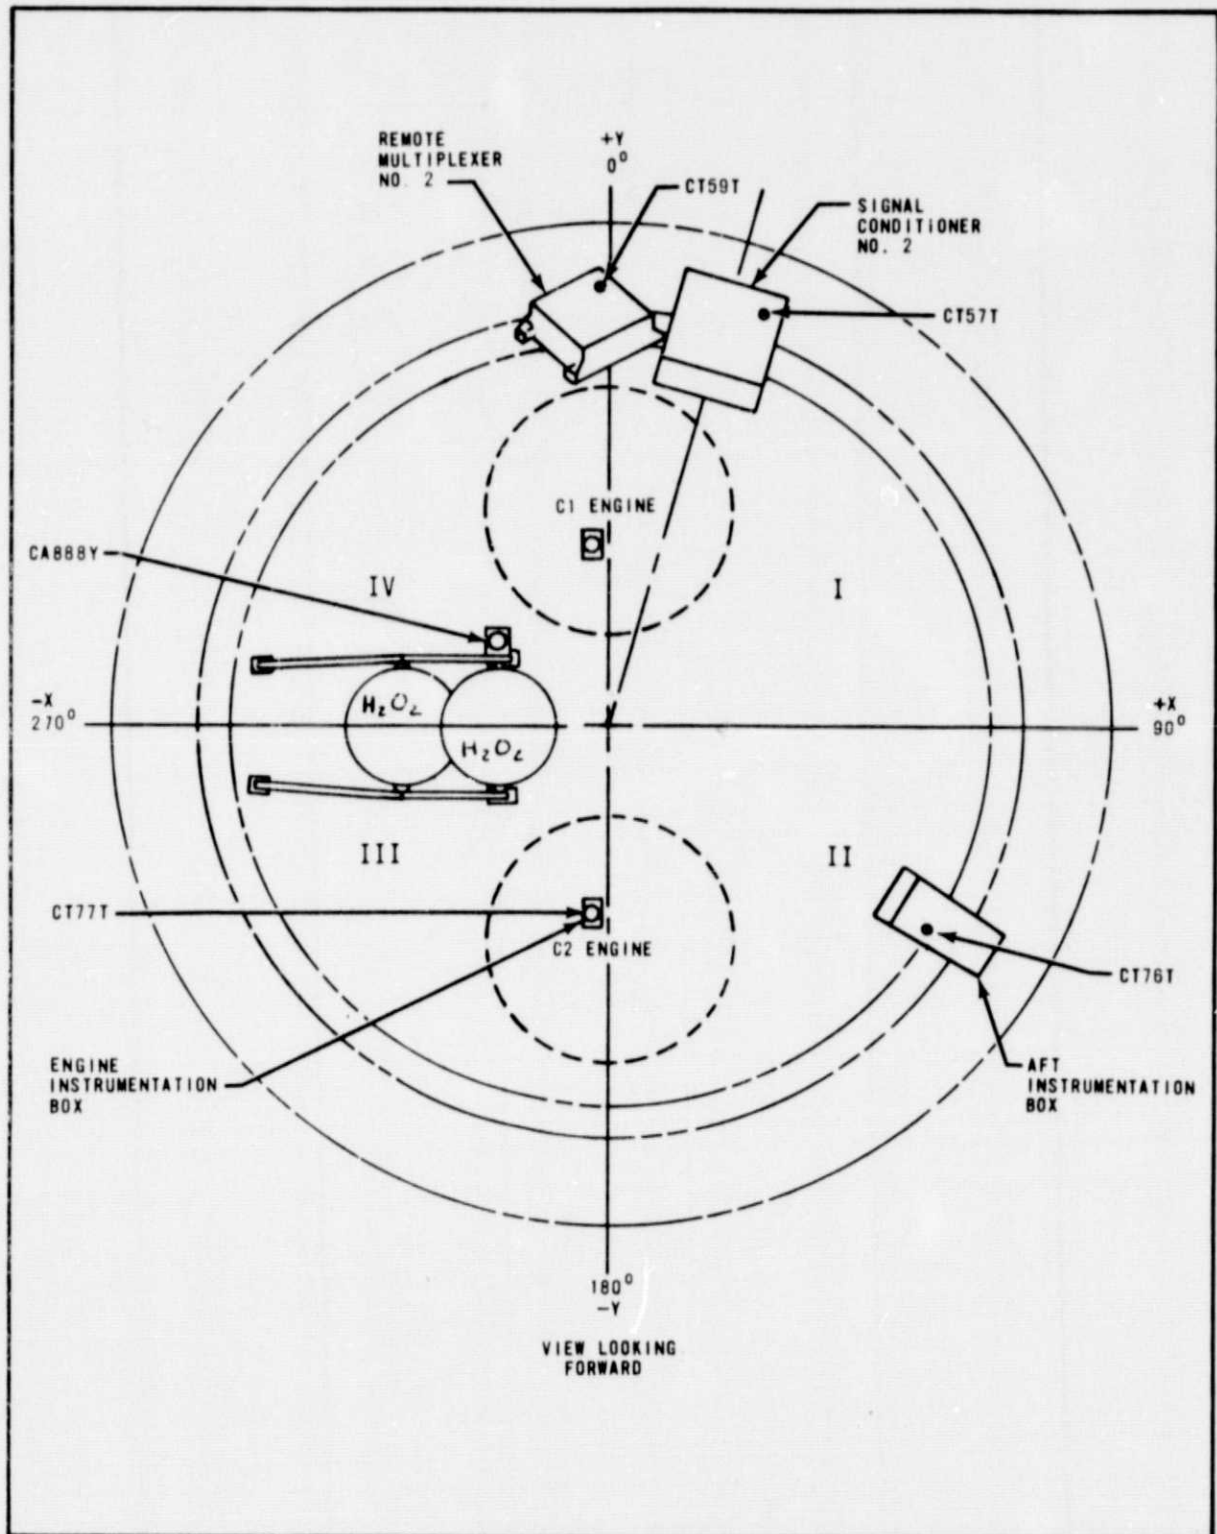
Figure 2H. CENTAUR Thrust Section Instrumentation Unit Installation

* SEE FIGURE 2H FOR INSTRUMENTATION LOCATION

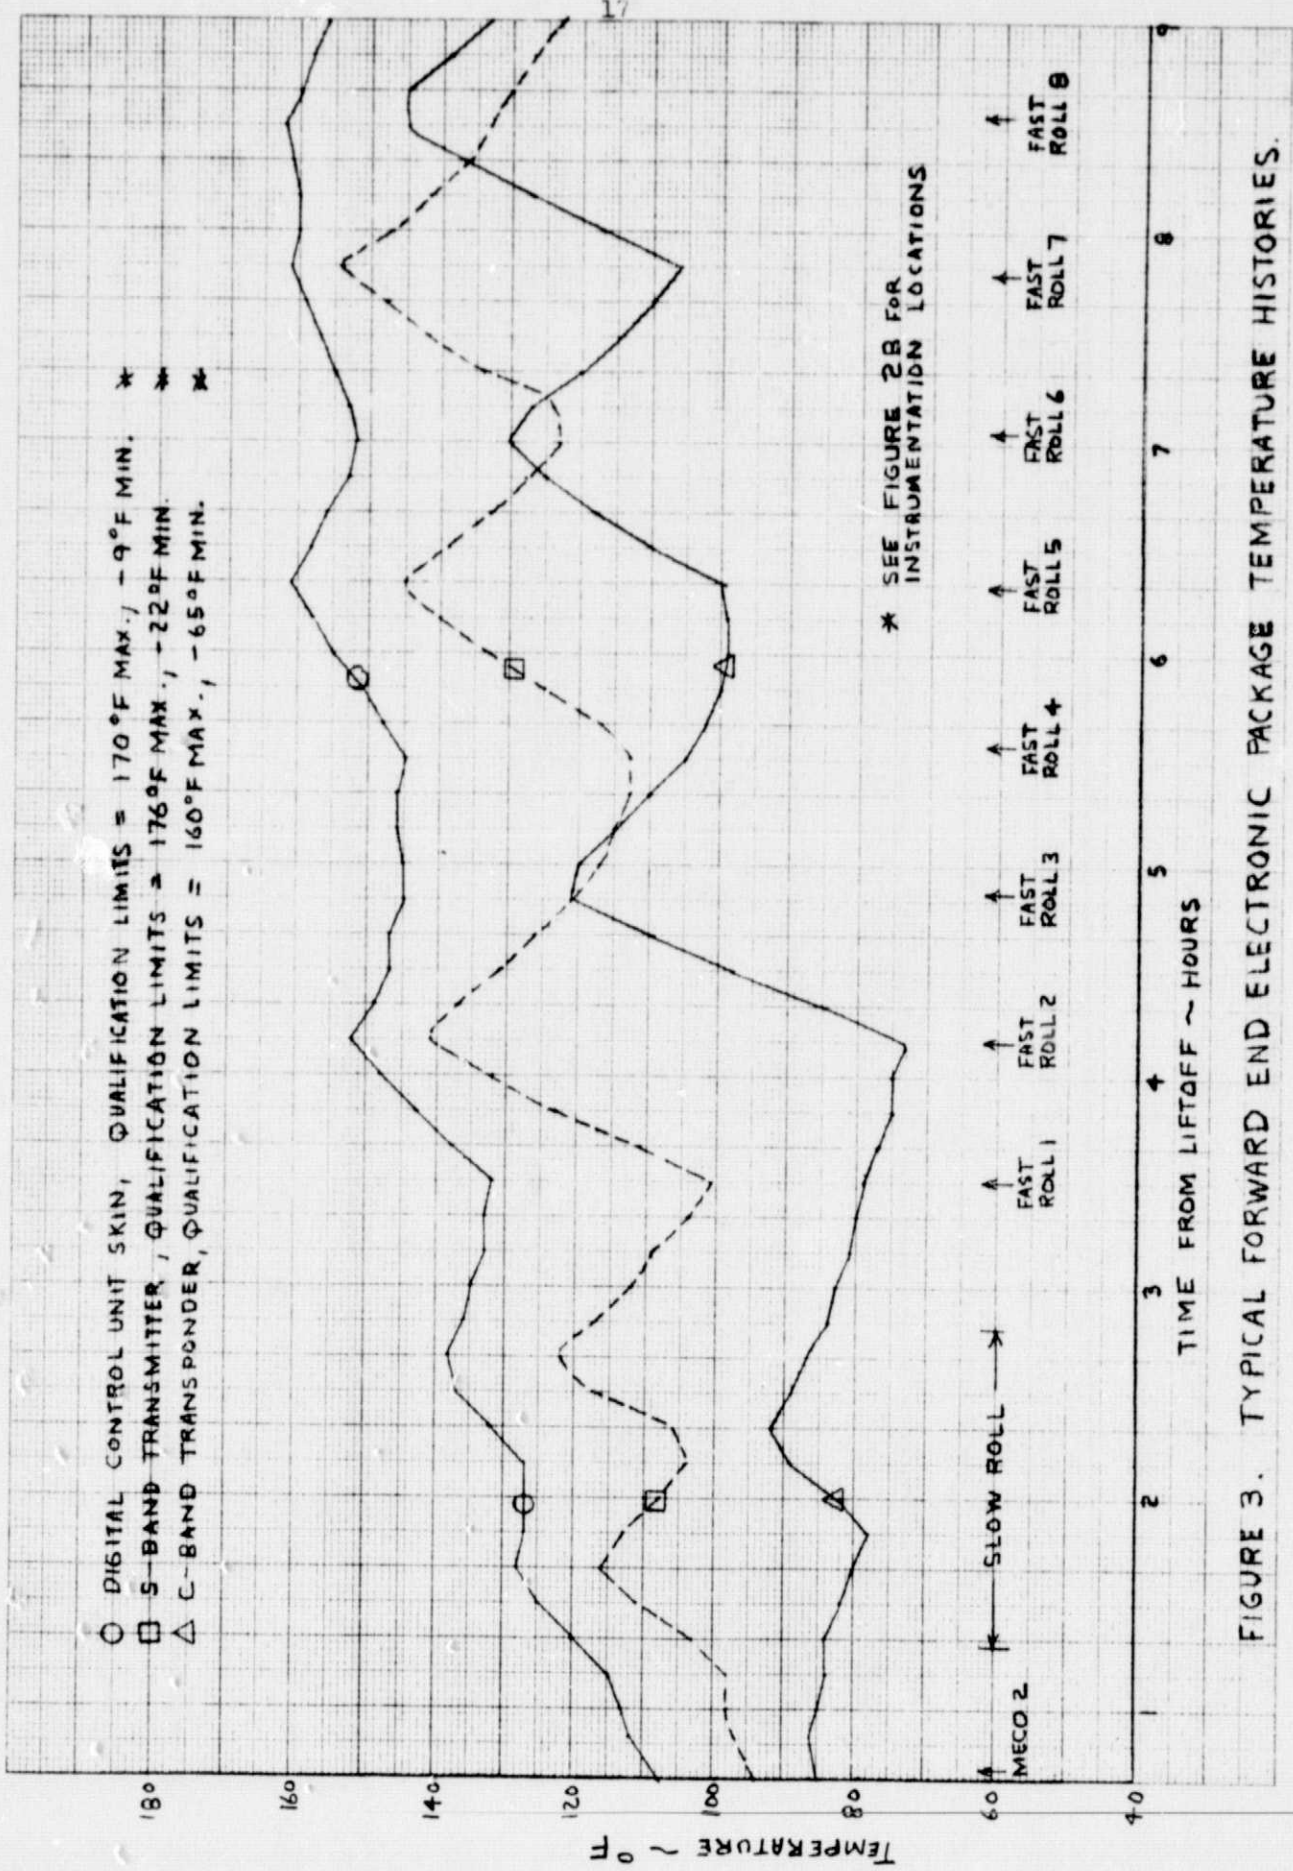
FIGURE 3. TYPICAL FORWARD END ELECTRONIC PACKAGE TEMPERATURE HISTORIES.

The packages on the forward end generally tended to increase in temperature throughout the mission in response to the maximum heating environment. An example of this trend for 3 selected electronic packages is shown in figure 3. The effectiveness of the thermal rolls in maintaining the temperatures at reasonable values is evident, even though the general trend is still increasing to the extent that the upper qualification temperature limits may have been reached after a few additional hours of coasting.

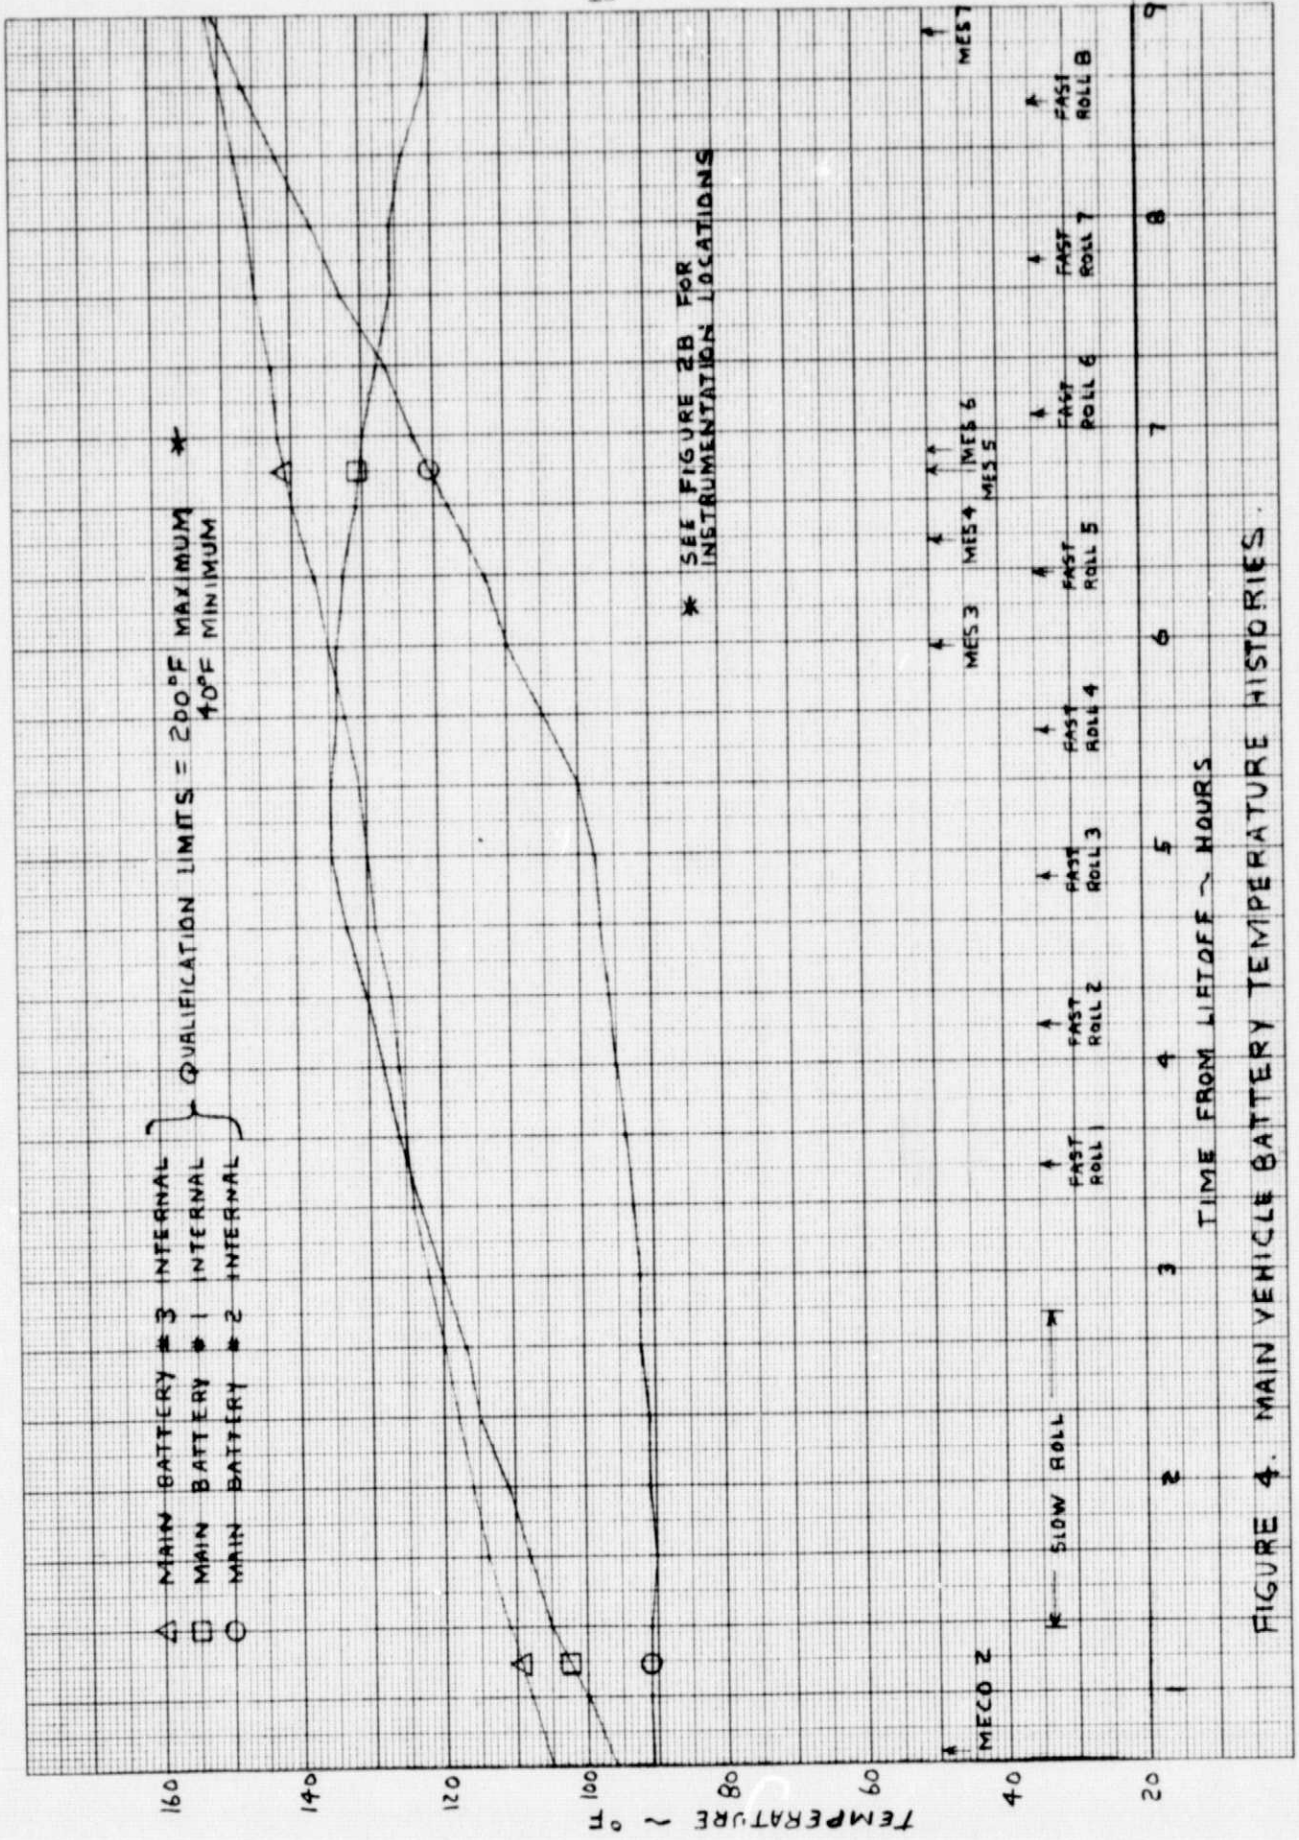
FIGURE 4. MAIN VEHICLE BATTERY TEMPERATURE HISTORIES.

Another example of forward end electronic package heating is given in figure 4 for the three main vehicle batteries. These batteries can have an internal heat dissipation of up to 240 watts and as a result are somewhat independent of the space heating environment. This is evident in the figure which shows no clear effect of the thermal rolls on the battery temperatures. At about 5 hours into the flight the battery No. 1 voltage began to decrease and resulted in a greater load being shared by batteries No. 2 and No. 3. As a result the battery No. 2 and No. 3 temperatures increased and the battery No. 1 temperature decreased. Battery No. 2 could have reached its upper qualification limit (200°F) in about 3 additional hours of flight time.
