NASA TM X-73605

**THERMODYNAMIC DATA REPORT FOR THE
TITAN/CENTAUR TC-5 EXTENDED MISSION**

by Raymond F. Lacovic
Lewis Research Center
Cleveland, Ohio 44135
January 1977

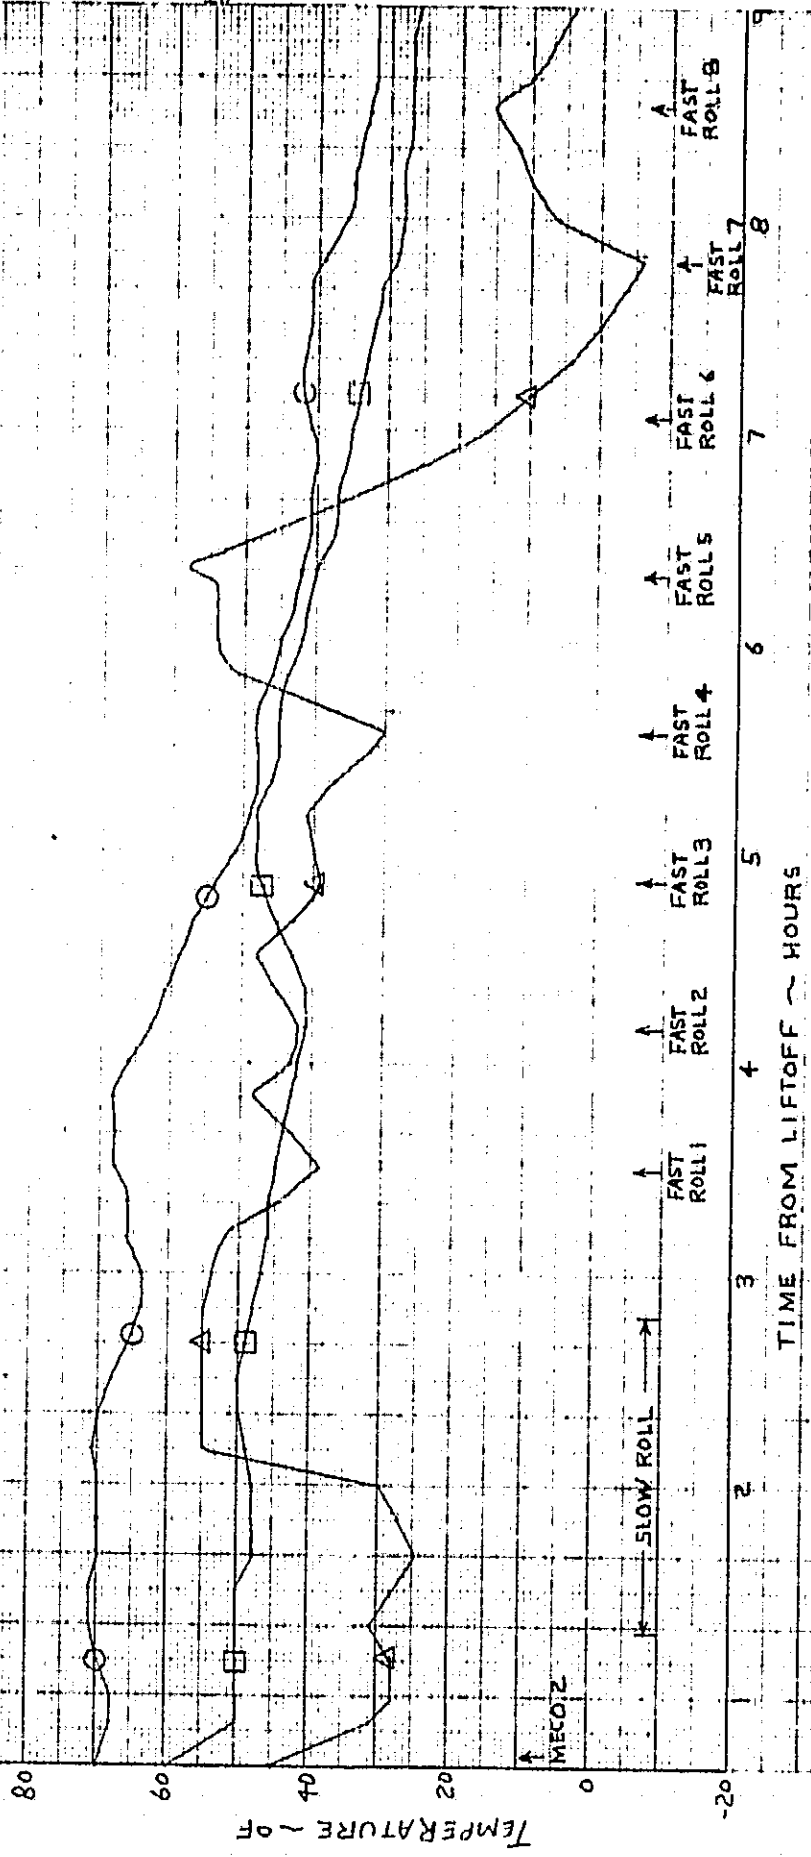
- AFT BULKHEAD INSTRUMENTATION BOX. QUALIFICATION LIMITS = 165°F MAX., -65°F MIN.
- C-2 ENGINE INSTRUMENTATION BOX. QUALIFICATION LIMITS = 166°F MAX., -65°F MIN.
- △ C-1 SERVO POSITIONER HOUSING. QUALIFICATION LIMITS = 160°F MAX., -50°F MIN.

FIGURE 5. TYPICAL AFT END ELECTRONIC PACKAGE TEMPERATURE HISTORIES.

The aft end package temperatures tended to decrease during the mission in response to the less than nominal aft end heating environment. An example of this trend for three selected aft end packages is shown in figure 5. For a minimum heating environment the package temperature decrease would have been slightly greater but the package temperatures would still have been well above their minimum qualification temperature limits.

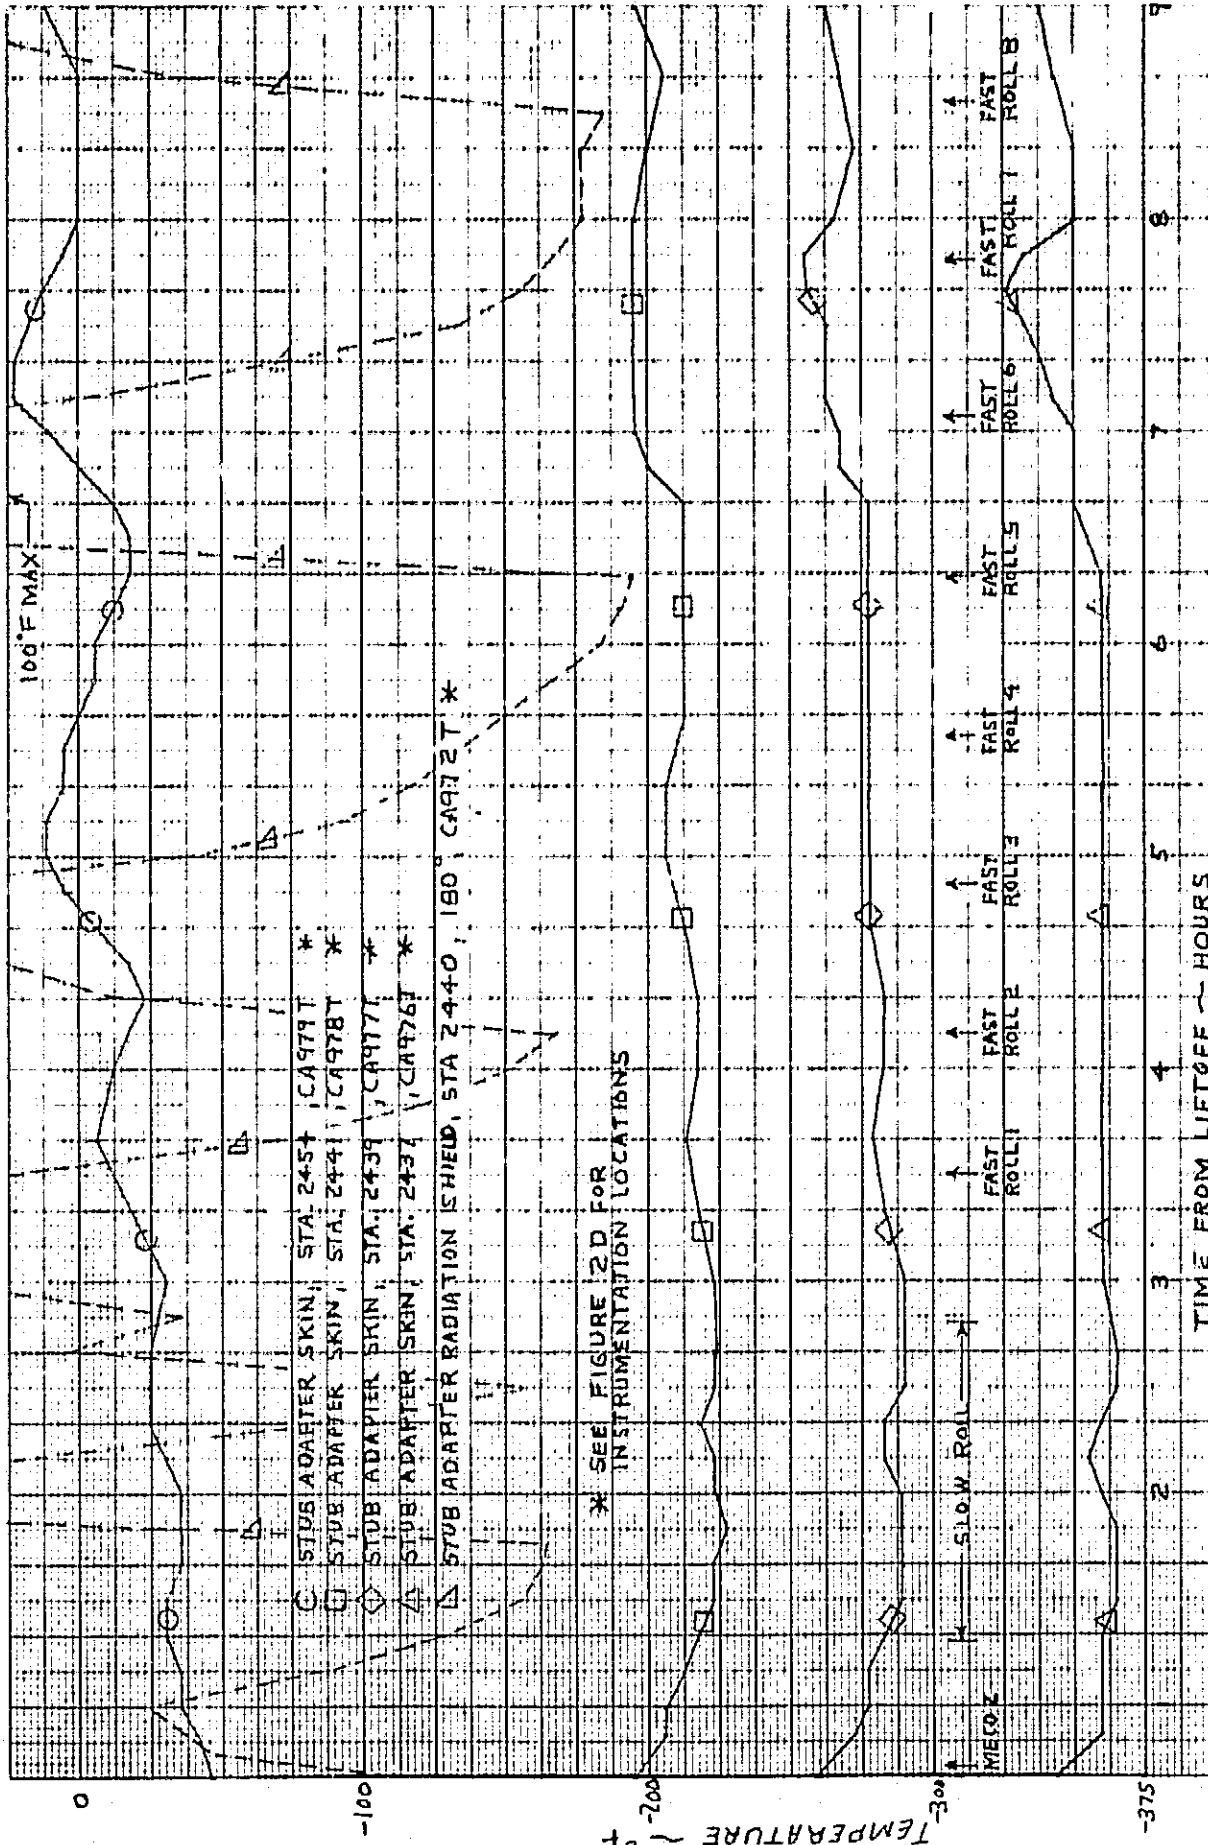
FIGURE 6. STUB ADAPTER TEMPERATURE HISTORY.

The flight temperature history at select locations of the stub adapter is shown in figure 6. As shown in this figure, the stub adapter steady state temperature gradient was established about 1-1/2 hours after liftoff. The heating and cooling of the radiation shield in response to the space environment, and the large temperature difference between the shielding and the adapter, shows that the shielding was effective in attenuating the solar heating to the adapter. As a result of this attenuation, the stub adapter temperature remained relatively constant throughout the duration of the extended mission.

Since the stub adapter is like a cylindrical fin attached to the forward ring of the LH₂ tank, the metallic conduction heat input to the LH₂ tank can be directly calculated. The calculated steady state conductive heat input is 225 BTU/Hr., well below the design goal of 500 BTU/Hr.

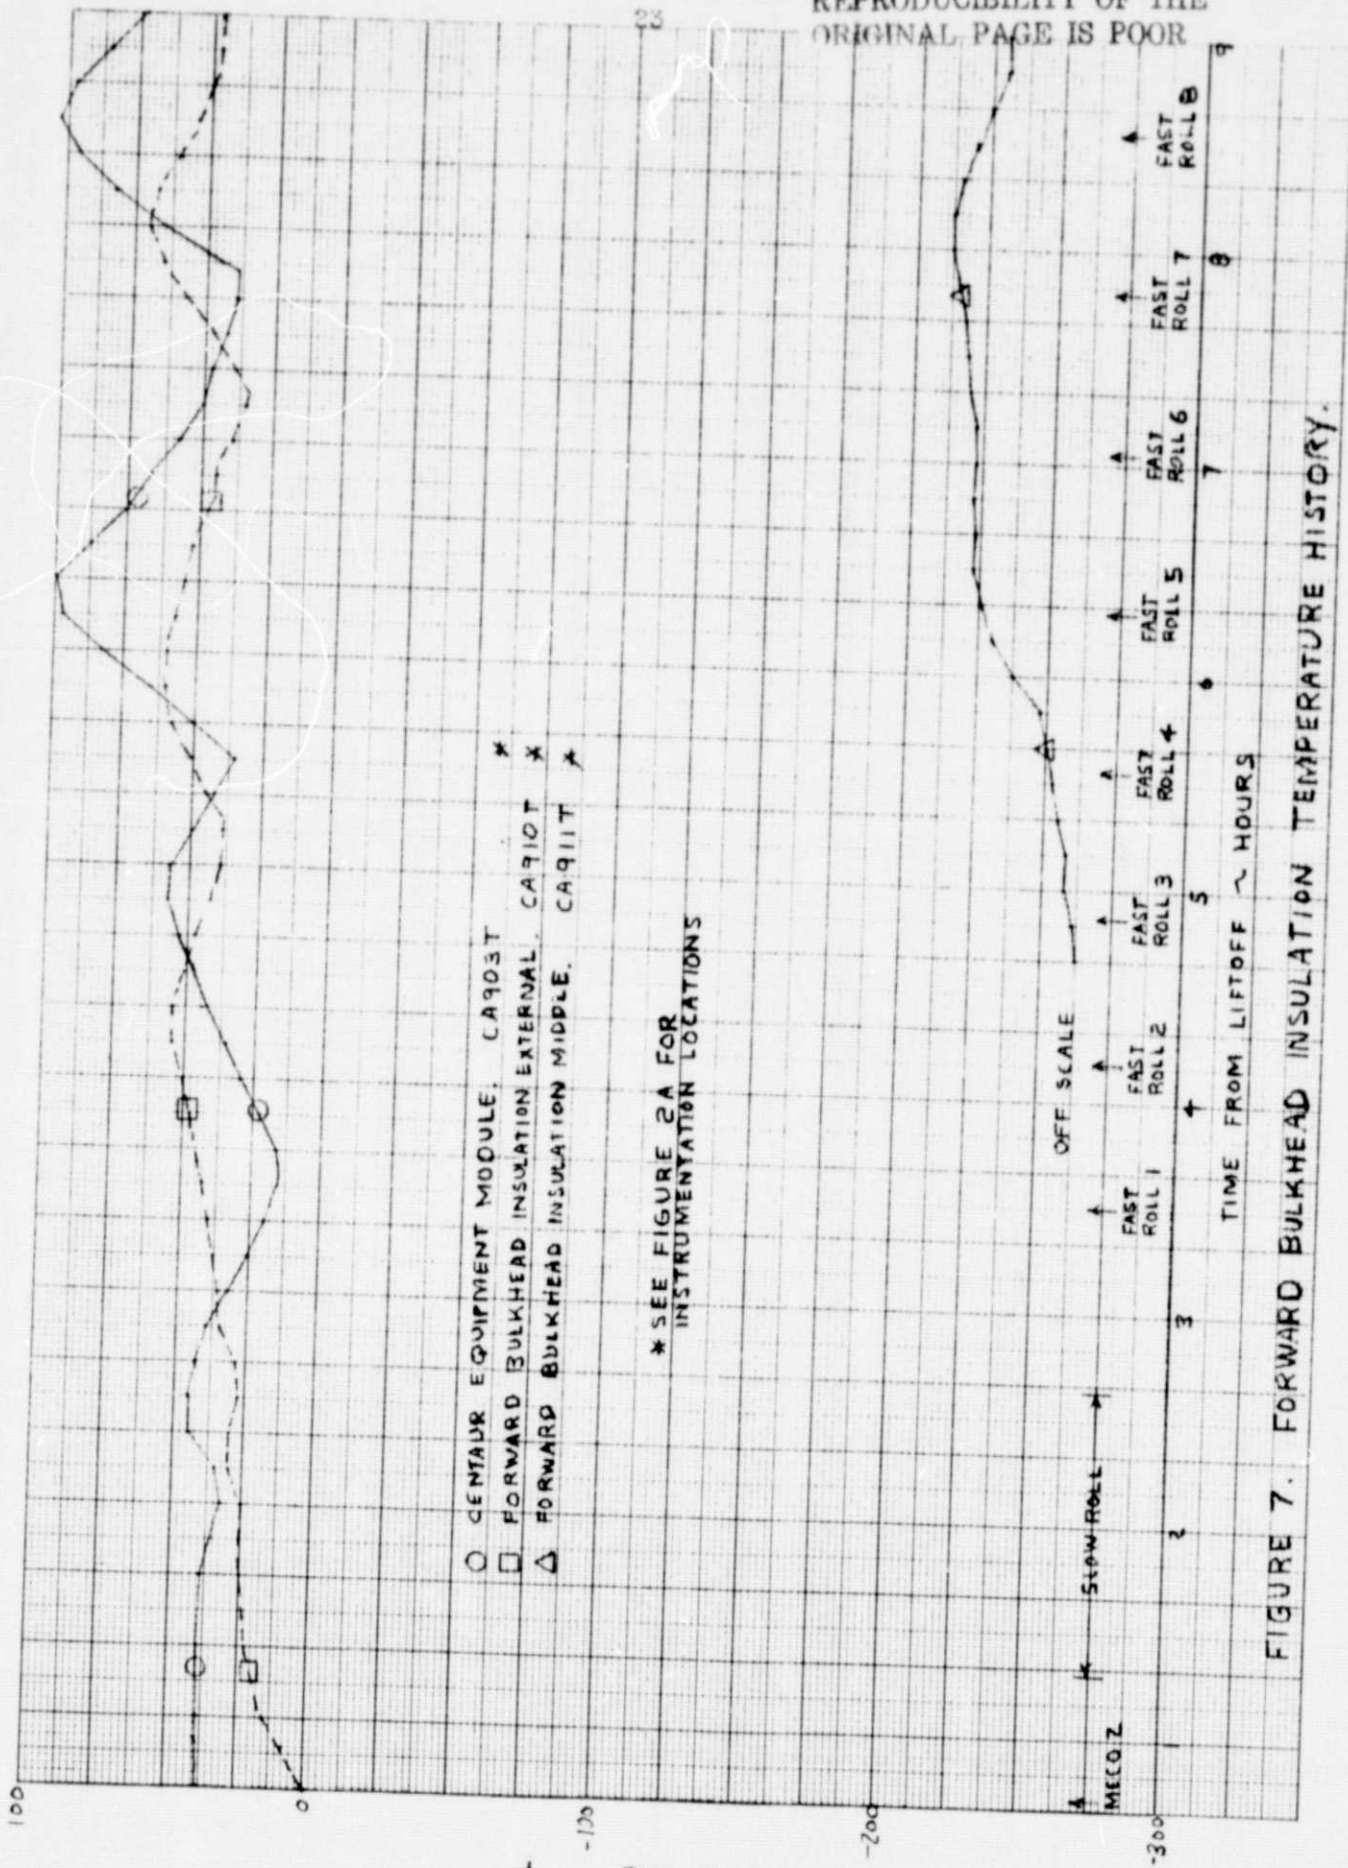
- CENTAUR EQUIPMENT MODULE. CA903T *
- FORWARD BULKHEAD INSULATION EXTERNAL. CA910T *
- △ FORWARD BULKHEAD INSULATION MIDDLE. CA911T *

FIGURE 7. FORWARD BULKHEAD INSULATION TEMPERATURE HISTORY.

Figure 7 shows an example of the temperature data of the 1.5-inch thick, 23 layer, forward bulkhead radiation shield insulation blanket. This insulation, which does not directly view the space environment, responds to radiation and residual gas convection from inside the stub adapter and the equipment module. As a result of this configuration, the temperature of the external layer of the radiation shielding closely follows the equipment module temperature behavior.

There is a considerable thermal lag in the insulation blanket, as shown by the temperature of the middle layer which comes on scale at about five hours after liftoff. This lag is the result of the conduction of residual gases that exist in the insulation blanket. As the residual gases are slowly evacuated the inner layers of the blanket warm up due to the decoupling of the insulation from the tank bulkhead surface. As the warming occurs, the radiation heat transfer to the tank increases and the conductive heat transfer through the residual gases decreases. Based on vacuum chamber test data of the insulation, the thermal lag observed during the extended mission is indicative of a residual gas pressure of 1×10^{-3} torr with a corresponding forward bulkhead heat flux of about 1.5 BTU/Hr.-Ft.². This heat flux is within the 2 BTU/Hr.-Ft.² design goal of the forward bulkhead insulation space performance.

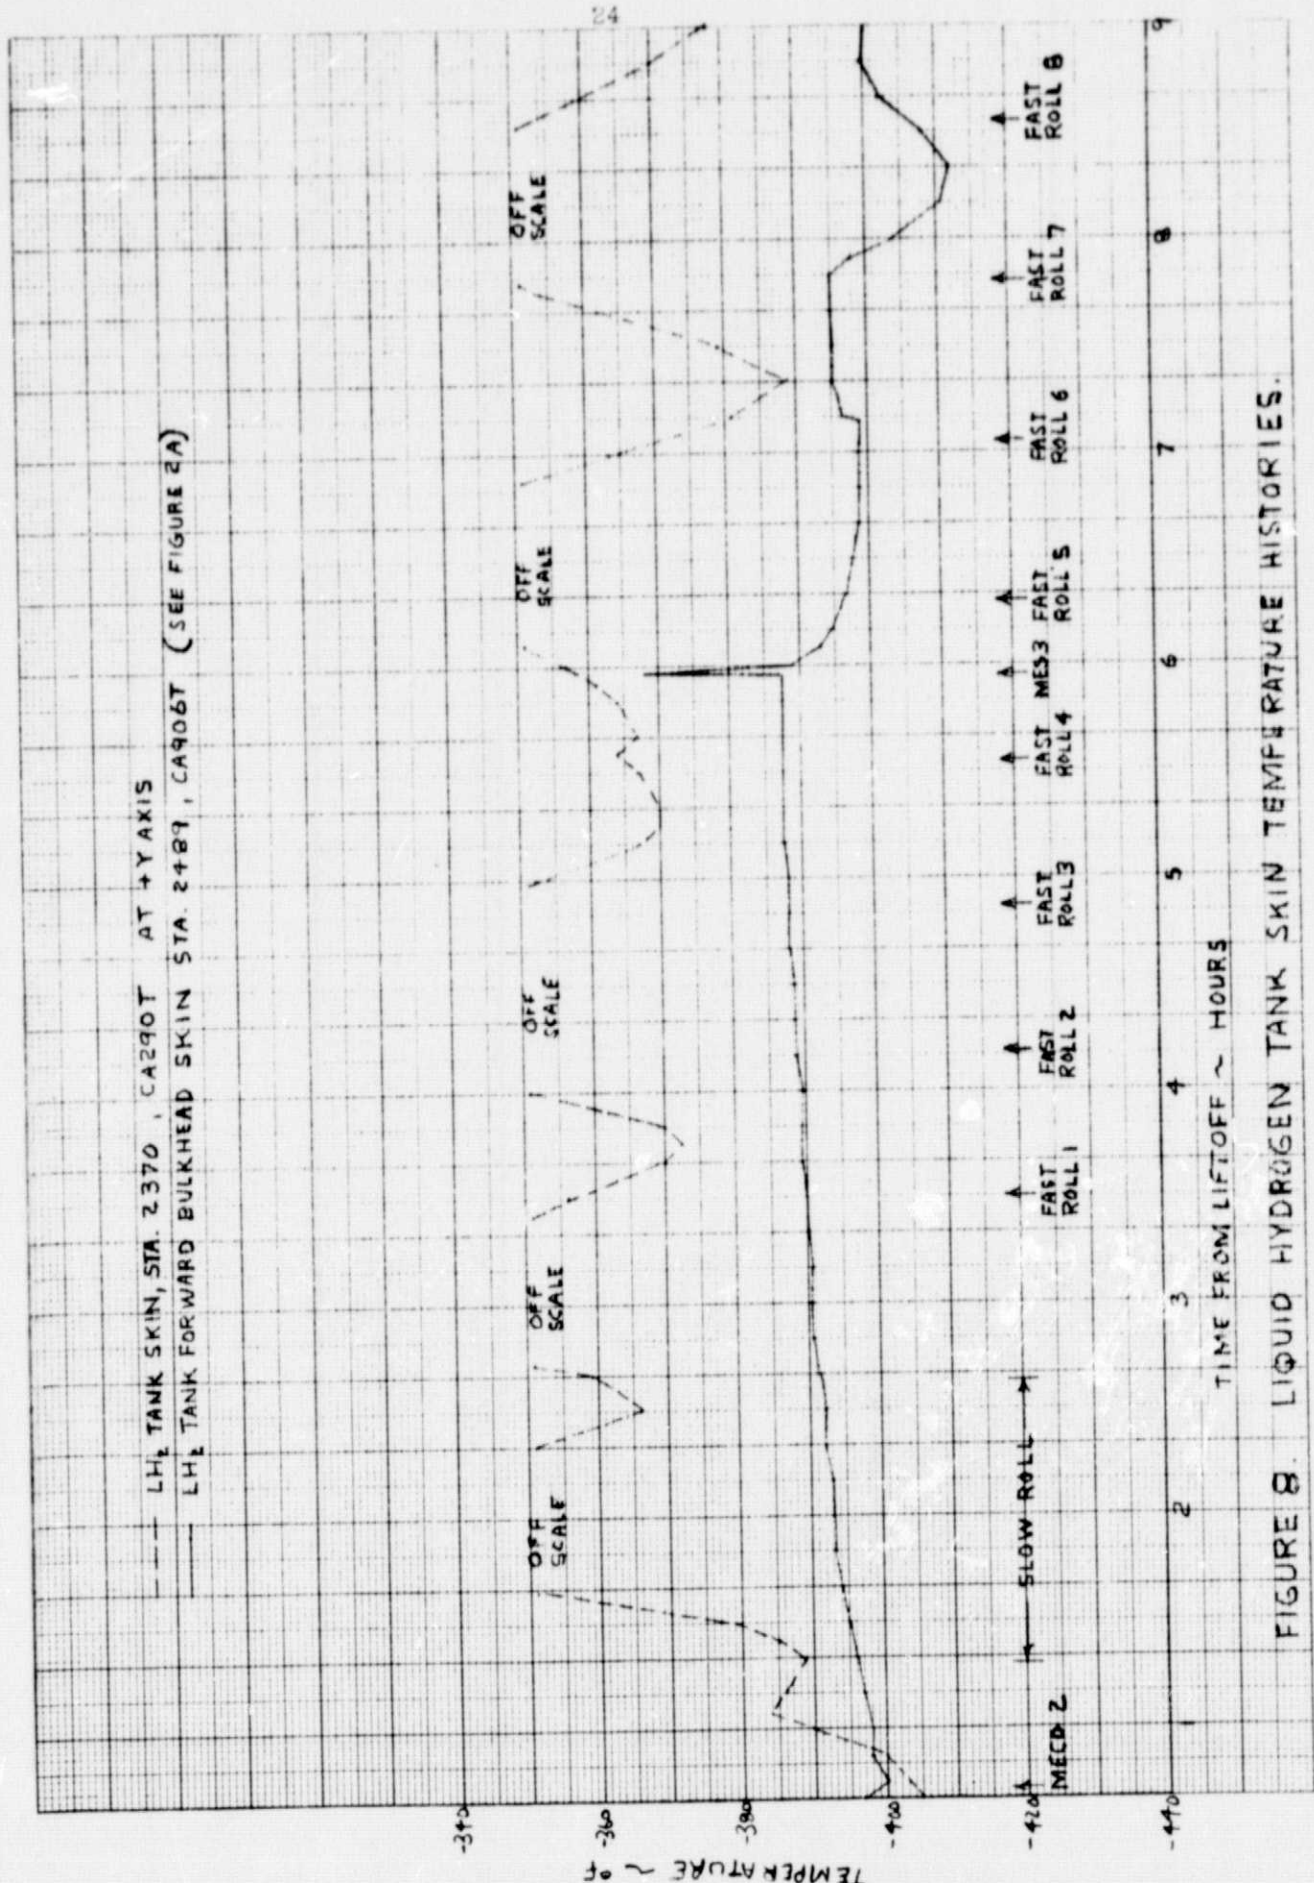
FIGURE 8. LIQUID HYDROGEN TANK SKIN TEMPERATURE HISTORIES.

The forward bulkhead skin temperature (located beneath the insulation blanket) history is shown in figure 8. This skin temperature increased from -400°R to -387°R during the 5-1/4-hour zero gravity coast, which indicates that liquid hydrogen was not present at this location. However, at other locations other tank instrumentation (liquid-vapor sensors, not discussed in this report) did indicate the presence of liquid, which accounts for the absorption of some of the heat input through the forward bulkhead insulation. Sufficient LH₂ did not migrate to the forward end of the tank during the zero gravity coast to reach the forward bulkhead skin temperature location.

An example of the LH₂ tank sidewall skin temperature response is shown in figure 8. The skin temperature also closely follows the thermal rolls. This temperature, together with the inner radiation shield temperature of figure 9, can be used to approximate the heat flux to the tank sidewall. This calculated heat flux is 0.3 BTU/Hr.-Ft² (average) and is well within the 1.0 BTU/Hr.-Ft² performance goal of the sidewall radiation shielding. The sidewall skin temperatures also indicate that no LH₂ is present along the sidewall during the zero gravity coasts.

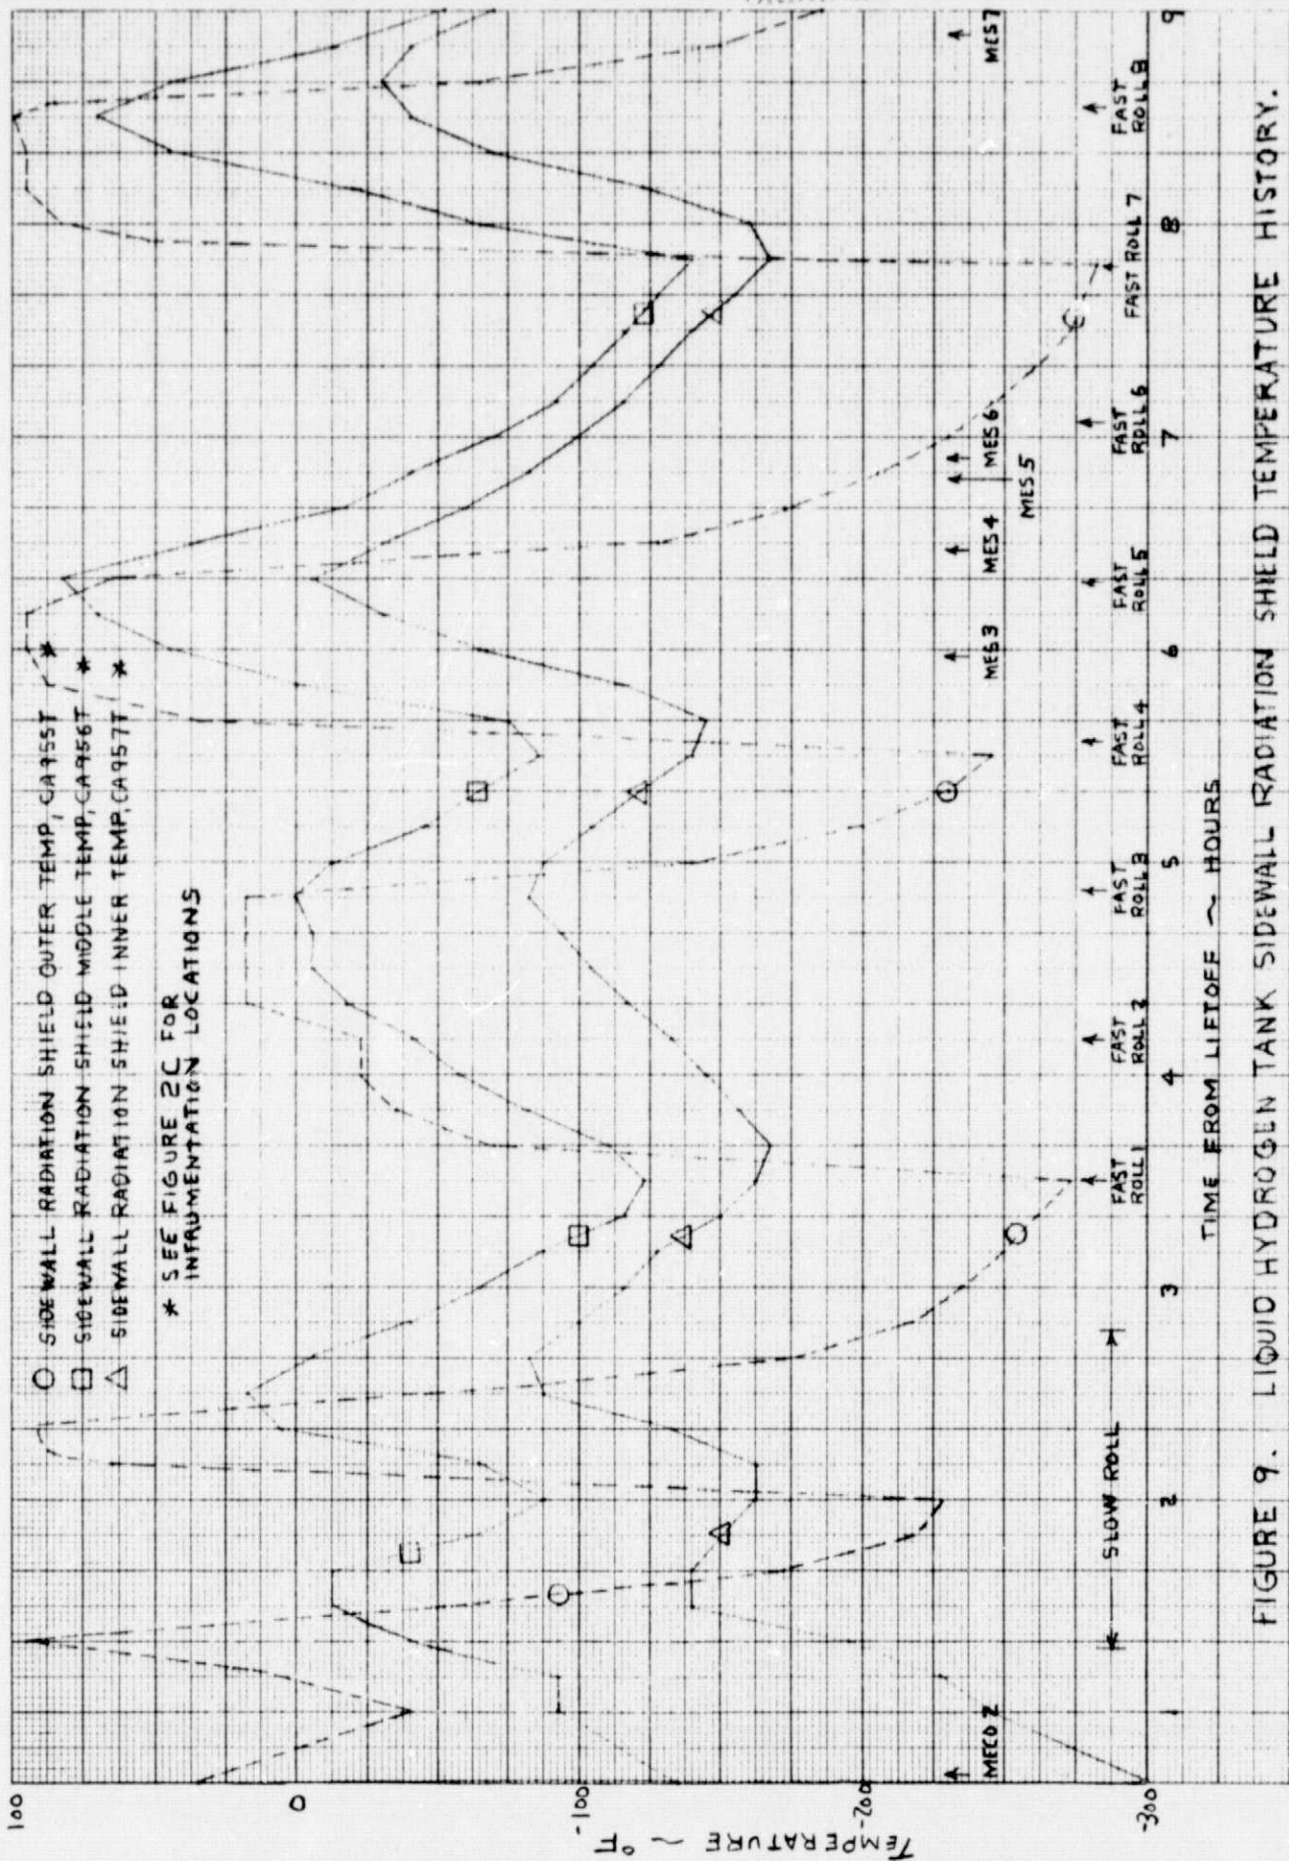
FIGURE 9. LIQUID HYDROGEN TANK SIDEWALL RADIATION SHIELD TEMPERATURE HISTORY.

The hydrogen tank sidewall is thermally protected with a covering of three layer radiation shielding. An example of the thermal performance of this shielding during the extended mission is shown in figure 9. As shown in this figure, the radiation shield temperatures respond rapidly to the changes in the solar environment resulting from the roll maneuver. The sun position with respect to the tank sidewall is clearly seen by the large temperature excursions of the external radiation shield. The rapid temperature response, and the corresponding large thermal gradients, demonstrate that the shielding has achieved the evacuated conditions and thermal isolation required for good space performance.

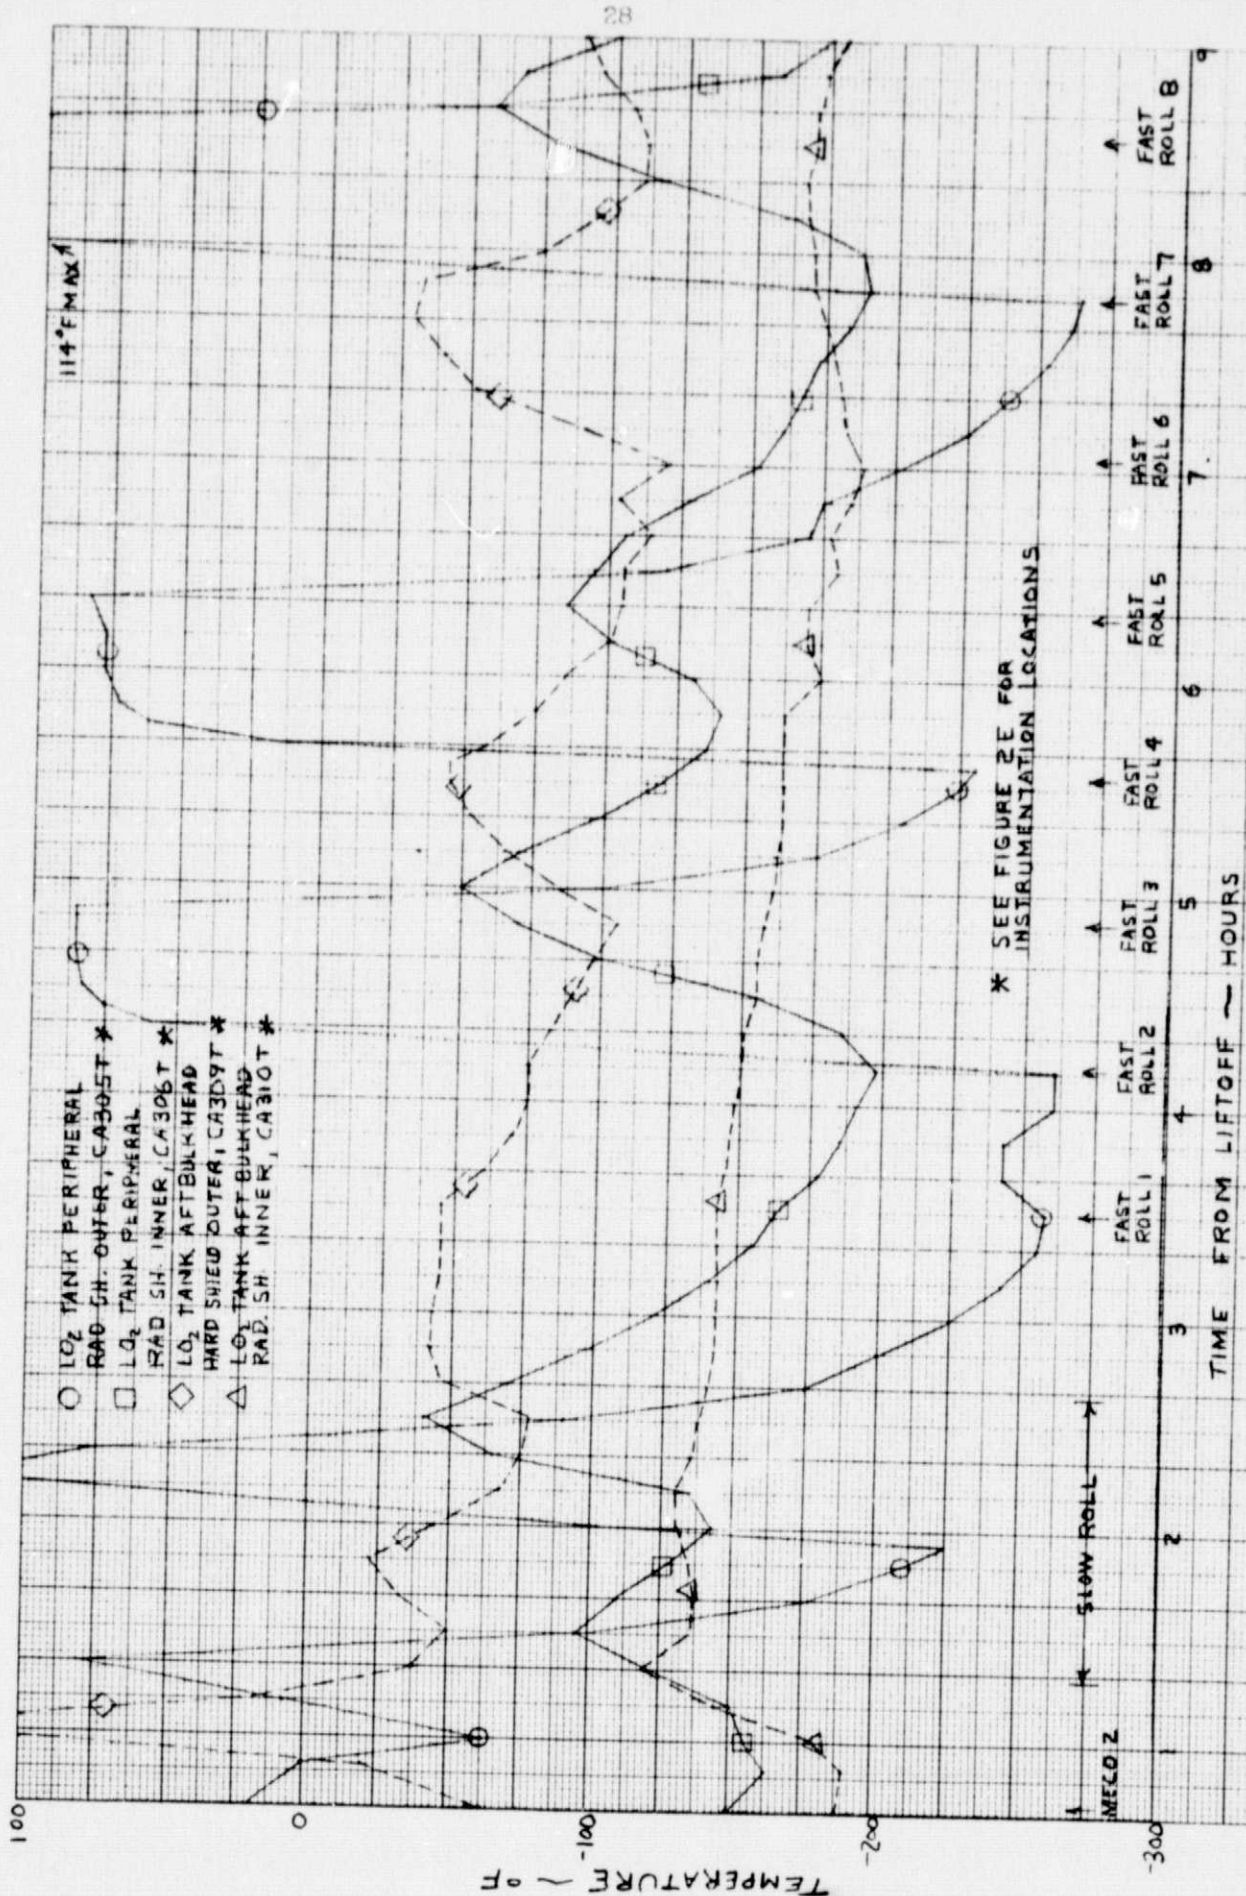
FIGURE 10. OXYGEN TANK AFT BULKHEAD RADIATION SHIELDING TEMPERATURE HISTORIES

The LO₂ tank aft bulkhead 3-layer radiation shield (using the same material as used on the LH₂ tank sidewall) system is sandwiched between a hard fixed nylon shield and the tank bracketry (see figure 2E). The thermal performance of this radiation shielding is shown in figure 10. The inner radiation shield temperature underneath the hard shield remained relatively constant at about -160°F. The high level of this temperature indicates that the shielding is evacuated and no cryogenic leakage flow exists under the shielding. Cryogenic leakage would increase the conduction between the tank and the shield and result in a very low shield temperature. The indicated heat flux, based on the inner shield temperature and LO₂ tank skin temperature, is 0.3 BTU/Hr.-Ft.² through the hard shield - 3-layer radiation shield composite. This heat flux is well below the performance goal of 1.0 BTU/Hr.-Ft.².

The thermal behavior of the LO₂ tank "peripheral" radiation shielding, which extends beyond the hard shield, is very similar to the LH₂ tank sidewall radiation shield temperature behavior. The large temperature excursions and gradients resulting from the thermal rolls indicate the good space performance of the shield systems.

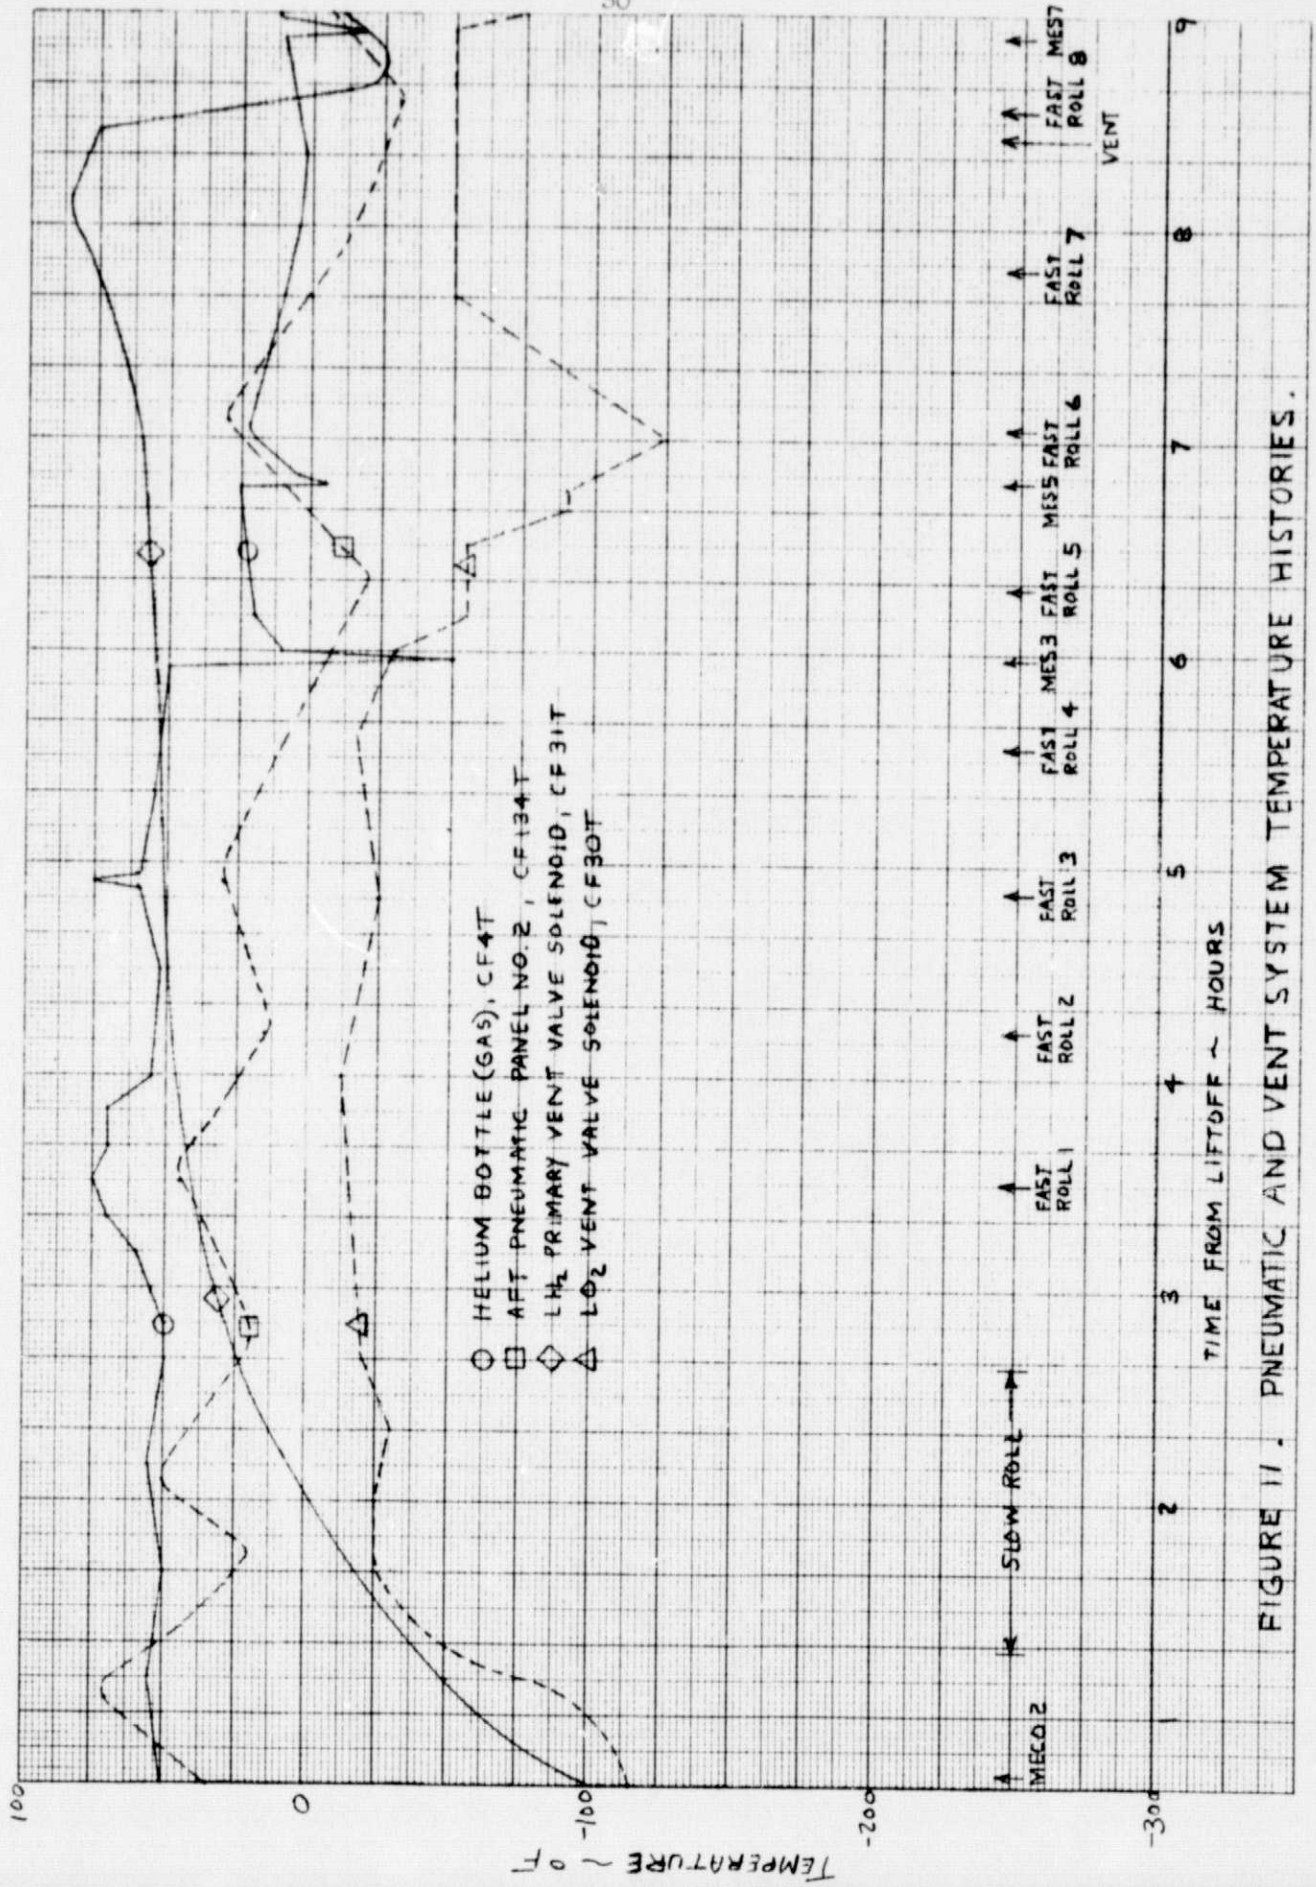
FIGURE 11. PNEUMATIC AND VENT SYSTEM TEMPERATURE HISTORIES.

For the extended mission, the two aft pneumatic panel temperature histories were nearly identical and ranged between 70°F and -30°F (the No. 2 pneumatic panel temperature history is shown in figure 11). The flight temperatures of the pneumatic panel components would also be within this range because of their larger thermal mass, and, hence, were well within their qualification limits (-100°F to 160°F for valves and -50°F to 125°F for regulators).

The helium storage bottle was wrapped with bonded aluminized mylar to keep the bottle warm during the coast in order to supply warm helium at an adequate pressure to the pneumatic and propulsion system components. The helium temperature history during the extended mission is shown in figure 11. As shown in this figure, the helium temperature decreases from 50°F to -50°F as helium is expelled for MES-3 pressurization but recovers rapidly after MES-3 as the result of heat soakback from the helium bottle. At the end of the mission, after most of the helium had been expelled, the helium temperature was 15°F, which is still sufficiently warm to have no adverse effect on those components that receive helium.

The LH₂ and LO₂ vent valves are normally open and require electric power (34 watts at 68°F) to be locked. In order to dissipate this energy during the extended mission the vent valve solenoids were painted white and thermal conductive grease was added between the solenoids and valve bodies. The resulting vent valve solenoid temperature histories are shown in figure 11. The LH₂ and LO₂ vent valve solenoids reached a maximum steady state value of 85°F and -10°F respectively. These temperatures were well below the 198°F qualification limit. The LH₂ vent valve solenoid temperature decreased nearly 100°F during the extensive tank venting during the 2-hour zero gravity coast prior to MES-7.

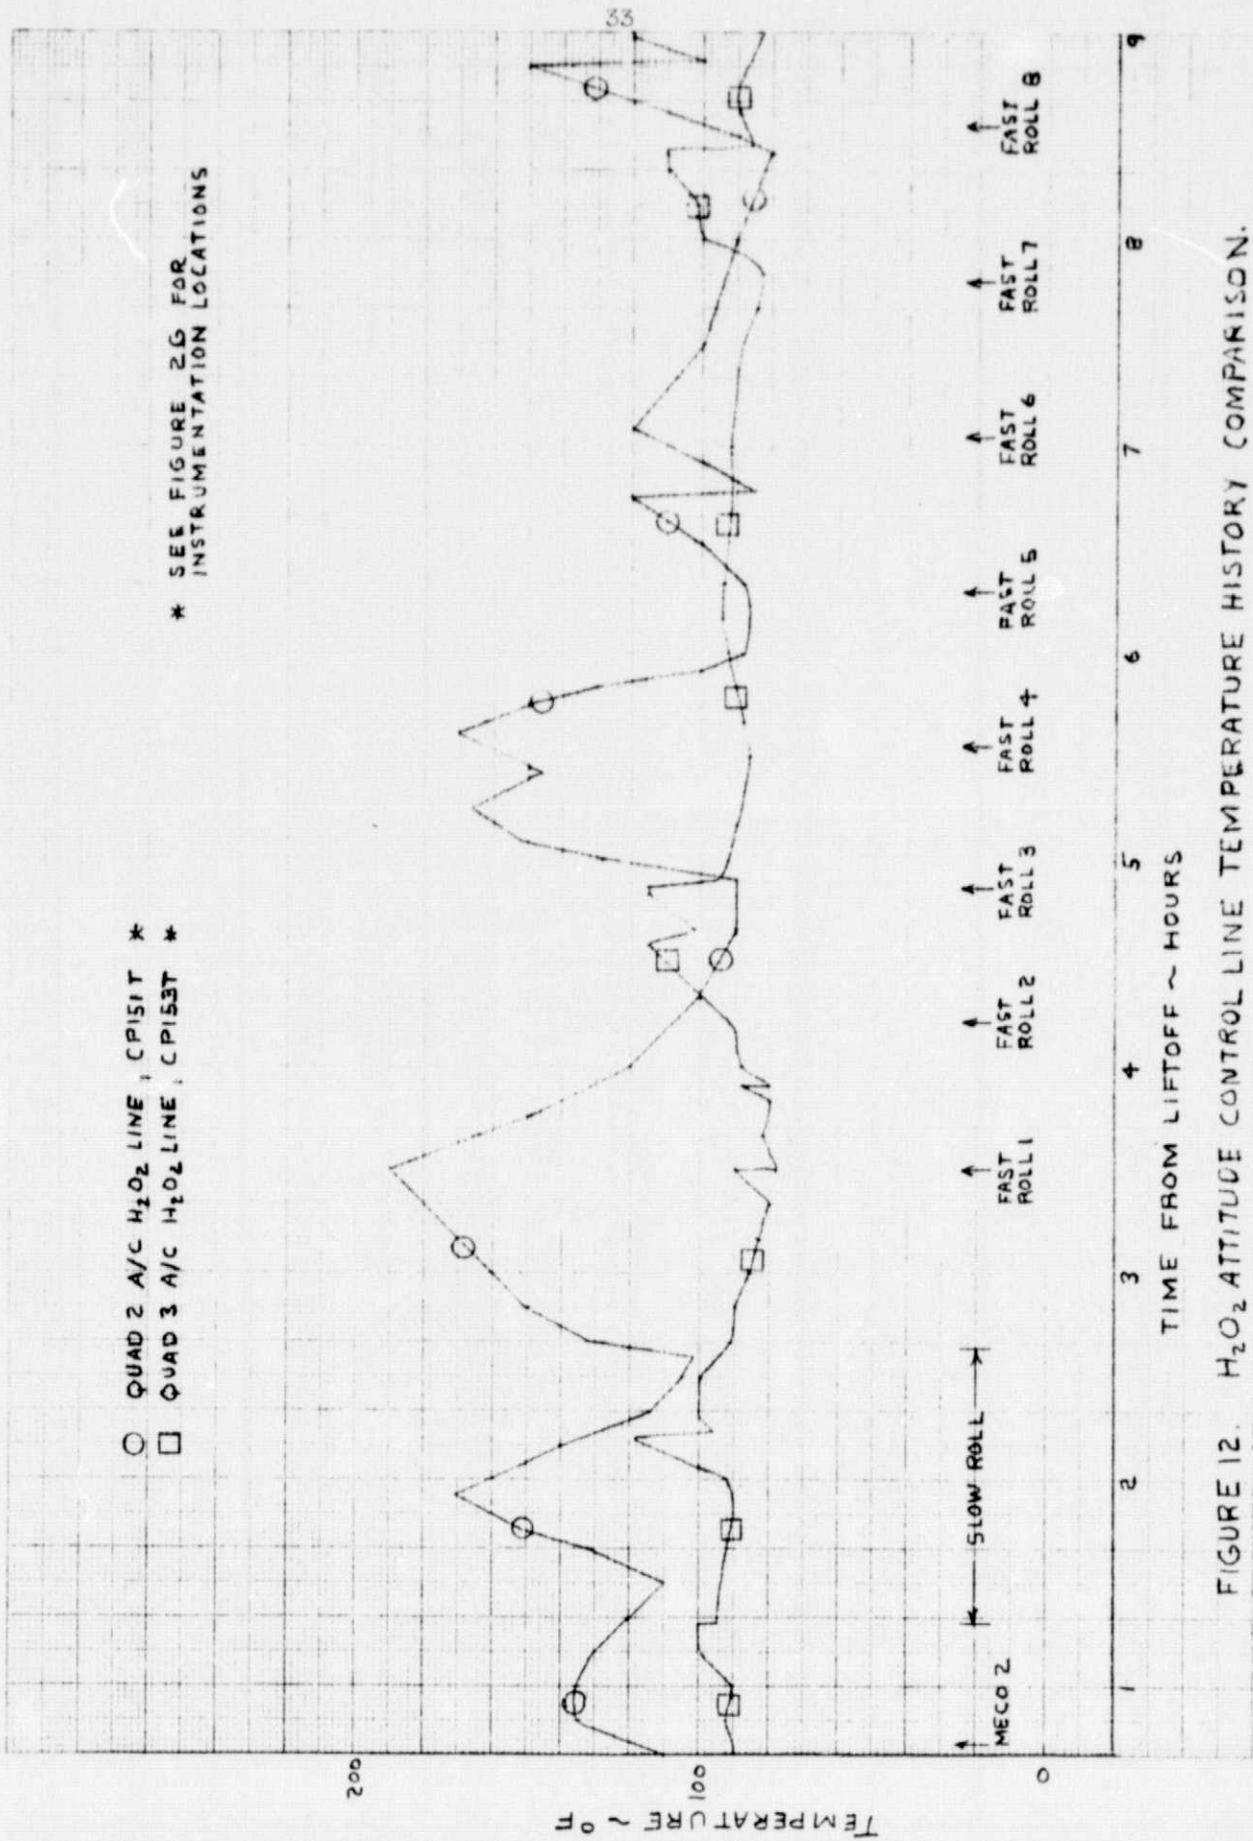
FIGURE 12. H₂O₂ ATTITUDE CONTROL LINE TEMPERATURE HISTORY COMPARISON.

All of the H_2O_2 system temperatures were satisfactory throughout the extended mission. Most of the temperatures were maintained within narrow bands. However, some of the heated lines did warm considerably due to location and H_2O_2 usage. An example of this warming is shown in figure 12, which compares the temperature histories of the heated H_2O_2 lines at two different locations. Because of the redundant H_2O_2 flow line configuration, some lines contain stagnant H_2O_2 for long times. The quad 2 attitude control line temperature (CP151T), which contains stagnant H_2O_2 , exhibits much larger excursions than the quad 3 line which benefits from the frequent flow of H_2O_2 required for engine firings.
