NASA TM X-73605

**THERMODYNAMIC DATA REPORT FOR THE
TITAN/CENTAUR TC-5 EXTENDED MISSION**

by Raymond F. Lacovic
Lewis Research Center
Cleveland, Ohio 44135
January 1977

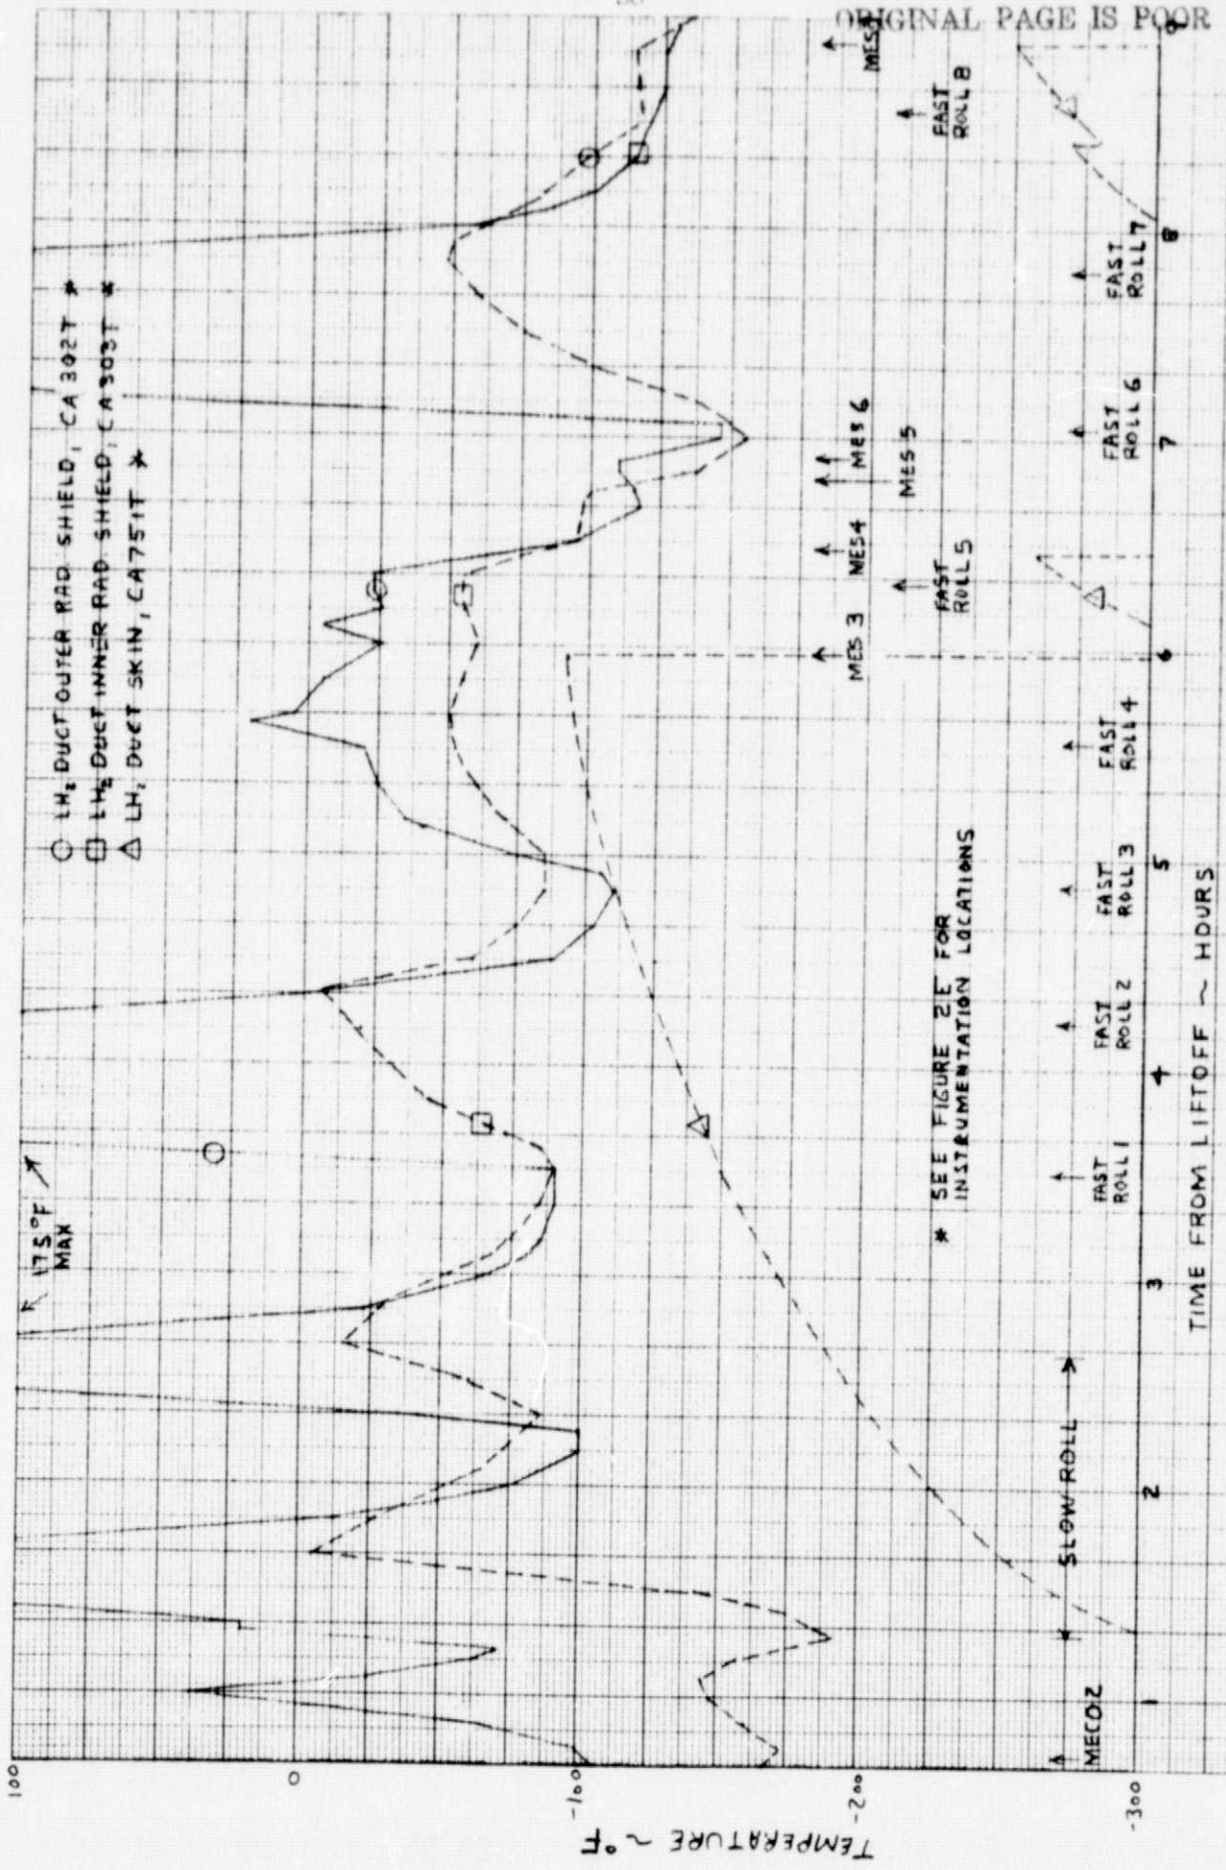
FIGURE 13. LIQUID HYDROGEN DUCT TEMPERATURE HISTORY.

The LH₂ and LO₂ propellant duct temperature histories during the extended mission are shown in figures 13 and 14 respectively. The maximum duct temperatures at the end of the 5-1/4-coast were -94°F for the LH₂ duct and -200°F for the LO₂ duct. The LO₂ duct radiation shielding, which got as warm as 260°F from H₂O₂ engine exhaust heating prior to MES-3, performed satisfactorily in limiting the duct temperatures.

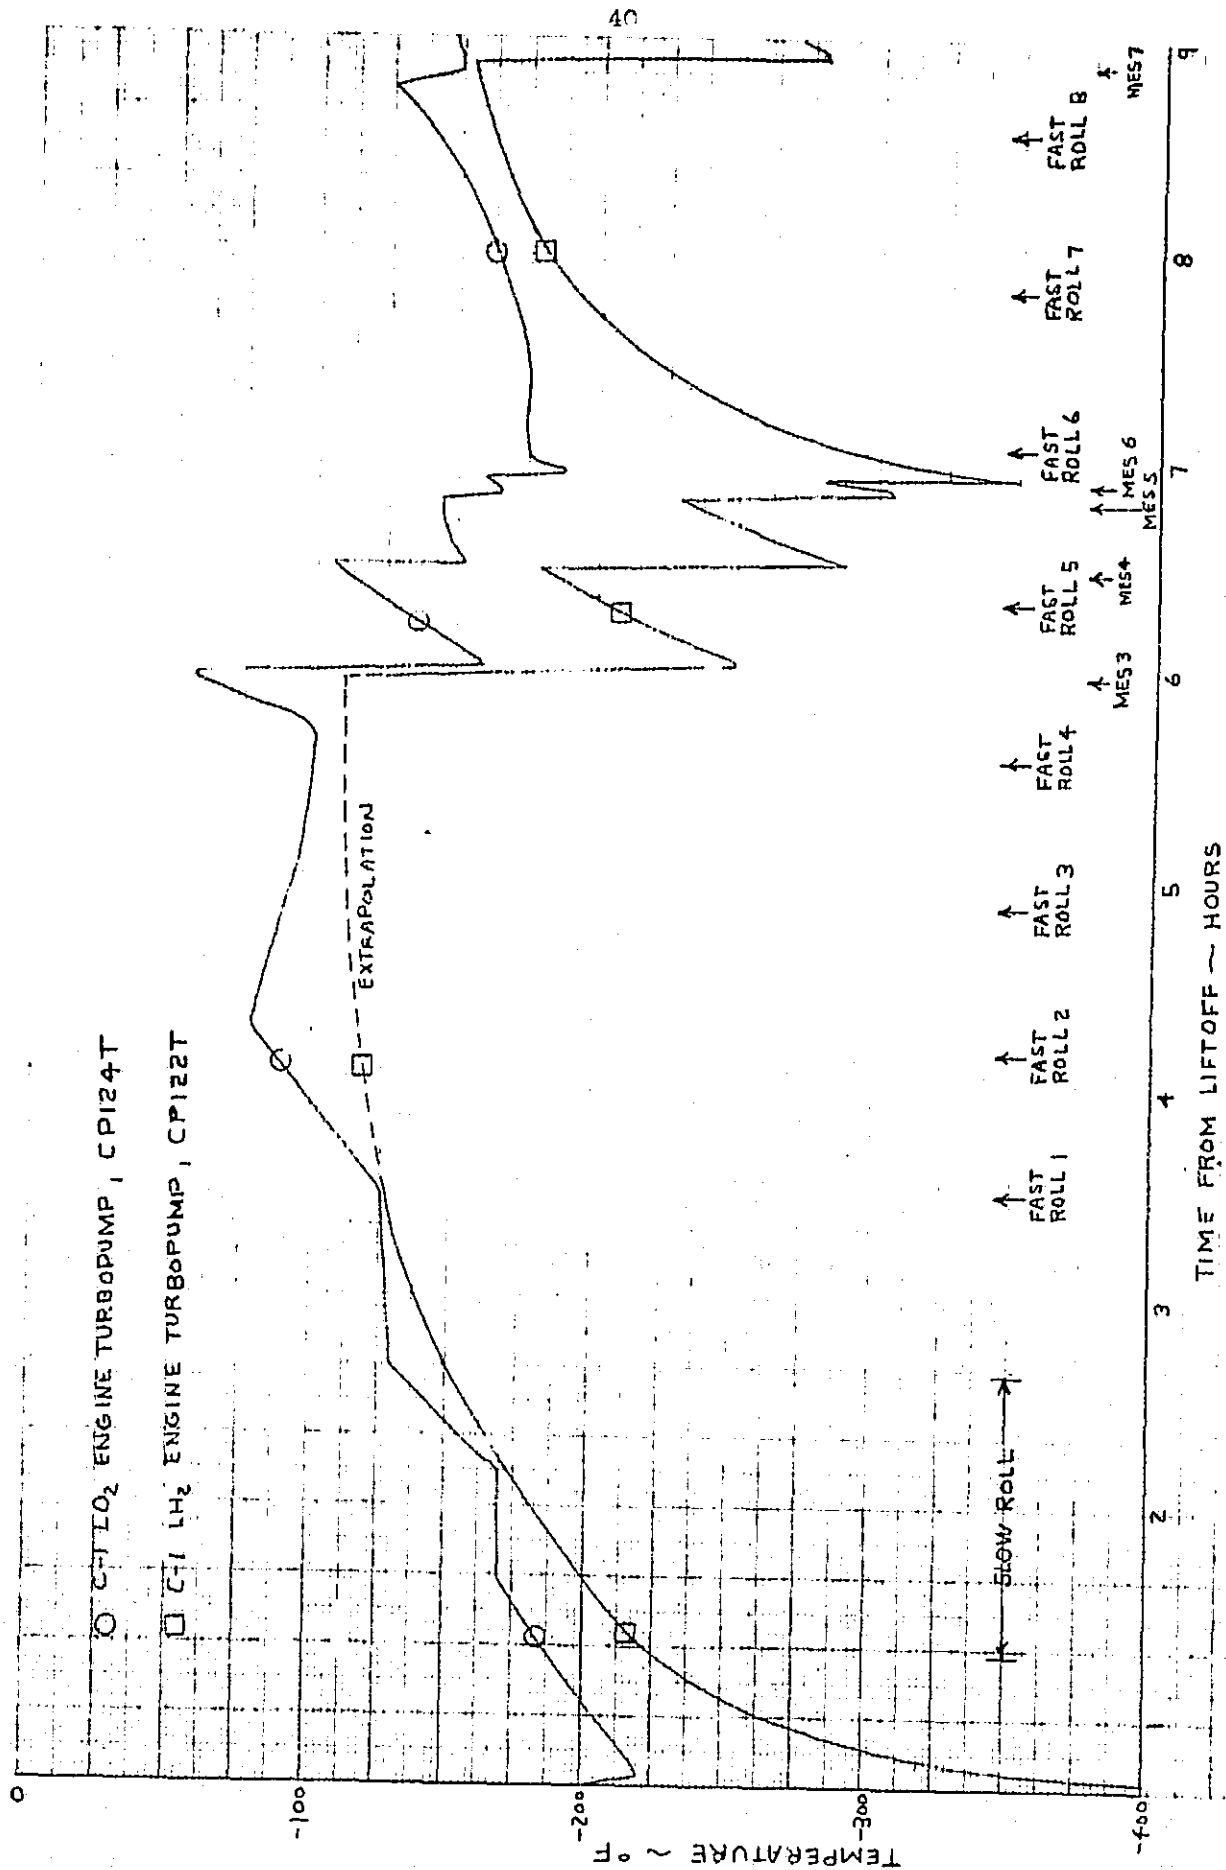
FIGURE 15. ENGINE TURBOPUMP TEMPERATURE HISTORIES.

The main engine systems were retained in the standard configuration used on previous Centaur missions and did not receive any thermal control changes for the extended mission. The engine components, however, did benefit from the thermal rolls as shown in figures 15 and 16. The LO₂ and LH₂ engine turbopump temperatures (see figure 15) at the end of the 5-1/4-hour coast were -55°F and -110°F respectively. These temperatures, together with the propellant duct temperatures, were well within the range of previous engine test experience.

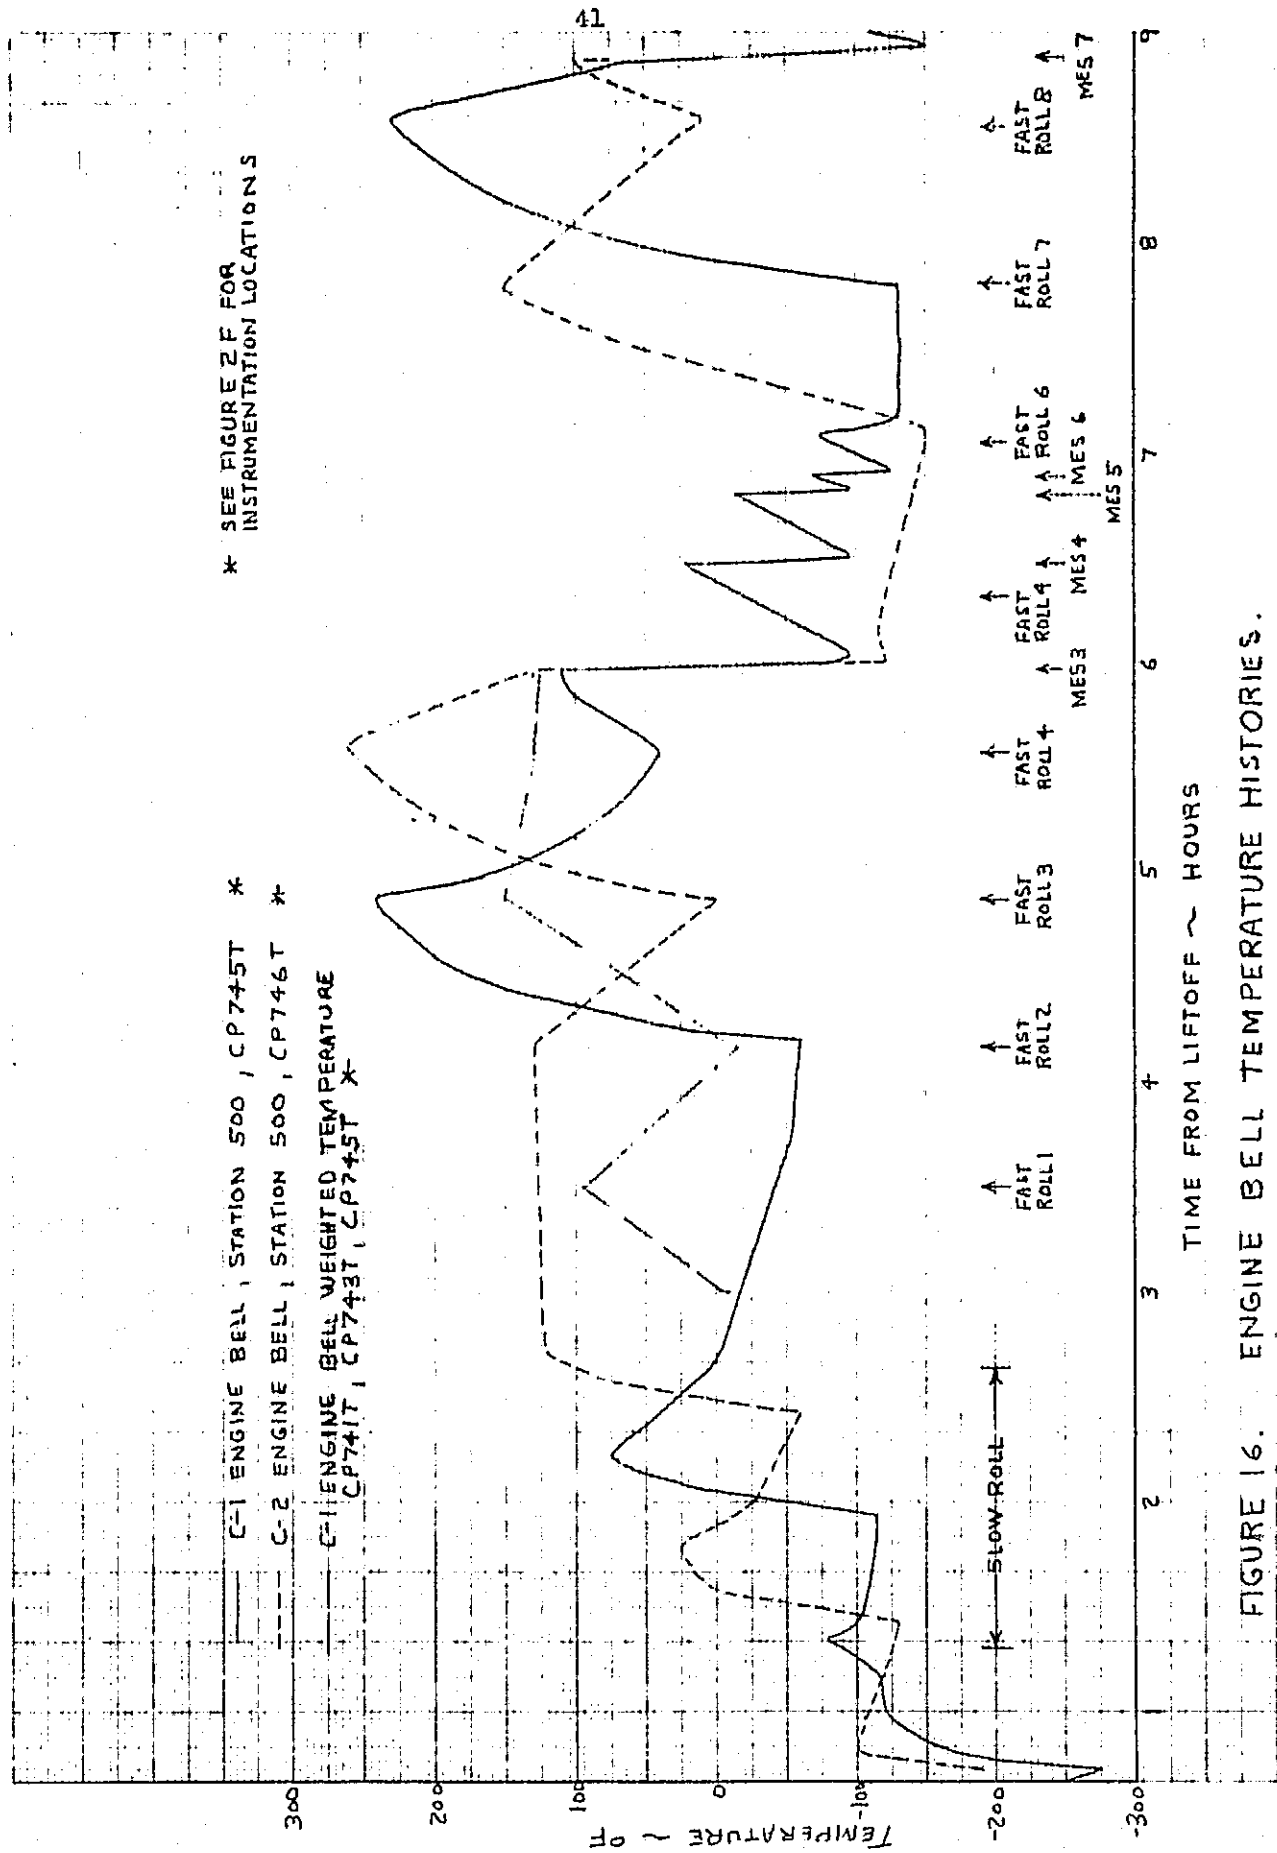
FIGURE 16. ENGINE BELL TEMPERATURE HISTORIES.

The engine bell temperatures, as shown in figure 16, reached a local maximum temperature of 260°F, and a weighted average maximum temperature of 150°F, during the 5-1/4-hour coast. The temperatures of the engine bells (the bells are 30% of the engine weight) are part of an engine requirement to maintain the weighted average engine temperature below 110°F. The maximum weighted average engine temperature was about 90°F for the C-1 engine at the end of the 5-1/4-hour coast. The thermal rolls prevented the various engine components from getting too warm. The maximum engine component temperatures experienced during the extended mission are listed in Table 5. Most of the maximum temperatures were obtained near the end of the 5-1/4-hour coast, as expected.

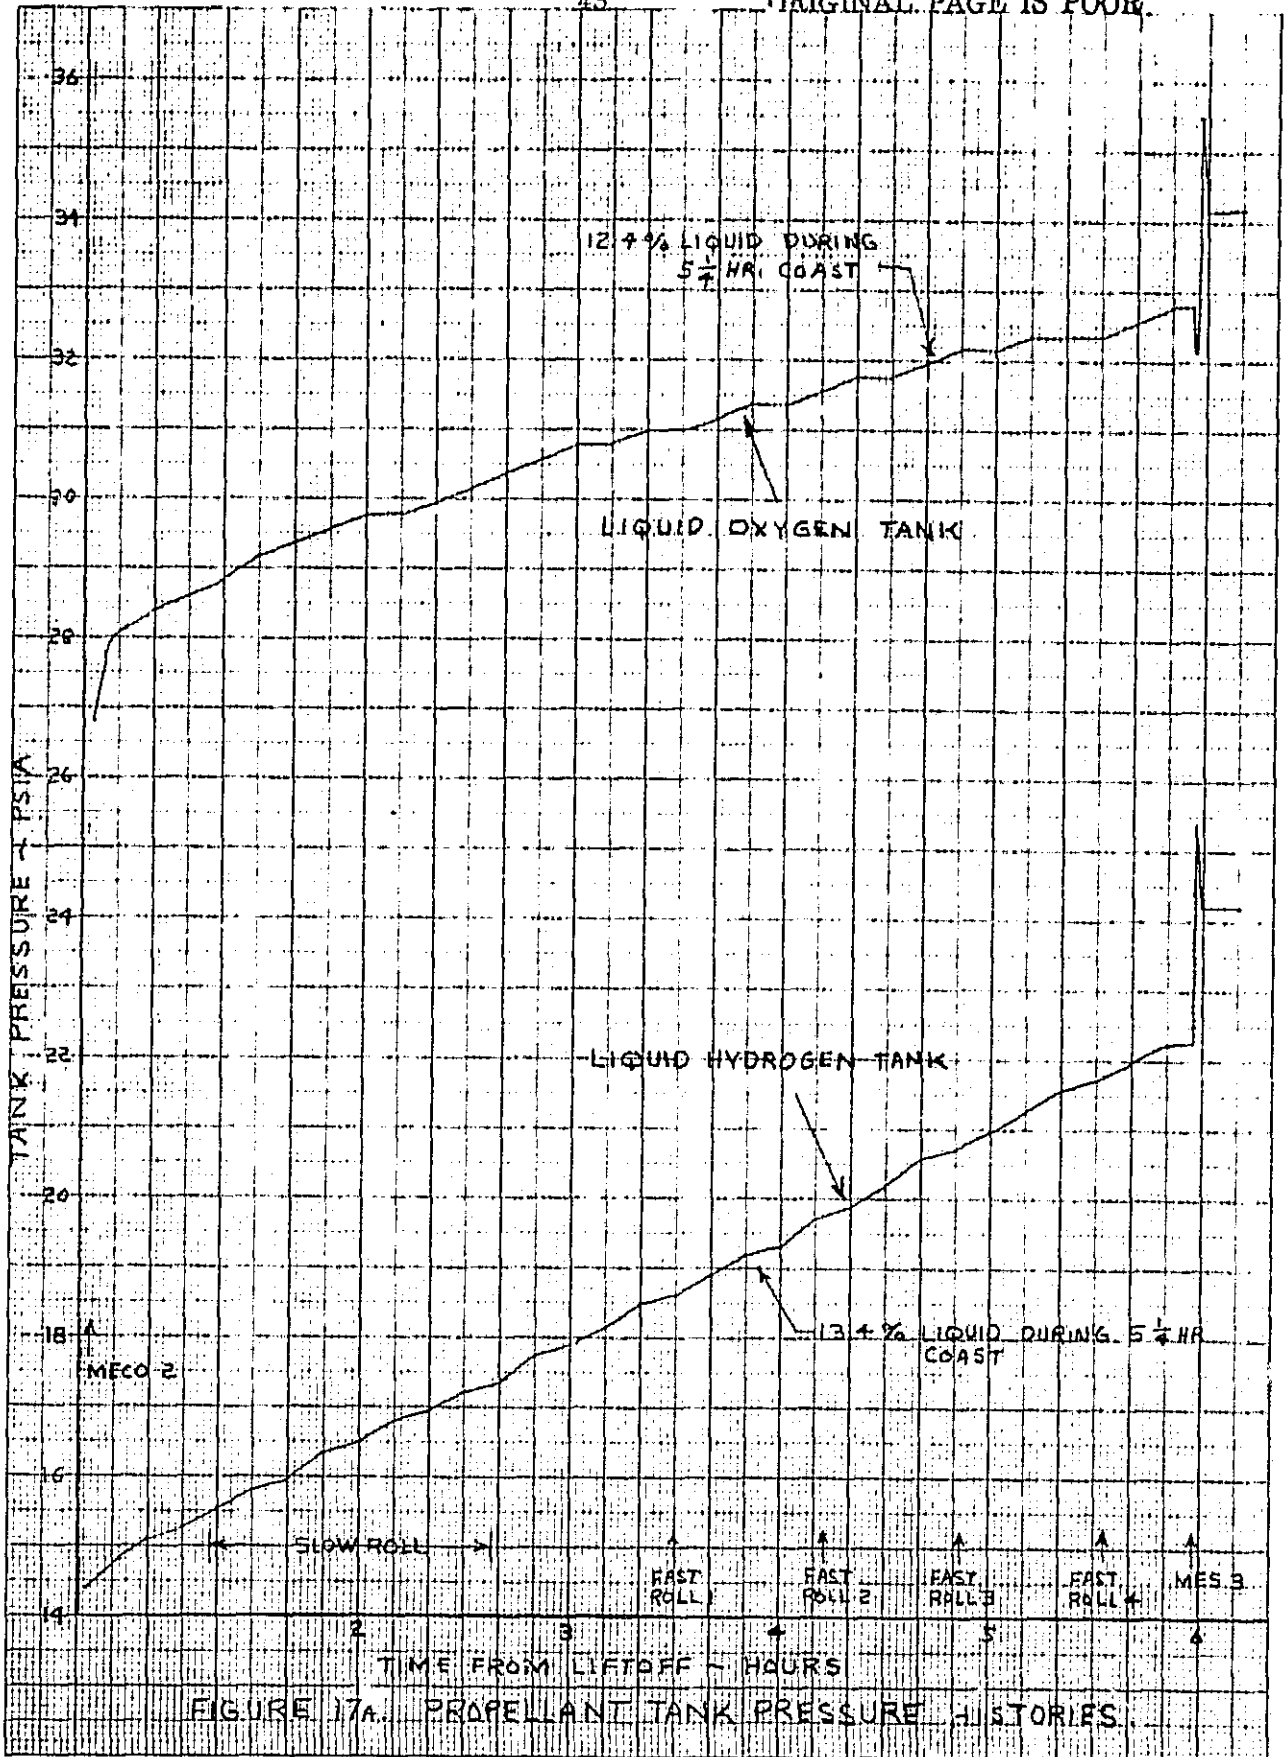
FIGURE 17A. PROPELLANT TANK PRESSURE HISTORIES.

The propellant tank pressure histories during the extended mission are shown in figures 17A and 17B. During the 5-1/4-hour zero gravity coast the tank pressures increased at a low rate, indicating the overall effectiveness of the vehicle thermal control systems. The LO₂ tank average pressure rise rate was 0.95 psi/hr., and the LH₂ tank average pressure rise rate was 1.47 psi/hr. These pressure rise rates were very close to the rates expected for thermodynamic equilibrium conditions assuming that all of the tank heat inputs going into the liquid.

The total heating rates are estimated to be 1400 BTU/Hr. and 2100 BTU/Hr. for the LO₂ tank and LH₂ tank respectively. These heating rates were sufficiently low to enable the Centaur to accomplish the 5-1/4-hour coast without requiring a venting of either tank. The tank pressures at the end of the 5-1/4-hour coast were 32.8 psia for the LO₂ tank and 22.3 psia for the LH₂ tank. These pressures were well below the vent initiation pressures of 45.0 psia for the LO₂ tank and 27.6 psia for the LH₂ tank.

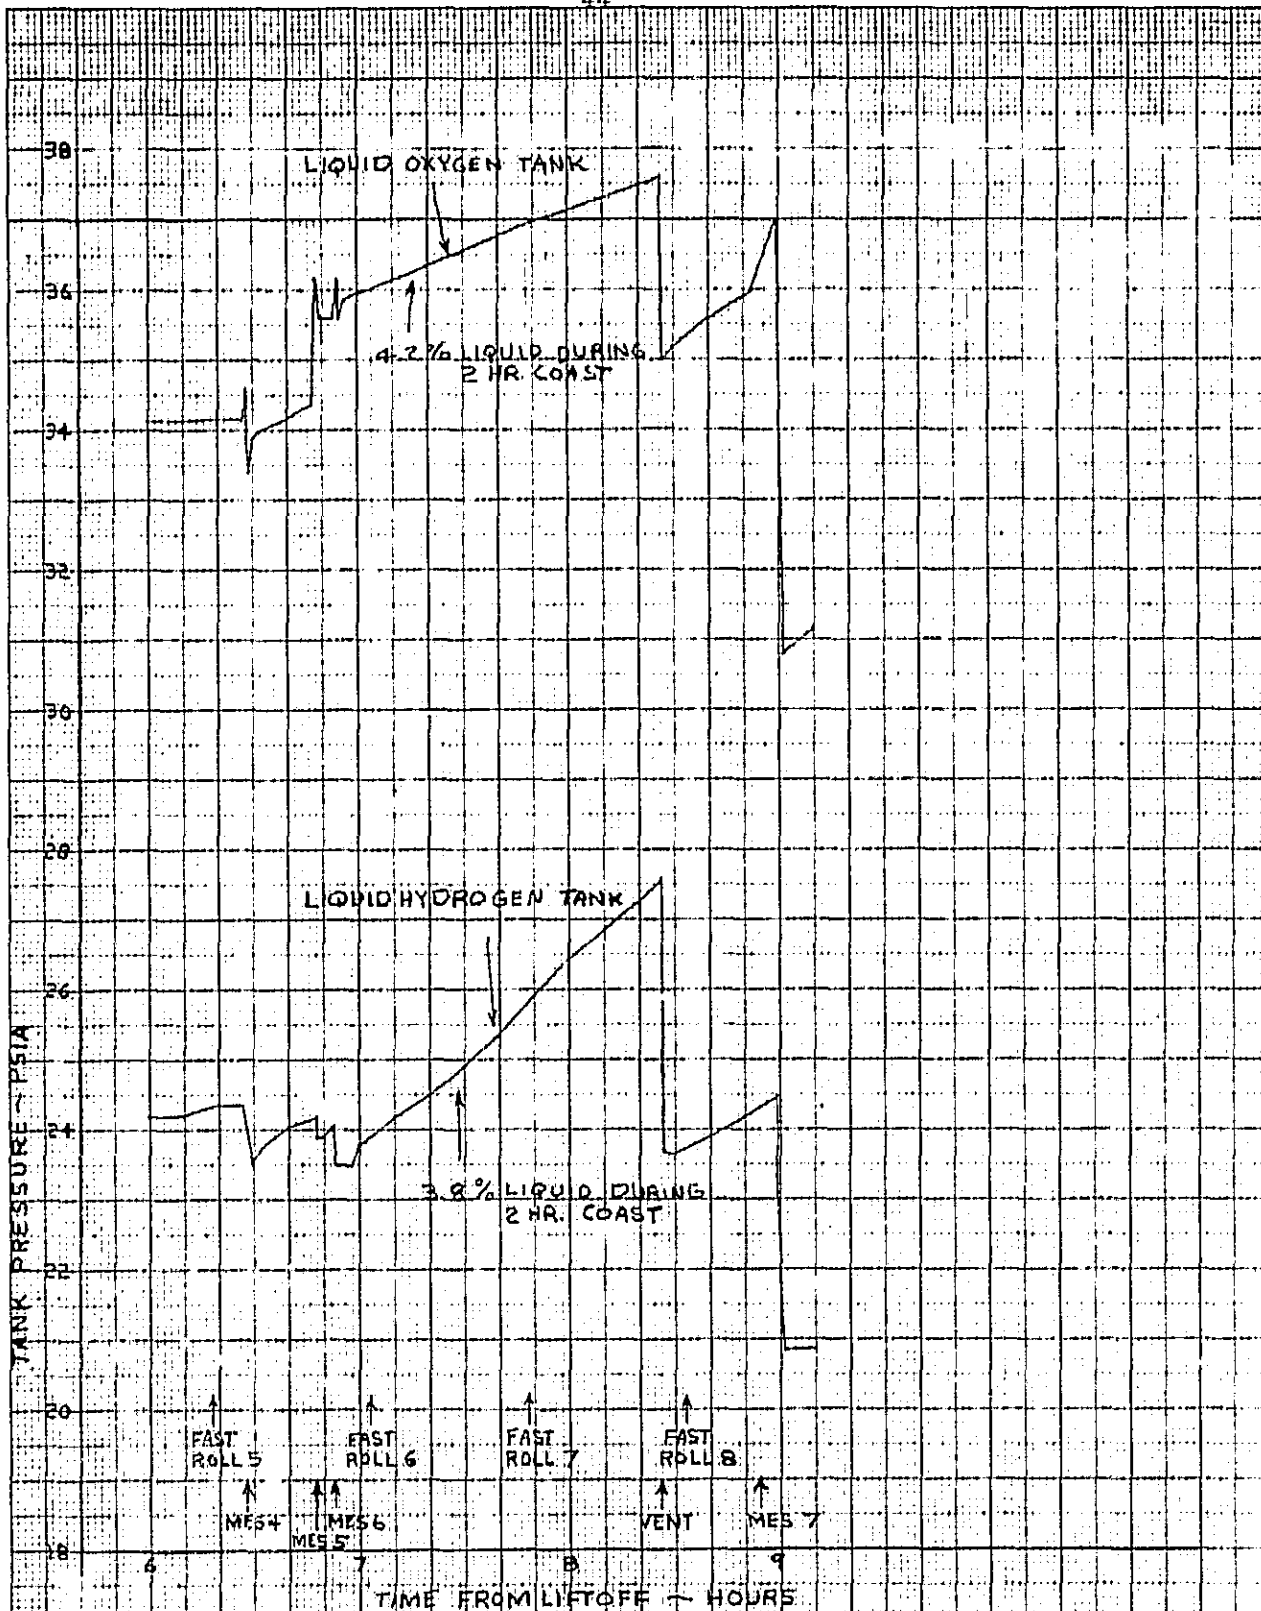
FIGURE 17B. PROPELLANT TANK PRESSURE HISTORIES (CONTINUED)

By the start of the two-hour zero gravity coast (after MECO-6) the liquid levels in the propellant tanks had been reduced considerably. With less liquid to absorb the tank heat inputs the pressure rise rates increased significantly to 1.2 psi/hr. for the LO₂ tank and 2.8 psi/hr. for the LH₂ tank. At about 1-1/2 hours into the 2-hour coast (8 hours and 25 minutes after liftoff) the LH₂ tank pressure reached the vent initiation pressure resulting in a propellant settling (collection) period of 150 seconds followed by a venting period of 40 seconds. During the venting period the tanks were vented down to the vent termination pressures of 35.0 psia for the LO₂ tank, and 23.5 psia for the LH₂ tank.
