NASA CR-135050

COATINGS FOR DIRECTIONAL EUTECTICS

FINAL REPORT

Metallurgy Laboratory
Corporate Research and Development
General Electric Company
Schenectady, New York 12301

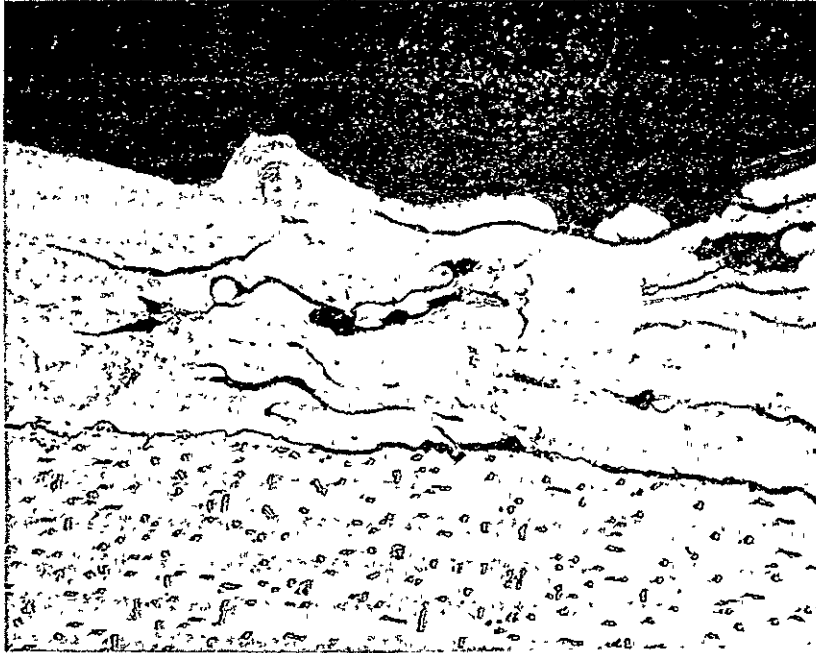
Figure 8. Ni-20Cr-5Al-0.1Y-0.1C coating metal spray deposited onto NiTaC-13: (a) as-deposited, (b) heat treated 3 hours at 1160°C in Ar. 500X

An ingot containing Ni-20Cr-5Al-0.1Y-0.1C was prepared and this was successfully swaged to 0.32-cm-diameter wire suitable for metal spraying. Pin specimens were coated with layers about 50 to 100 μm thick using gun flame to preheat the surface. The coating as deposited is quite nonuniform in thickness and is porous as is shown in figure 8(a). Heat treatment did not densify the coating much, as can be seen in figure 8(b). However, it should be noted that there is very little substrate decarburization which indicates that this concept of carburizing the coating is a valid approach. However, the preheating did result in the formation of a thin oxide layer at the substrate-coating interface. It was considered possible that the denudation resistance might be a result of this oxide layer, rather than the carbon-bearing coating. Therefore, new specimens were prepared without the substrate preheat step. Micrographs of one of these specimens are shown in figure 9 in the as-deposited and as-heat treated conditions. In many regions of this sample, the bond between the coating and substrate was intimate. As before, the tendency toward carbide denudation is essentially eliminated.

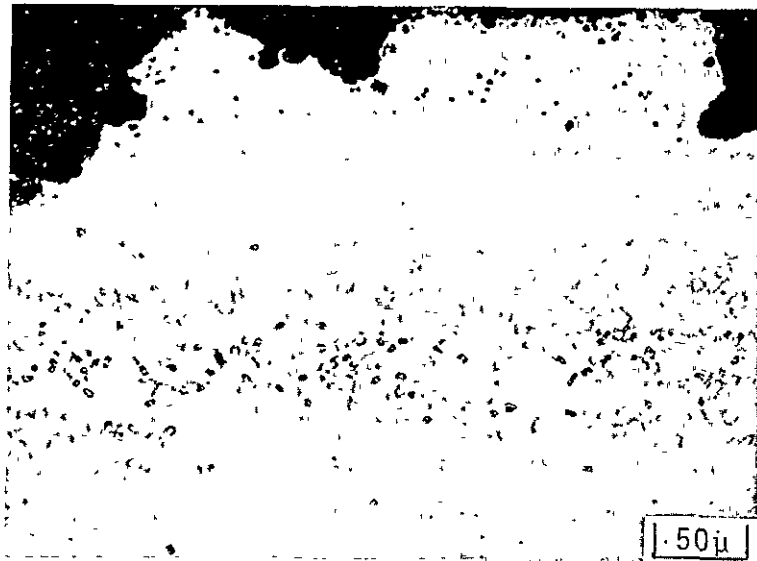
Figure 17. E.B. Co-30Cr-5Al-1Y+aluminize on NiTaC-13 after 2000 hours cyclic oxidation (1100° -93° C).

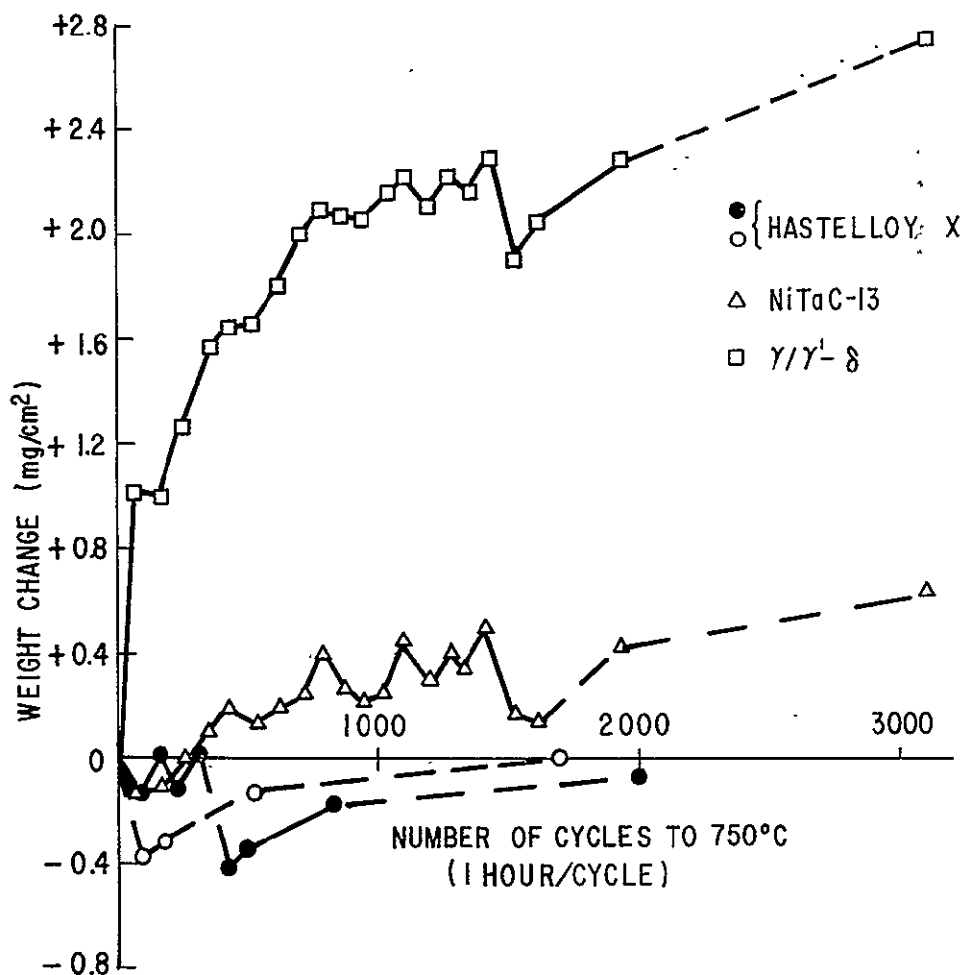
Figure 22. Weight change as a function of number of 1-hour cyclic oxidation exposures to 750°C for NiTaC-13, $\gamma/\gamma'-\delta$, and Hastelloy-X.

Weight change data for the three alloys are shown in figure 22. The total weight changes for both eutectics after 3100 hours of cycling are small. The weight gains correspond to $\sim 3 \mu\text{m}$ of Al_2O_3 formation for NiTaC-13, and $\sim 15 \mu\text{m}$ of Al_2O_3 formation for γ/γ' - δ , if oxidation is uniform. For NiTaC-13, the surface of the sample retains a metallic sheen with a slight green cast to it. The γ/γ' - δ is no longer metallic in surface appearance, but is covered with a yellow-green layer of oxide. Microstructures of transverse sections of the two alloys are shown in figure 23. Apparently, NiTaC-13 type alloys will not require a coating for turbine blade roots. The preferential oxidation in γ/γ' - δ , observed here and under another NASA program

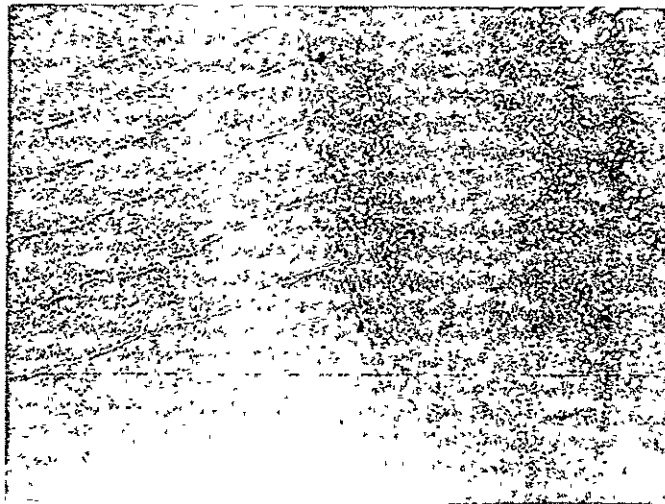
Figure 49. SEM micrograph of replica of coated bar strained 1.3%. 40X
