## STUDIES OF NOBLE-METAL THERMOCOUPLE STABILITY AT HIGH TEMPERATURES

P. D. Freeze and D. B. Thomas

Prepared for  
NATIONAL AERONAUTICS AND SPACE ADMINISTRATION

Issued July, 1976

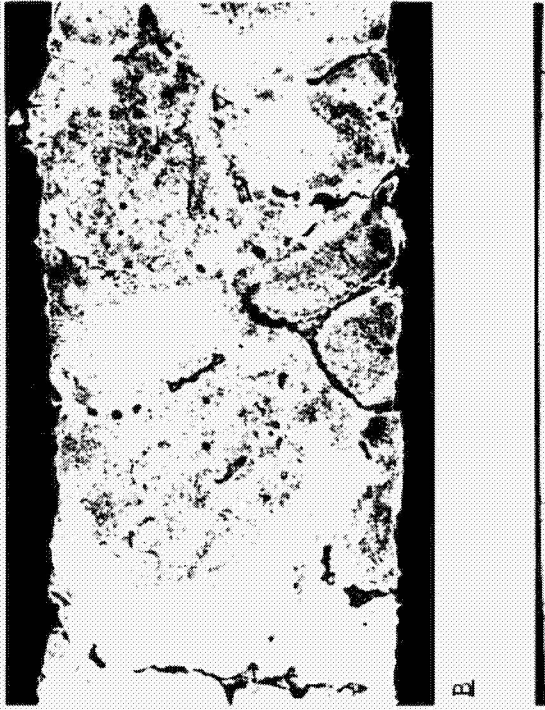
FIGURE 10: MICROGRAPHS OF SECTIONED COMPONENTS OF TEST THERMOCOUPLES UNHEATED (A, ALLOY AND C, IRIIDIUM) AND AGED AT 2000°C FOR 8 HOURS (B, ALLOY AND D, IRIIDIUM). THE MAGNIFICATION WAS 80X, FURTHER DESCRIPTION IS IN THE TEXT, 2.7.2. THERMOCOUPLE SYSTEM: IRIIDIUM-40% RHODIUM VERSUS IRIIDIUM.

Figure 10 consists of four micrographs at a magnification of 80X and illustrates changes in microstructure that may occur following exposure to a high-temperature oxidizing environment. Photograph 10a is of a specimen taken from an unheated portion of a thermocouple alloy component; photograph 10b is of a specimen taken from the same thermocouple component, but from a portion exposed to 2000°C, in air. Similarly, photograph 10c is of a specimen taken from an unheated portion of the iridium component of the same thermocouple, and photograph 10d is of a specimen taken from a portion of the same iridium component exposed to 2000°C, in air. The aged specimens were
